**Web Cracking Repair Design for Bridge
SR 46-3020-0020-0000 on US 202 in
Montgomery County, PA**

PennDOT ECMS No. E00511: Work Order No. 10

**Field Instrumentation, Monitoring
and Analysis**

ATLSS Report No. 07-10

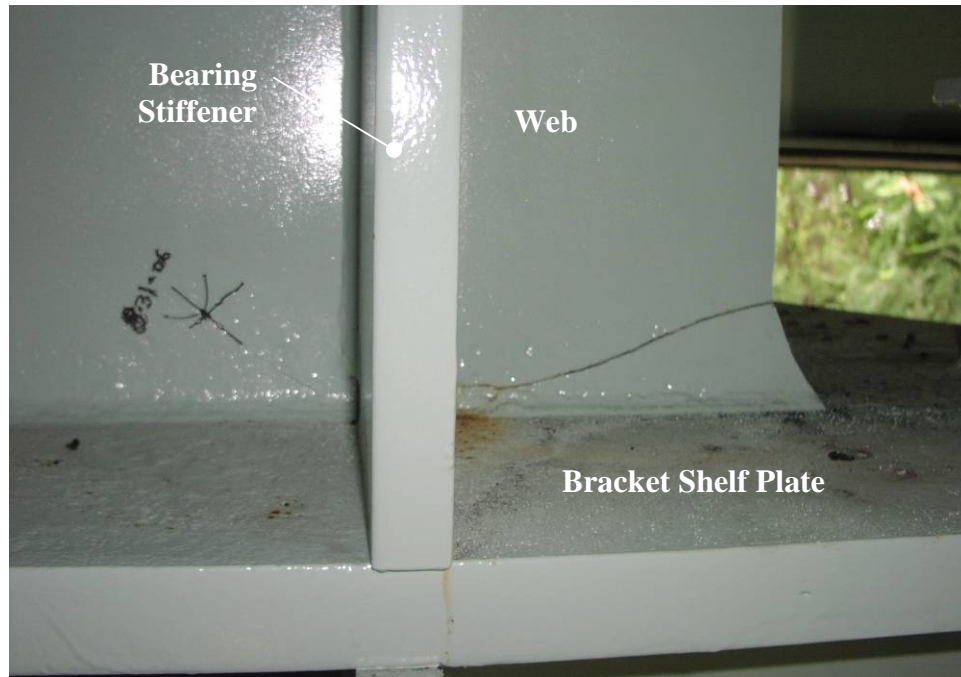
The bridge SR 46-3020-0020-0000 in Montgomery County, PA, carries new US Route 202. During the painter's inspection of a completed paint job in late August 2006, a crack was detected in the web of Girder 3 in the North Bound Span 2 at the intersection with the floor beam, above the seating for Span 1. The bridge was last inspected on April 22, 2005 by DMJM Harris and no crack was detected. In May 2006 the deck joint at this pier was replaced.

Figure 1 Crack detected in the web of Girder 3

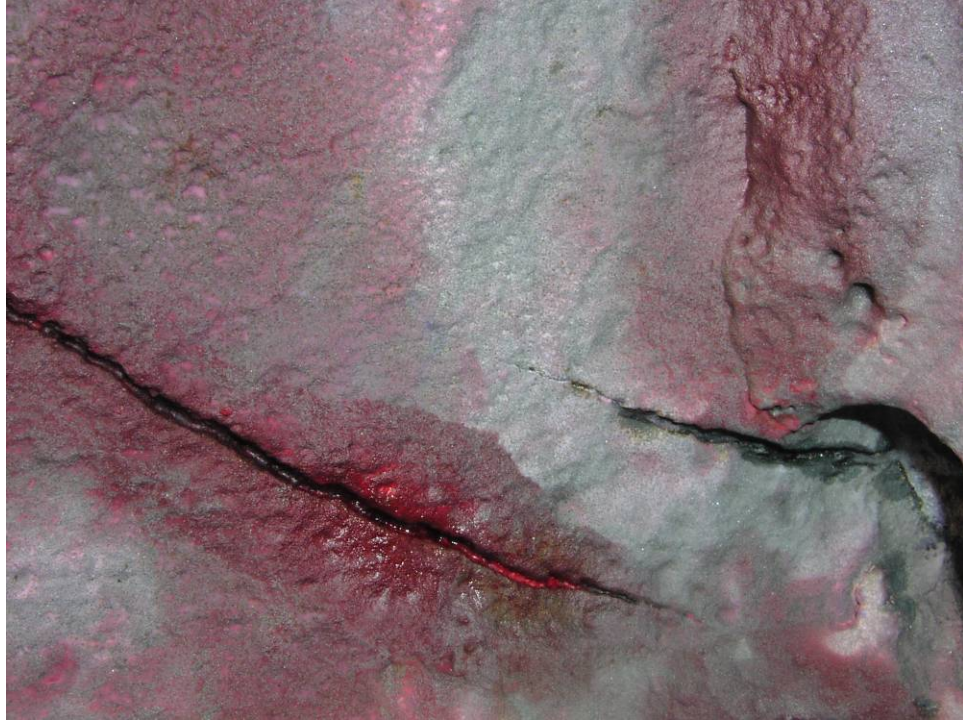
The cracks in Girder 3 had initiated from the cope in the transverse bearing stiffener near the termination of the bearing stiffener/floor beam connection plate-to-web weld above the bracket shelf plate (Figures 12 and 13). The crack then propagated diagonally into the web on both sides of the stiffener/connection plate. Towards the end of the girder the crack completely fractured the girder web (Figure 1). On the other direction, the crack terminated after growing for about three inches. Further possible growth into the web was arrested by drilling holes at the crack tip. Except at Girder 3 (the NB interior girder), no cracking was observed in any of the other girders.

Based on the field instrumentation, controlled load test, short term monitoring, fractographic investigation material tests and finite element analyses, it appears that cracking of the web of Girder 3 was due to cleavage fracture that probably initiated from a flaw condition at the termination of the transverse stiffener to web weld near the cope, during an unusually extreme load event, such as low temperature and/or impact from overloading. The flaw condition could be due to a relatively large weld fabrication defect or propagation of fatigue crack from micro discontinuities. Efforts were made to core out any such flaw at the crack origin for examination, but in vain. Due to the presence of floor beam and bearing stiffeners close to each other near the crack origin, the core could only be drilled away from the origin. Limited FEA verified the relatively small live load stresses measured at the web gap, which was insufficient to cause fatigue crack propagation under service loading.

Figure 12 Crack origin (north side of bearing stiffener)

To prevent cracking at similar locations in other girders, it was recommended to drill 2 in diameter holes on either side of the floor beam connection plate/bearing stiffener and just above the longitudinal weld between the bracket shelf plate and the web of the girders. The holes were drilled as close to the stiffeners as possible. The edges of the holes were ground smooth to remove any possible stress concentration from surface irregularities that might become initiators of fatigue cracks. In case of any unstable crack growth these holes are expected to act as crack arrestors. These holes are also expected to provide some relief to the constraint condition that may exist at the intersection of bearing shelf plate, floor beam connection plate and bearing stiffeners. The girder ends should also be inspected at the existing inspection cycle of two years interval.

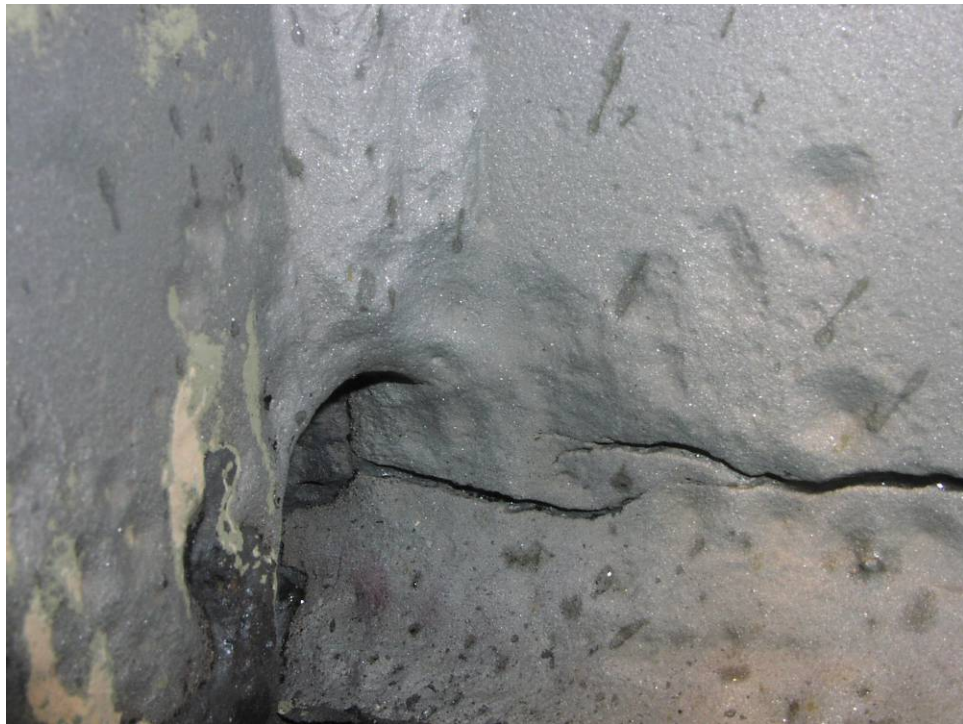
Another reason for this cracking could be the over-constraint provided by the floor beam connection plate, the bearing stiffeners and shelf plate, all of which are welded to the web in close proximity near the crack location. As such, the web plate is under high tensile residual stress field at this junction. The existing copes in the connection plates/stiffeners are too small to provide sufficient relief to the constrained condition. On the contrary, presence of small gaps in this highly constrained region may create a crack like condition that can initiate unstable fracture.

Figure 13 Crack origin (south side of bearing stiffener)

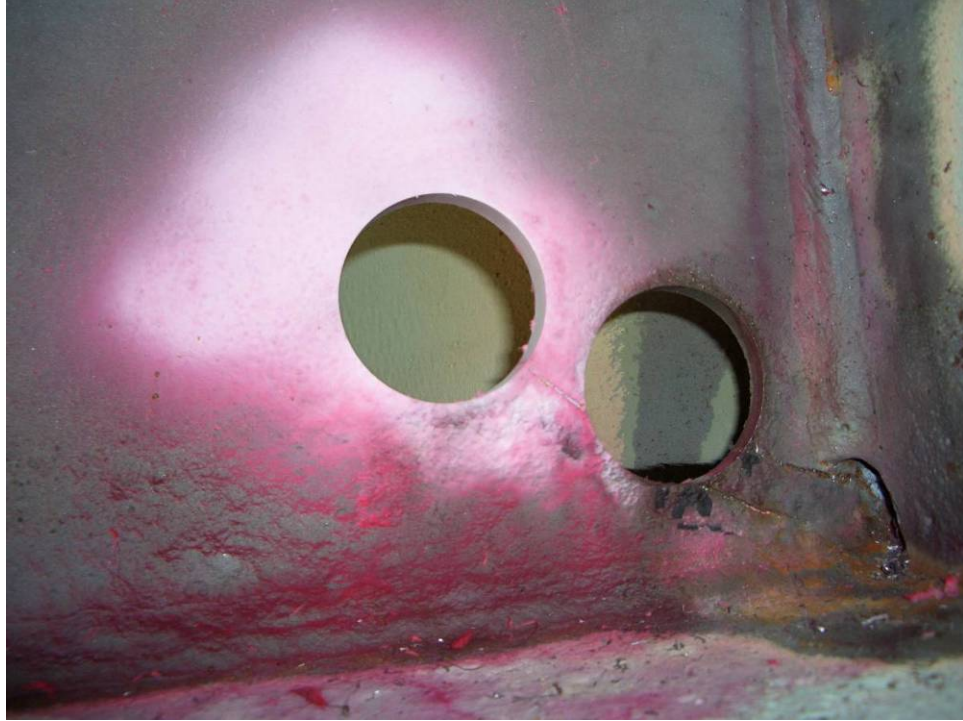
Holes were drilled at the crack tips in the web of Girder G3 to arrest possible crack growth. One of the cores retrieved from these holes contained part of the crack surface. The fracture surface and the crack front was exposed by brittle fracture after cooling down the core to cryogenic temperature.

Figure 14 Holes drilled at crack tips

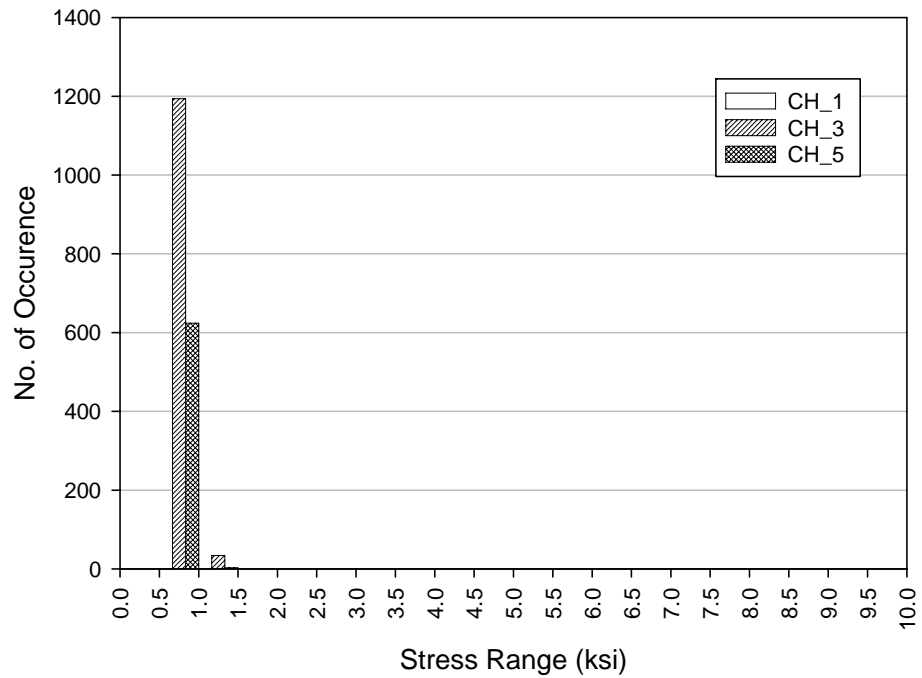
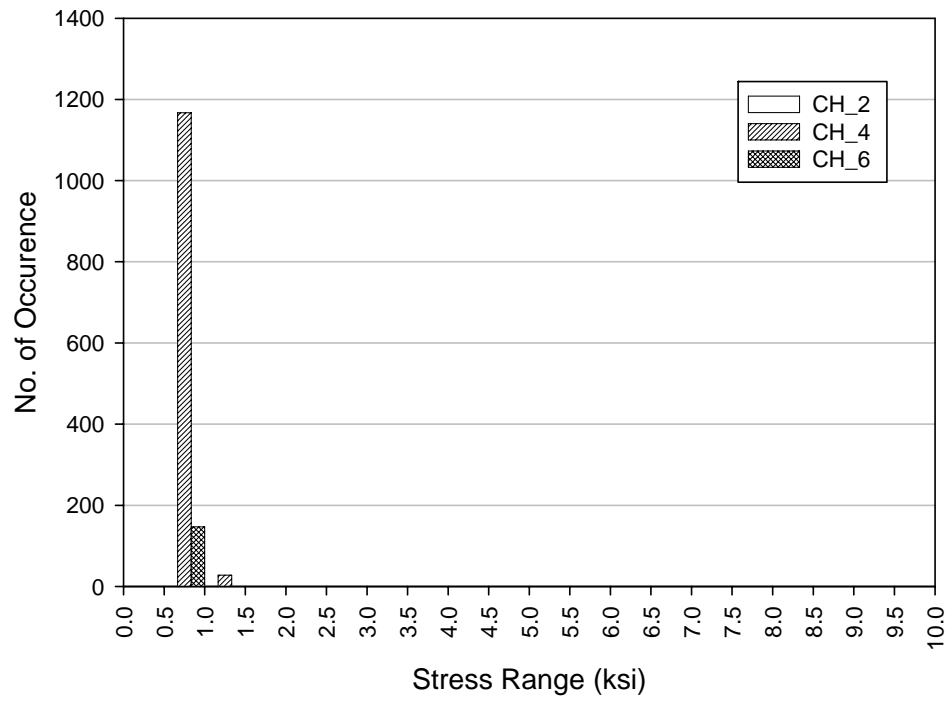
Histograms of live load stress ranges measured at the strain gage rosettes on the span side web of Girder 1 (channels CH_1 to CH_6) near the possible crack origin are shown in Figures 46 and 47.

The live load stress ranges near the bracket shelf plate were less than 1.5 ksi under both controlled loads and in-service traffic. Noting that the fatigue threshold for the most severe AASHTO detail category E' is 2.6 ksi, fatigue crack propagation in the girder web under usual traffic condition is unlikely.

Figure 46 Measured stress range histogram at strain gage channels CH_1, CH_3 and CH_5

Figure 47 Measured stress range histogram at strain gage channels CH_2, CH_4 and CH_6

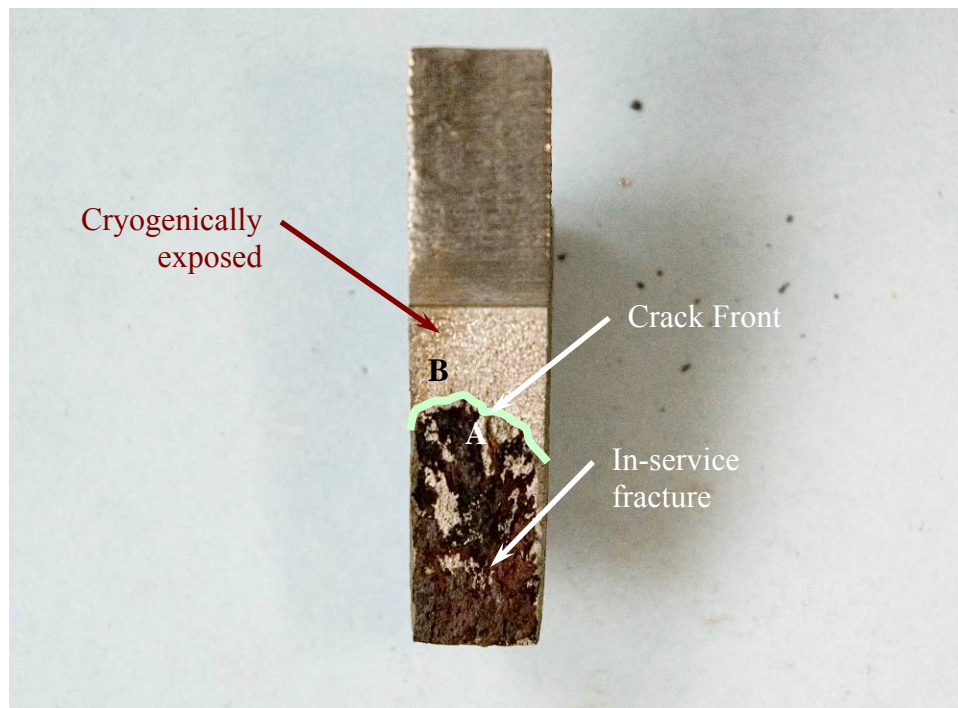
The exposed fracture surface is shown in Figure 48. The crack surface was substantially corroded, which indicated that it was probably a few years old. No evidence of paint marks was noted on the crack surface, however.

Figure 48 Exposed surface of crack in web

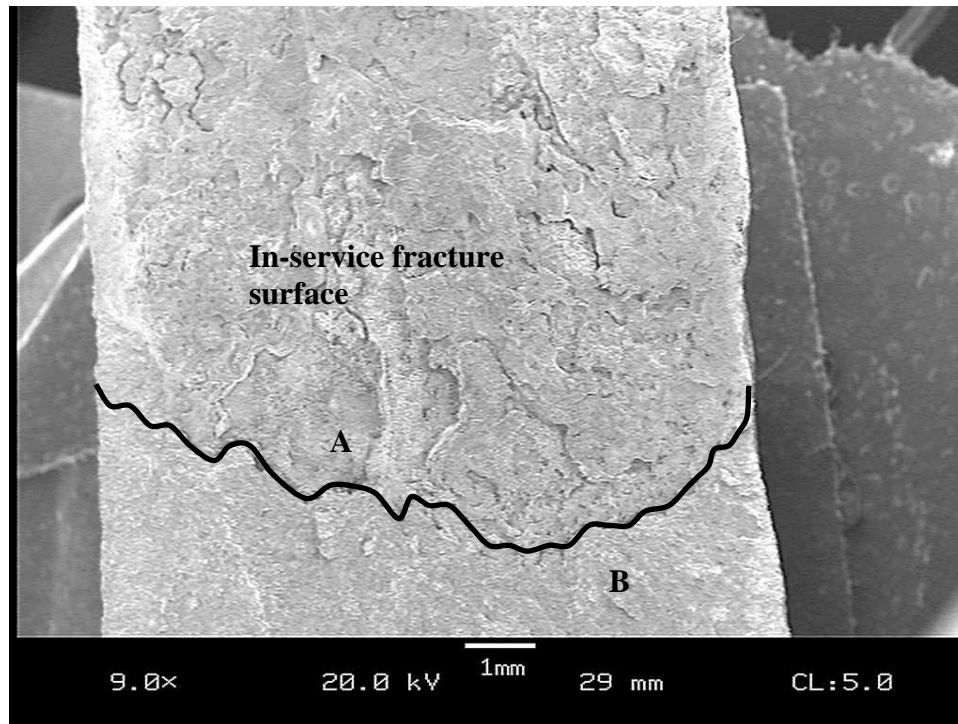
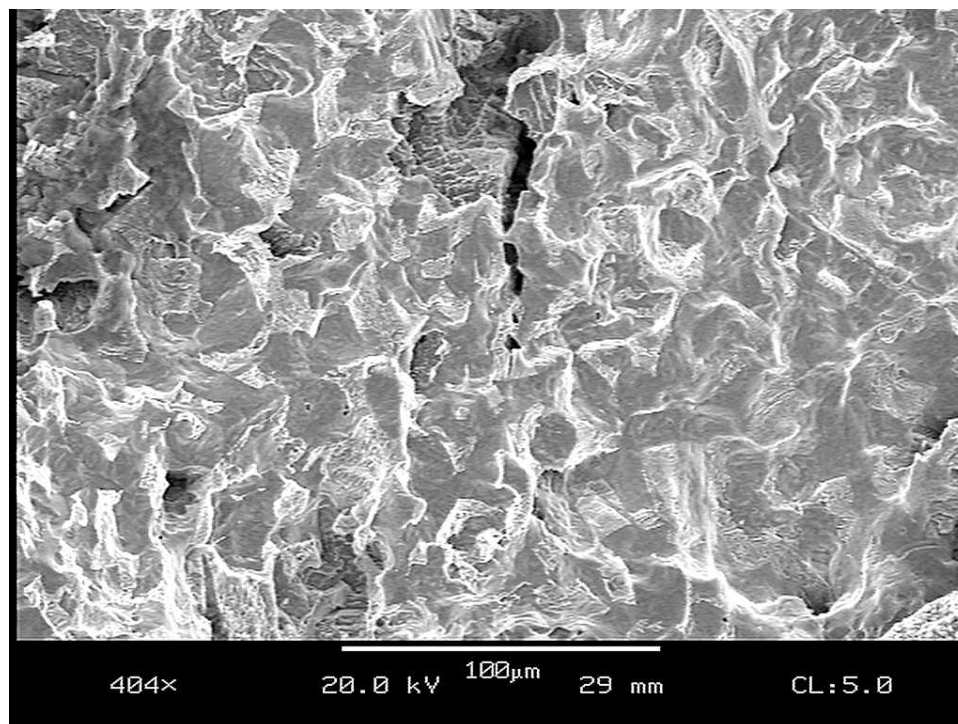
Examination of the crack surface under scanning electron microscope (Figures 49 and 50) revealed cleavage facets indicating that the cracking of the web had occurred by cleavage fracture rather than stable fatigue crack growth.

Figure 49 Scanning Electron Micrograph of fracture surface near crack front, 9x

Figure 50 Scanning Electron Micrograph of fracture surface near point A of Figure 49, 404x

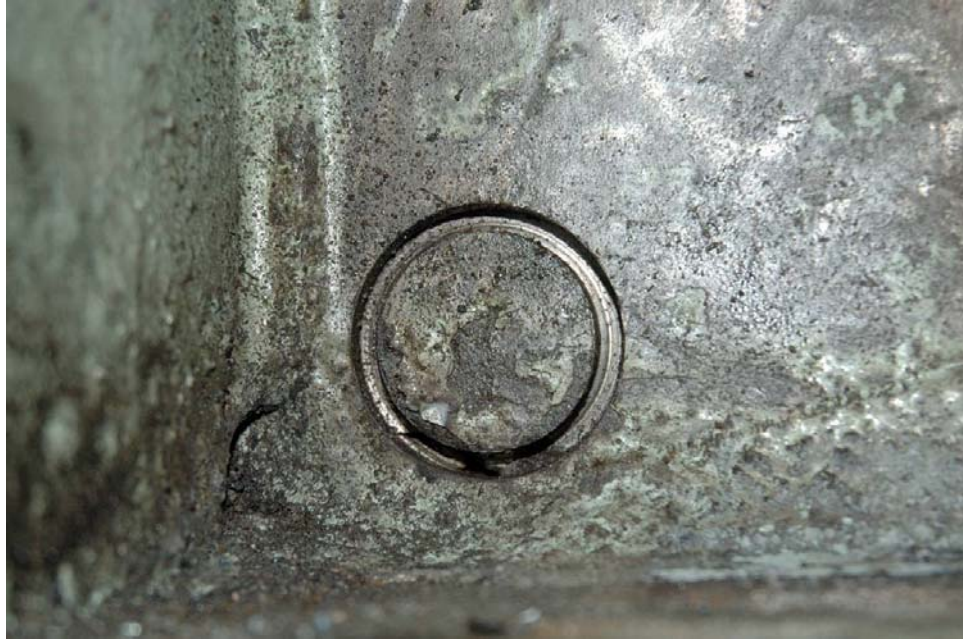
Subsequently, efforts were made to core out the web of Girder 3 as close to the bearing stiffener to the shelf plate intersection as possible with the purpose of determining the crack origin. This effort was unsuccessful by the presence of floor beam connection plate and bearing stiffener on the inside face of the girder web, which prevented the core drilling bit from penetrating through (Figure 51). Further investigation on the source of cracking was continued with material testing of the girder web.

Figure 51 Attempt of drilling core to retrieve possible crack origin

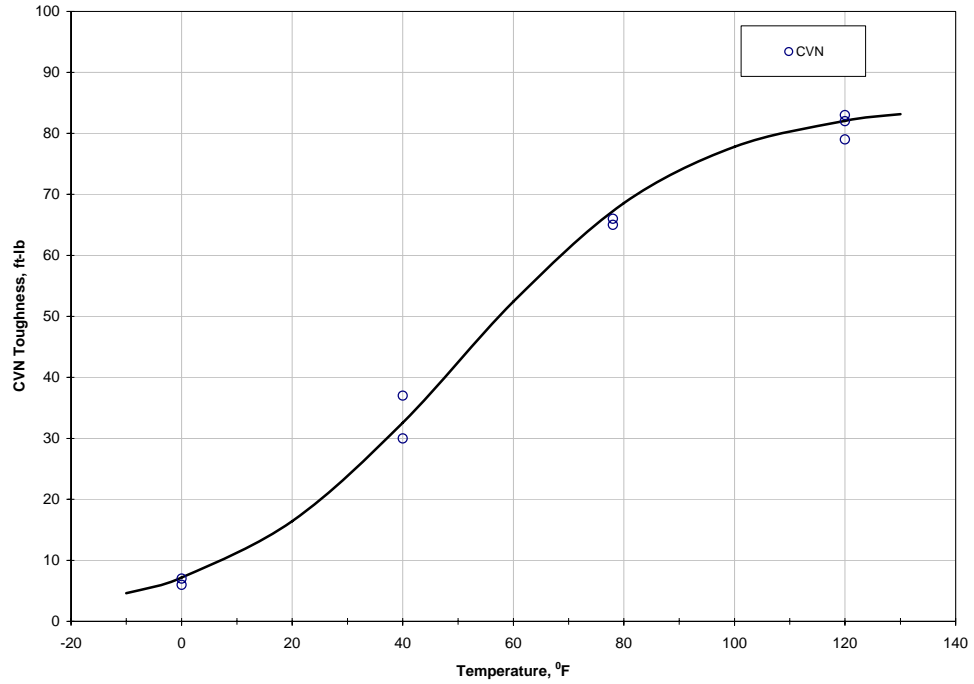
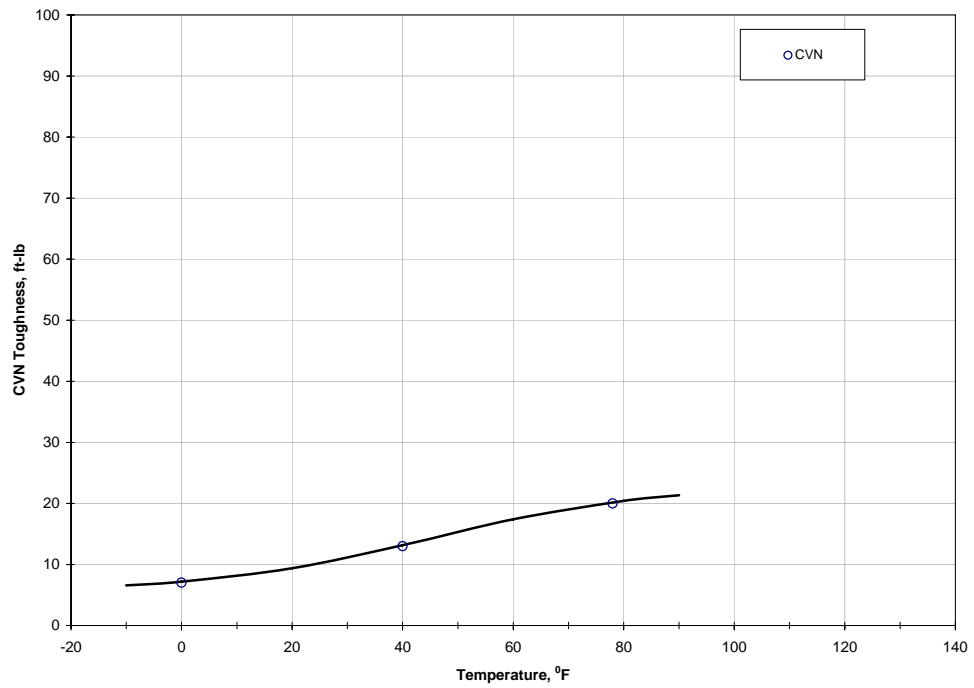
The CVN test results are shown in Figures 56 and 57. The results exhibited a toughness of the web steel of about 30 ft-lb at 40° F in the longitudinal direction, which is more than the required 25 ft-lb at 40° F for Fracture-Critical Members in Zone 2, as per the current AASHTO Bridge Design Specification. In the transverse direction, however,

This low toughness in the transverse direction explains the observed cleavage fracture surface in the web of Girder G3. Differences in mechanical properties of hot rolled steel plates measured along the rolling direction (L-T orientation) and transverse to this direction (T-L orientation) are commonly observed, particularly in plates manufactured in the past. This difference is primarily due to the effects of hot rolling on the resulting shape of non-metallic inclusions in the steel. Hot rolling tends to flatten and elongate inclusions along the rolling direction which can vary the tensile strength, tensile ductility, and notch toughness of the steel measured in the two directions. This difference is markedly reduced in modern day steel plate by (a) cross rolling which subjects the plate to the effects of rolling in multiple directions and (b) reductions in the concentration of non-metallic inclusions.

Figure 56 Charpy V Notch toughness of web steel: longitudinal

Figure 57 Charpy V Notch toughness of web steel: transverse
