Field Monitoring Prototype Retrofits of Floorbeam Connections on the I-95 Girard Point Bridge

Final Report

ATLSS Report No. 05-01

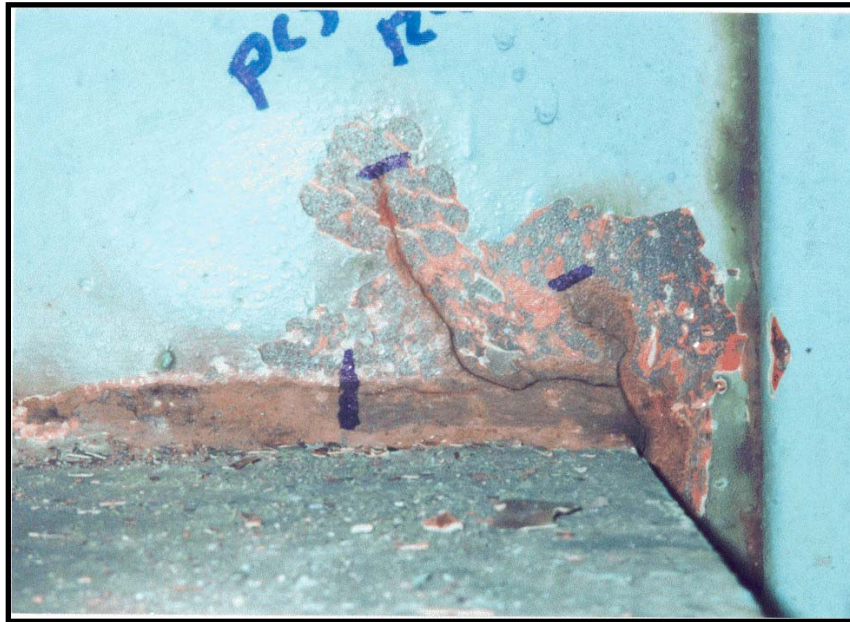
The bridge has experienced cracking problems at various locations since 1993 [1]. The cracking under investigation in this study exists at the floorbeam-to-kneebrace connections (Figure 1.2). The cracks originated at the flame cut radius hole where the top flange is terminated as well as along the web-to-flange weld in the floorbeam. The initiation of the cracks was driven by the relative displacement between the top flange of the floorbeam and the hanger of the bridge. At several locations, cracks branched and propagated in the direction perpendicular to the primary bending stresses in the floorbeam. Detailed listings of the location of the cracks could be found in the inspection report prepared by the firm of URS Corporation [1].

Figure 1.2 – Typical cracking of floorbeam-to-kneebrace connection

With the aid of ATLSS researchers, the firm of URS developed and proposed a retrofit strategy to repair the cracked floorbeams and to eliminate the possibility of the development of future cracking. The initial prototype, which was introduced on the west side of the northbound roadway at floorbeam FB77 was instrumented. Controlled load testing and monitoring of random traffic was conducted. However, the field measurements suggested that the initial retrofit geometry could be improved by making minor modifications to the prototype geometry. The modified retrofit was implemented at FB78 and additional measurements were made. This report summarizes the results of this work.

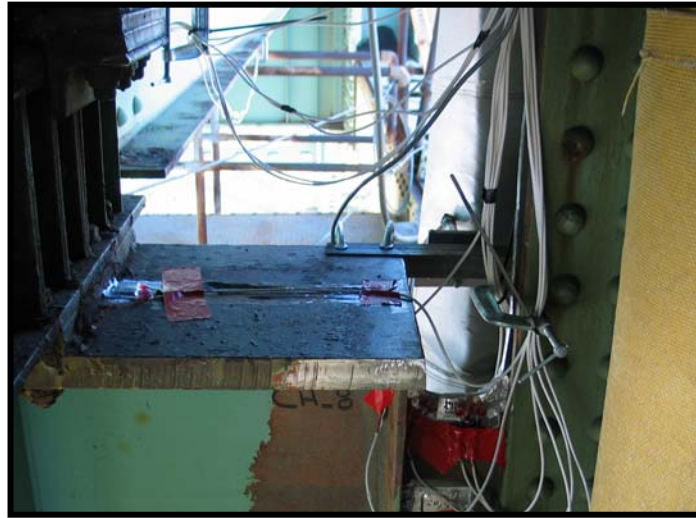
Figure 4.1 - Initial retrofit scheme at FB78 with the knee-brace removed and the cutout introduced in the web of FB78 (View looking south)

Two prototype retrofits schemes were proposed to engineers at PennDOT by the firm of URS. The retrofits were implemented at different floorbeams (FB77 and FB78). Instrumentation was installed at both floorbeams to investigate the performance of the retrofit. Figure 4.1 and 4.2 show both retrofits. Instrumentation of both retrofits will be discussed separately.

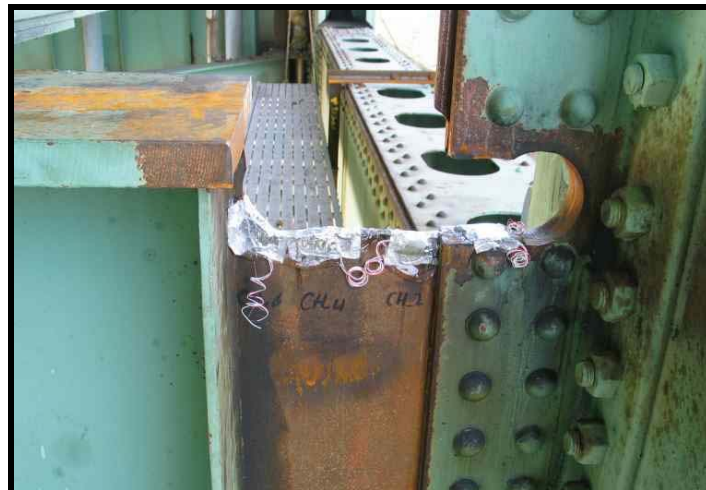
Figure 4.2 – Second retrofit scheme with knee-brace removed and the cutout introduced in the web of floorbeam FB78 as well as the back-to-back angle (View looking south)

Based on the measurements obtained from FB77 and previous experience with similar floorbeam cracking problems, it was concluded that making a relatively small modification to the geometry of the initial retrofit could potentially result in a significant decrease in the live load stress ranges at the details of concern. The second prototype retrofit strategy was incorporated at FB78. Additional instrumentation was added and measurements made.

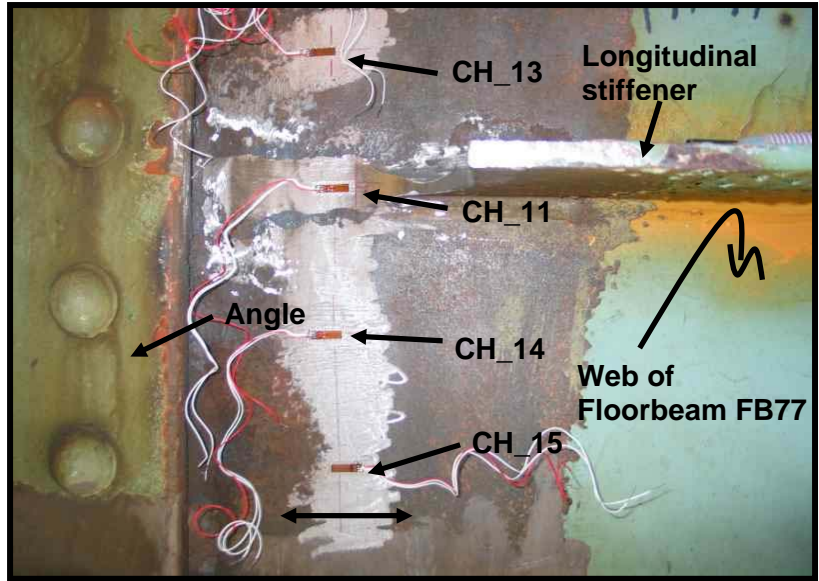
Figure 4.4 – CH_13, CH_14, and CH_15 installed on the web of floorbeam FB77 below the cutout in-line with CH_3 and CH_11 installed on the web at the termination of the longitudinal stiffener (View looking north)

As part of the retrofit, the longitudinal stiffener welded to the web was cut back with a transitional radius to increase the fatigue resistance of the detail and to reduce the potential for future cracking. The stress range at the termination of the longitudinal stiffener after it has been cut was monitored using CH_11, which was installed on the web at the termination of the longitudinal stiffener. CH_12 was installed on the other side of the web directly opposite CH_11.

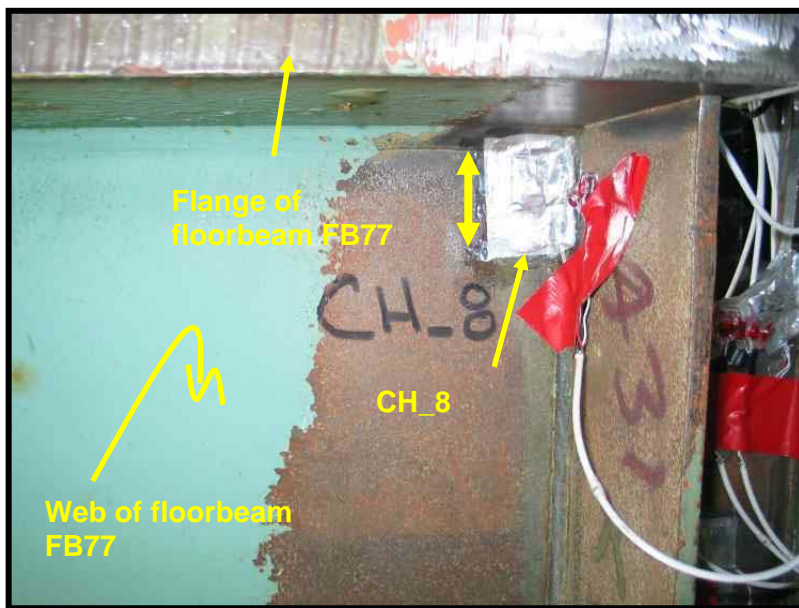
As shown in Figure 4.5, CH_8 was installed in the vertical direction on the web at the termination of the transverse stiffener to measure any out-of-plane bending of the web at floorbeam FB77 at this location. Since the stiffener is not rigidly attached to the top flange, the potential for cracking exists.

Figure 4.5 – CH_8 installed on the web of floorbeam FB77 at the web gap (View looking south)

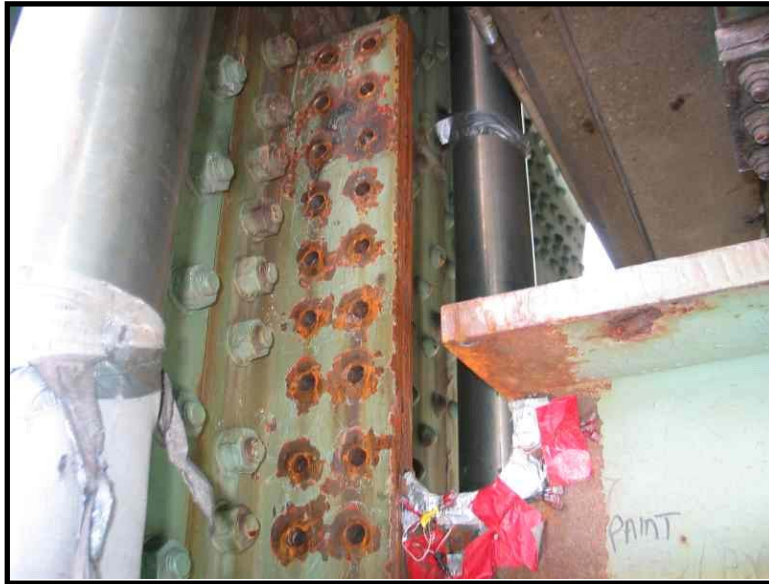
Figure 4.10 – Prototype retrofit at floorbeam FB77 with rivets removed

Eighteen of the rivets used for connecting the angle to the floorbeam web and connection plate (previously in-place) were removed as shown in Figure 4.10. The rivets were removed to redirect the stress flow downward and away from the area of the web cut near the connection angles. The reduction in stress due to this modification was determined primarily by measurements made at CH_1 and CH_2 installed during the initial retrofit.

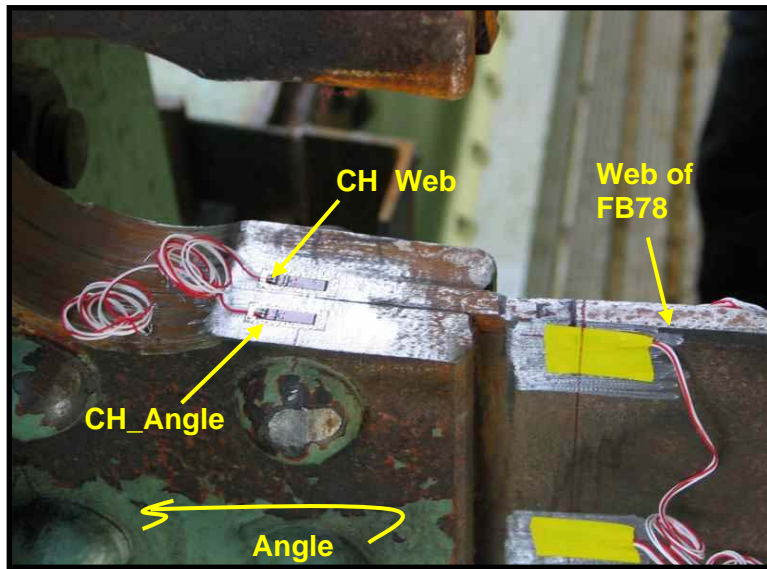
The geometry of the retrofit at FB78 allows a more uniform and smooth stress flow from the web into the connection angles. As the web passes between the angles, stress slowly leaves the web and is transferred into the angles. CH_Web was installed to verify that net section stresses were not unreasonably high and that stresses on the base metal of the web were also within reason. CH_Angle can be used to estimate the proportion of the stress in the web which has been “transferred” to the angles and hence the effectiveness of the retrofit. In addition, the potential for net section cracking in the angles is identified.

Figure 4.12 – Strain gages installed on the top face of the cut web and angle of Floorbeam FB78 (View looking north)

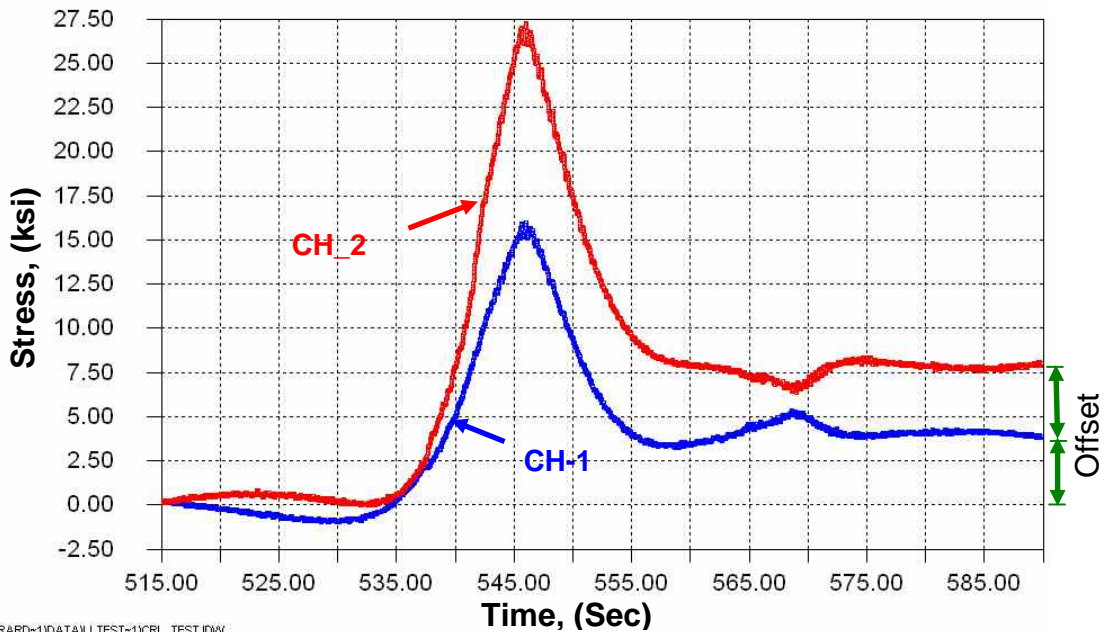
A summary of the maximum, the minimum, and the stress range measured by the gages in the crawl test CRL_TEST is listed in Table 5.1. As listed in the table, high stress range values were recorded by some of the channels.

Figure 5.1 – Response of CH_1 and CH_2 installed 1/4 inch below the cutout of floorbeam FB77 as both test trucks drove side-by-side over the west and the middle lanes in the crawl test (CRL_TEST)

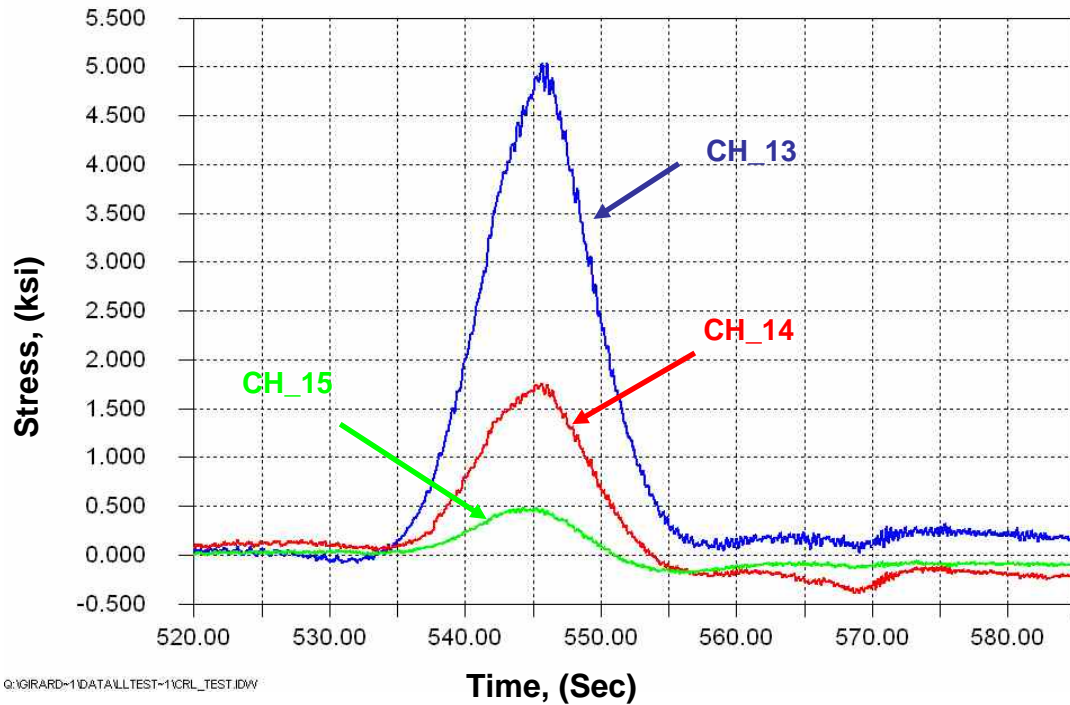
As discussed before, CH_13, CH_14, and CH_15 were installed on the web of floorbeam FB77 away from the cutout and in-line with CH_3, to measure the stresses through a portion of the depth of the floorbeam below the cut. The detail where the channels were installed is classified as category A. The CAFL of category A is 24 ksi. Figure 5.3 shows the response of the three channels as both test trucks passed side-by-side in the crawl test CRL_TEST. The stress gradient, which exists through the instrumented portion of the web, is clearly shown in Figure 5.3 with the highest magnitude of stress recorded by CH_13 and the lowest by CH_15. A summary of the maximum, the minimum, and the stress range measured by the gages in the crawl test CRL_TEST is listed in Table 5.2. The listed values in the table indicate low magnitude of measured stress range. The highest magnitude of stress range measured was 5.2 ksi at CH_13, which is well below the CAFL of the detail.

Figure 5.3 – Response of CH_13, CH_14, and CH_15 installed on the web of floorbeam FB77 away from the cutout and in-line with CH_3 as both test trucks drove side-by-side over the west and the middle lanes in the crawl test (CRL_TEST)

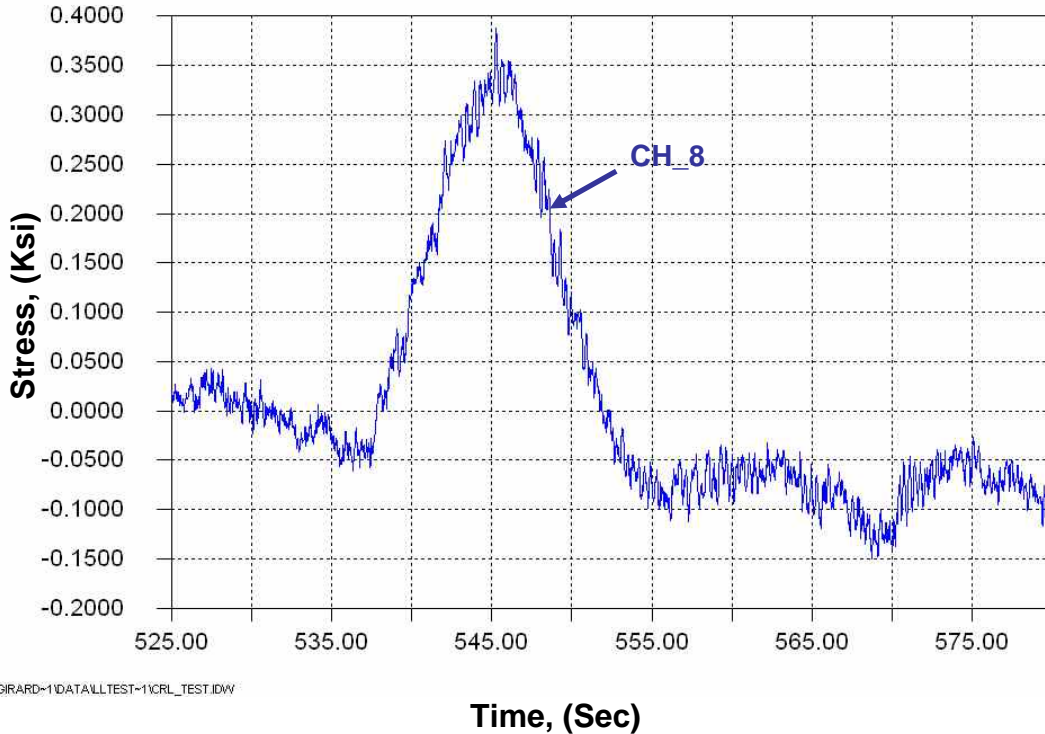
The response of the strain gage (CH_8) installed at the transverse stiffener detail is shown in Figure 5.4. The detail is classified as category detail C. The CAFL of the detail is 10 ksi. As shown in the figure, a low stress range value of 0.5 ksi was measured by the gage in the crawl test CRL_TEST. Table 5.3 lists the measured maximum, minimum, and the stress range recorded by the channel in the crawl test CRL_TEST.

Figure 5.4 – Response of CH_8 installed on the web of floorbeam FB77 at a transverse stiffener detail as both test trucks drove side-by-side over the west and the middle lanes in the crawl test (CRL_TEST)

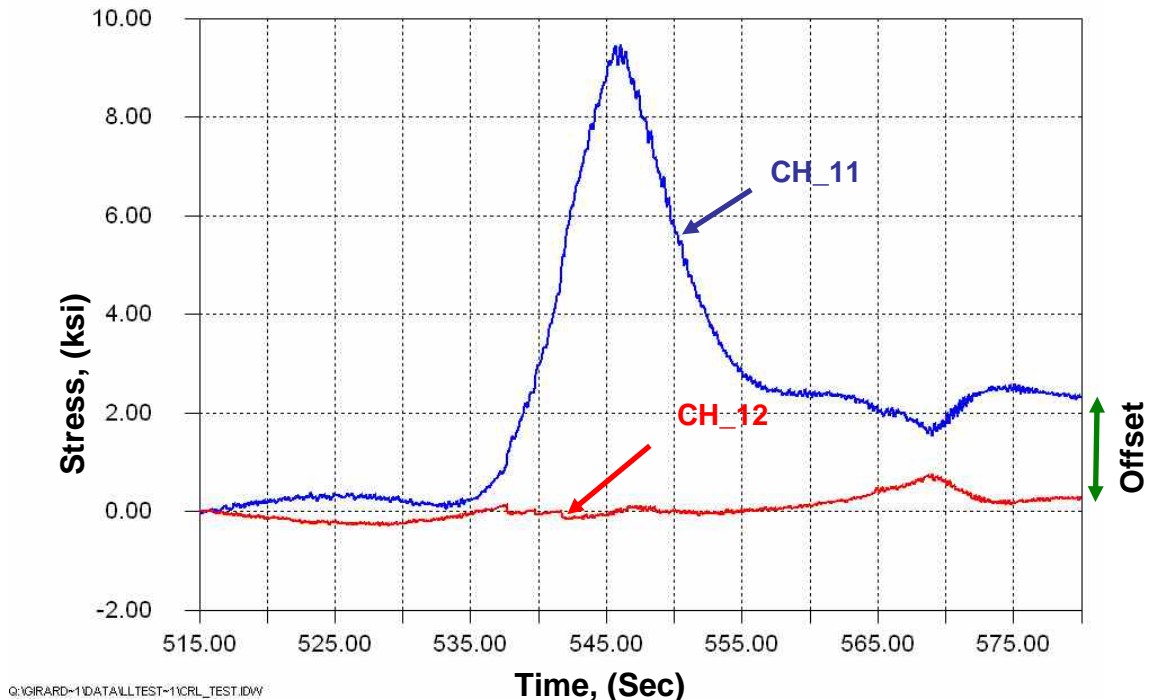
difference of the magnitude of the measured stresses between CH_11 and CH_12 could also be attributed to an out-of-plane stress component, which when added to the in-plane component, causes the difference in the magnitude of the measured stress range between both faces of the web at the same cross section. The out-of-plane component is a result of a lateral shift in the vertical axis of bending in the web. Since the longitudinal stiffener is only on one side of the web, the vertical neutral axis is not located at the center of the web. Hence, out-of-plane bending is produced and will contribute to the difference in the observed response at CH_11 and CH_12. Similar to the discussion above, the offset in the strain gage measurements could be attributed to slipping in the floorbeam to truss hanger connection.

Summary of the measured maximum, minimum, and the stress range recorded by the channel in the crawl test CRL_TEST is listed in Table 5.4. The table shows in CH_11, stress range higher than the CAFL of the detail. No stress range measured at CH_11 was greater than the CAFL of the detail was however recorded where CH_12 was installed.

Figure 5.5 – Response of CH_11 installed on floorbeam web below the cutout at longitudinal stiffener termination as both test trucks drove side-by-side over the west and the middle lanes in the crawl test (CRL_TEST)

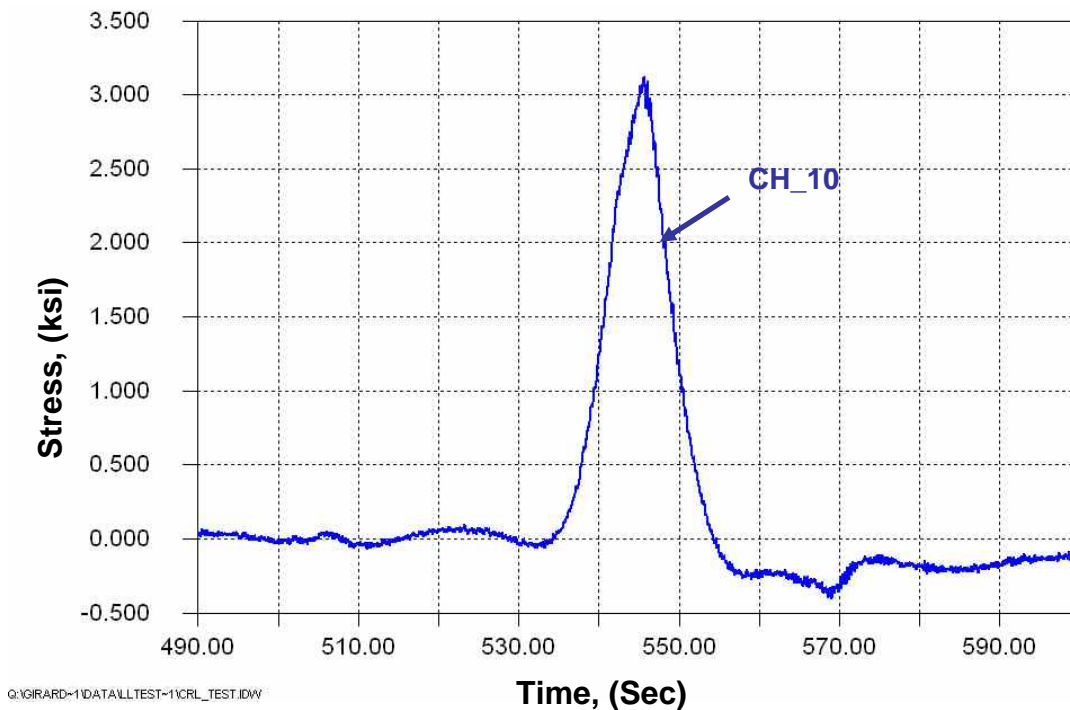
The stress on the web at the longitudinal stiffener to transverse stiffener detail was recorded by CH_10. The detail is classified as category detail E with a CAFL of 4.5 ksi. As shown in Figure 5.6, the stress range measured at the detail in the crawl test (CRL_TEST) is approximately 3.2 ksi, which is below the CAFL of the detail. Table 5.5 lists the measured maximum, minimum, and stress range recorded by the channel in the crawl test CRL_TEST.

Figure 5.6 – Response of CH_10 installed on floorbeam web at longitudinal stiffener detail as both test trucks drove side-by-side over the west and the middle lanes in the crawl test (CRL_TEST)
