Williamsburg Bridge Replacement Orthotropic Deck As-Built Fatigue Test

ATLSS Report No. 98-04

Interim Report on Phase II for Federal Highway Administration U.S. Dept. of Transportation, New York Dept. of Transportation and New York City Dept. of Transportation

May 1998

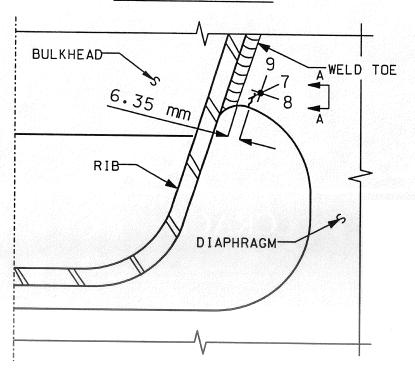
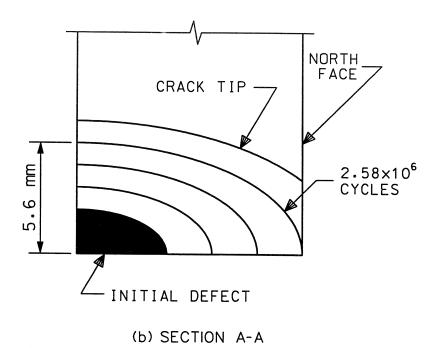
(a) Schematic showing south surface crack

Figure 4.4 Diaphragm Crack on East Side of Rib 7

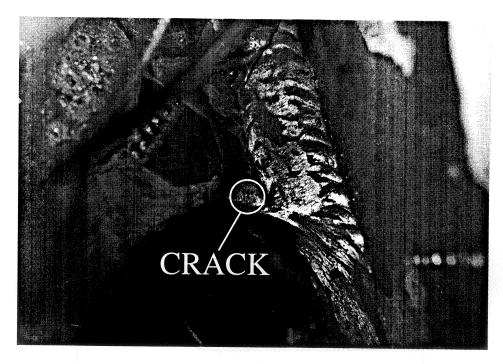
Figure 4.5 Crack on Northern Face of Diaphragm on East Side of Rib 7

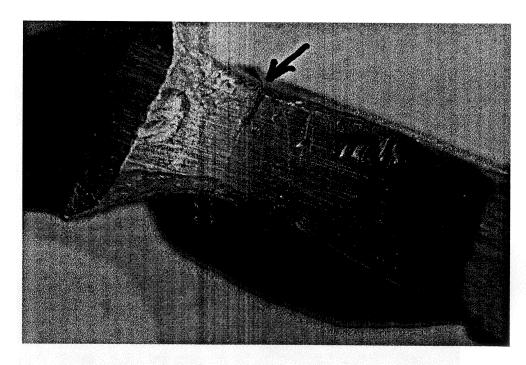
Figure 4.7 View of Ground Edge of Diaphragm Plate Showing Defects and Crack

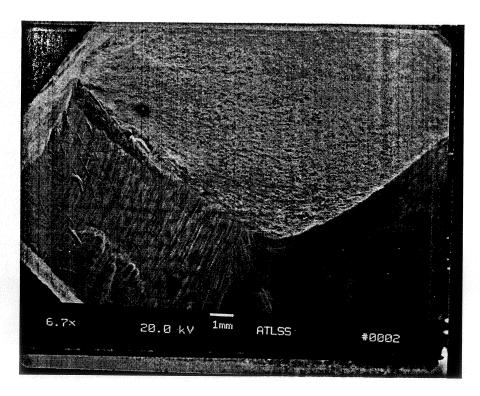
Figure 4.9 SEM View of the Crack Surface Showing Groove Along Plate Edge and Corner Crack Development @ 6.7X

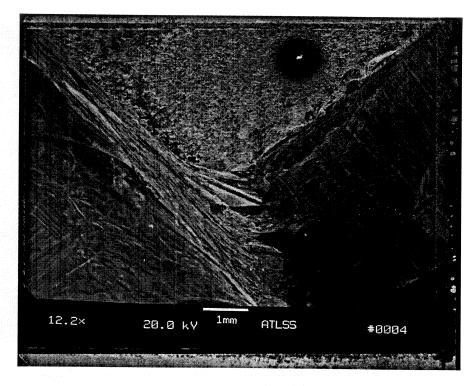
Figure 4.10 SEM View of the Initial Defect Along Plate Edge and Corner Notches @ 12.2X
