**RESISTANCE OF WELDED
DETAILS UNDER VARIABLE AMPLITUDE
LONG LIFE FATIGUE LOADING**

ATLSS Report No. 92 - 04

Final Report

Prepared for
National Cooperative Highway Research Program
Transportation Research Board
National Research Council

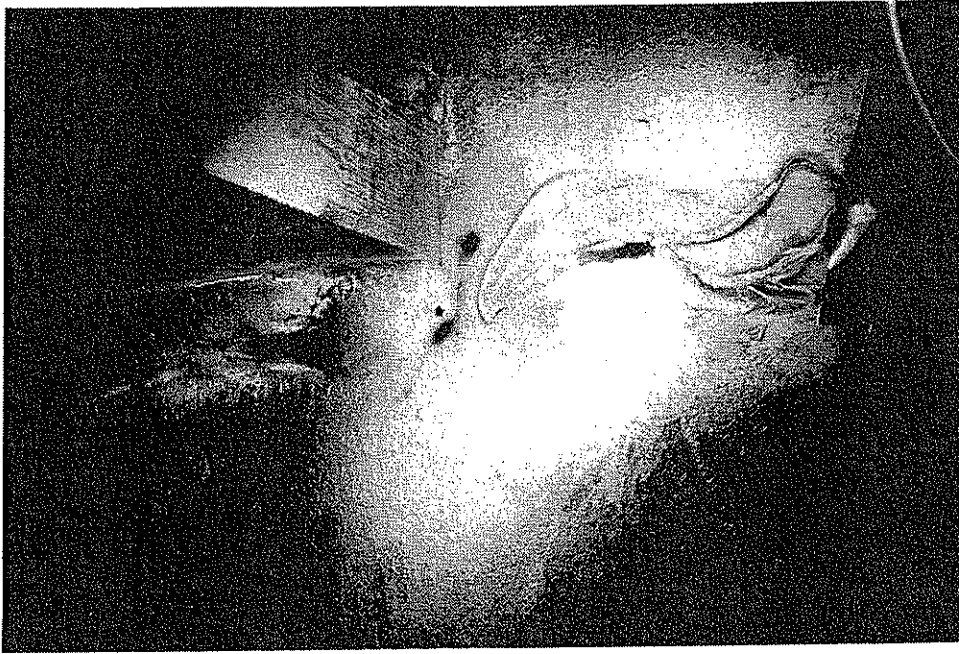
Fig. 11: Typical fatigue crack at weld end of gusset plate, detail 7, girder 3E.

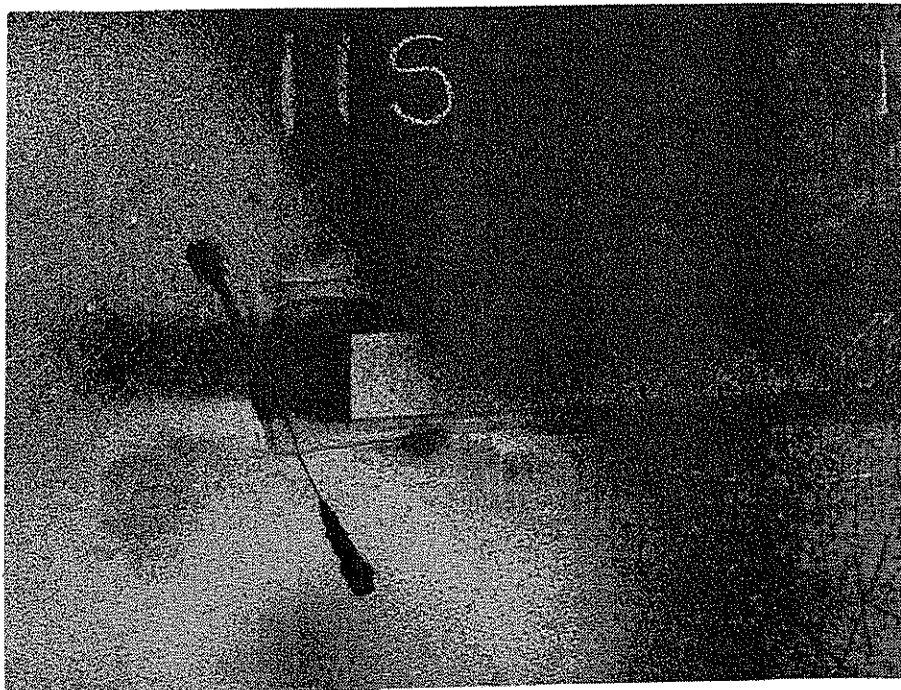
Fig.12: Crack initiated at ground end of gusset plate weld, detail 11, girder 1S.

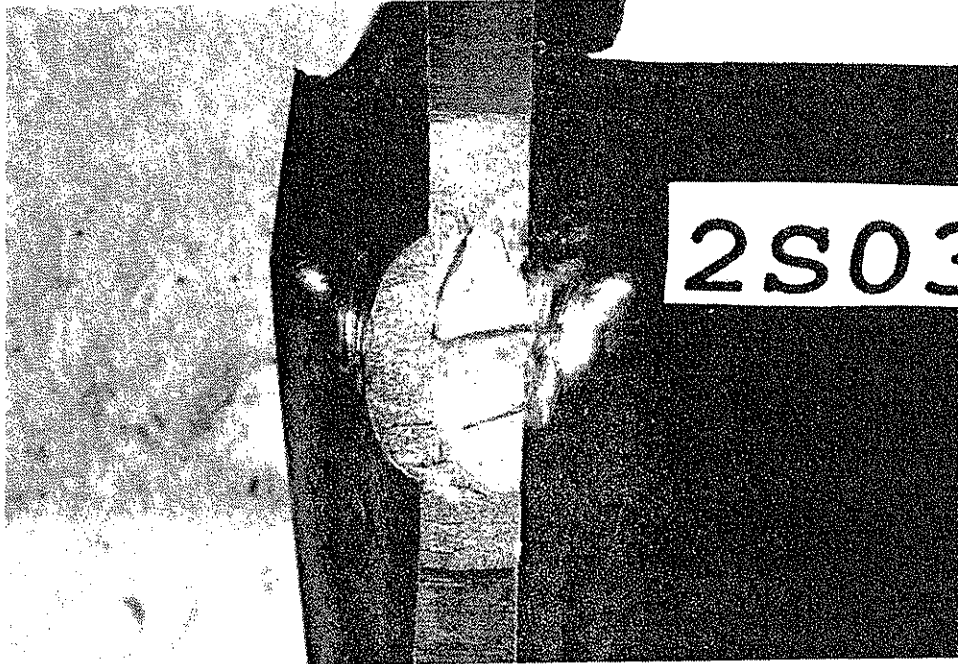
Fig. 13: Semi-elliptical crack at web gusset.
(note crack can exceed web thickness as a result of weld on back surface)

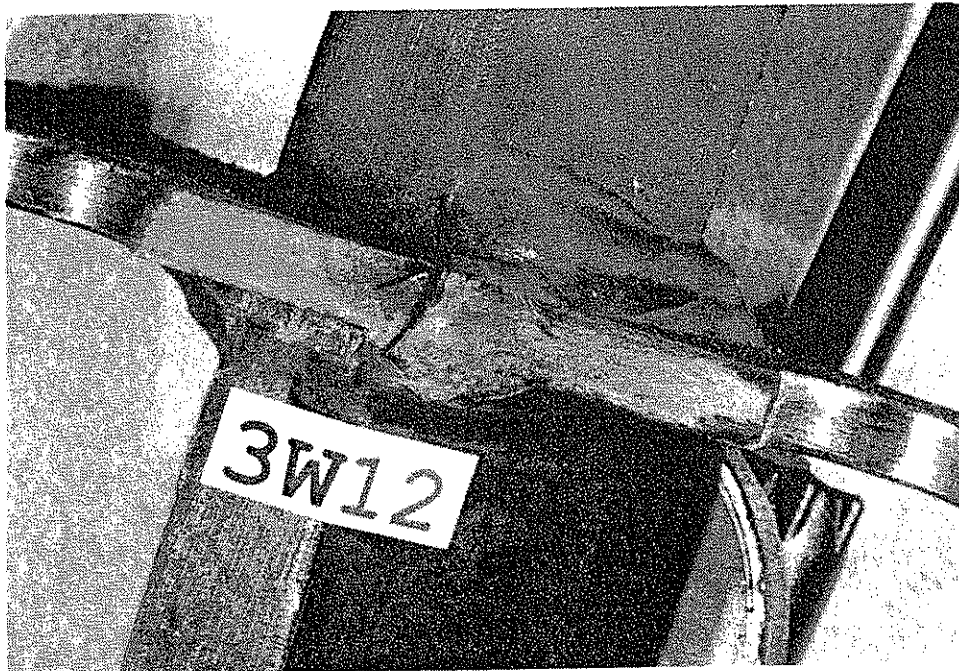
Fig. 14: Typical through thickness crack arrested by retrofit holes.

Placement of holes at the crack tips in the girder web was an effective means of arresting fatigue cracks originating at a weld toe on the web plate. It was observed that the peak stress range in the cycle must satisfy the relationship $\Delta K / \sqrt{\rho} \leq 4 \sqrt{\sigma_y}$ if the hole was to prevent the crack from reinitiating. In this relationship ΔK is the stress intensity factor range for a through thickness crack, ρ is the radius of the drilled hole and σ_y is the yield stress of the web plate.

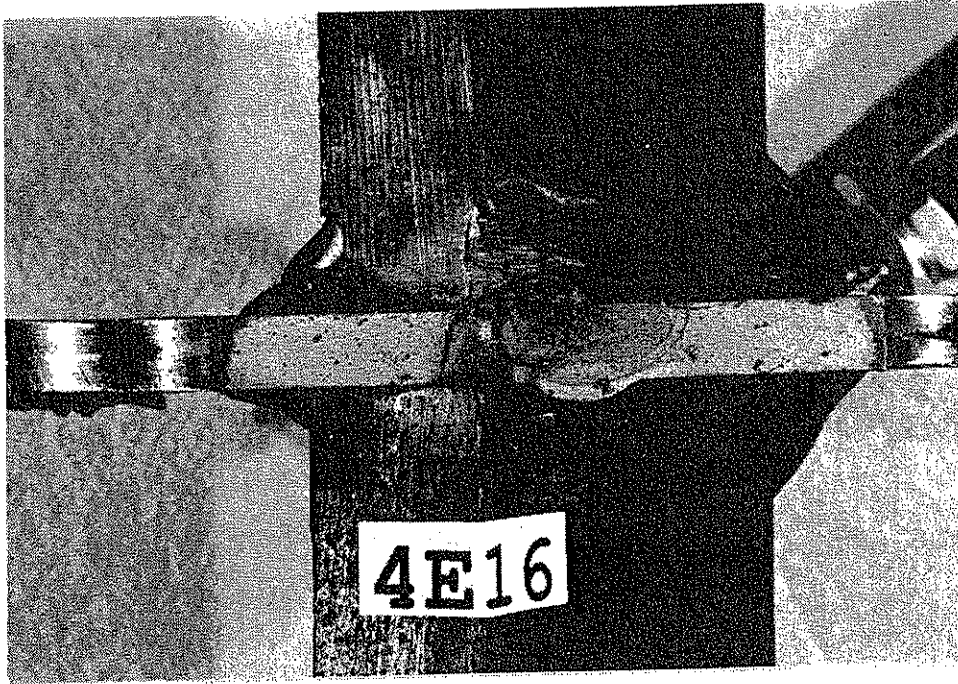
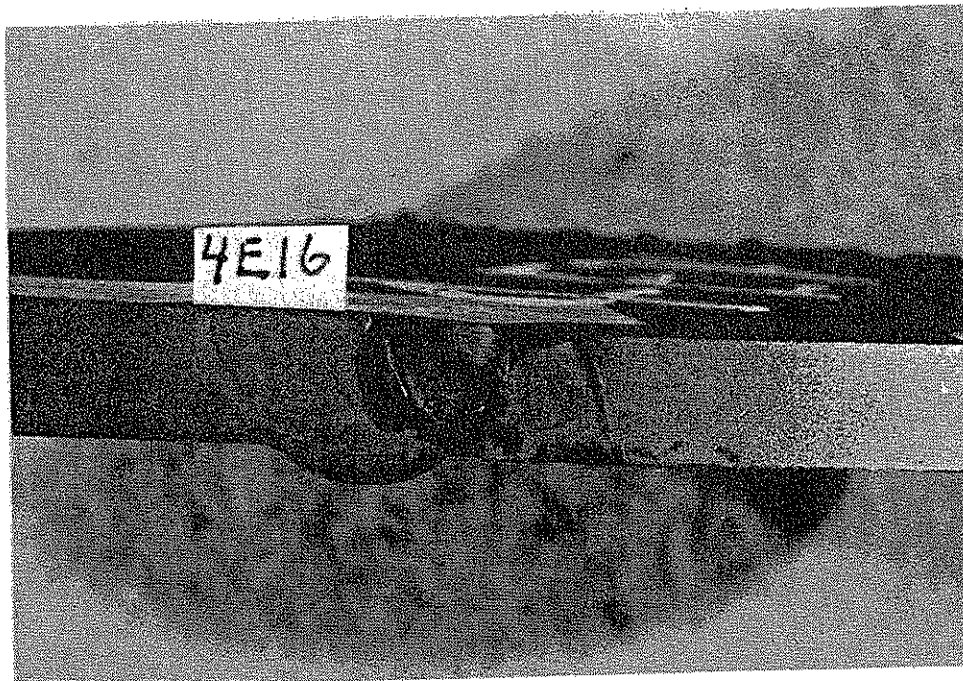
Fig. 15: Crack surfaces of web detail 16 beam 4E with large initial defect.

One detail (4E16) was found to have a very low fatigue resistance with fatigue cracking detected after 14×10^6 cycles at an effective stress range of 1.71 ksi (11.8 MPa). Examination of the crack surface showed that an unusually large initial weld toe defect existed as a gouge. The defect was about 0.13 in. (3.3 mm) deep. The defect in question was unusual as it appeared to be related to an undercut in the web plate and overlap of the weld. The size of the defect is about an order of magnitude larger than normal at a weld toe. It appeared to be an extreme condition not normally present in fabricated structures. One other web attachment detail (2N02) was below the Category E' resistance curve at an effective stress range of 1.36 ksi (9.4 MPa). It was retrofitted at 94.3 million cycles.

(a) View of crack surface showing origin at weld toe.

(b) Closeup view of initial defect in web plate.

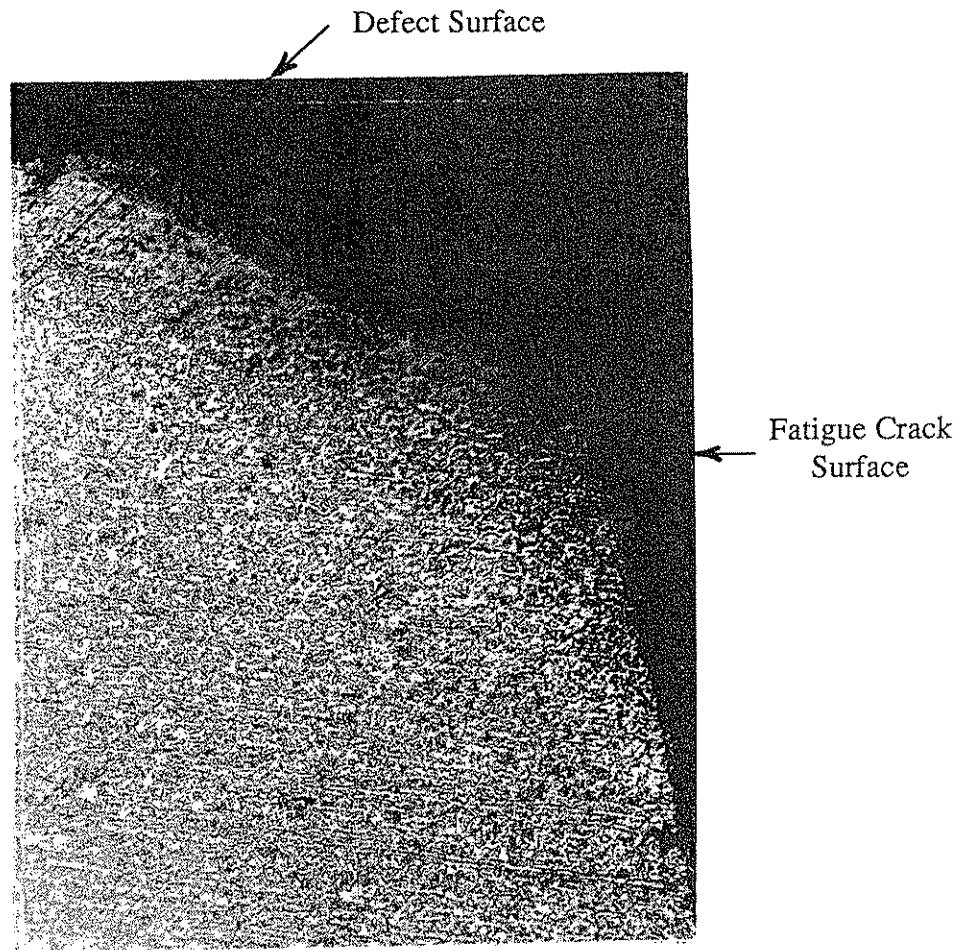
Fig. 16: Polished and etched section per perpendicular to crack surface to crack surface showing defect and HAZ @40x.

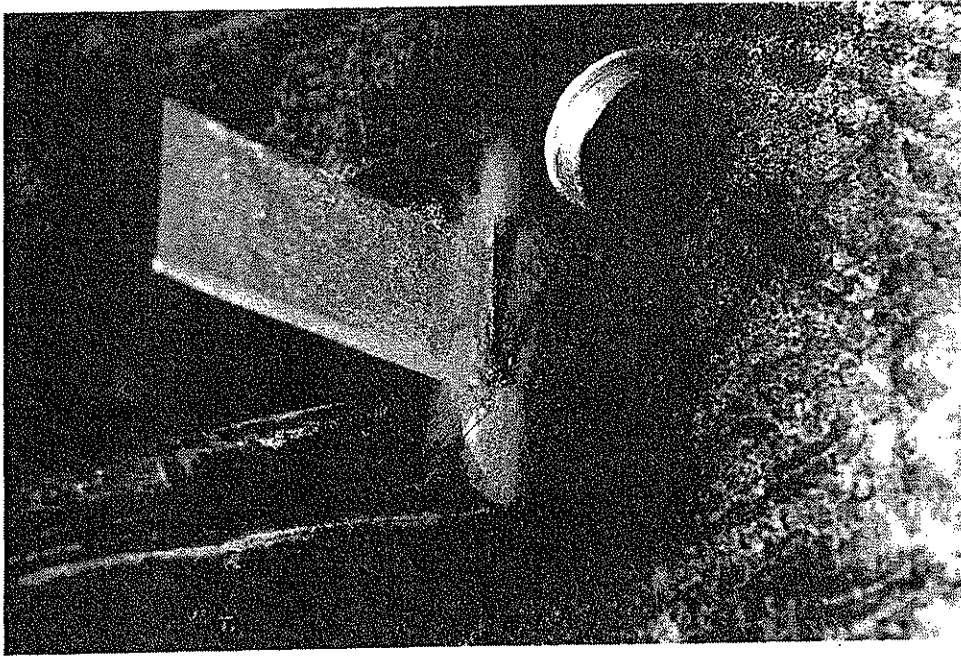
Fig. 19: Retrofit hole at top end of crack at detail 12, beam 3W.

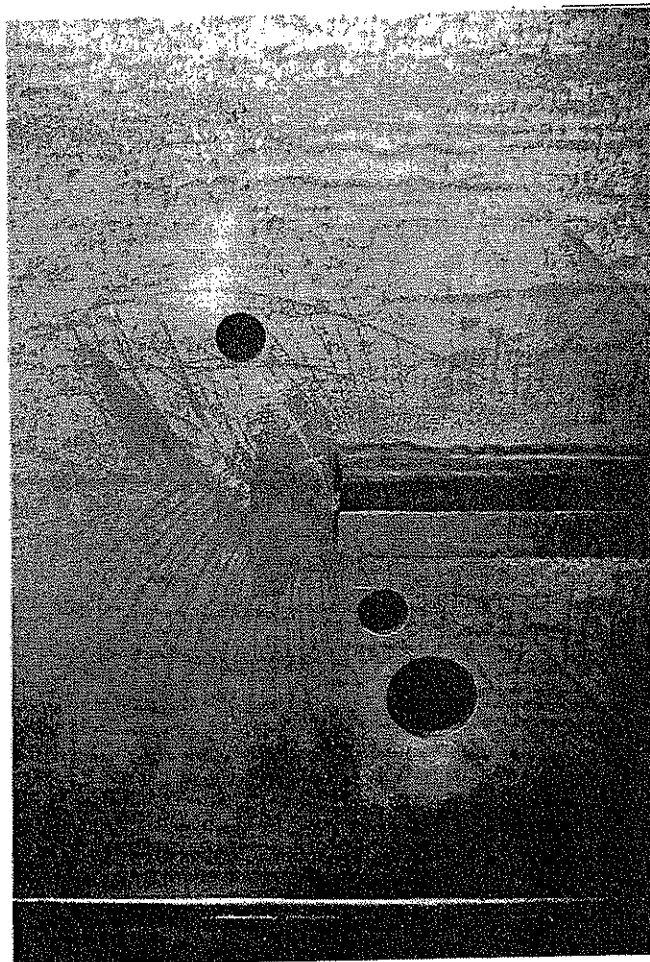
Fig. 20: Retrofit holes at detail 7 Beam 3W.

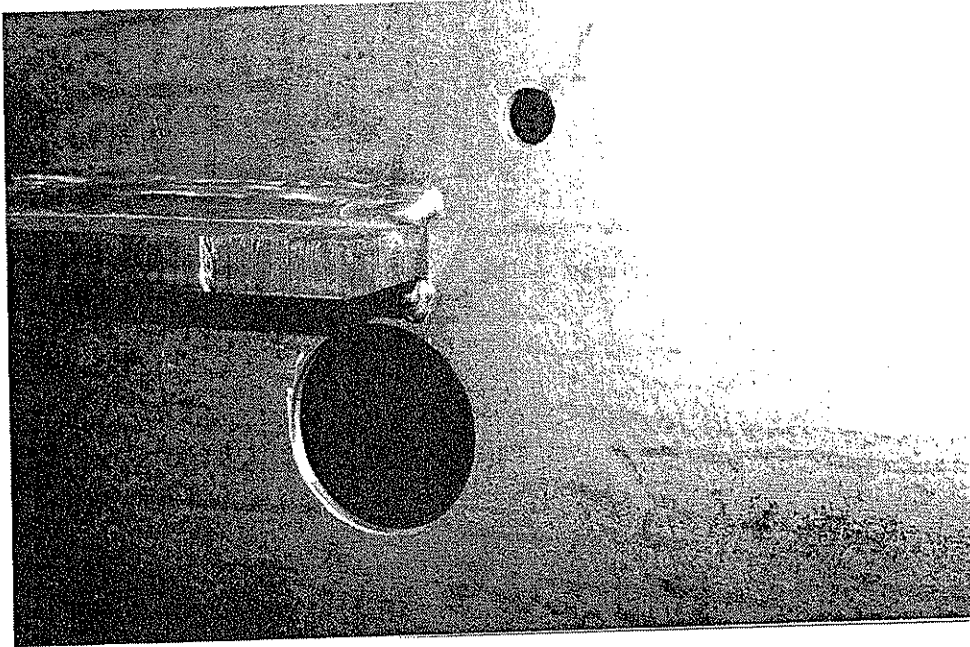
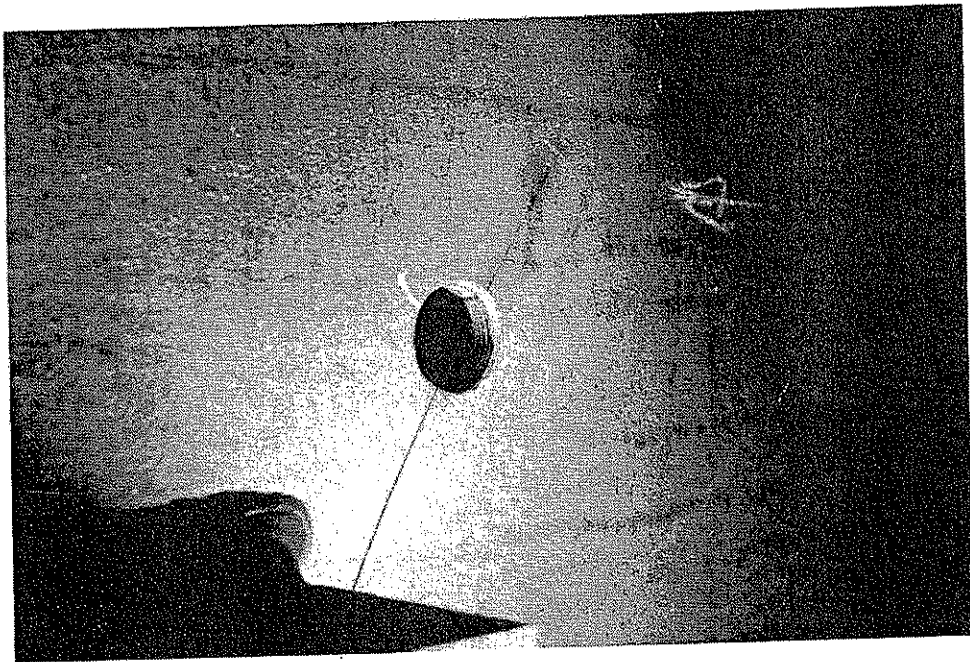
Fig. 22: Retrofit holes at detail 11, 2N showing large hole after 2nd retrofit.

(a) Large retrofit hole in girder 2N, detail 11; crack reinitiated at top hole.

(b) Close-up view of crack at top hole.

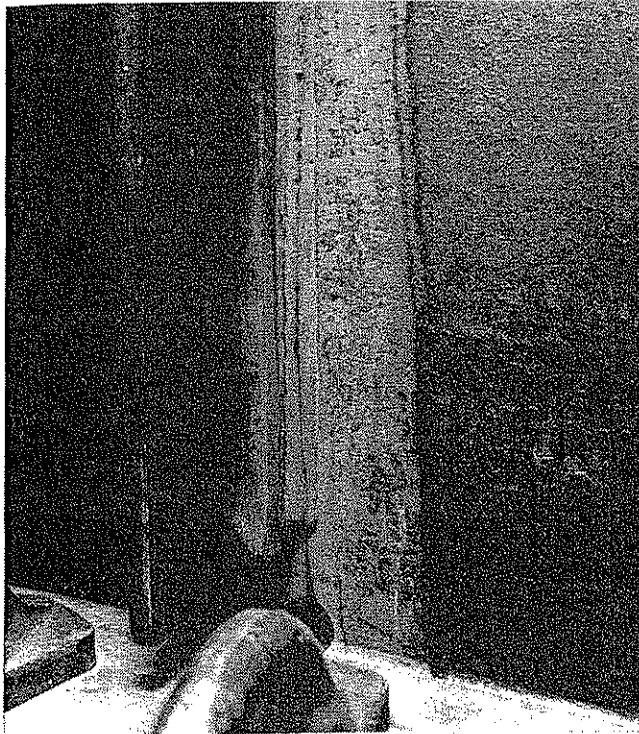
Fig. 24: Fatigue crack originating on far side stiffener weld toe of girder 2N.

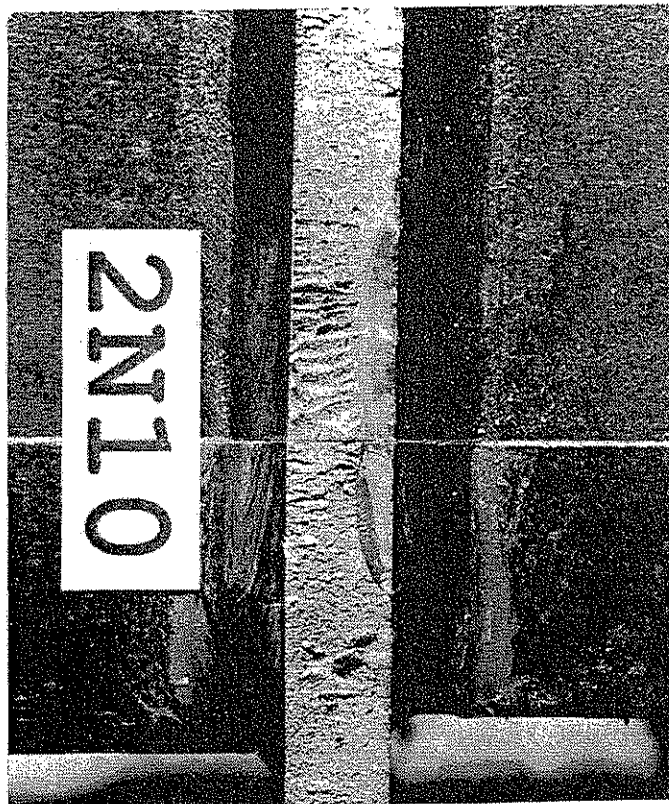
Fig. 25: Fatigue crack at detail 10, girder 2N.

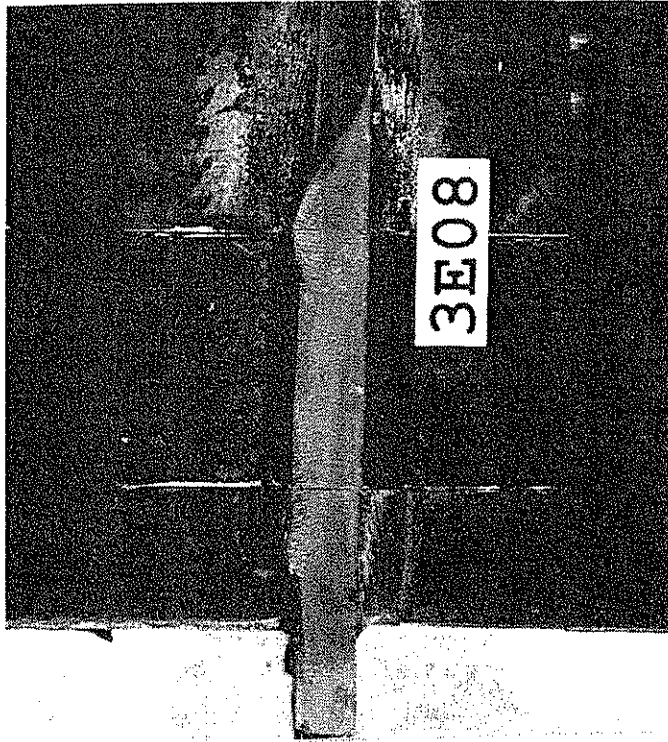
Fig. 26: Crack surface at detail 3E08.

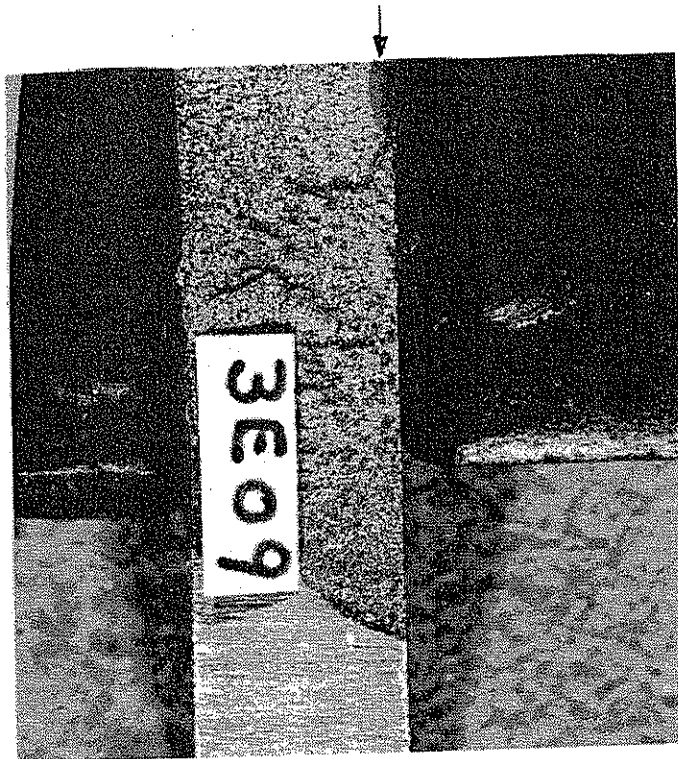
Fig. 27: Small fatigue crack at detail 3E09.

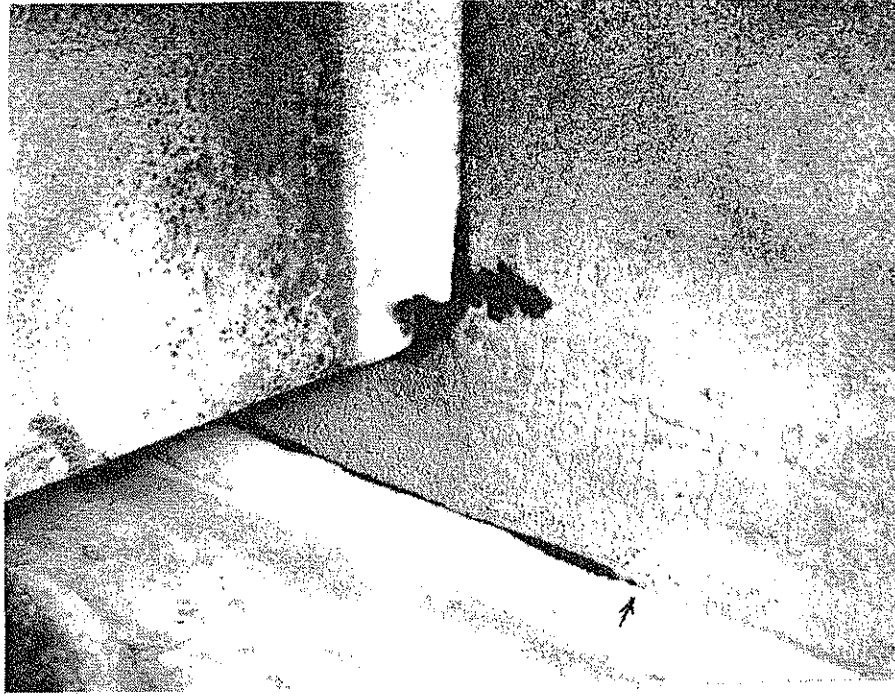
Two midspan stiffeners on the first pair of beams were subjected to out-of-plane distortion which resulted in large web gap stresses which exceeded the yield strength of the web plate. This resulted in cracks forming under variable amplitude loading at approximately 50,000 random load cycles. The second pair of girders with the larger web gap {4-1/2 in. (114 mm)} were subjected to 20 million cycles of variable loading and out-of-plane distortion. Two small cracks were detected at the distorted stiffener.

Fig. 29: Fatigue cracks at web gap of 1N09.

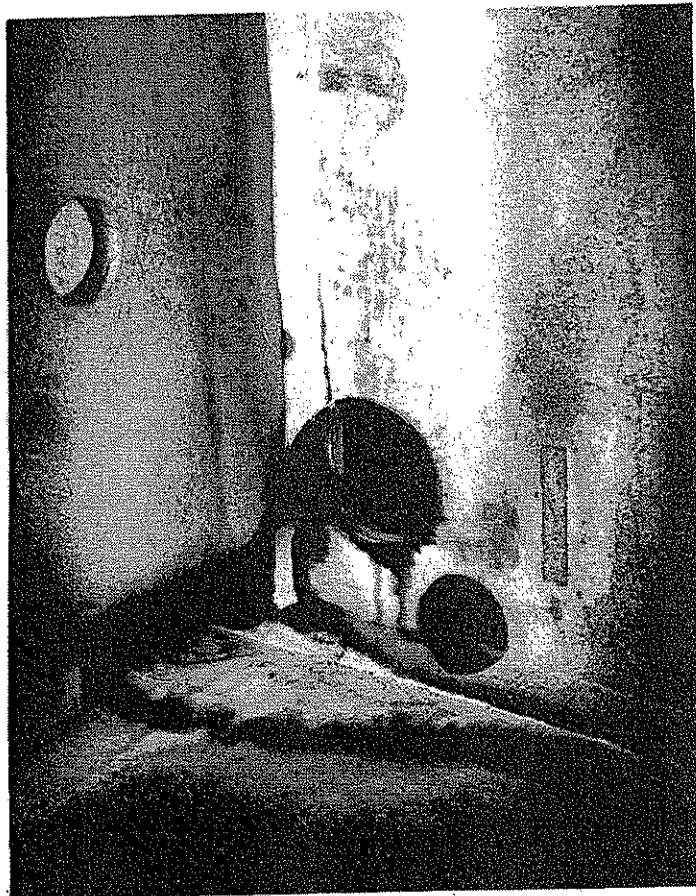
At the transverse connection plate that was deformed out-of-plane, holes could not prevent the crack from reinitiation.

Fig. 30: Retrofitted distortion cracks at detail 1N09.

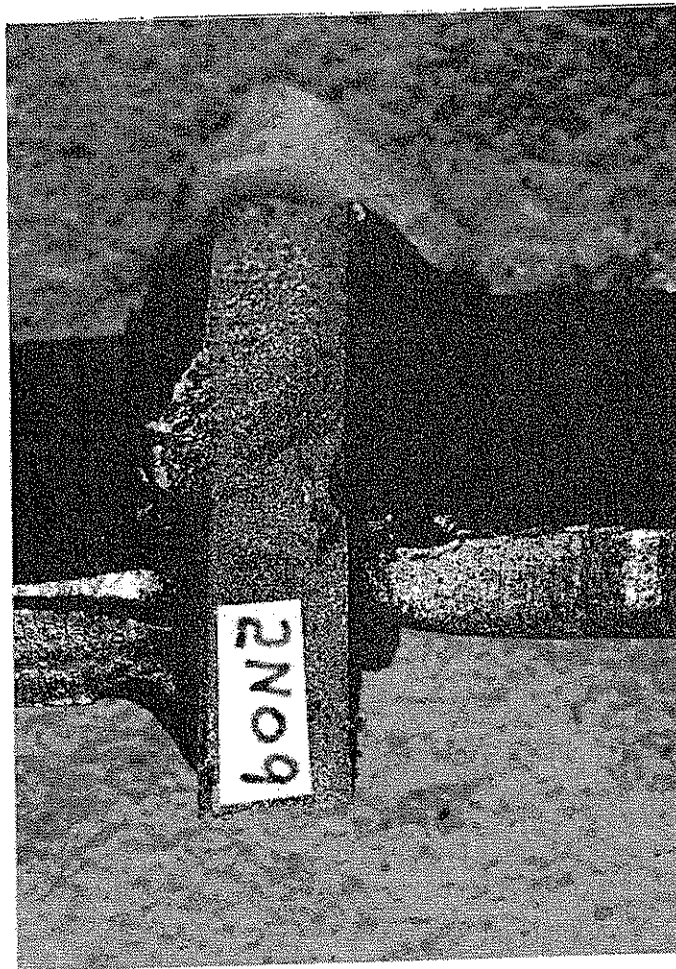
Fig. 33: Small crack in girder 2N web after distortion induced stresses.

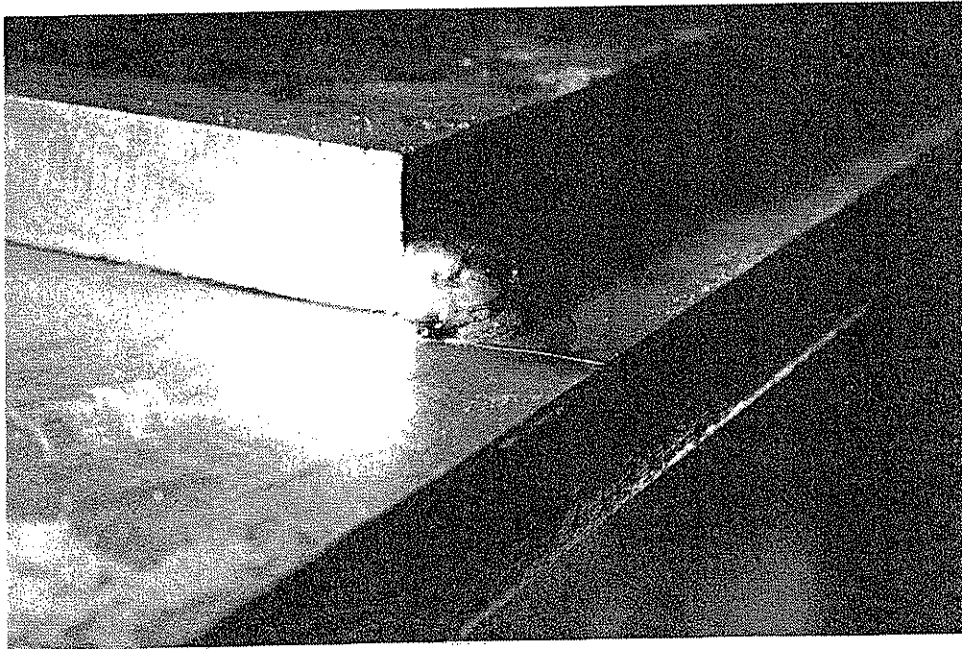
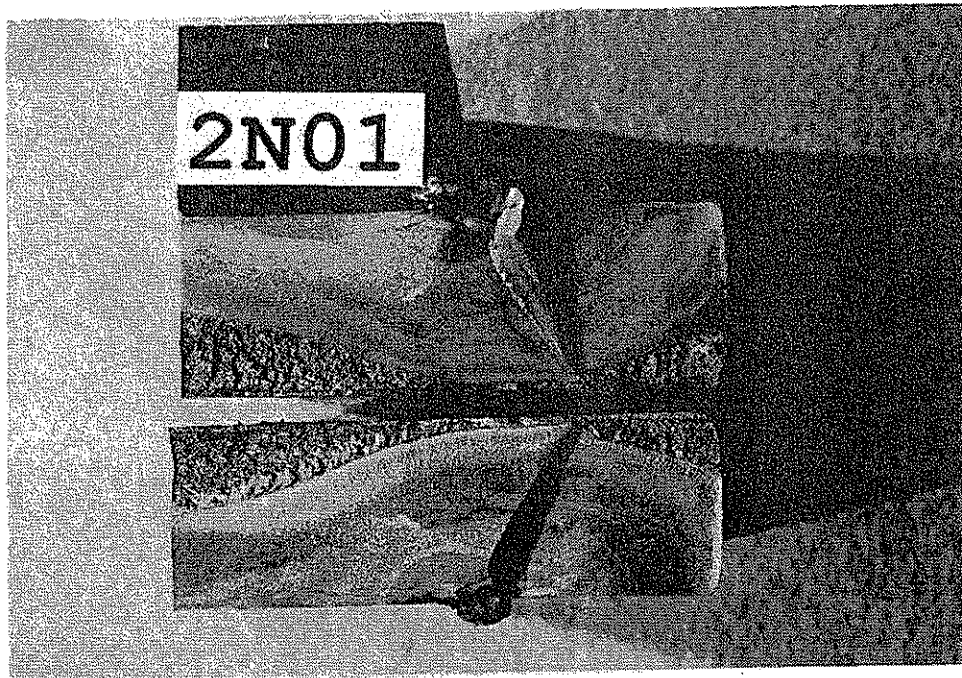
Fig. 35: Fatigue crack at detail 2N01 at end of test.

(a) Fatigue crack at weld termination.

(b) Fatigue crack surface.

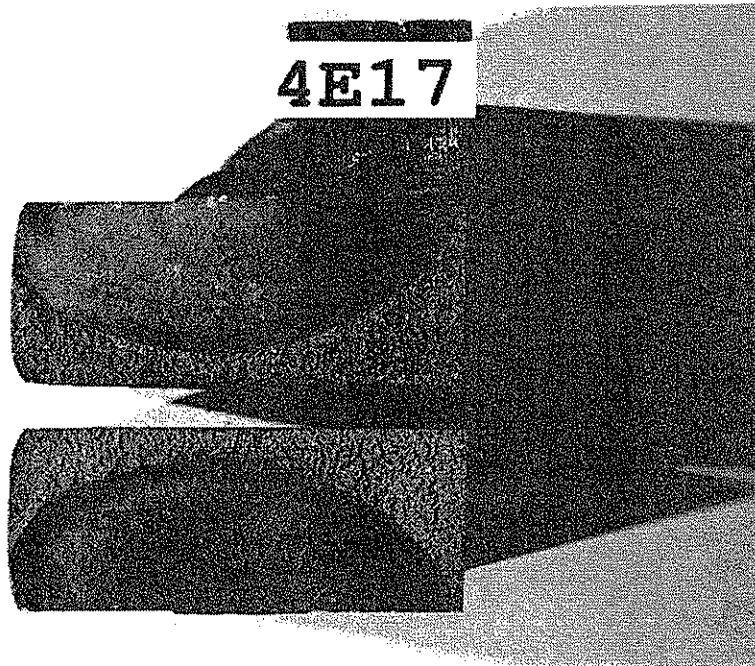
Fig. 36: Fatigue crack at coverplate end weld detail 4E17.

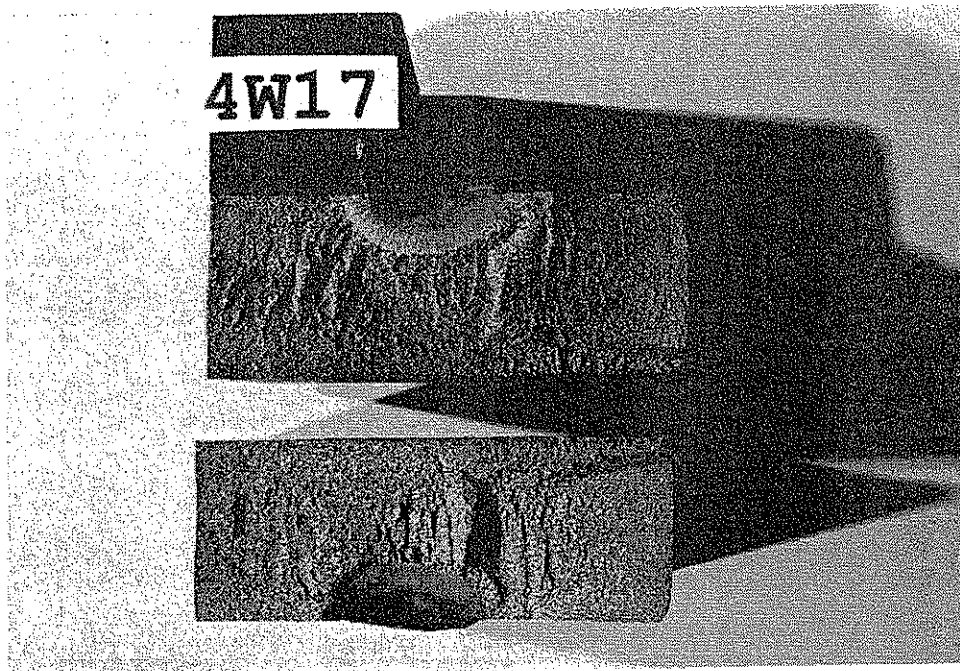
Fig. 37: Fatigue crack at ground weld end detail 4W17.
