Failure Investigation of Two Cantilevered Sign Structures in the City of Hazelton

Final Report

ATLSS Report No. 04-24

November 2004

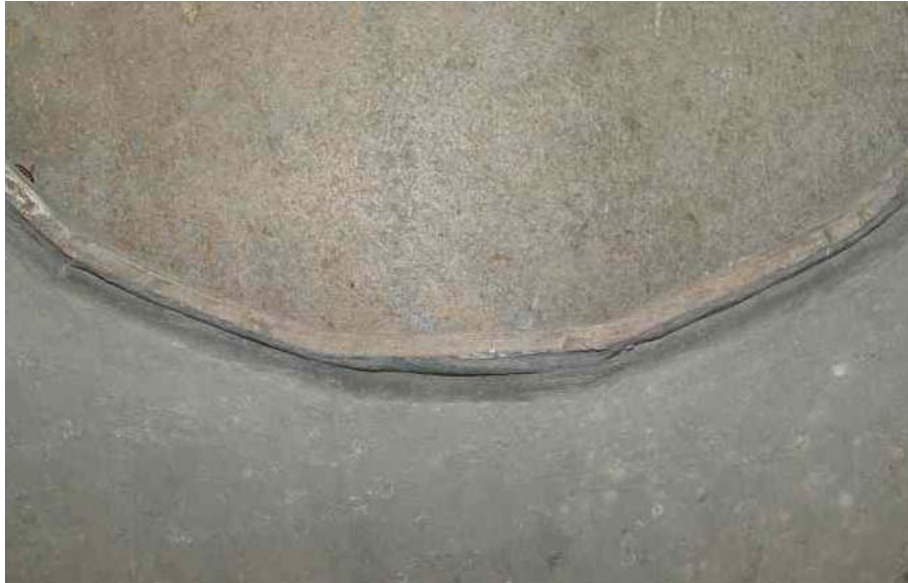
The cracked baseplate of the galvanized structure (Figure 2.2) was stored in a secure area inside the laboratory to assure that corrosion products would not further accumulate on the crack surface. Figure 2.3 shows a close-up view of cracked weld in the baseplate.

Figure 2.3 – Close-up view of cracked weld in baseplate

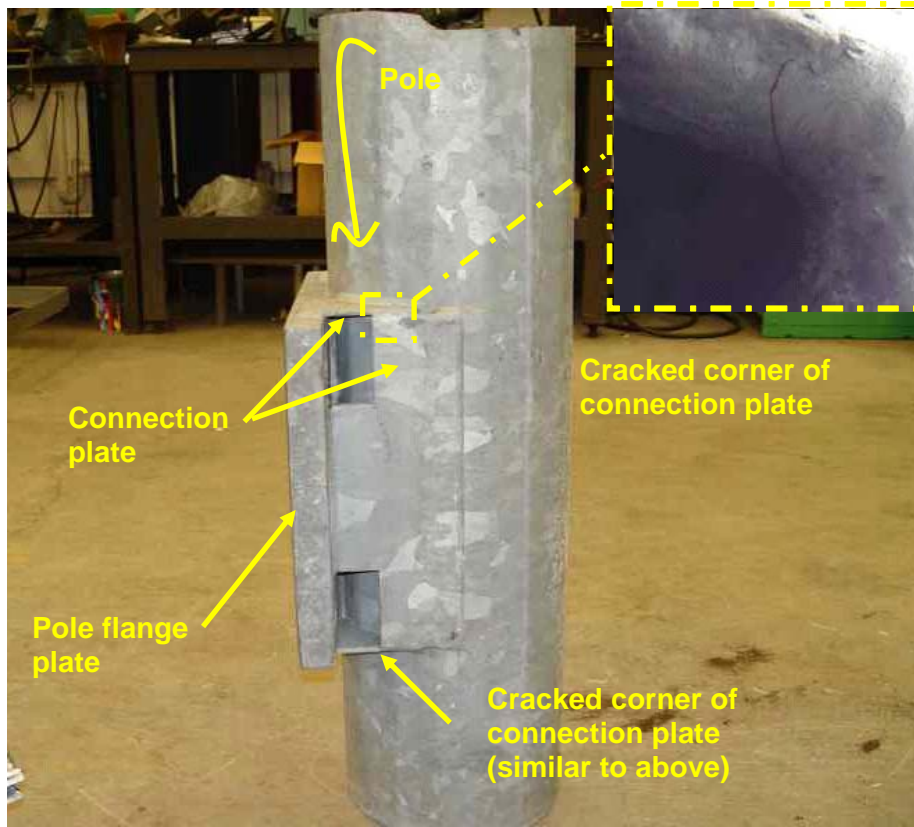
Visual inspection was conducted on another fatigue sensitive detail referred to as the “connection flange” detail (Figure 2.4 and Figure 2.5). The connection flange area is used for connecting the vertical pole to the mast arm. The detail was removed from the pole using an acetylene torch and taken inside the laboratory for further inspection. As shown in Figure 2.4, a crack was found at the intersection of the connection plates welded to the vertical pole’s outer shell. A similar crack was found on the lower portion of the connection as indicated in Figure 2.4.

Figure 2.4 – Cracked connection flange detail of the pole

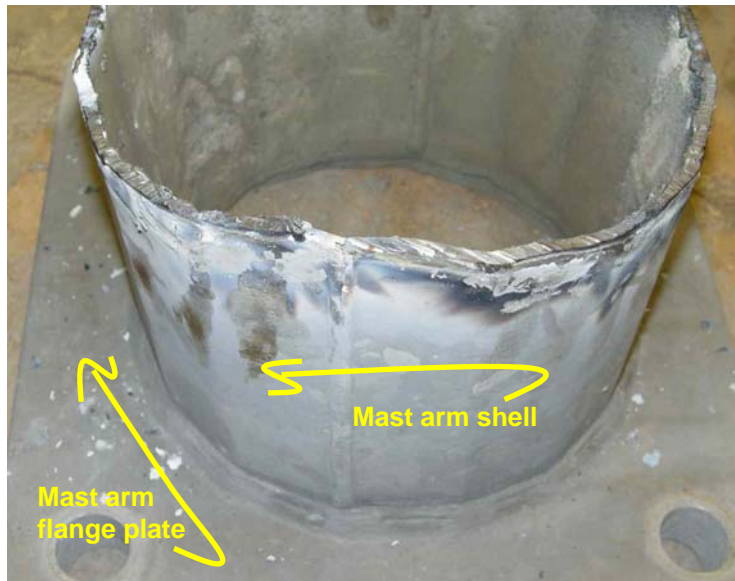
Figure 2.5 shows the mast arm flange plate detail in which the plate is fillet welded to the mast arm. Cracks, if present, would be expected along the toe of the fillet weld connecting the baseplate to the mast arm shell. Inspection did not reveal any cracks at this location.

Figure 2.5 – Uncracked connection flange detail of the mast arm

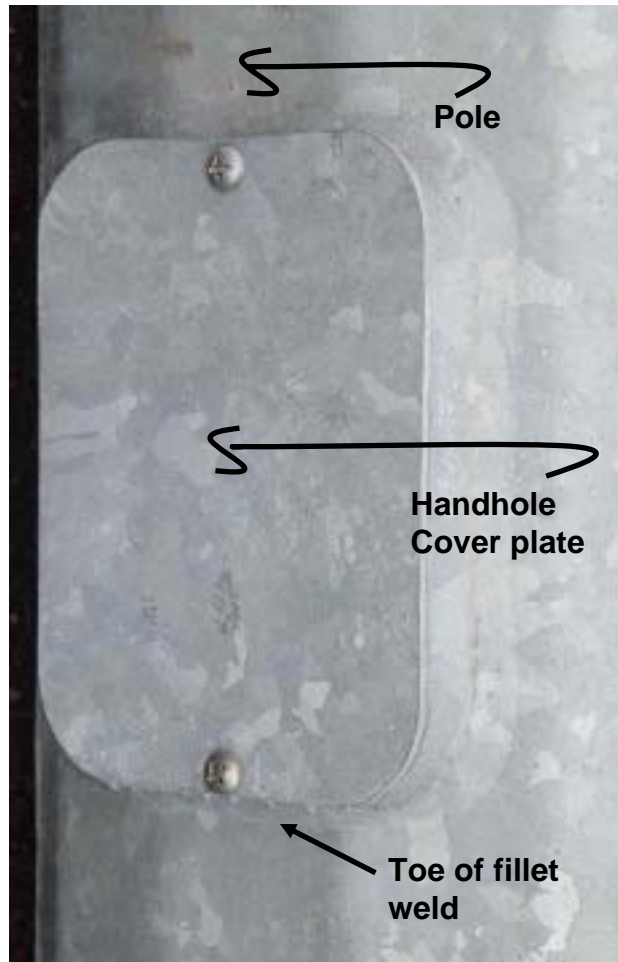
Figure 2.6 – Handhole detail

The handhole detail (Figure 2.6) was also inspected for any sign of cracking. Experience has shown that cracks along the toe of the fillet used for welding the handhole to the pole are not uncommon. Typically, a lack-of-fusion plane exists where the edge of the pole wall contacts the stiffening flanges used to frame the handhole. Such lack-of-fusion defects have very poor fatigue resistance and act like embedded cracks. Close visual inspection did not reveal any cracks at this detail.

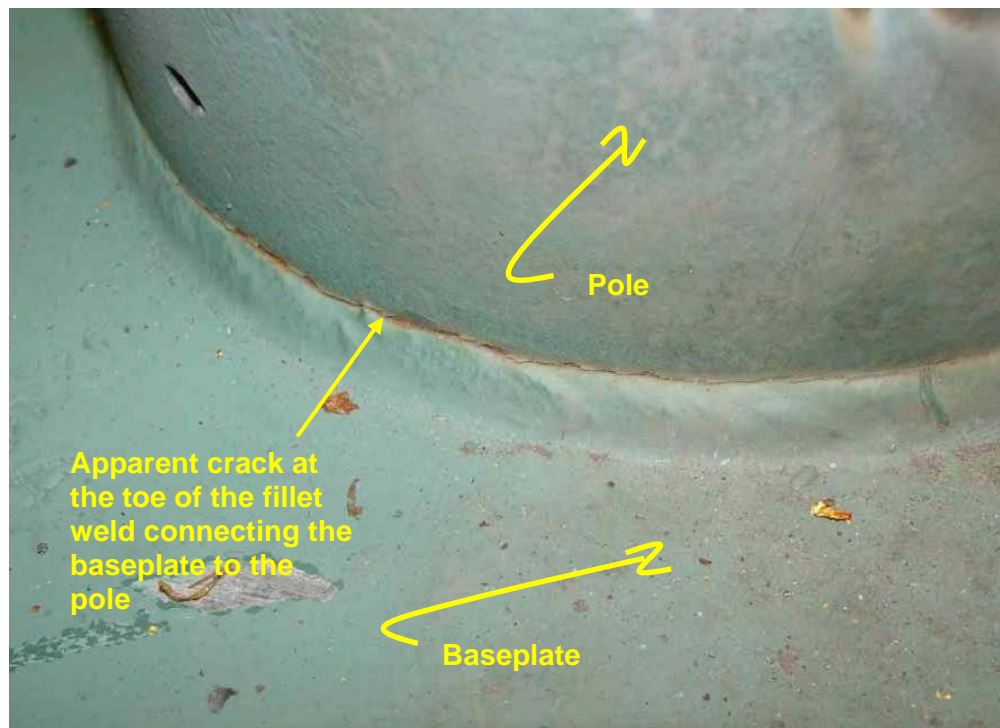
Although the baseplate of the painted structure was intact to the pole, visual inspection revealed a through-thickness crack at the toe of the fillet weld connecting the baseplate to the pole. Furthermore, the crack was found to be approximately 28% of the circumference of the pole (Figure 2.7). To assure that corrosion products would not further accumulate on the cracked surface, the baseplate and a portion of the pole was cut off and stored in the laboratory. The cut was made in the pole at approximately 6 inches above the cracked baseplate, as shown in Figure 2.2, so the heat from cutting and spatter would not damage the crack surface.

Figure 2.7 – Crack at baseplate to pole connection

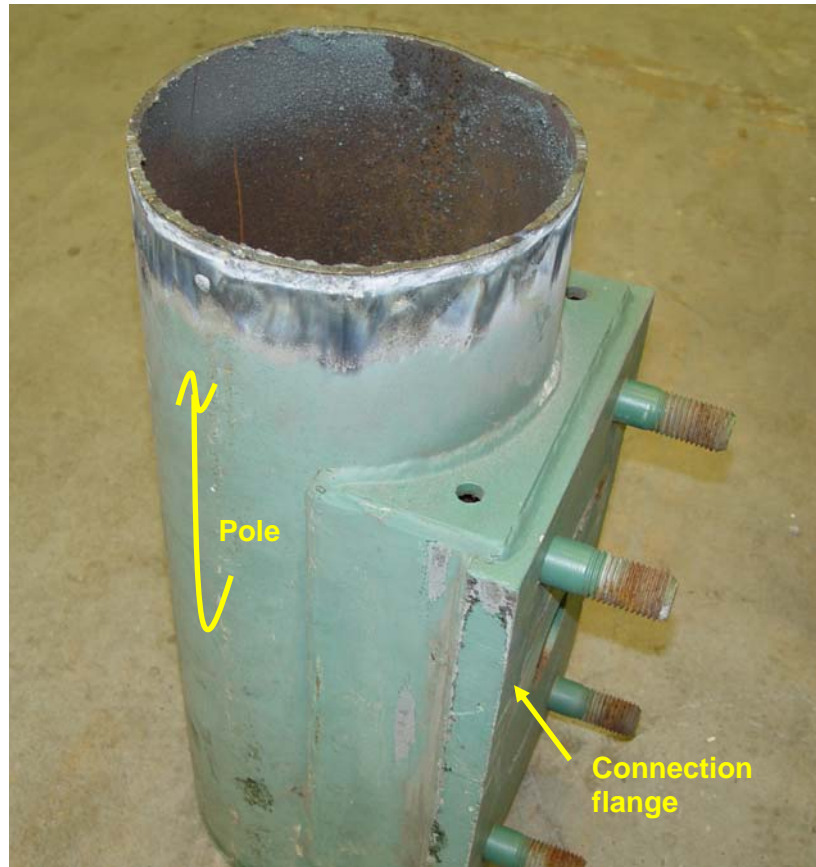
The connection flange details (Figure 2.8 and Figure 2.9) were also visually inspected for cracks. Figure 2.8 shows the connection flange detail in which the connection flange is fillet welded to the pole. There were no signs of fatigue cracking at this detail.

Figure 2.8 – Connection flange detail of the pole

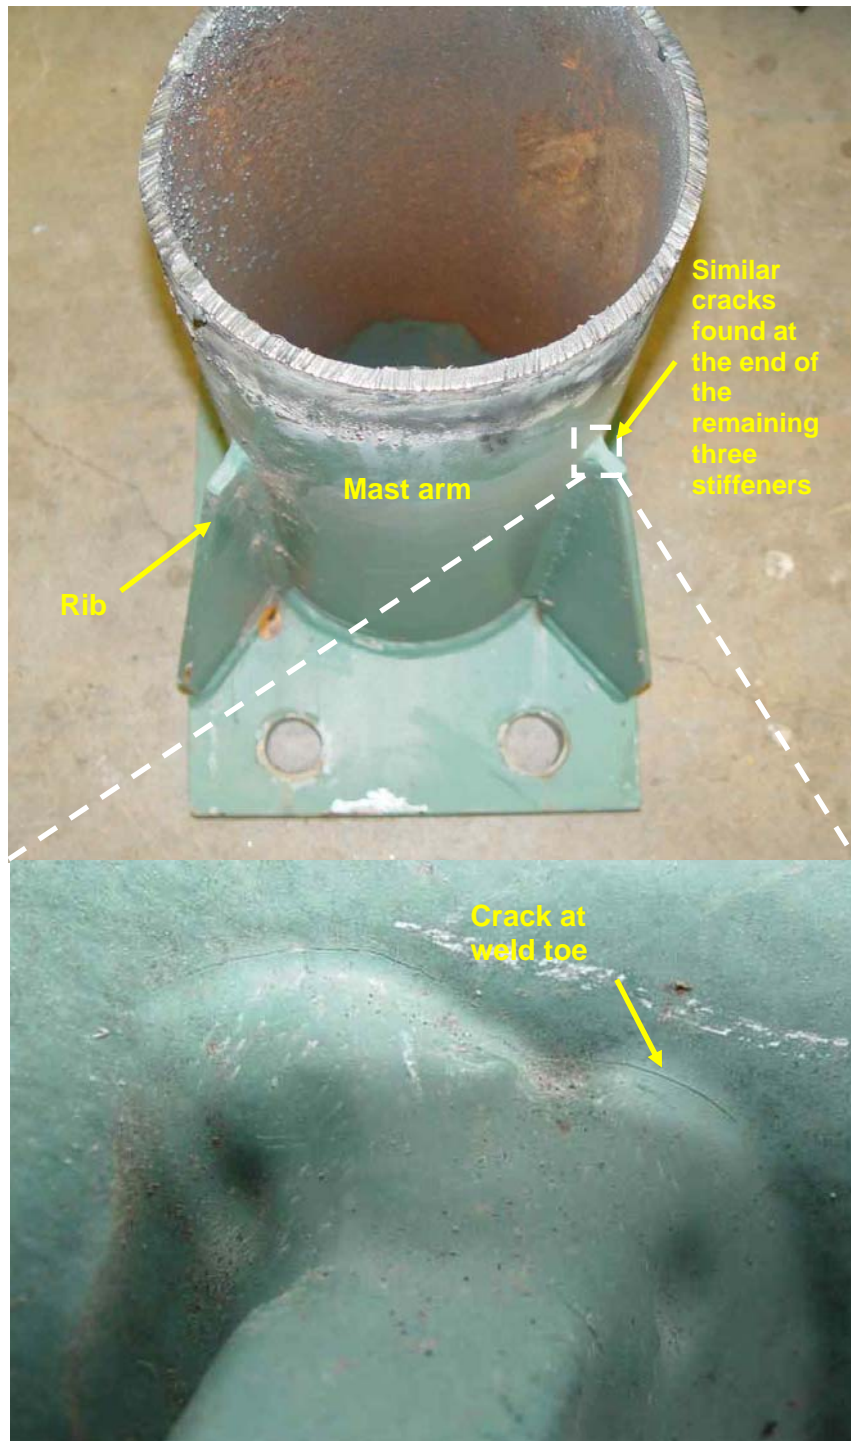
Figure 2.9 shows the detail in which a crack was found at the weld toe at the end of the mast arm stiffener. Similar cracks were found at the termination of the other three stiffeners as indicated in Figure 2.9. The apparent cracks were found to be typical defects, which are common in welded structures. As explained later in Section 3.2. There was no sign of crack initiation or propagation from the defects into the pole's shell.

Figure 2.9 – Connection flange detail of the mast arm showing a close up of a crack found at the end of the rib that is fillet welded to the pole's outer shell

As previously mentioned and as shown in Figure 2.9, four cracks in the paint were found at the termination of the longitudinal stiffeners welded to the pole's outer shell. Often, cracks in the paint at fatigue sensitive details are indicators of cracks in the steel below. Two out of the four regions were extracted for evaluation. Before exposing the surfaces the extracted regions were immersed in an acetone bath to remove the green paint coating on the outer surface for more thorough visual inspection. Visual inspection of the two extracted regions revealed that the first, which could be seen with the naked eye before removing the paint disappeared and was no longer visible after the removal of the paint. This indicates that the crack was only in the paint coating and did not penetrate in the base metal of the shell.

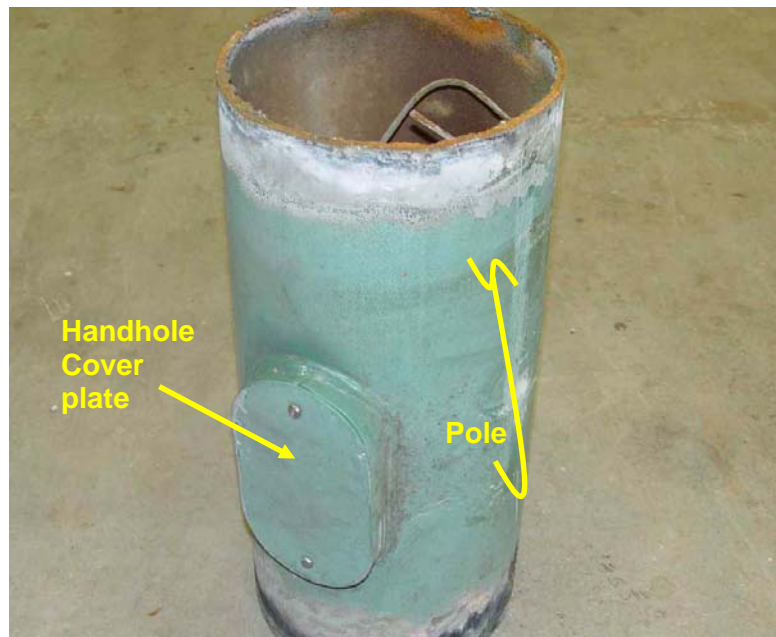
Figure 2.10 – Handhole detail

The handhole detail on the painted pole (Figure 2.10) was also visually inspected for any sign of cracking. No cracking was observed however at the detail.

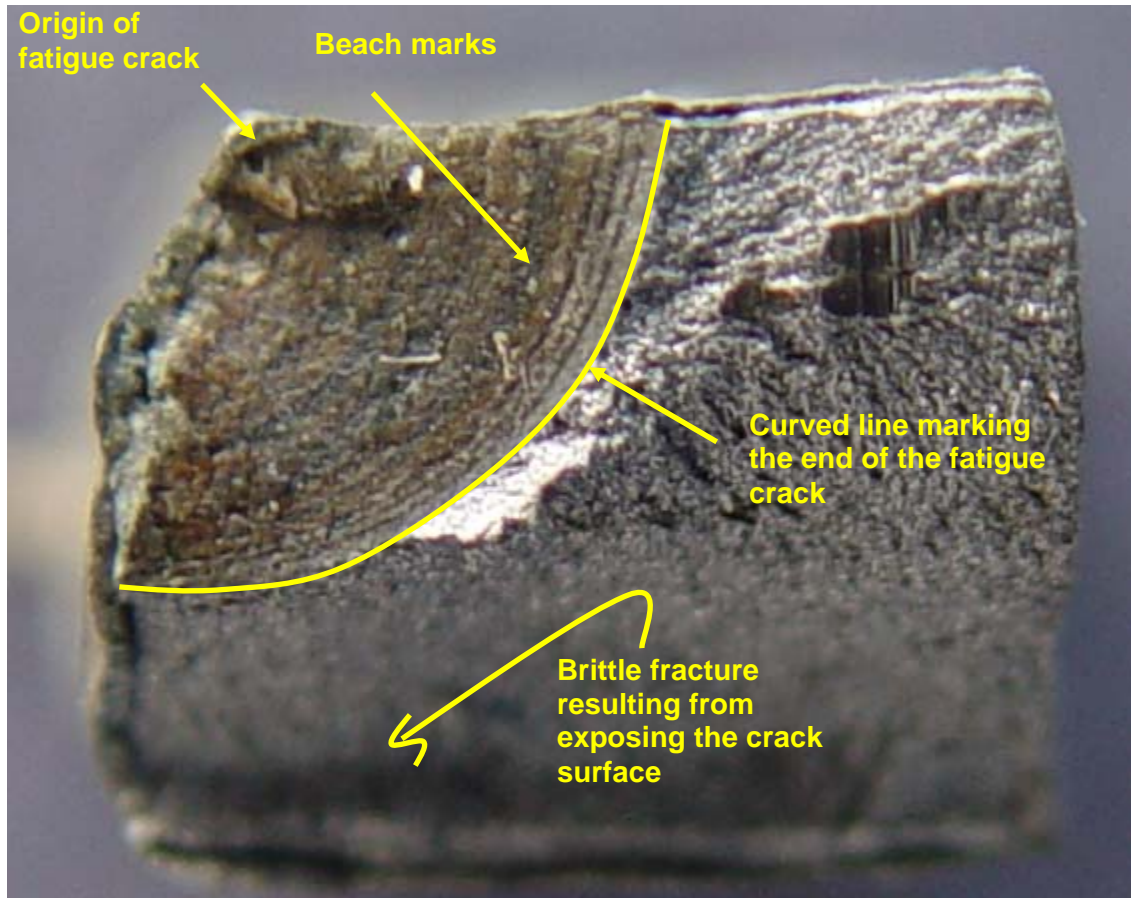
Once exposed, it was clear that the crack originated at the corner of the detail (location of a high stress concentration resulting from a change in geometry in the detail) and propagated under fatigue. A close up of the cracked surface is shown in Figure 3.1. Beach marks on the crack surface are clear indication of the successive advancement of the fatigue crack.

Figure 3.1 - Close up of exposed crack surface of the galvanized connection flange detail of figure 2.4 showing fatigue beach marks

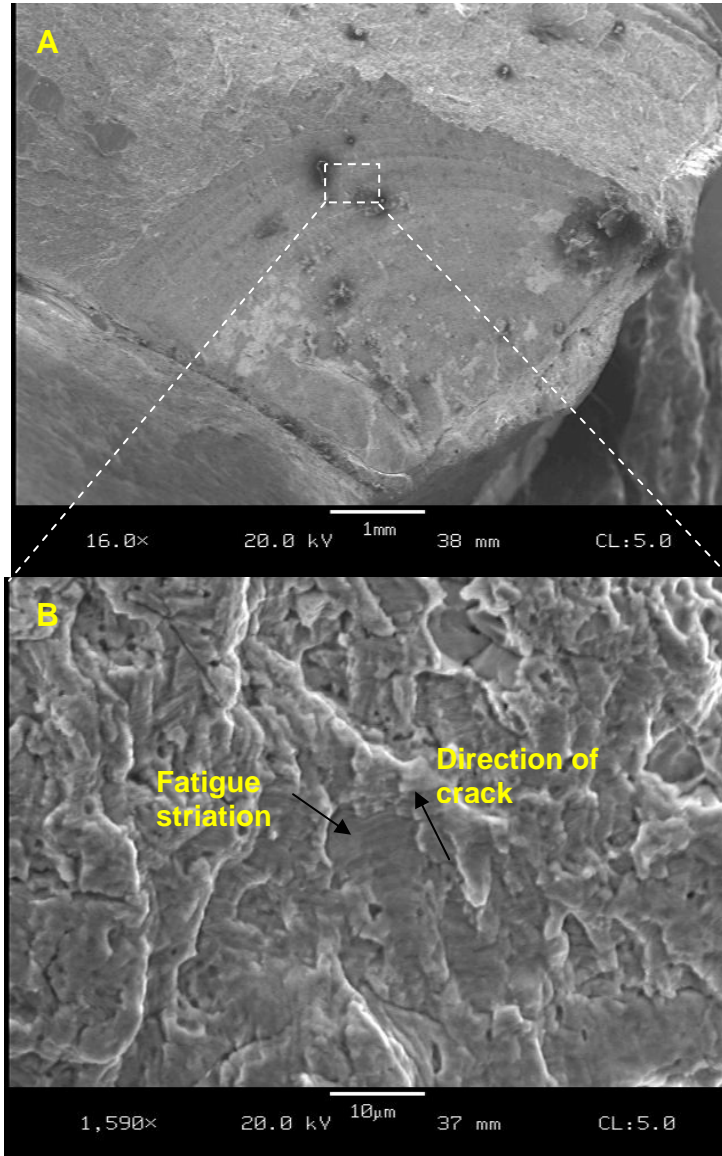
More analyses were conducted using a Scanning Electron Microscope (SEM) to characterize the fracture mechanism. Figure 3.2 B is a high magnification image of Figure 3.2 A. Fatigue striations in the figure are an indication of the propagation of the crack front (indicated by the arrow on the figure). Figure 3.2 B also shows a typical appearance of fatigue fracture surface with no sign of damage to the fracture surface. Such observation indicates that the fatigue cycles were predominantly in tension (i.e., damage of the crack surface did not occur as a result of rubbing and strongly suggests that the applied stress cycles were predominantly in tension).

Figure 3.2 – A SEM image of cracked surface showing beach marks [Mag. 16 X]
Figure 3.2 – B shows a typical appearance of fatigue fracture surface [Mag. 1590 X]

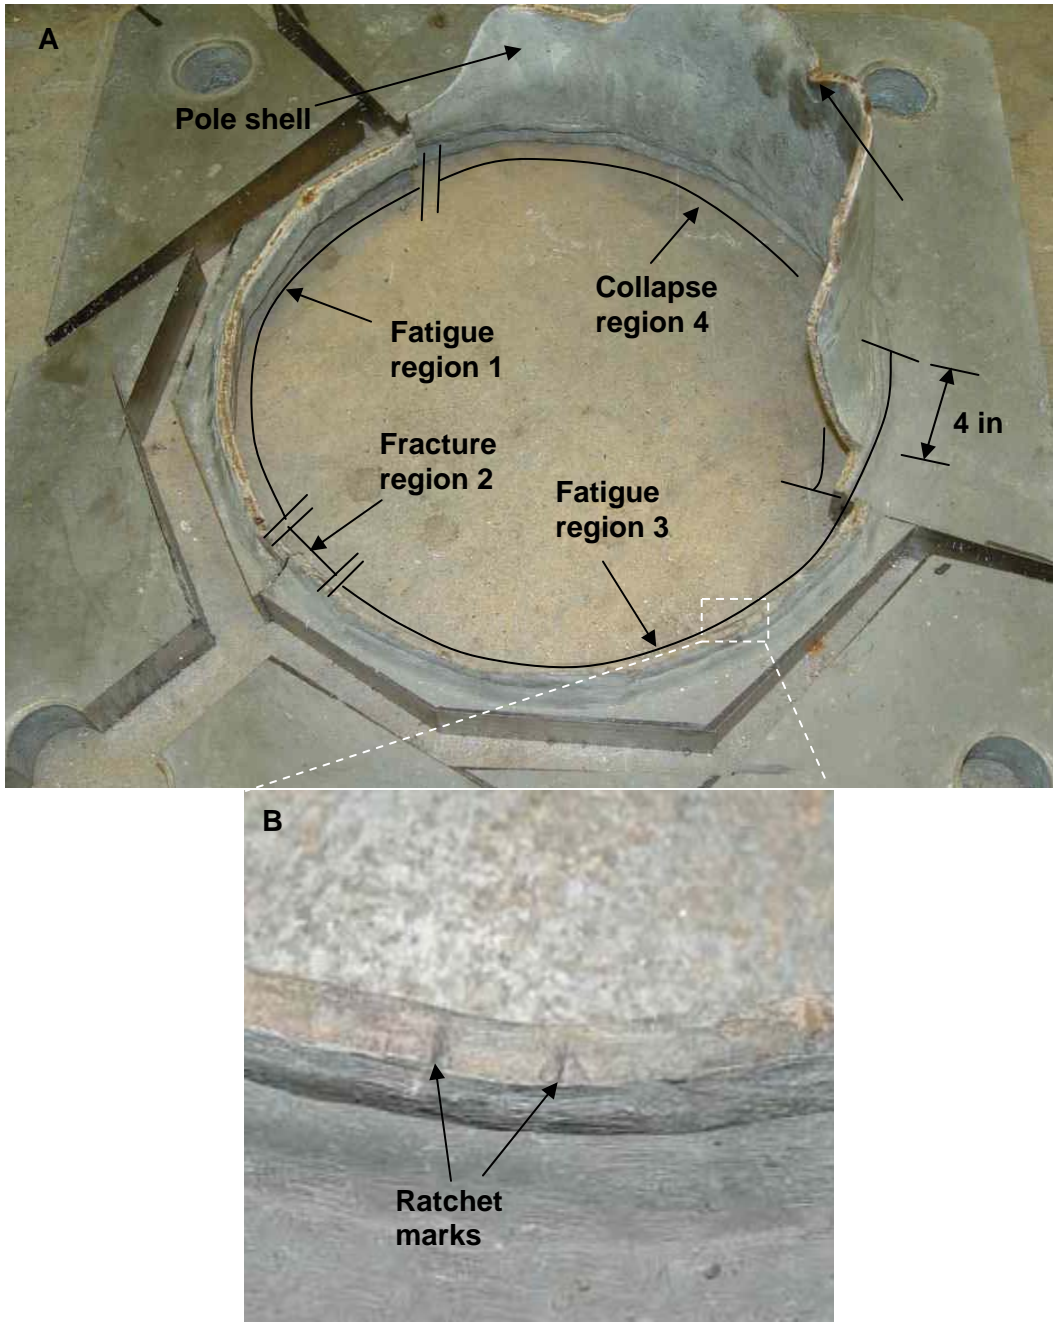
As shown in Figure 3.3 A, the baseplate is divided into four different regions. Region 1 and region 3 were defined by visual inspection as fatigue regions (i.e. fatigue was the failure mechanism). The figure shows region 1 with more severe sign of corrosion than region 3, which suggests that cracking in region 3 did not proceed until region 1 was partially or fully cracked (i.e., region 1 was exposed to sever weathering condition for a longer period than region 3). It is also possible that the different level of corrosion could have been a result of the pole laying along the road for a long time where the heavily corroded surface of region 1 was subjected to more severe weathering conditions than the less corroded surface of region 3 (i.e. the baseplate could have been partially immersed in dirt, where the surface covered with dirt below the ground level was subjected to different weathering condition than the surface above the ground level). Unfortunately there is no evidence to support one scenario over the other.

Further inspection also reveals that a crack initiated at every bend in the plate. This suggests that the wind-induced vibration of the pole occurred from wind in multiple directions. Furthermore, multiple cracks initiated within each bend. The multiple cracks eventually joined up through tear ridges, or shear, as the crack increased in size. The presence of multiple cracks is indicated by the ratchet marks showing in Figure 3.3 B. The marks are usually present at the surface of components where a high local stress concentration is present (the bends in the pole tube).

In both fatigue regions, the multiple fatigue cracks within each bend and in the different bends eventually all joined to form two long fatigue cracks (one in each region). Failure of the pole did not take place until the length of the two fatigue cracks in region 1 and region 3 reached a critical size. The collapse region (formed during failure) of the pole is clearly shown in Figure 3.3 A and marked as region 4. Plastic collapse of the pole is clear by the presence of plastic deformation in the remaining ligament of the pole shell (attached to the baseplate). It is worth noting that fatigue region 3 tunneled under collapse region 4 for approximately 4 inches.

The fracture region (region 2) is located radially across from the collapse region. The roughness on the surface and the slight necking of the pole shell at the fracture location is a characteristic of a ductile fracture.

The existence of corrosion products (ferrous hydroxide) on the cracked surfaces was evident in regions 1, 2, and 3. The specimens were immersed in an ultrasonic bath to remove the layers of corrosion. The Scanning Electron Microscope (SEM) analyses of the crack surface in both the fatigue regions and the fracture region did not reveal any valuable information since the accumulated corrosion products over the surface caused a great deal of damage to the surfaces. Although metallurgical analyses of the cracked region did not provide valuable information, it is clear that fatigue was the mechanism in which cracks initiated and propagated as explained above.

Figure 3.3 – A Cracked baseplate of galvanized pole showing four regions describing the failure mode

Figure 3.3 – B Close up of part of the cracked surface of the galvanized pole showing ratchet marks.

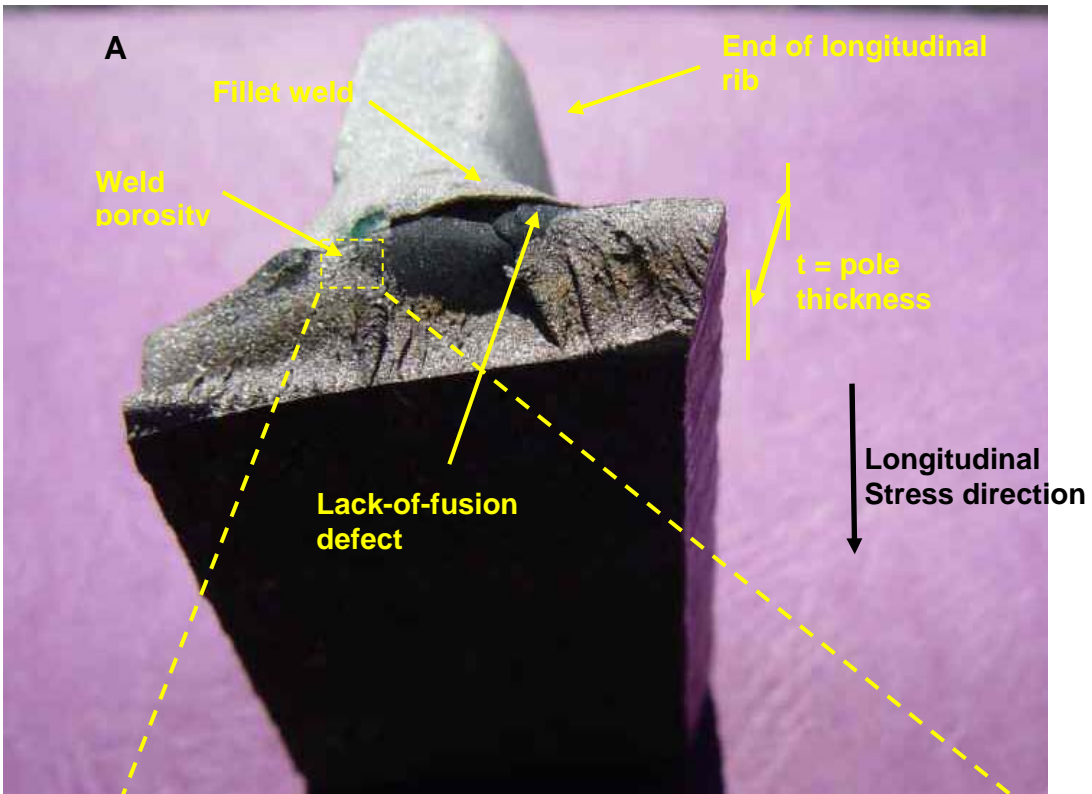
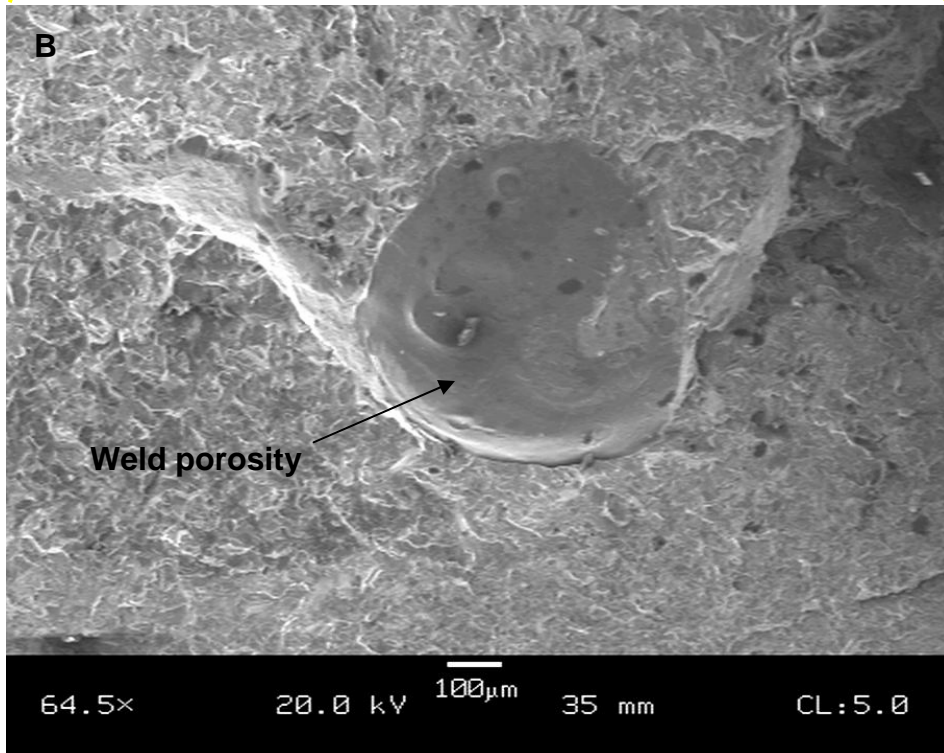
The condition at the other extracted region was however still visible after the removal of the paint coating. Exposing the possible crack was therefore necessary for further evaluation. Exposing the surface was done similar to the cracked connection flange detail in the galvanized structure by immersing the specimen in a liquid hydrogen bath to lower the fracture toughness of the metal and facilitates the separation of the surfaces. Figure 3.4 A shows a close up of the exposed surface. The figure shows a lack-of-fusion defect (also known as cold lap) between the fillet weld and the pole's shell. This could have been a result of many things including high travel speed of the welding gun such that the base metal failed to reach its melting point, unclean pole surface during welding, etc. There was no sign of cracks initiating or propagating from the defect in the thickness direction of the shell. Also shown in the figure is weld porosity, which is typically a result of dissolved gases or gases released during the welding process. SEM analysis of the weld porosity was conducted to examine if any cracks have initiated and propagated from the defect. There was no sign of crack initiation or propagation from the weld defect.

Although fatigue cracks have been known to initiate from lack-of-fusion defects and weld porosities, no cracks were found to have been initiated from neither defects discussed above.

Figure 3.4 A – Exposed painted pole shell at the termination of one of the longitudinal stiffeners

Figure 3.4 B – A SEM image of the weld porosity

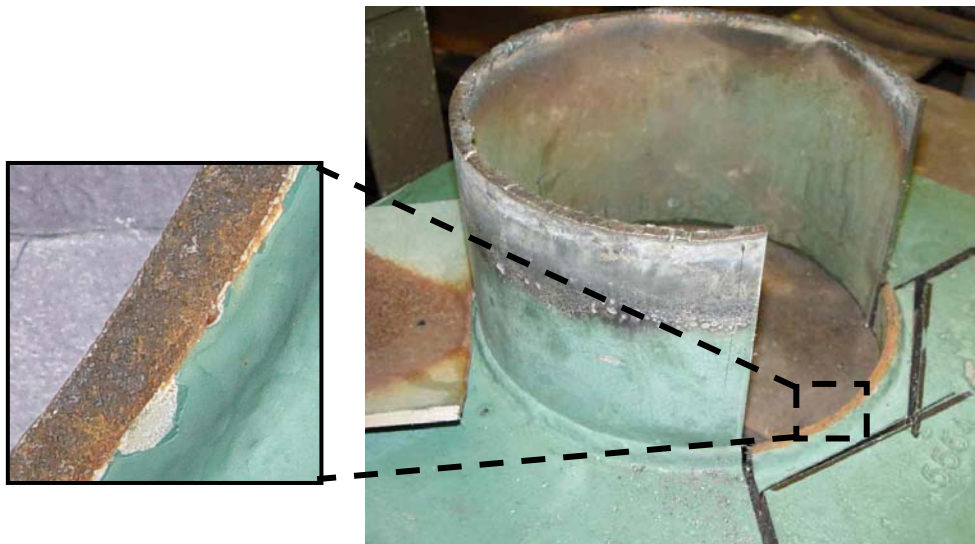
As previously mentioned, a large crack in the baseplate of the painted sign structure was discovered upon visual inspection of the pole at the ATLSS Research Center. The crack is approximately 28% of the circumference of the pole. As shown in Figure 3.5, a high level of corrosion is apparent on the crack surface. The severity of the corrosion indicates that the crack has existed and been exposed to weathering conditions for sometime. It is also possible that the high level of corrosion was a result of the pole laying along the highway for a long period of time.

Conducting SEM analyses of the crack surface would not yield any additional information due to the extensive damage caused by corrosion. The smoothness of the fracture surface suggests that fatigue was the failure mechanism under which the crack initiated and propagated.

Figure 3.5 – Cracked baseplate of painted pole with a close up on the highly corroded crack surface
