Results of the Fatigue Evaluation and Field Monitoring of the I-39 Northbound Bridge over the Wisconsin River

Final Report

ATLSS Report No. 05-04

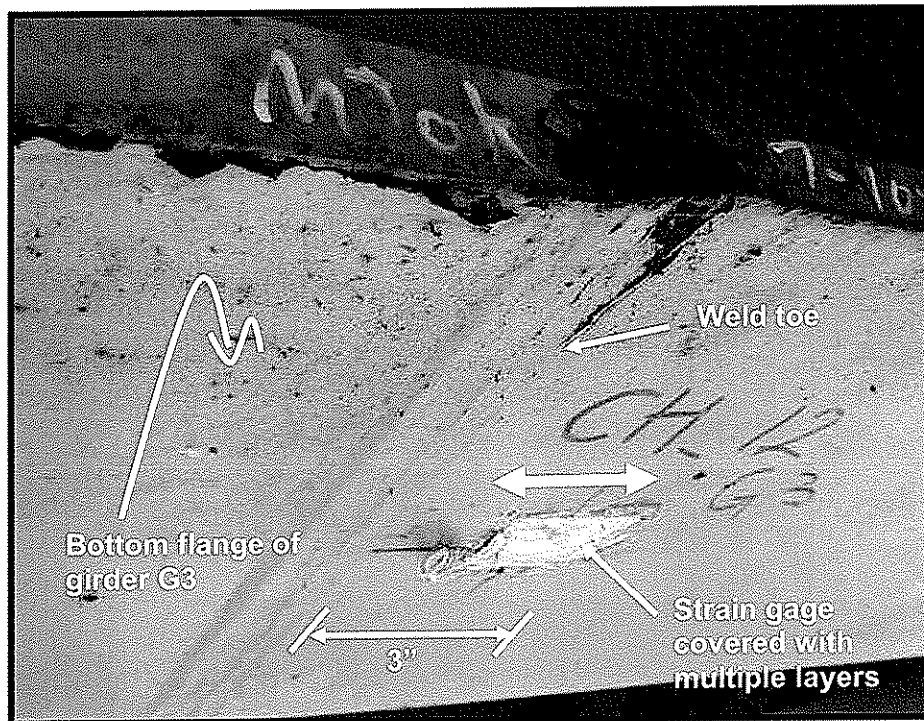
Figure 4.1 – CH_12 installed in span 1 between P.P. 5 and P.P. 6 on the bottom face of the bottom flange of girder G3 (3 inches away from weld toe)

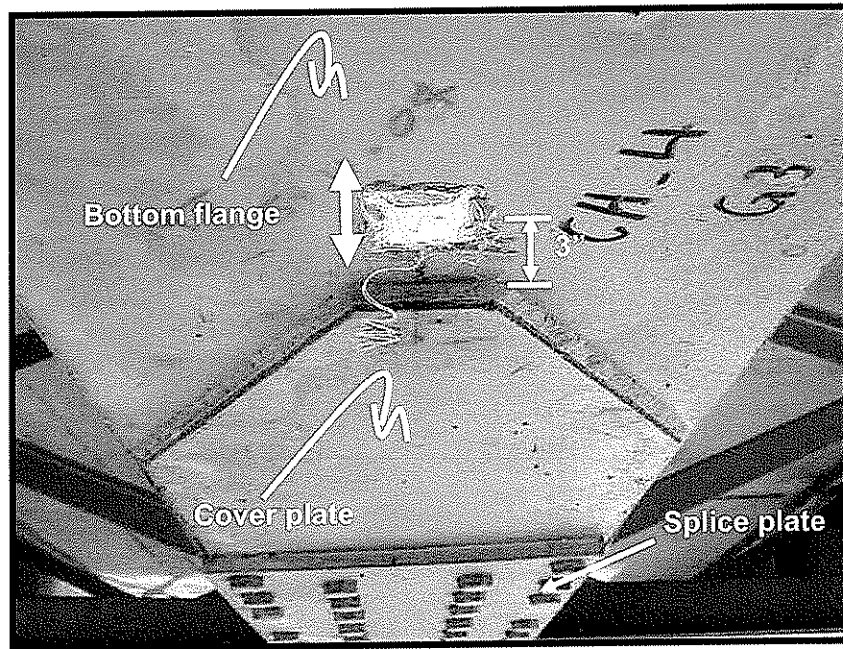
Figure 4.2 – CH_4 installed in span 2 at P.P. 9 on the bottom face of the bottom flange of girder G3 (3 inches away from weld toe)

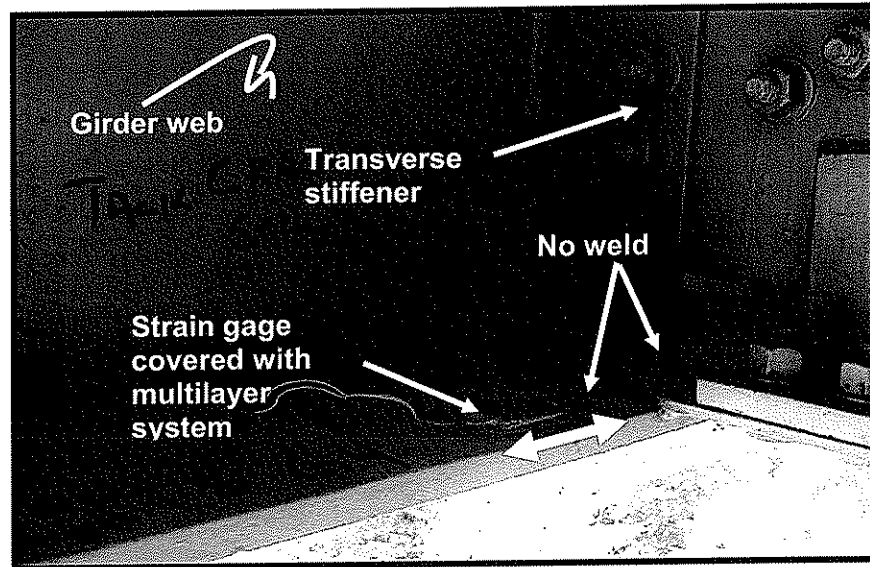
Figure 4.3 – CH_1 installed on the top face of the bottom flange of girder G4 in span 1 at P.P. 3

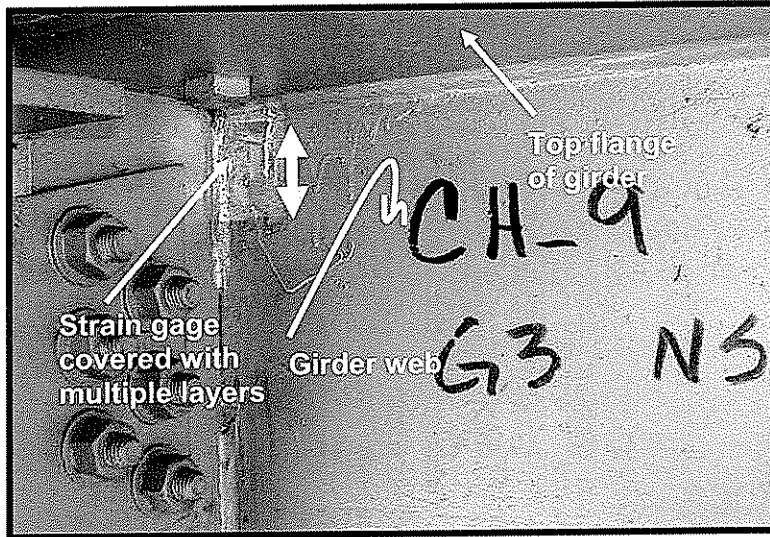
Figure 4.4 – CH_9 installed in span 1 at P.P. 5 on the web of girder G3 adjacent to the weld toe of the transverse connection plate.
Channel CH_10 is directly behind CH_9 on the opposite face of the web

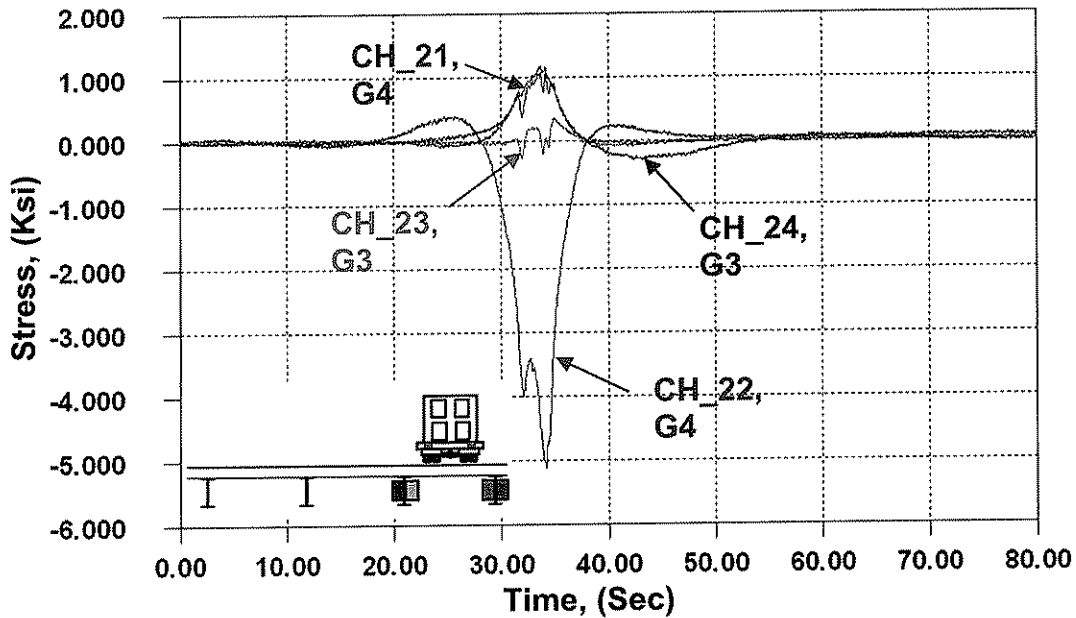
As the figure shows, the magnitude of the stress in CH_22 installed on the web of girder G4 adjacent to the transverse connection plate is considerably higher in the absolute magnitude than that of CH_24, which was installed in the same position at similar detail on girder G3. The high magnitude of stress experienced by the channel is an indication of a greater relative displacement between the transverse connection plate and the web of the girder G4. However, the magnitude of the stress range, about 5.5 ksi, is not of concern from a fatigue standpoint.

Figure 5.6 – Response of CH_21 through CH_24 installed in span 2 at P.P. 13 (on girders web adjacent to transverse stiffeners) as test truck #169 passed over the right lane in the crawl test (CNBRT_2) (View looking north)

It is important to note that although the stress range produced by the test truck at CH_22 is not critical for fatigue, out-of-plane stresses and the potential for associated fatigue cracking can only be assessed using the random variable-amplitude data. This is because the effects of reversals and other random effects, which produce fatigue damage, are revealed during such monitoring.

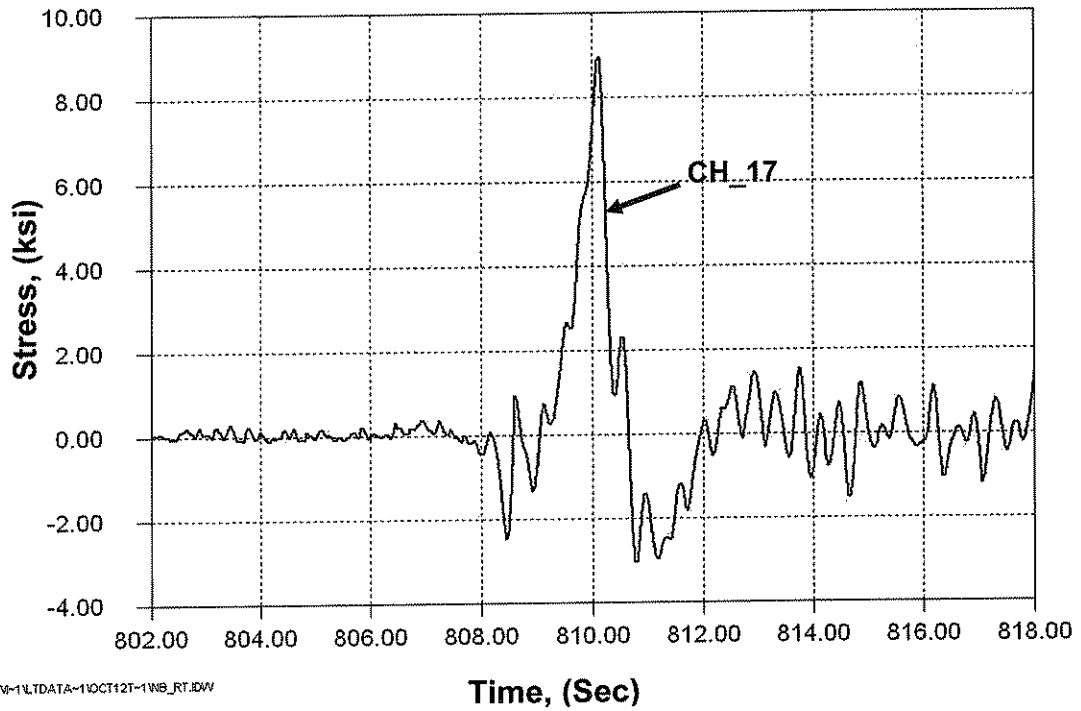
Figure 6.1 - Stress time-history for CH_17 installed in span 2 at P.P. 13 on girder G4 at welded shelf plate during the passage of a mobile crane on October 20, 2004 at 5:39 pm

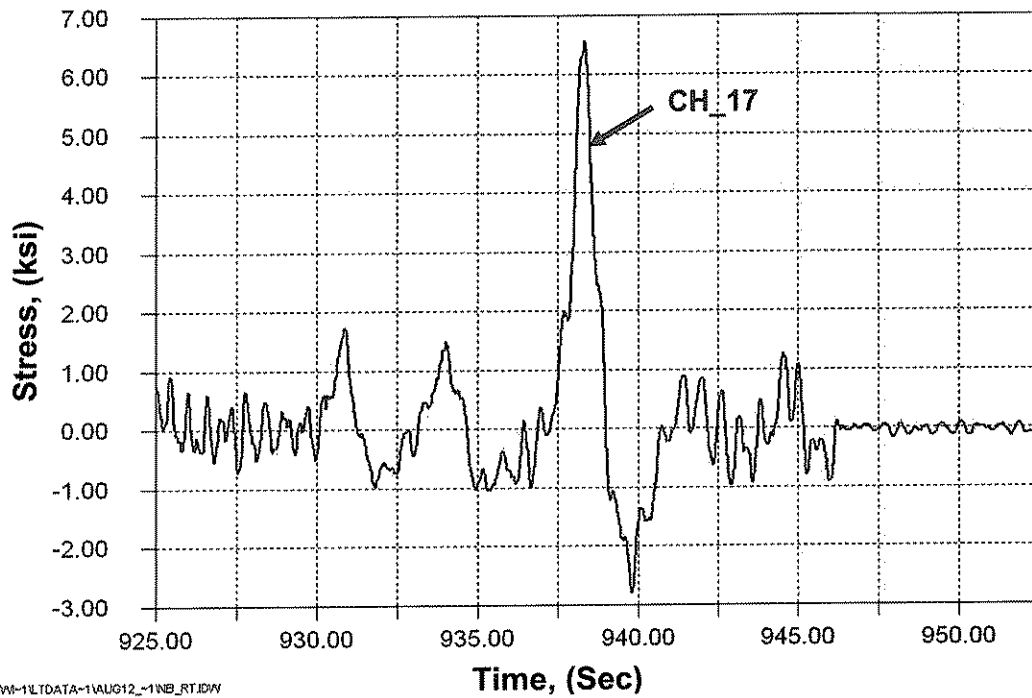
In another trigger event recorded on October 21, 2004 at 7:39 am, a stress-range cycle of 9.4 ksi was measured by CH_17 (Figure 6.3). The measured stress range was caused by a flat-bed truck loaded with logs as shown in Figure 6.4.

Figure 6.3 - Stress time-history for CH_17 installed in span 2 at P.P. 13 on girder G4 at a welded shelf plate detail during the passage of a flat-bed truck loaded with logs on October 21, 2004 at 7:39 AM

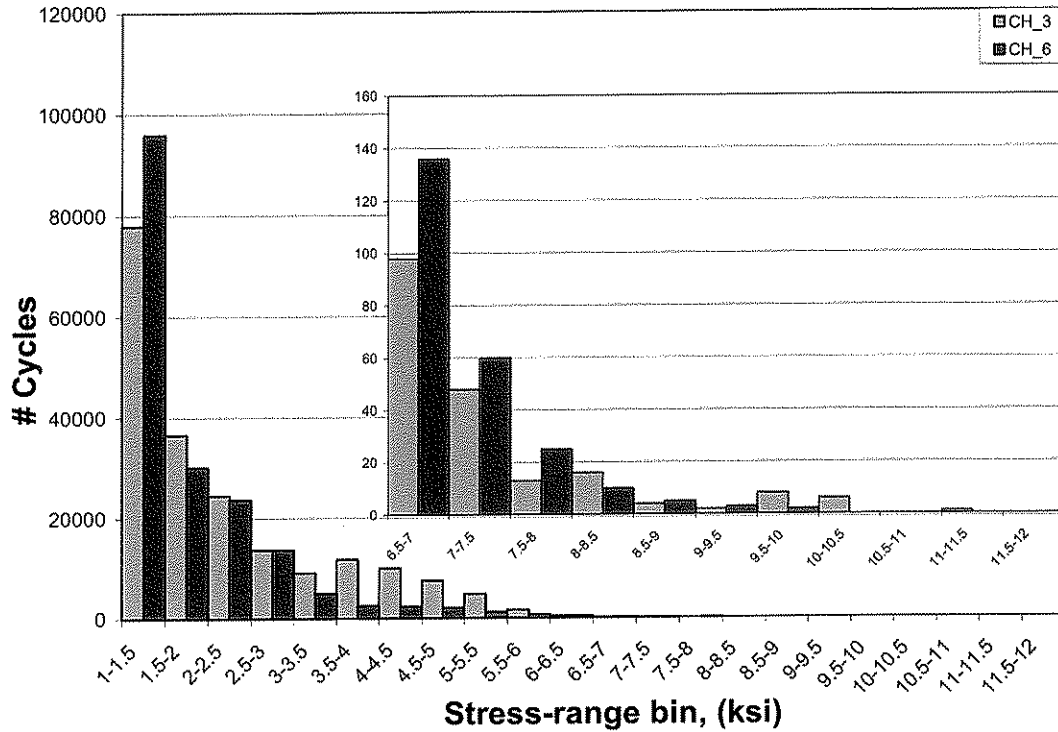
The detail is classified as category E per the AASHTO specifications with a CAFL of 4.5 ksi. Figure 6.10 presents the stress-range histogram for CH_3 and CH_6. A lower-bound stress-range truncation level of 1 ksi (1/4 of the CAFL of the detail) was used for producing the histogram. Stress-range cycles higher than the CAFL of the detail (4.5 ksi) were recorded by both channels. The figure also shows that in the bins from 3-3.5 ksi through 5.5-6 ksi, a higher number of cycles were measured for CH_3 (right lane exterior girder) than CH_6 (left lane exterior girder). The higher count of cycles in those bins resulted in lower fatigue life estimates for CH_3 than CH_6 as shown in Table 6.4.

Figure 6.10 – Stress range histogram for CH_3, CH_4, CH_5, and CH_6 at the cover plate detail at flange splice

Table 6.4 shows that the estimated remaining fatigue life of the detail is approximately between 20 and 100 years. Although in all cases positive remaining fatigue life was estimated, it is felt that improving the remaining fatigue life of the detail at locations where the estimated remaining life is below 50 years is prudent (e.g. CH_3). The suggested rehabilitation strategy is to use the hammer peening technique to improve the fatigue strength of the detail to an acceptable level. The recommended locations of the cover details to be hammer peened are further discussed in Chapter 7.

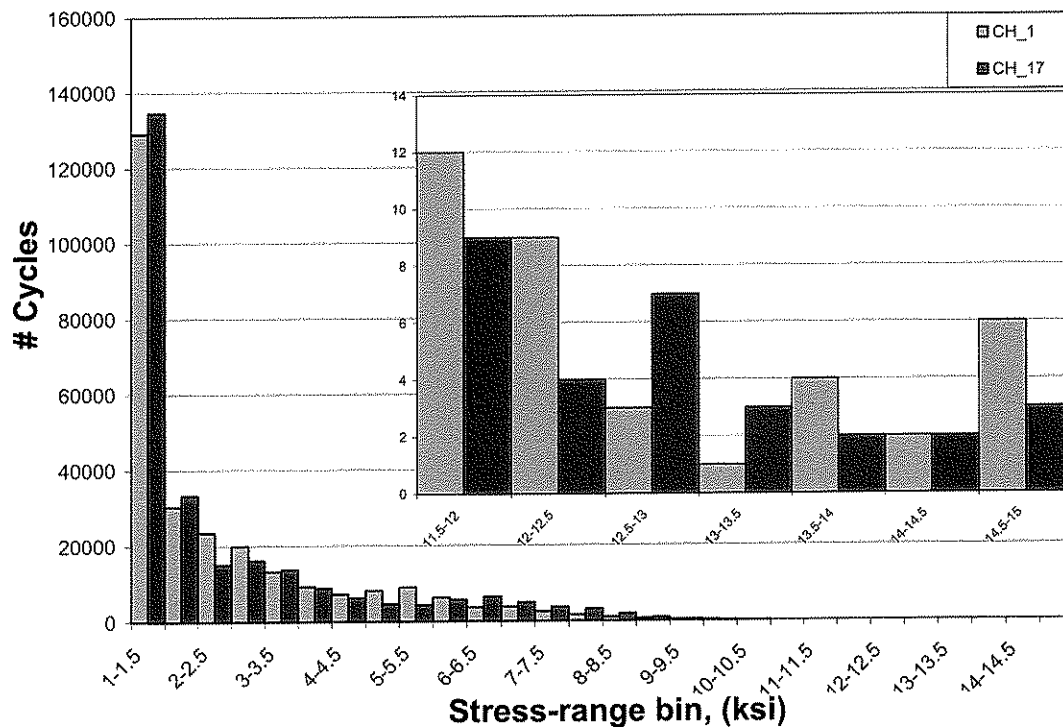
The detail where the channels were installed is classified as category detail E per AASHTO specifications and the CAFL of the detail is 4.5 ksi. Figure 6.11 presents the stress-range histogram for two of the six channels installed (CH_1 and CH_17). As shown in the figure, stress-range cycles higher than the CAFL of the detail were measured. The inset in the figure shows that stress-range cycles as high as 15 ksi were recorded by both channels during Long-term monitoring.

Figure 6.11 – Stress range histogram for CH_1 and CH_17

A summary of the fatigue life calculations is presented in Table 6.5. As shown in the table, the estimated fatigue life of all instrumented shelf plate details is less than 50 years. Furthermore, the calculations indicate an estimated negative remaining fatigue life at two of the instrumented locations (CH_1 and CH_17), which implies that cracking could be expected to occur at the shelf plate detail at the locations where CH_1 and CH_17 are installed. The most recent in-depth inspection of the bridge [1] indicated no sign of fatigue cracking at any of the shelf plate details on the bridge except for a 2 ¼" fabrication crack at the west shelf plate weld on edge of flange of girder G2 in span 2 at P.P. 8.

Although Table 6.7 shows positive remaining fatigue life for the channels, it is recommended that a retrofit be implemented at the lateral shelf plate connection detail where the estimated remaining fatigue life was less than 50 years (i.e. CH_1 and CH_2, and CH_17 and CH_18). Hence, all girders may not need to be retrofit at the present time. However, considering the proposed widening, it should be prudent to retrofit all girders in a given cross section. A reasonable approach would be to retrofit all shelf plates located in positive moment regions as well as those located in regions of stress reversal (e.g. P.P. 5 in span 1). Note, it is critical that these recommendations be verified

The suggested retrofit consists of bolting a plate to the bottom flange of the girders in the area of the shelf plates. The plate will effectively act like a bolted cover plate serving two purposes. The first is to reduce stresses in this portion of the flange. Hence, the plate must be long enough and attached with a sufficient number of bolts to ensure it is fully effective across the region where the shelf plate exists. The second advantage is that in the extremely unlikely event a fatigue crack were to form in the flange, the flange is already fully spliced thereby preventing a fracture of the girder. The dimension of the plate (i.e. thickness, width, and length) should be determined using conventional methods. The suggested retrofit scheme is illustrated in Appendix C. It is important to note that the retrofit detail shown in Appendix C will have to be modified for locations where the lateral shelf plate detail is next to cover plate field splice detail. It is also important to note that size of the plate and number of bolts shown in the sketches does not reflect the actual size to be used in the retrofit. It was only used for illustrative purpose.
