Results of Field Measurements of the Pearl Harbor Memorial Bridge on I-476 over the Schuylkill River

Interim Report

ATLSS Report No. 06-07

March 2006

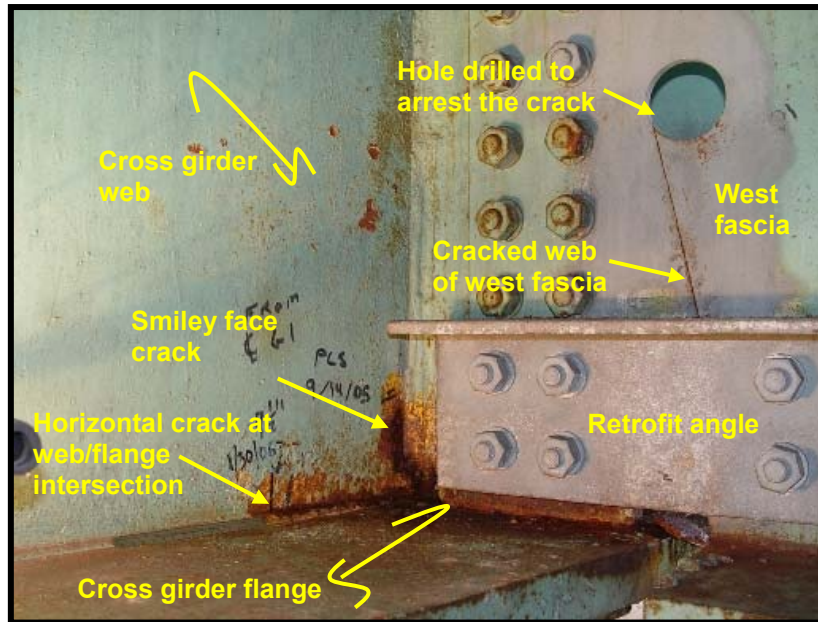
The bridge was opened to traffic in the 70's and have experienced some cracking in its superstructural elements. For example, cracks are located in some stringer webs and in the web of the floorbeam under the deck joints. In Span 12, cracks are located in the web of both the east and west fascia stringers and appeared to have originated from the cope in the stringer flange. An example of such crack can be seen in Figure 1.3, which shows the crack in the web of the west fascia stringer. Cracks are also located at the web gap of the cross girder at pier 11 at the cross girder-to-west fascia (Stringer S7) connection. The web gap is defined by the small segment of the cross girder web between the cross girder flange and the end toe of the vertical weld attaching the transverse connection plate to the web of the cross girder. Under live load, the small web gap size could give rise to high secondary stresses, which could result in out-of-plane distortional fatigue cracking, which typically form at the toe of the vertical weld connecting the connection plate to the cross girder web. Cracks could also form at the toe of the horizontal weld used for attaching the flange and the web of the cross girder. Both type of cracks are present on the web of the cross girder at the cross girder-to-west fascia stringer connection at pier 11 (Figure 1.3)

Figure 1.3 – Cracked web of the west fascia stringer (Stringer S7) and cracked web of the cross girder at pier 11

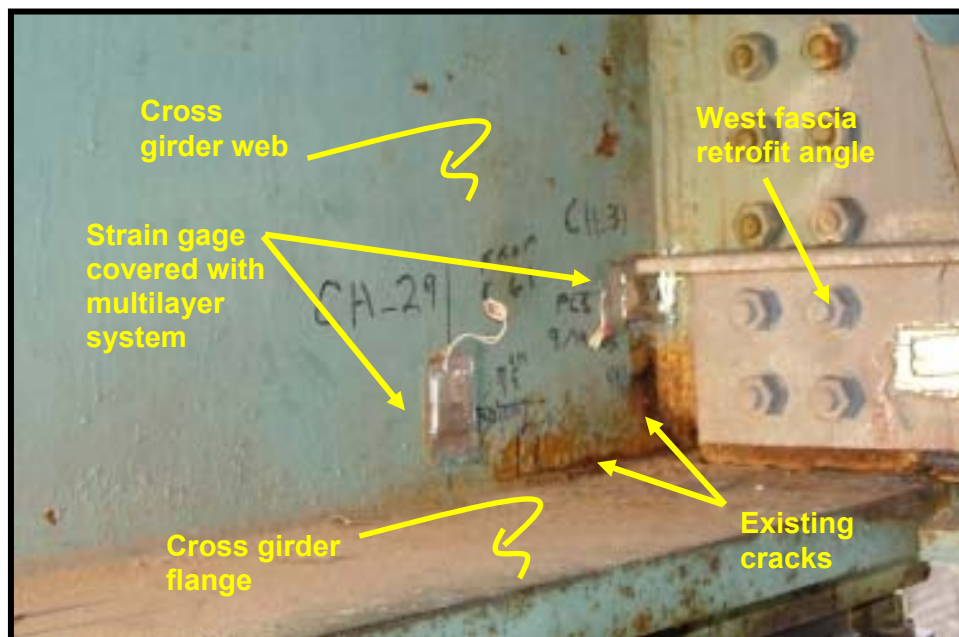
Strain gages were installed near the existing cracks located on the cross girder web at the west fascia to measure the nominal stresses around the cracks and estimate the driving force, which could be responsible for the development and the propagation of the cracks. Specifically, strain gages CH_28 and CH_29 were installed vertically on the south and north face, respectively, of the cross girder web 3 inches away from the existing longitudinal crack along the toe of the horizontal weld used for attaching the flange and the web of the cross girder. Strain gages CH_30 and CH_31 were installed horizontally on the south and north face, respectively, of the cross girder web 3 inches away from the “smiley face” crack which originated at the toe of the vertical weld connecting the connection plate to the cross girder web. Figure 4.5 shows strain gages CH_29 and CH_31 installed on the north face of the cross girder web near the existing cracks.

Figure 4.5 – Strain gages CH_29 and CH_30 installed on the north face of the cross girder web near the existing cracks

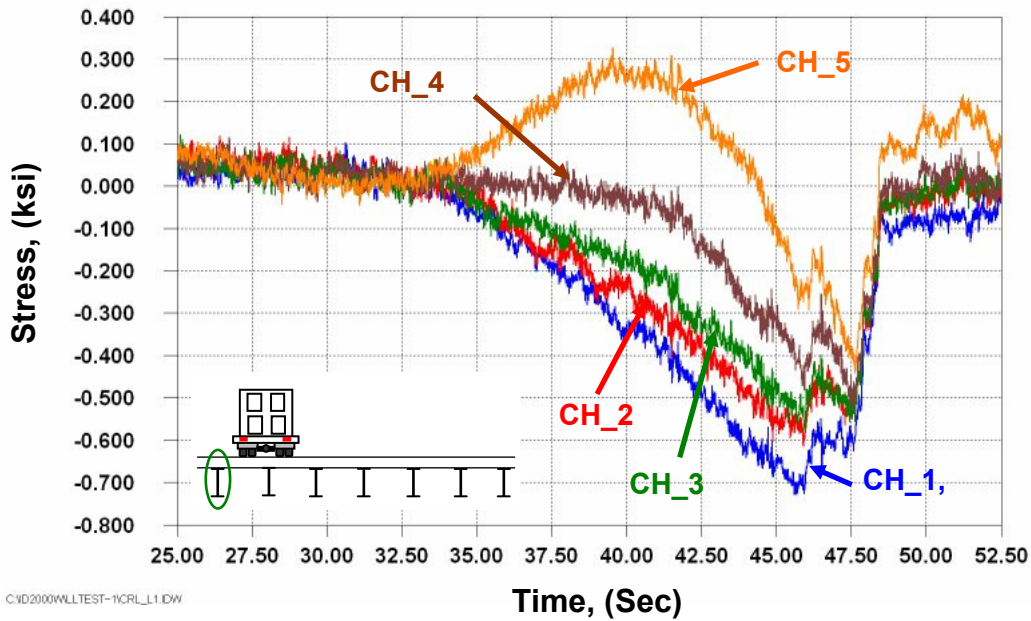
Figure 5.5 shows the response of the gages to the passing of the test truck in the left lane in the controlled load test (CRL_L1). As shown in the figure, stress gradient was measured at the detail with strain gage CH_1 measuring the largest peak compressive stresses and strain gage CH_5 measuring the highest peak tensile stresses. It is important to note that the stress range of the two gages were equivalent. A summary of the maximum stress, minimum stress, and stress range values experienced by the gages in the first crawl tests is presented in Table 5.5. The table shows low stresses measured by the gages. All stress ranges were very low, suggesting that trucks with similar or lighter weight will not cause fatigue cracking at the cross girder connection detail at the east fascia.

Figure 5.5 – Response of strain gages CH_1 through CH_5 installed on the web of the cross girder adjacent to the web gap area of zero inches at the east fascia to cross girder connection as the test truck passed in the left lane in the crawl test (CRL_L1)

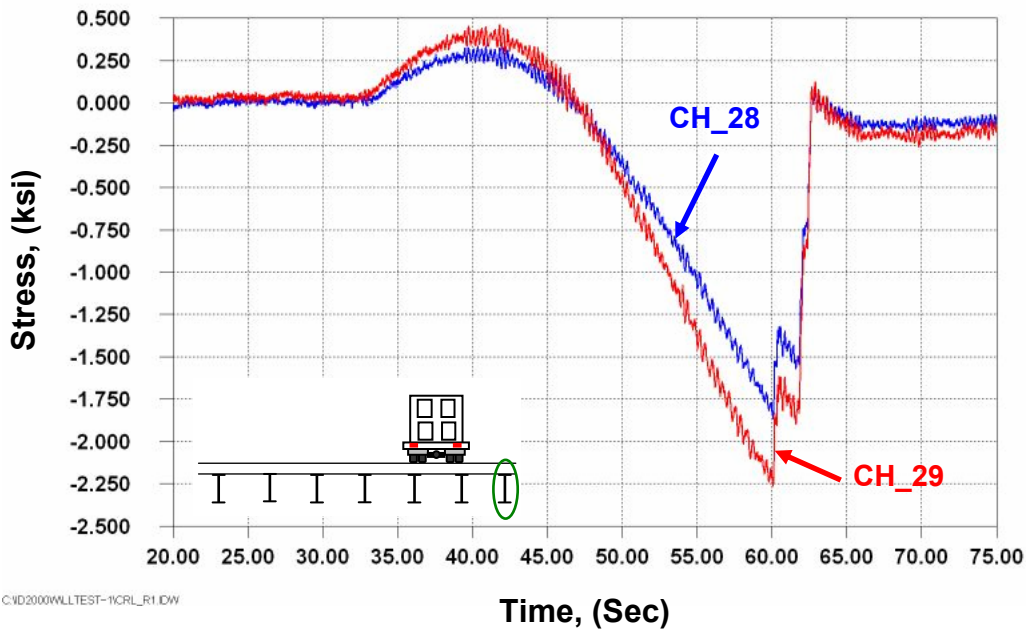
Figure 5.6 shows the response of strain gages CH_28 and CH_29 as the test truck passed over the span in the right lane in the crawl test CRL_R1. The response in both gages is similar, which indicates that there is little out-of-plane distortion of the web. The response in strain gages CH_30 and CH_31, however, is similar in magnitude but with opposite signs, implying out-of-plane bending of the web. Figure 5.7 shows the response of strain gages CH_30 and CH_31 as the test truck passed over the span in the right lane in the crawl test CRL_R1. A summary of the maximum stress, minimum stress, and stress range values experienced by the gages in the first crawl tests is presented in Table 5.6.

Figure 5.6 – Response of strain gages CH_28 and CH_29 installed transversely on the south and north face, respectively, of the cross girder at 3 inches away from the existing longitudinal crack along the toe of the horizontal weld used for attaching the flange and the web of the cross girder as the test truck passed in the right lane in the crawl test (CRL_R1)

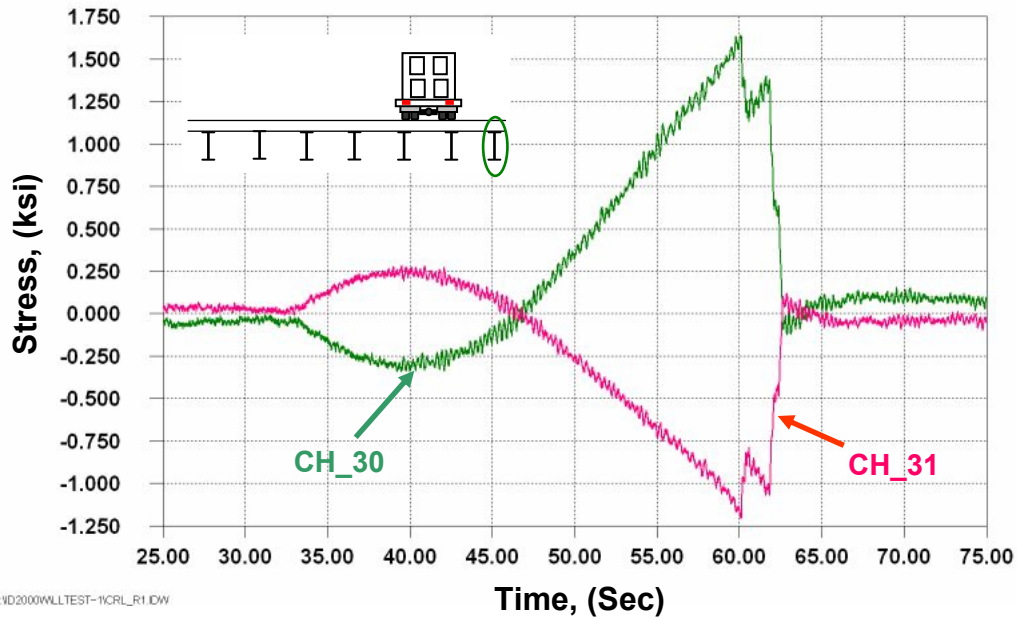
Figure 5.7 – Response of strain gages CH_30 and CH_31 installed longitudinally on the south and north face, respectively, of the cross girder web at 3 inches away from the smiley face crack which originated at the toe of the vertical weld connecting the connection plate to the cross girder web as the test truck passed in the right lane in the crawl test (CRL_R1)

Span 12, on web of cross girder near smiley face crack						
Truck in lane	Web of cross girder (ksi) (CH 30, south face)			Web of cross girder (ksi) (CH 31, north face)		
	σ_{max}	σ_{min}	$\Delta\sigma$	σ_{max}	σ_{min}	$\Delta\sigma$
Right	1.7	-0.3	2.0	0.3	-1.2	1.5
Middle	1.2	-0.3	1.5	0.2	-0.9	1.1
Left	0.6	-0.1	0.7	0.1	-0.4	0.5

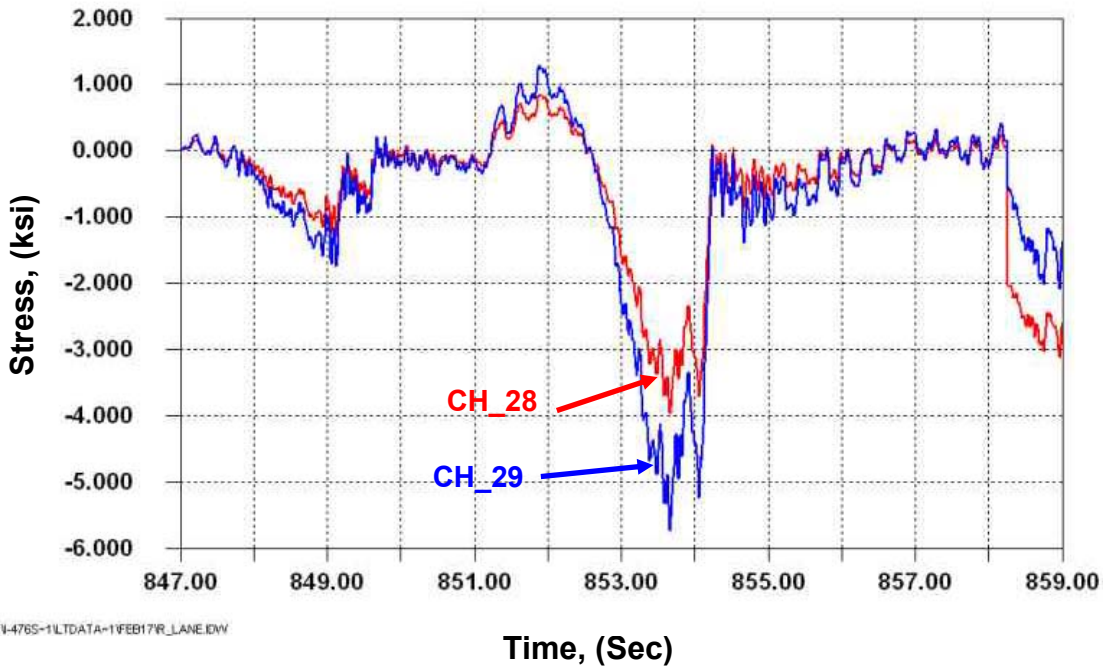
As mentioned in Section 4.2.4, strain gages were installed near the existing cracks located on the cross girder web at the west fascia. Specifically, strain gages CH_28 and CH_29 were installed vertically on the south and north face, respectively, of the cross girder web near the existing longitudinal crack, while strain gages CH_30 and CH_31 were installed horizontally on the south and north face, respectively, of the cross girder web near the existing smiley face crack. The maximum stress range measured by the gages during monitoring was 4.7 ksi in strain gage CH_28, 7 ksi in strain gage CH_27, 7.9 ksi in strain gage CH_30, and 6.9 ksi in strain gage CH_31. Figure 6.6 shows the time-history response of strain gages CH_28 and CH_29 during a trigger event.

Figure 6.6 - Stress time-history for strain gages CH_28 and CH_29 installed vertically on the south and north face, respectively, of the cross girder web near the existing longitudinal crack during the passage of a vehicle during monitoring
