# Structural Evaluation of Riveted Spillway Gates

**STRUCTURAL EVALUATION OF  
RIVETED SPILLWAY GATES**

U.S. Army Corps of Engineers  
Waterways Experiment Station

**ATLSS Report No. 92-12**

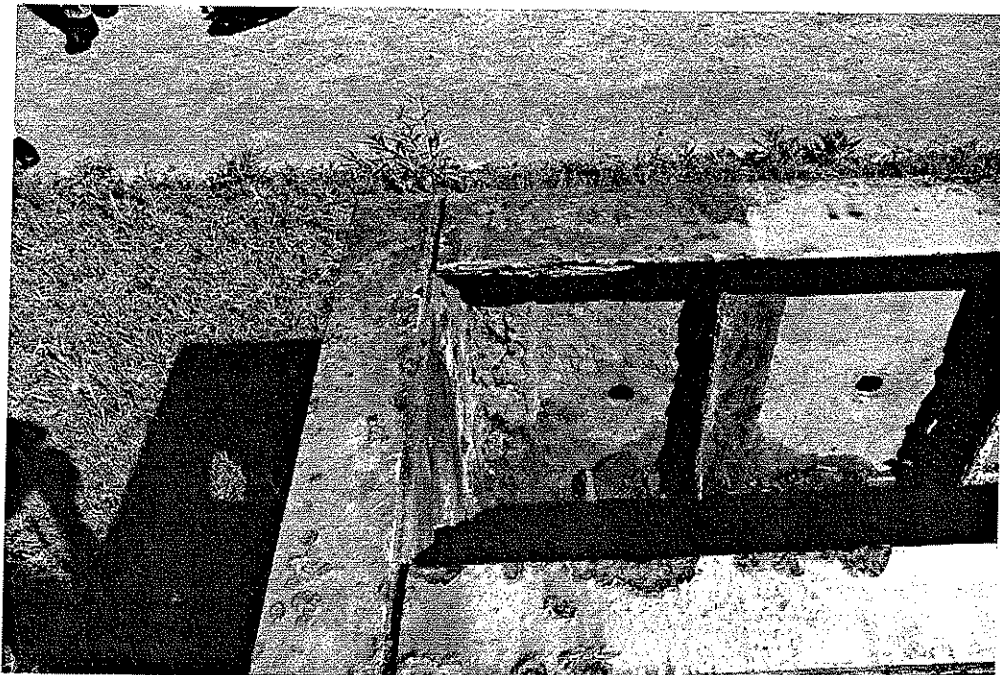
Figure 13: Heavy Corrosion in Lower Corner of Lift Gate at Bankhead Dam  
(5/92/1-8)

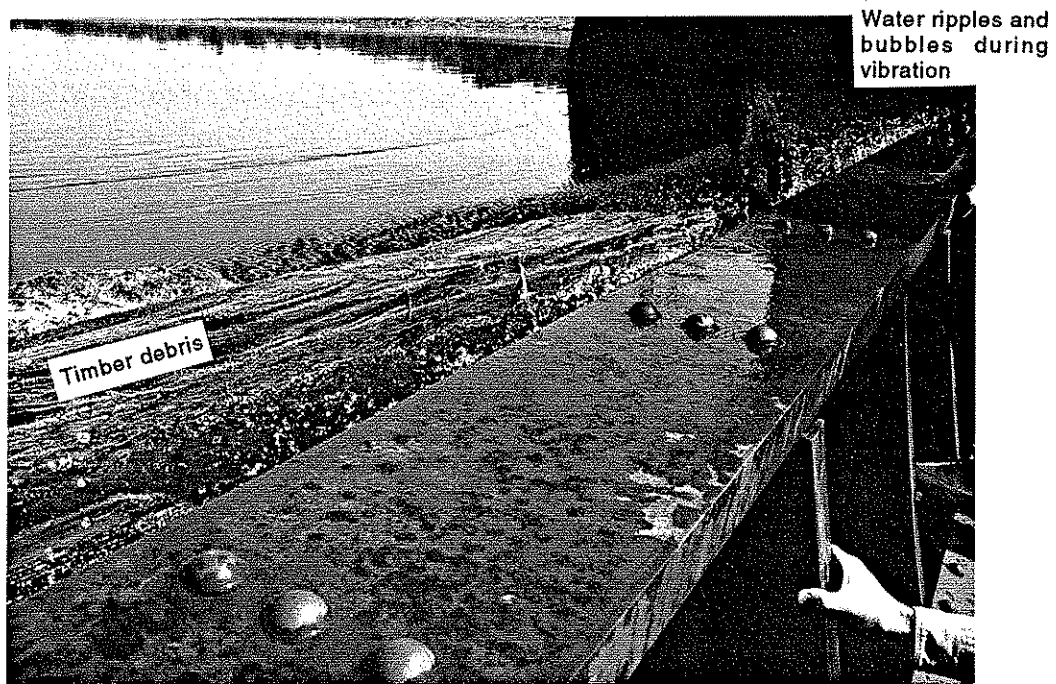
From the field measurements done on Gate 24 at Lock and Dam 5 on the Mississippi River, it was noted that the vibration frequency was about 10.5 Hz and the relevant stress range was about 3.7 ksi on the girder and about 4.4 ksi on the strut arm [11].

Figure 16: Effects of Vibration at Gate #23 on Lock & Dam #5  
(6/92/5-0)

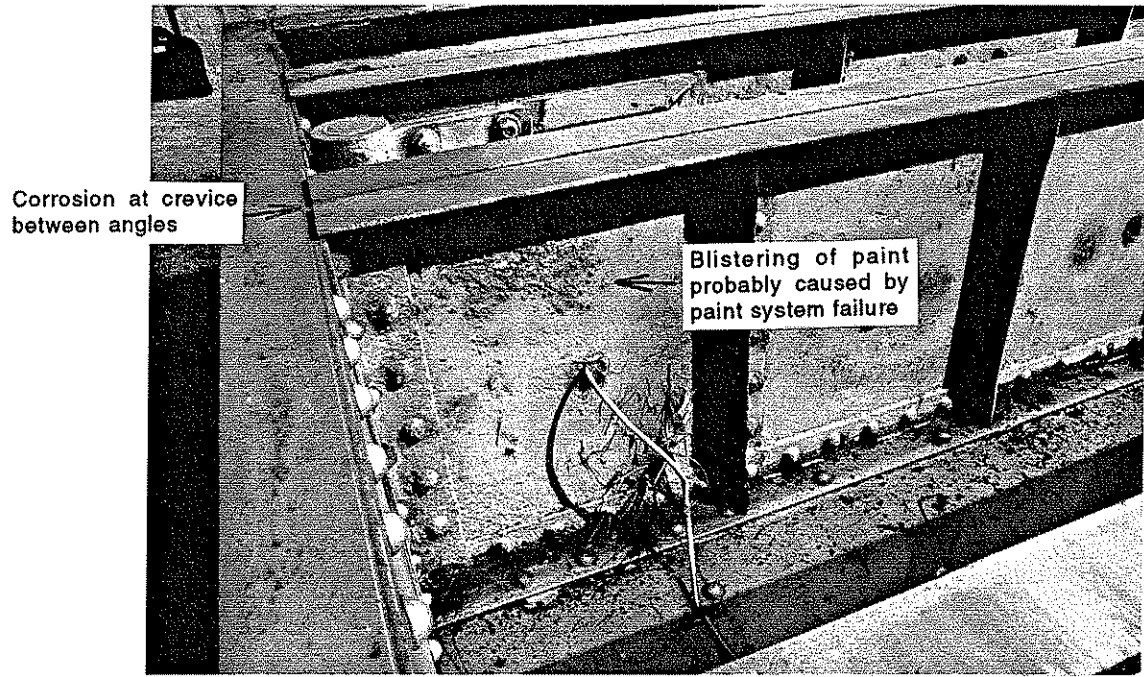
Figure 19: Vertical Lift Gate at Bankhead Lock & Dam with Paint Blistering and Corrosion (5/92/1-9)

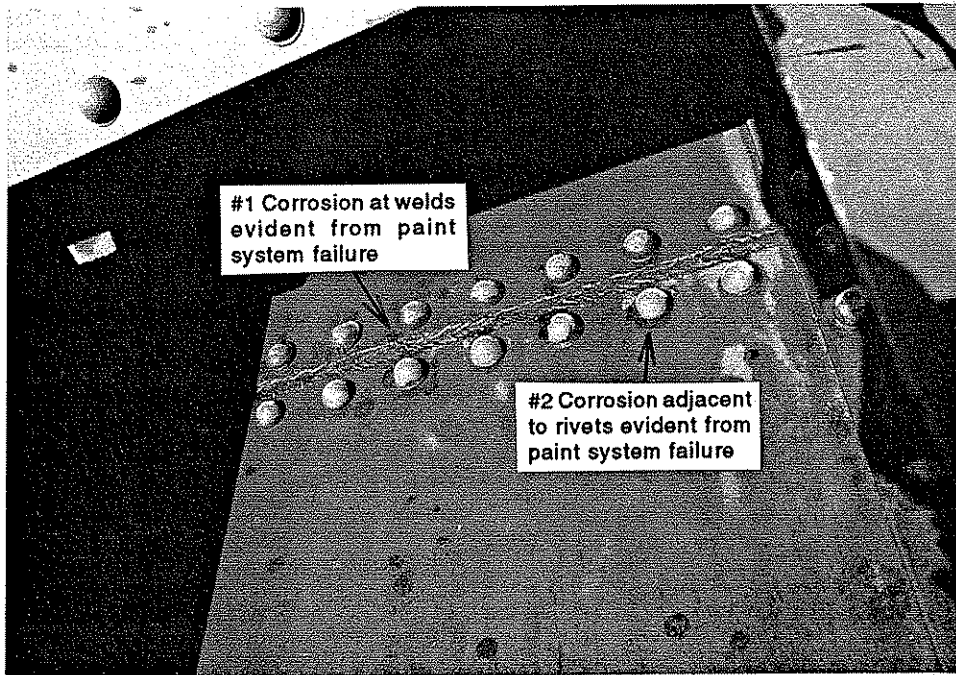
Figure 20: Tainter Gate at Mississippi Lock & Dam #5 with Seal Weld and Localized Corrosion (6/92/7-25)

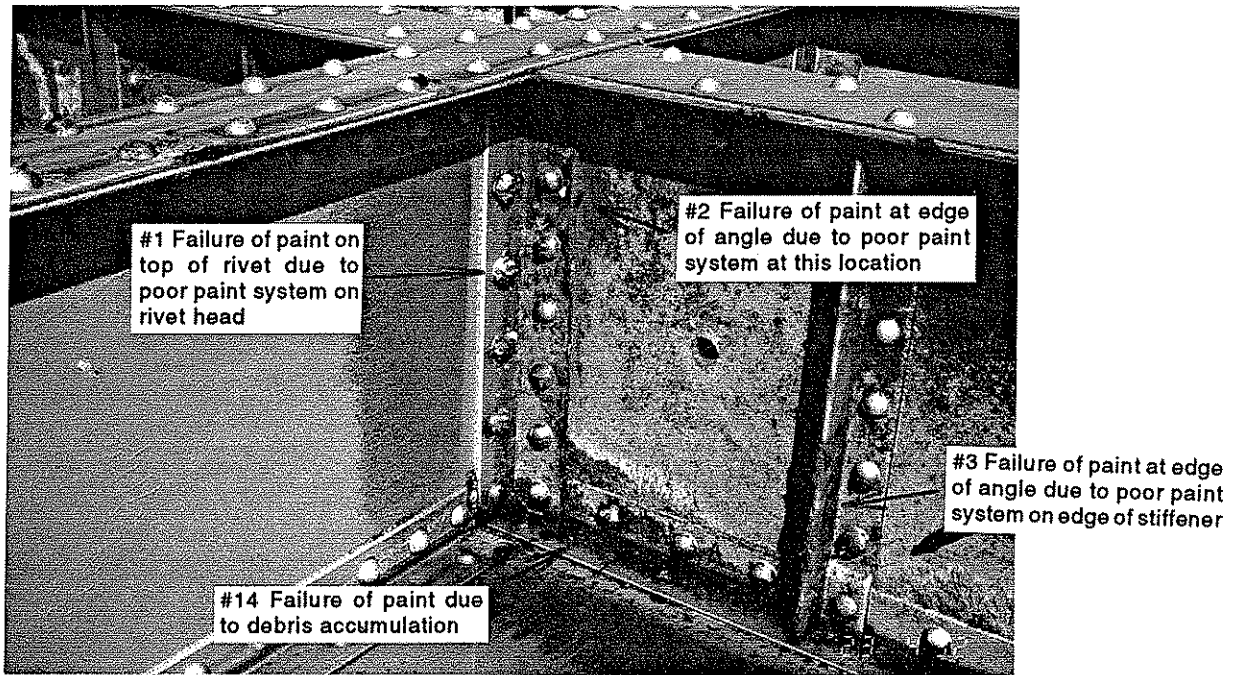
Figure 21: Vertical Lift Gate at Bankhead Lock & Dam with Crevice Corrosion, Corrosion at Edges and Corrosion of Rivet Heads (5/92/1-6)

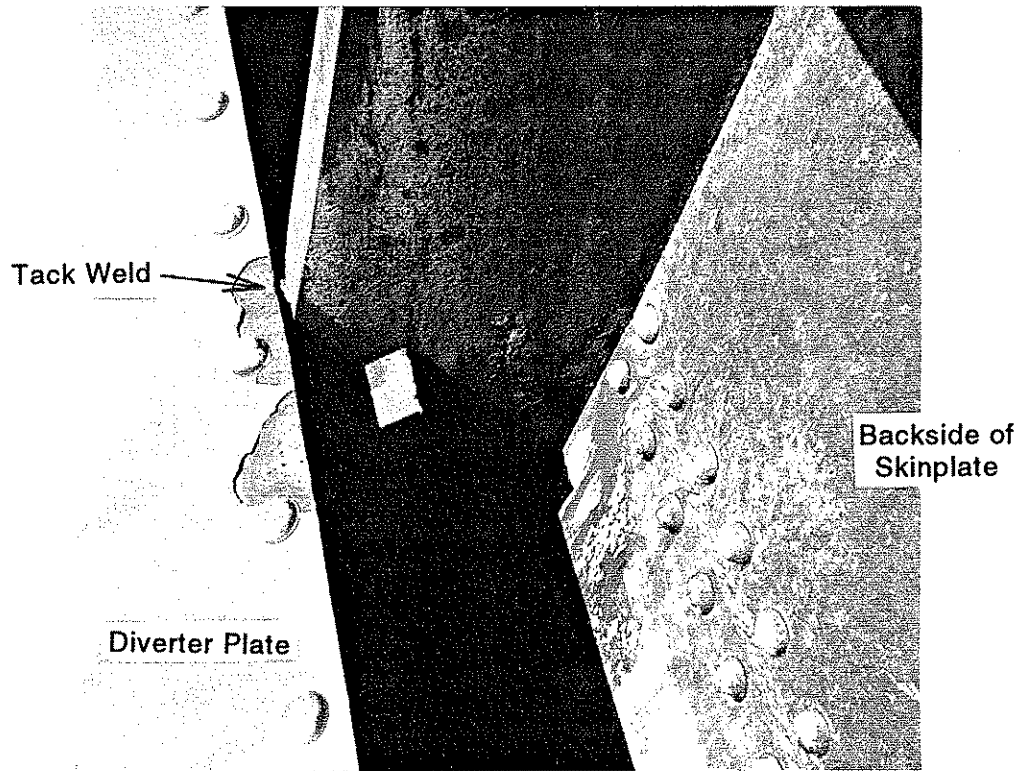
Figure 22: Failure of Paint System on Tainter Gate at Edge of Plate Near Tack Weld, Mississippi Lock & Dam #9 (Mark #25)

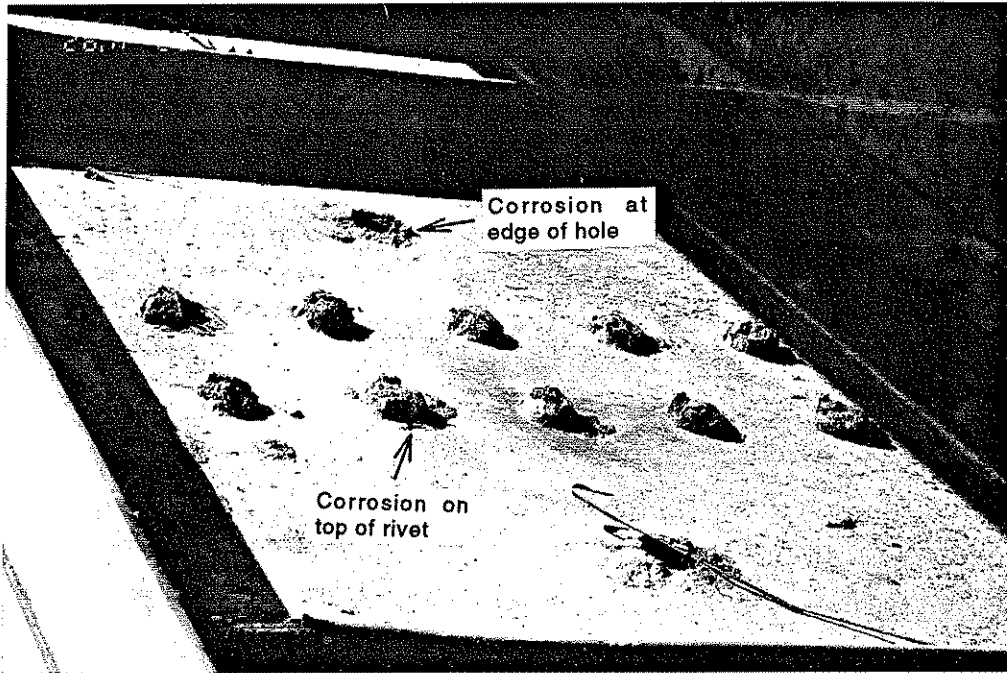
Figure 23: Vertical Lift Gate at Bankhead Lock & Dam with Corrosion of Rivet Heads (5/92/1-7)

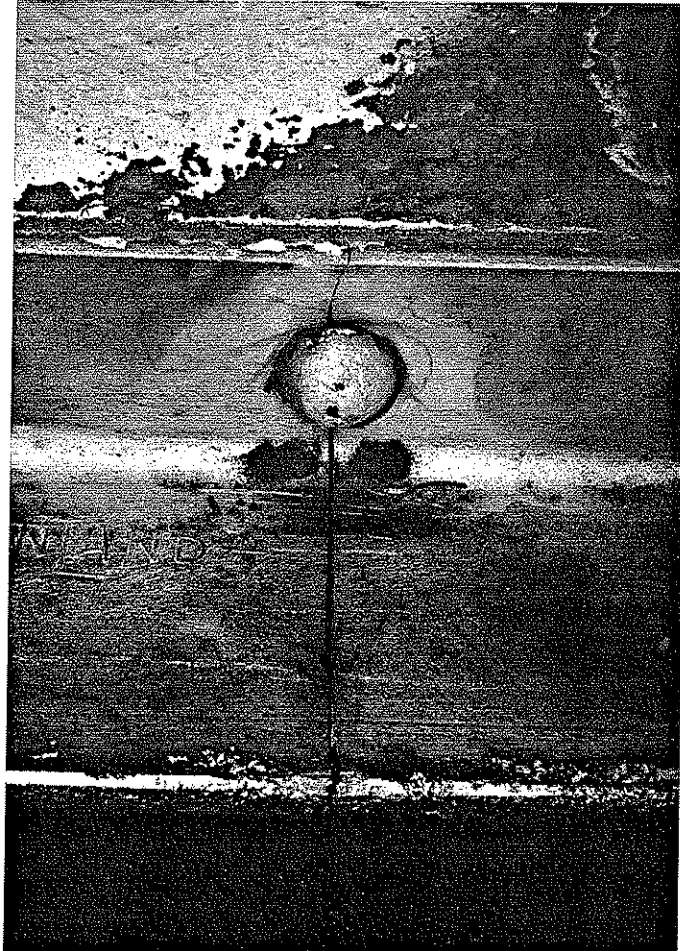
Figure 25: Typical Fatigue Cracking on Riveted Members  
(8/92/36-9)

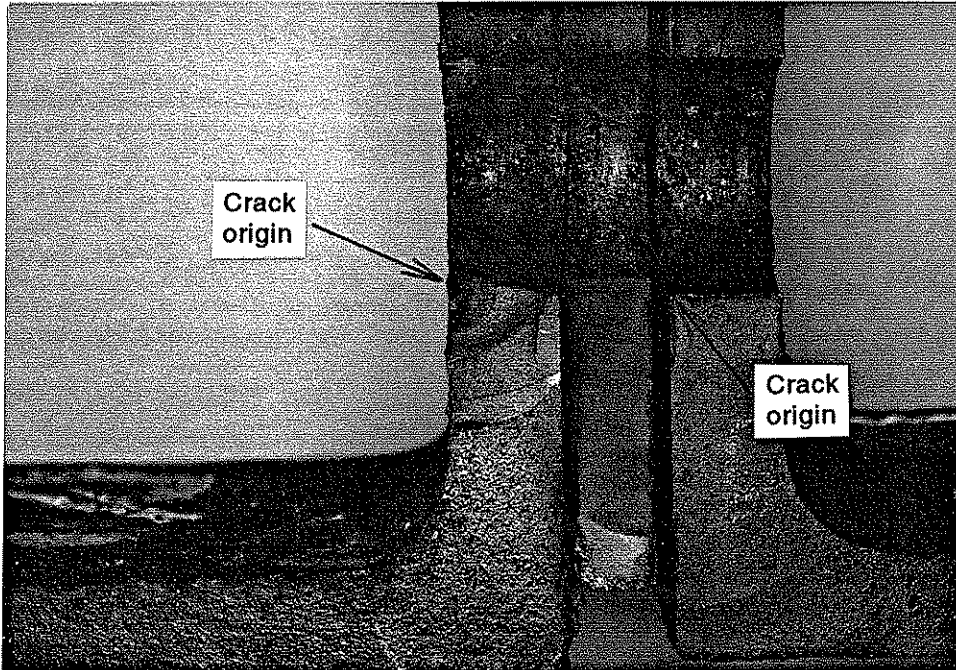
Figure 26: Crack Surface at the Edge of a Rivet Hole  
(6/92/43-1)

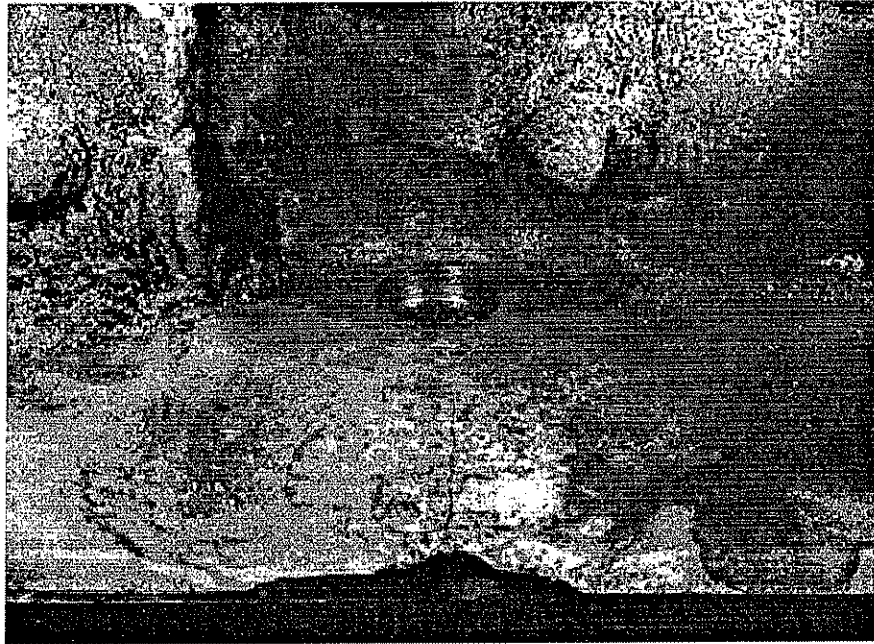
Figure 27: Fatigue Crack from Corrosion Notch into Rivet Hole

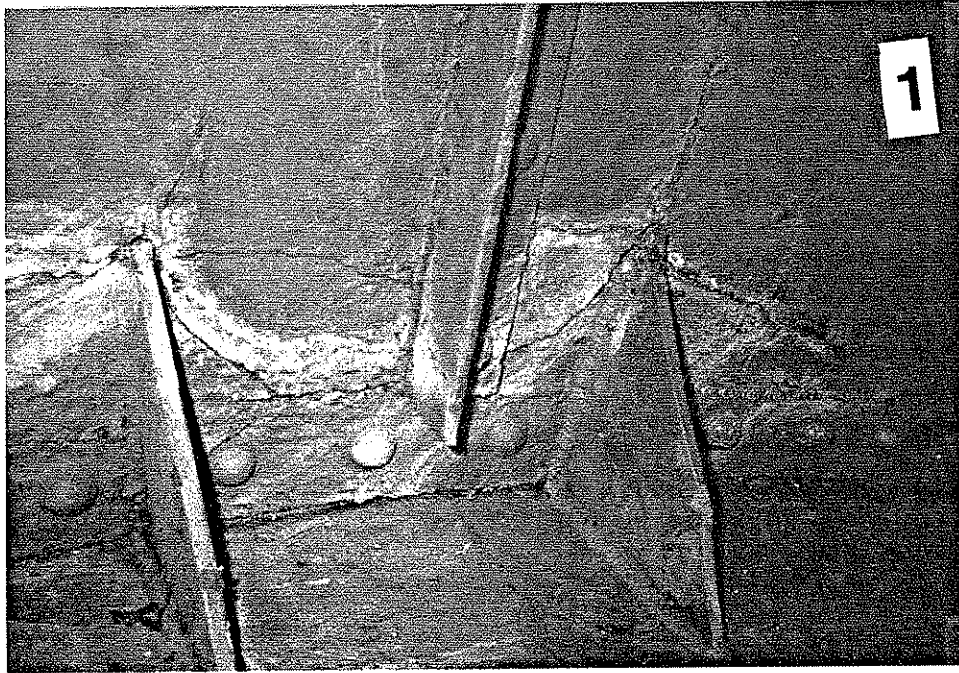
Figure 32a: Fatigue Cracks at Ends of Welded Stiffeners on Roller Gate End Shield (Ref. 12)

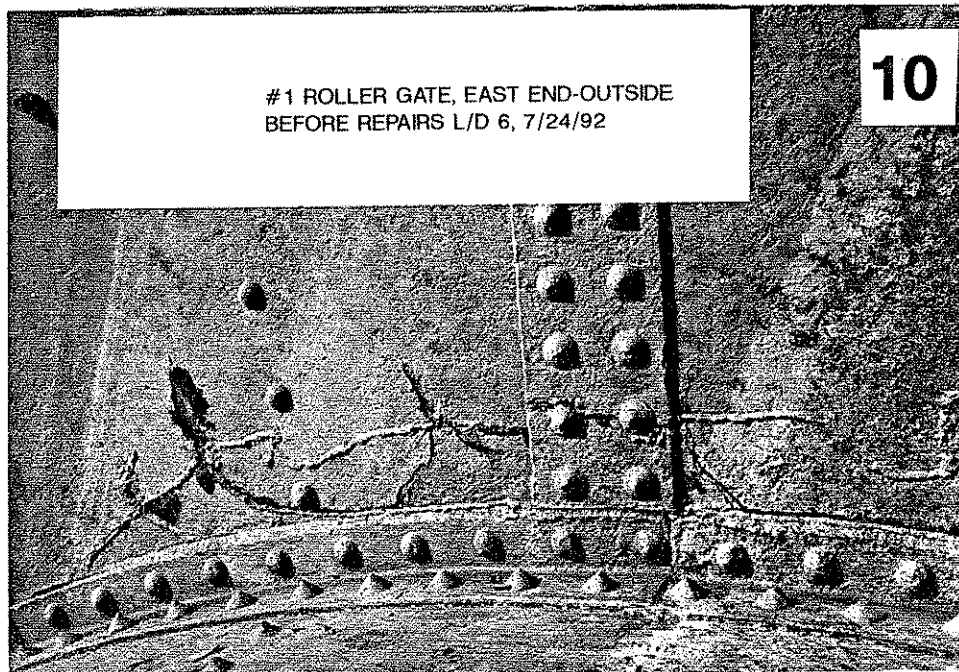
Figure 32b: Fatigue Cracks Redeveloped at Previous Repair Welds (Ref. 12)

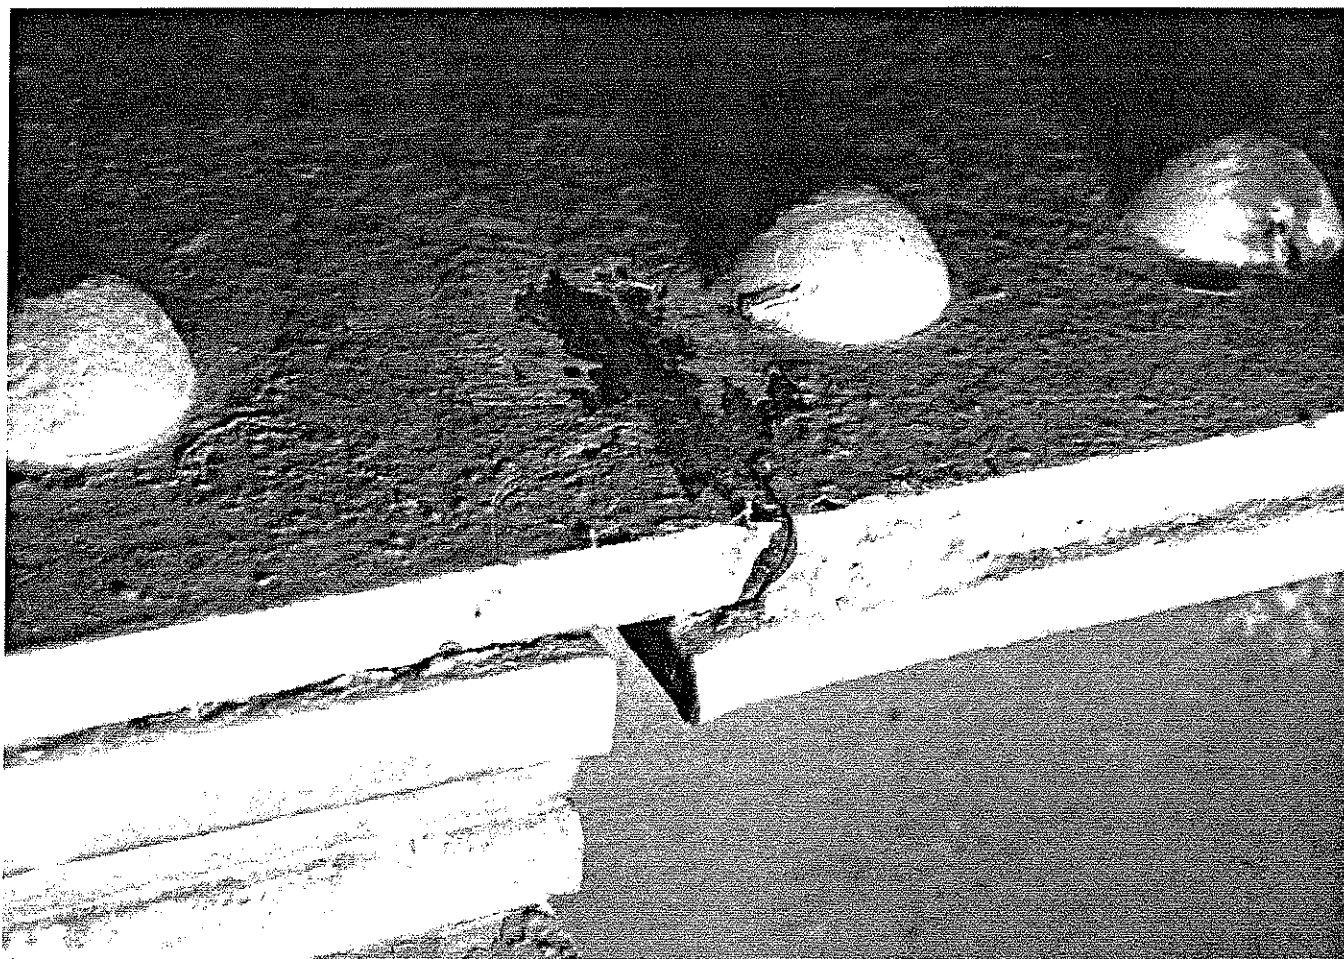
Inasmuch as both groove welds and filleted tack welds were observed during the on-site inspections, the fatigue strength of these details should be equated to that of the even more severe Type E welded detail.

Figure 33: Fatigue Crack Initiating from a Tack Weld on a Riveted Member  
(10/88/43)

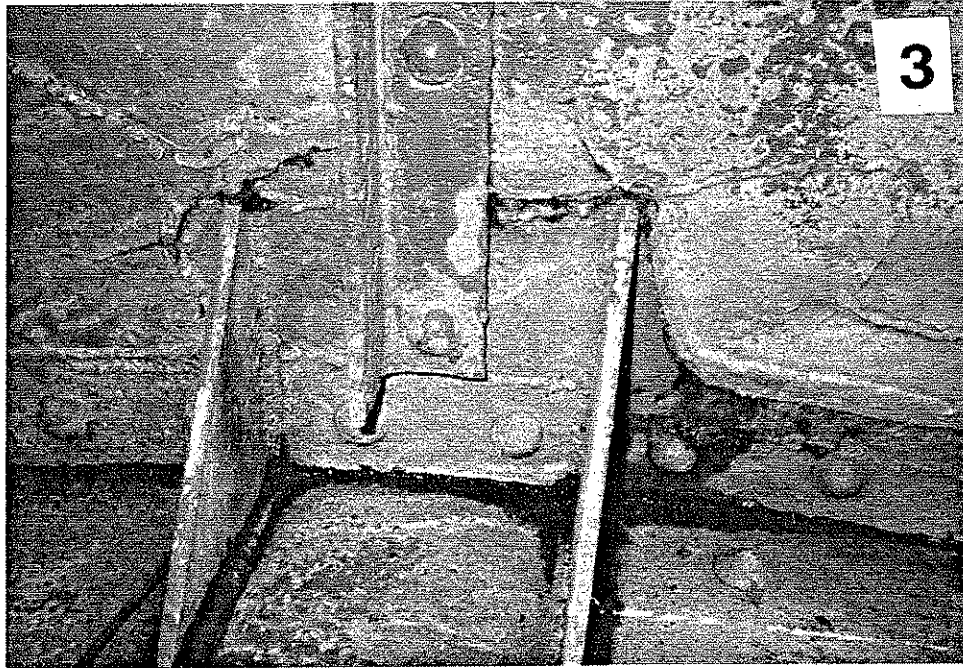
Figure 34a: Fatigue Cracks Redeveloping at Weld-Repair Sites on Roller Gate End Shield (Ref. 12)

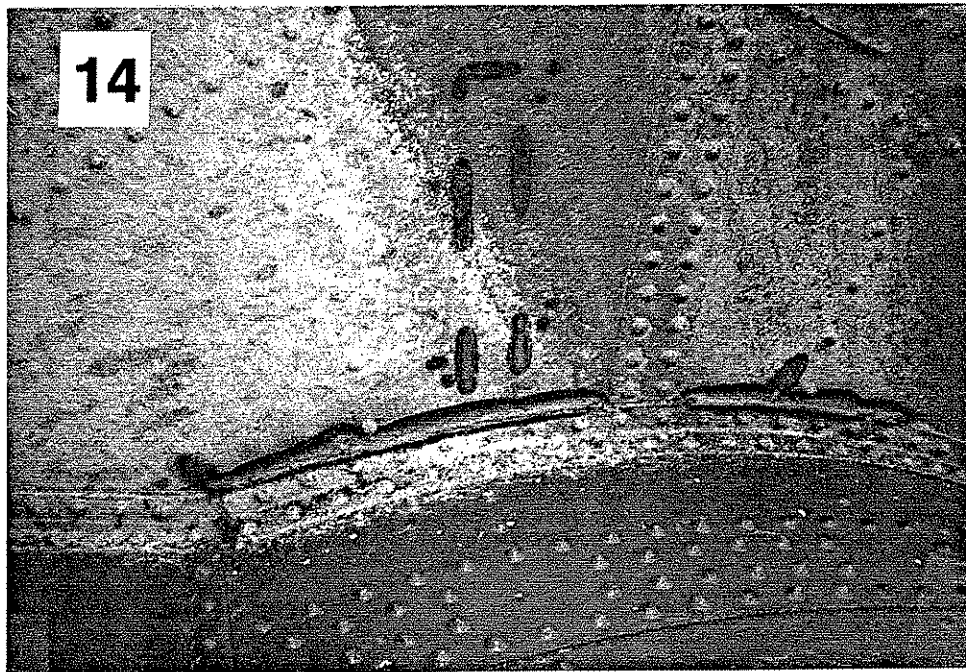
Figure 34: Fatigue Crack at Connection of Roller Gate Cylinder and End Shield (10/88/43)
