# Fatigue tests of welded plate girders in bending

Joseph A. Corrado  
*Lehigh University*

**A Thesis**  
**Presented to the Graduate Faculty**  
**of Lehigh University**  
**in Candidacy for the Degree of**  
**Master of Science**

**Lehigh University**

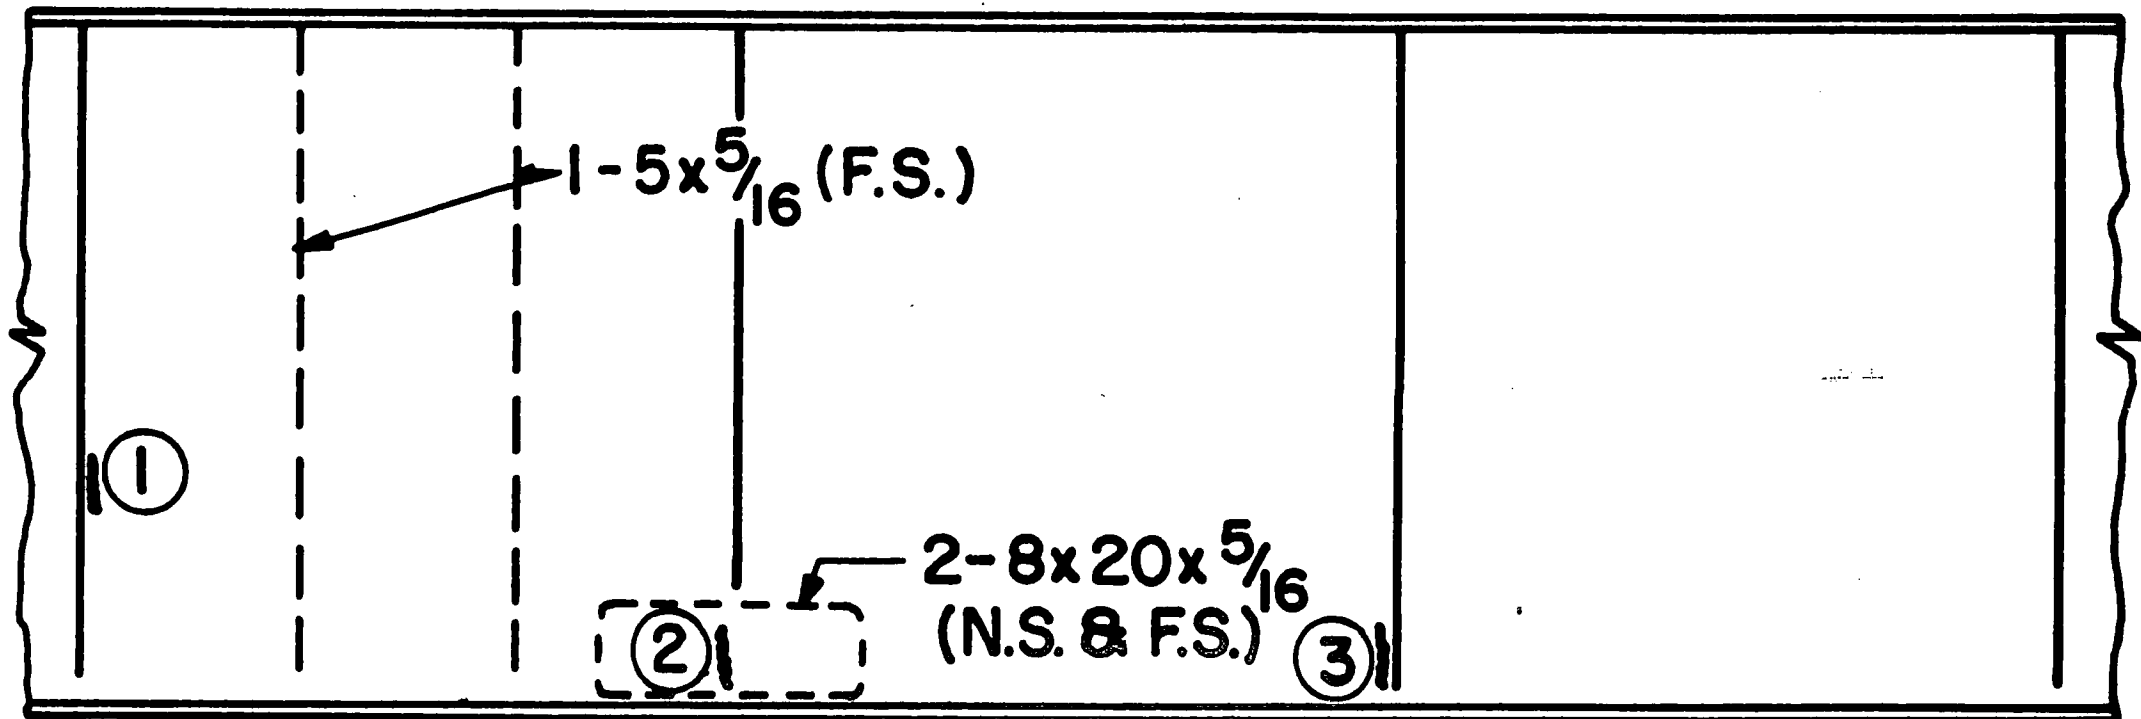
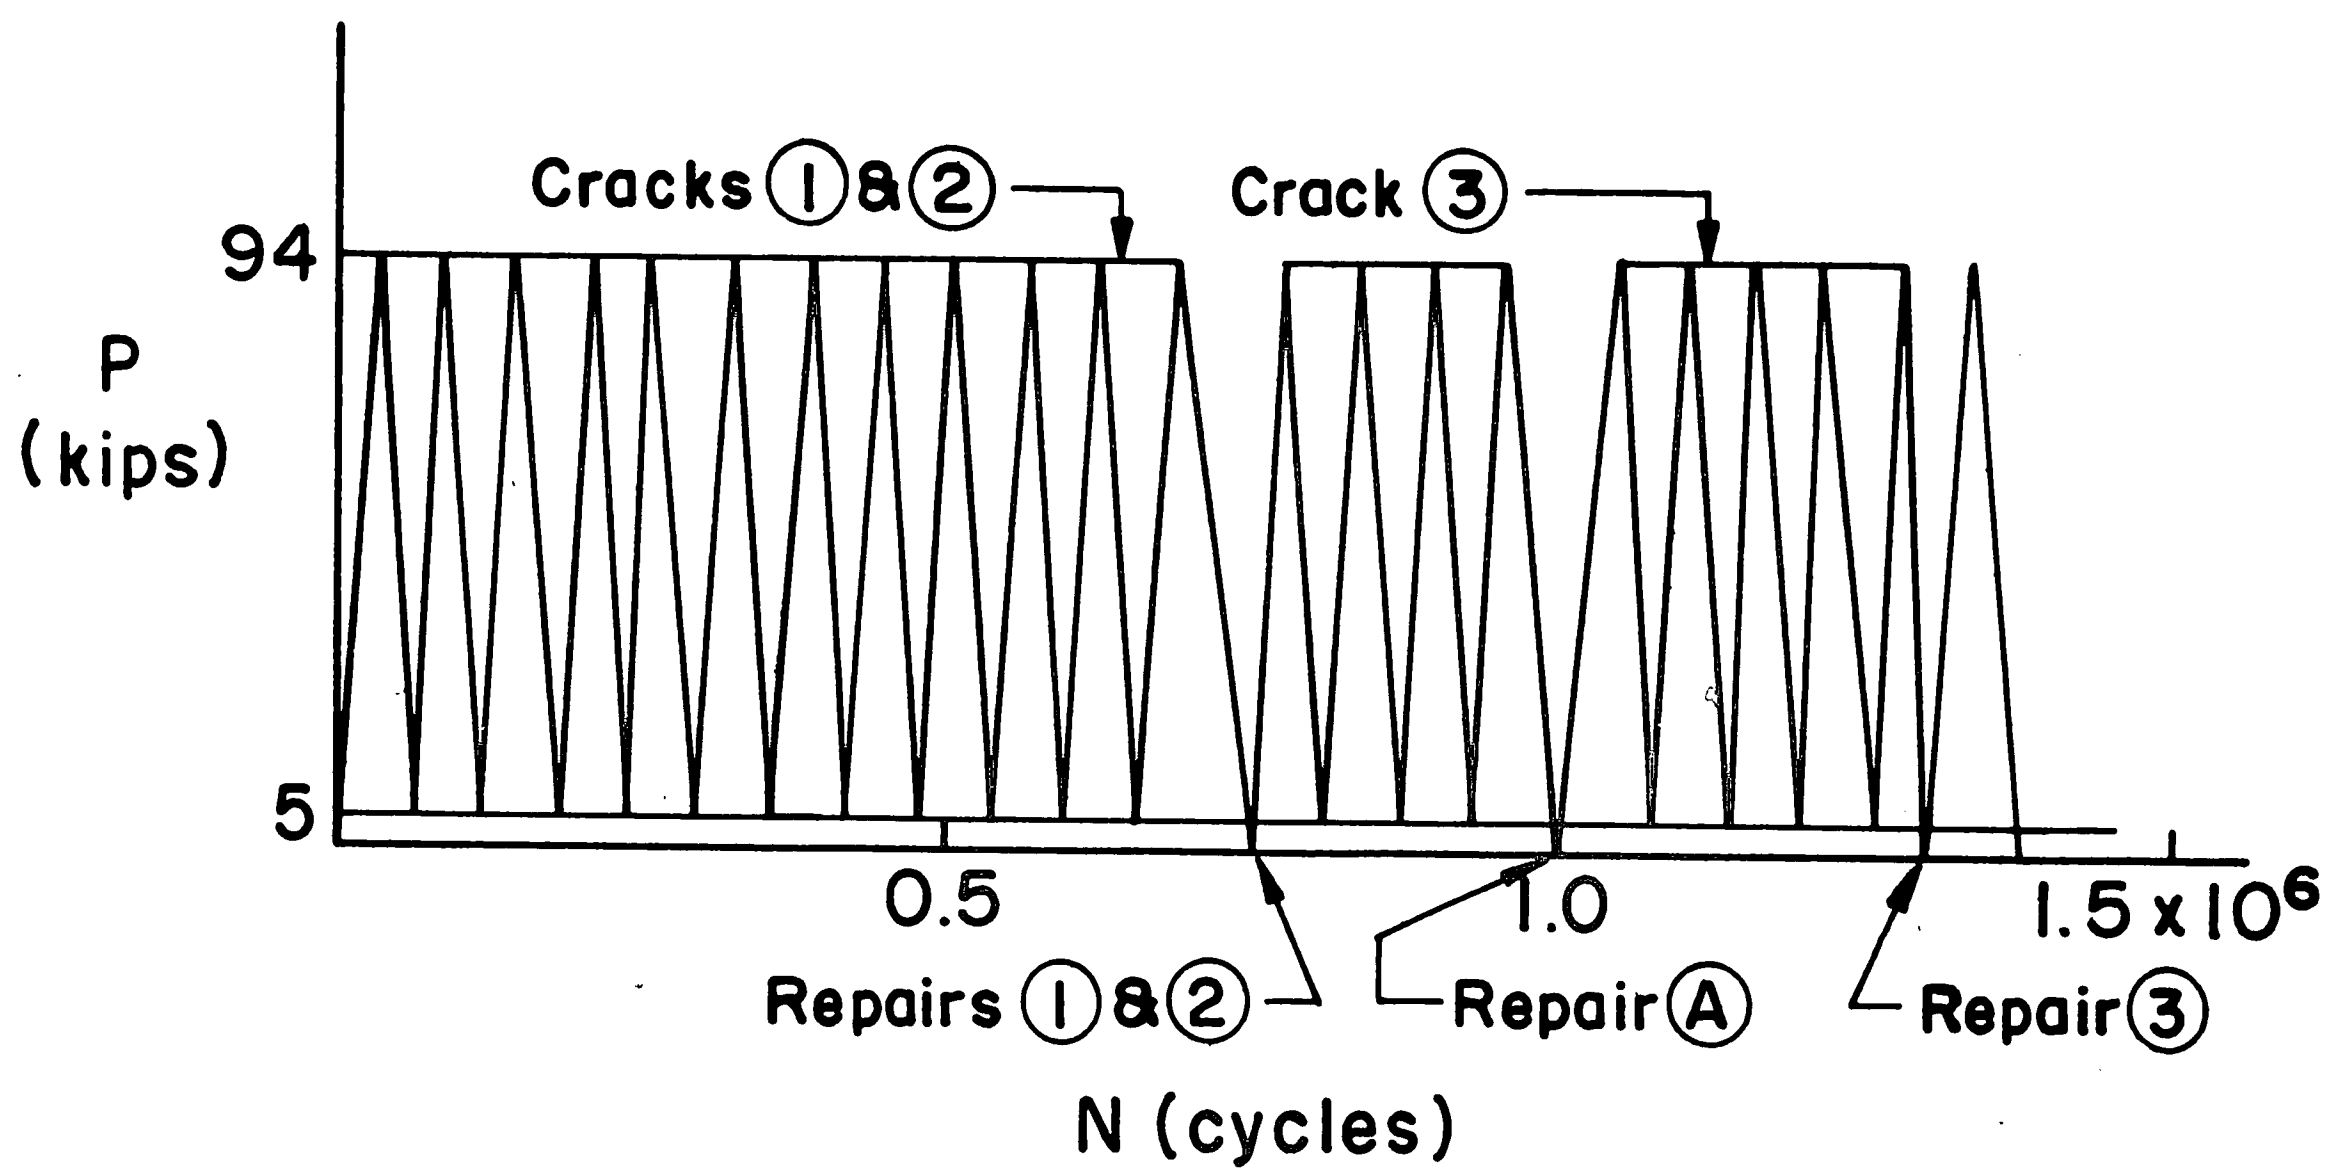
Fig. 6 Fatigue Testing of Girder F6

Fatigue testing proceeded at a measured rate of 262.5 load cycles per minute from 5 to 94 kips. At 600,000 cycles a pair of cracks, referred to as Cracks 1 and 2, were found on the far side of the web in test panel 1. Both cracks had initiated at the web-stiffener boundaries in the web, at the toe of the weld, and propagated parallel to the stiffener. After a total of 693,000 cycles, cracks were observed outside the test section in the web butt welds at  $x = \pm 82\frac{1}{2}$ . At 756,000 cycles it was decided that a repair would be made before relatively serious damage had been imposed by the butt-weld cracks. At that moment inspection revealed that Cracks 1 and 2 had propagated through the thickness of the web and had total lengths of 14 and 10 inches, respectively. (Close observation of Crack 2 indicated that it had not penetrated into the tension flange.) Final appearance and location of these cracks are shown in Fig. 6a. The history of loading is diagrammatically presented in Fig. 6b.

When testing was resumed, the cracks at the butt welds reappeared almost immediately. At a total of 869,000 cycles a crack appeared at the location of the repaired Crack 2 (referred to as Crack 2a). At 1,000,000 cycles testing was stopped for a careful inspection of all cracks. Plug samples were cut from the web butt welds adjacent to the flanges. When incomplete penetration of the welds was observed, the butt welds were completely removed and replaced. The voids which resulted from the inspection remained as cope holes. Along with these repairs (Repair A, Fig. 6b), an attempt was made to repair Crack 2a by gouging and welding.

Because of the excessive repairs a static test was performed before cyclic loading was resumed. Not long after pulsating was underway once again, Crack 2b appeared at the repair weld of Crack 2a at a total of 1,040,000 cycles. This crack was repaired shortly thereafter by first gouging and welding; then partially cutting away the intermediate stiffener and welding 8" x 20" x 5/16" doubler plates to the web at the location of the crack, as indicated in Fig. 6a.

Crack 3 was first observed along a stiffener (Fig. 6a) at 1,242,450 cycles. Before a repair was effected at 1,300,000 cycles this crack had grown to a total length of 5 inches. Repair (Repair 3) was made by first cutting away a small section of the stiffener, then gouging out the fractured material and welding.

Upon continuation of the test, cracks formed adjacent to the cope holes at the web butt welds. Another crack appeared at 1,372,000 cycles at the bottom of the tension flange, directly below the original Crack 2 and possibly an outgrowth of the same crack. Due to these cracks the stiffness of the girder began to decrease slightly as indicated by a measurable drop in the maximum load and an increase in the girder's deflection. Further repairs of the girder would not have significantly increased its life; therefore, the test was terminated at a total of 1,376,000 cycles.

All cracks were repaired by first gouging out the fractured material with an air hammer chisel or grinding stone, or both, and then filling the cavity with weld material. In addition, panel 1 was stiffened

by welding two 5" x 5/16" plates to the far side of the web at the panel's one-third points, as shown in Fig. 6a. This overall repair of all cracks is indicated in Fig. 6b as Repairs 1 and 2.

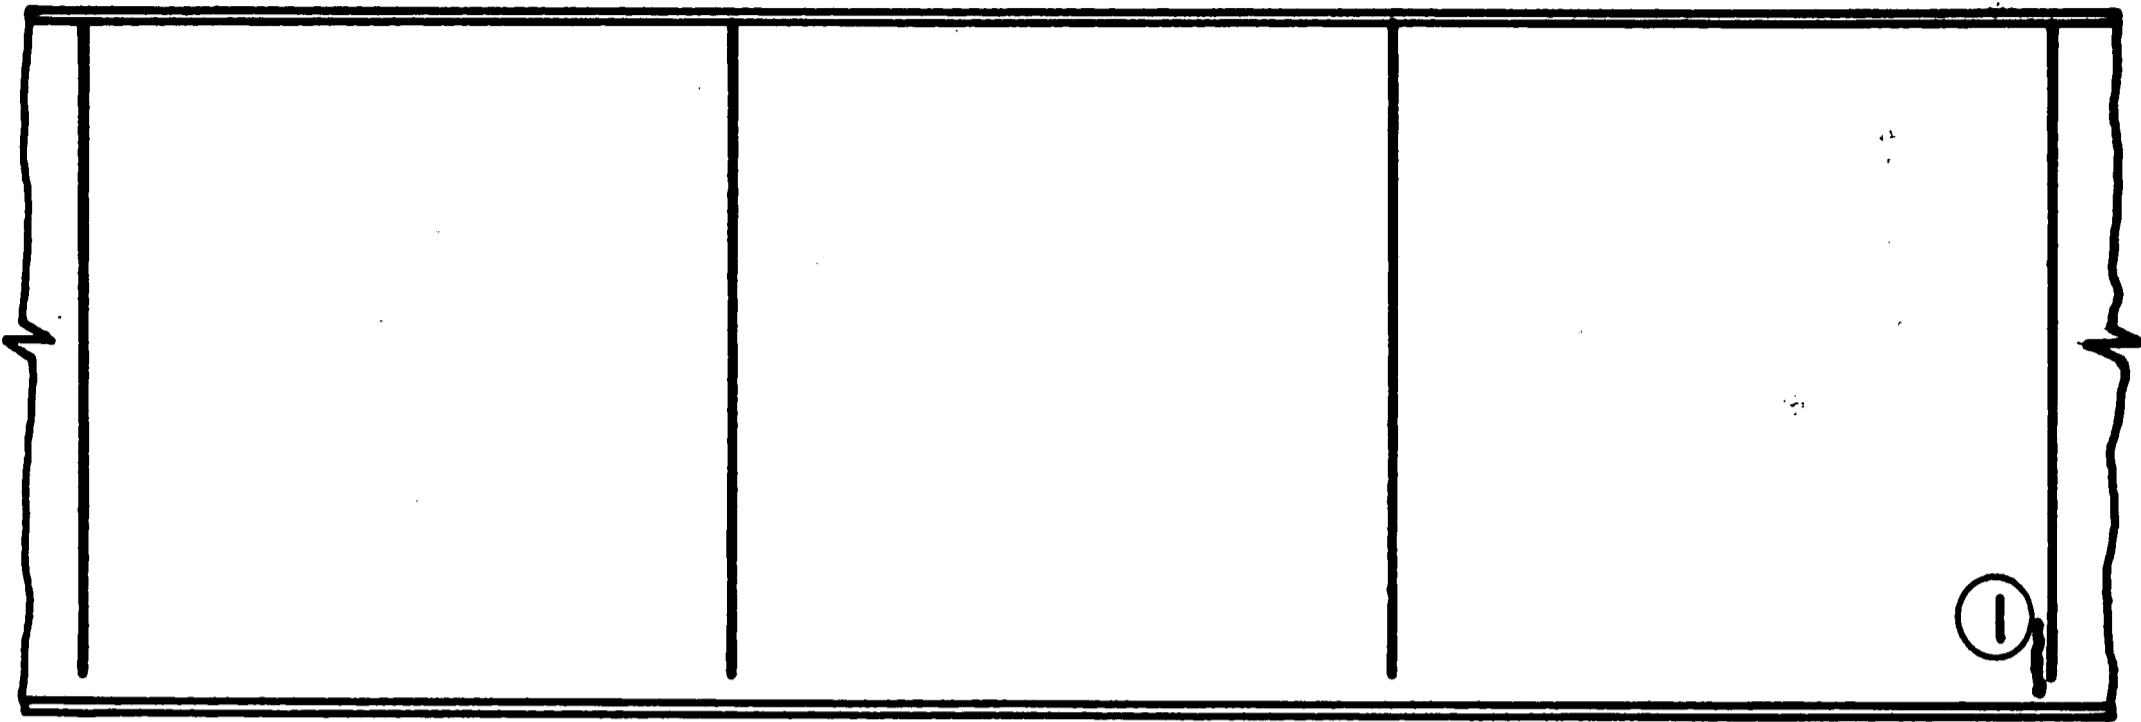
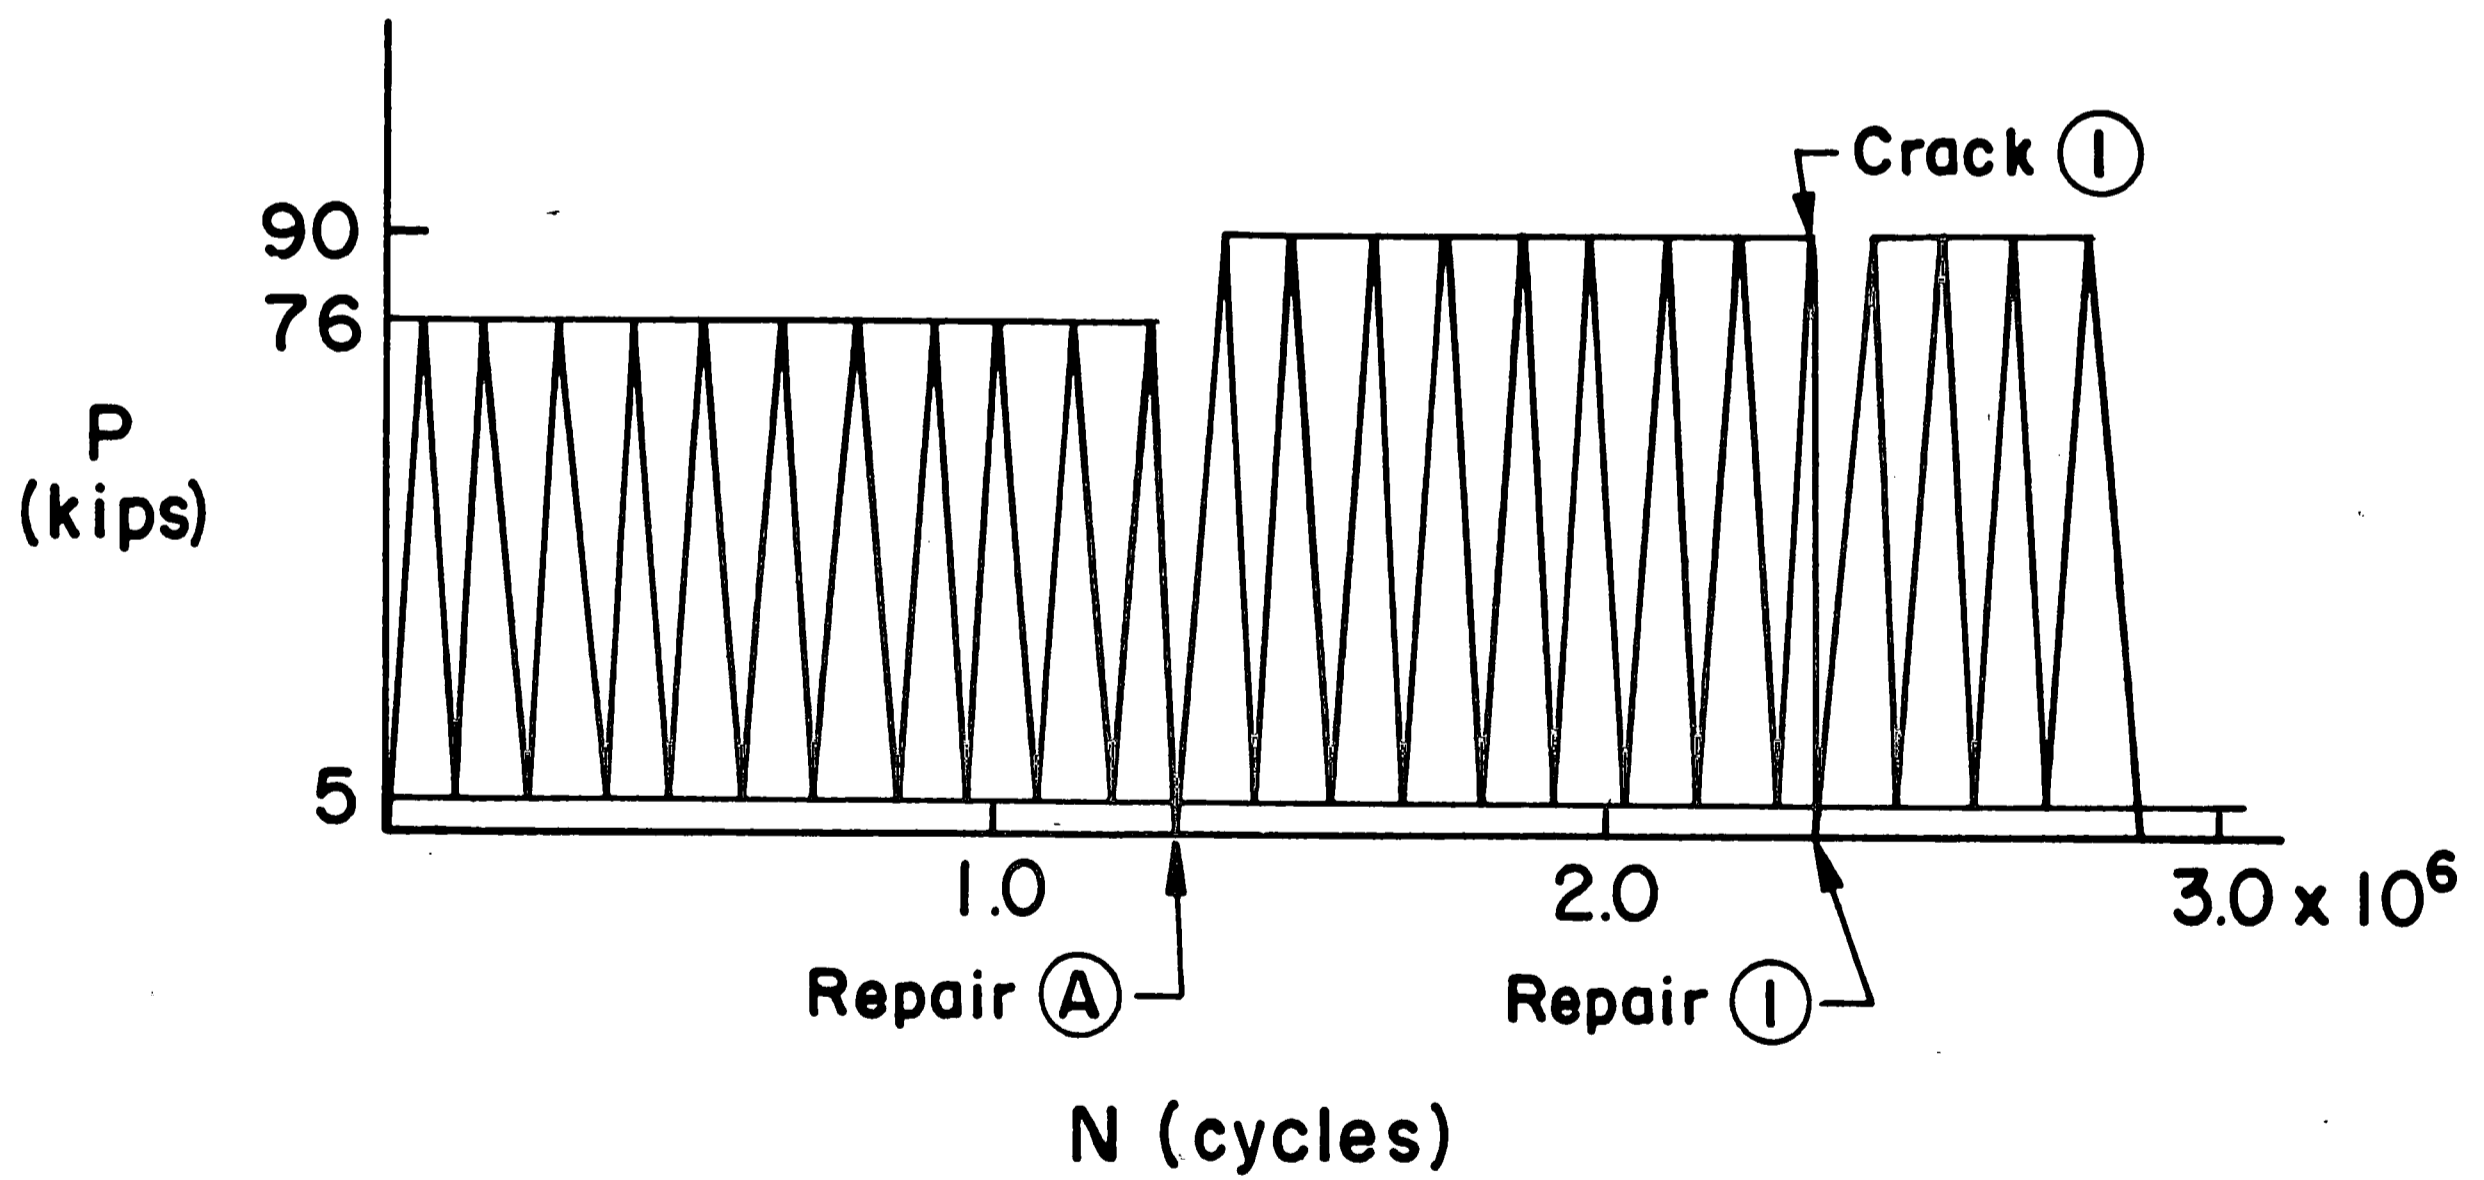
Fig. 8 Fatigue Testing of Girder F7

At 1,252,000 cycles after the beginning of fatigue testing, a crack was observed in the butt weld at  $x = - 82\frac{1}{2}$ . Following this observation, testing was stopped at 1,300,000 cycles and inspection of the butt welds made by once again cutting plug samples from the welds. A complete repair, identical to that for girder F6, was found necessary for the butt welds.

With a load range of 5 to 90 kips, fatigue testing continued for 980,000 cycles (2,280,000 total cycles) before a crack was observed to form in the test section. The crack (Crack 1, Fig. 8a) was found along the lower part of the stiffener in test panel 3. It grew in length to about 4 inches before a repair was made at 2,330,000 cycles. Thereafter no cracks were detected in the test section. Due to cracks which appeared at the cope holes, testing was terminated at a total of 2,879,000 cycles.

When this repair (Repair A, Fig. 8) was completed a static test was run prior to the continuation of the fatigue test. At this time the

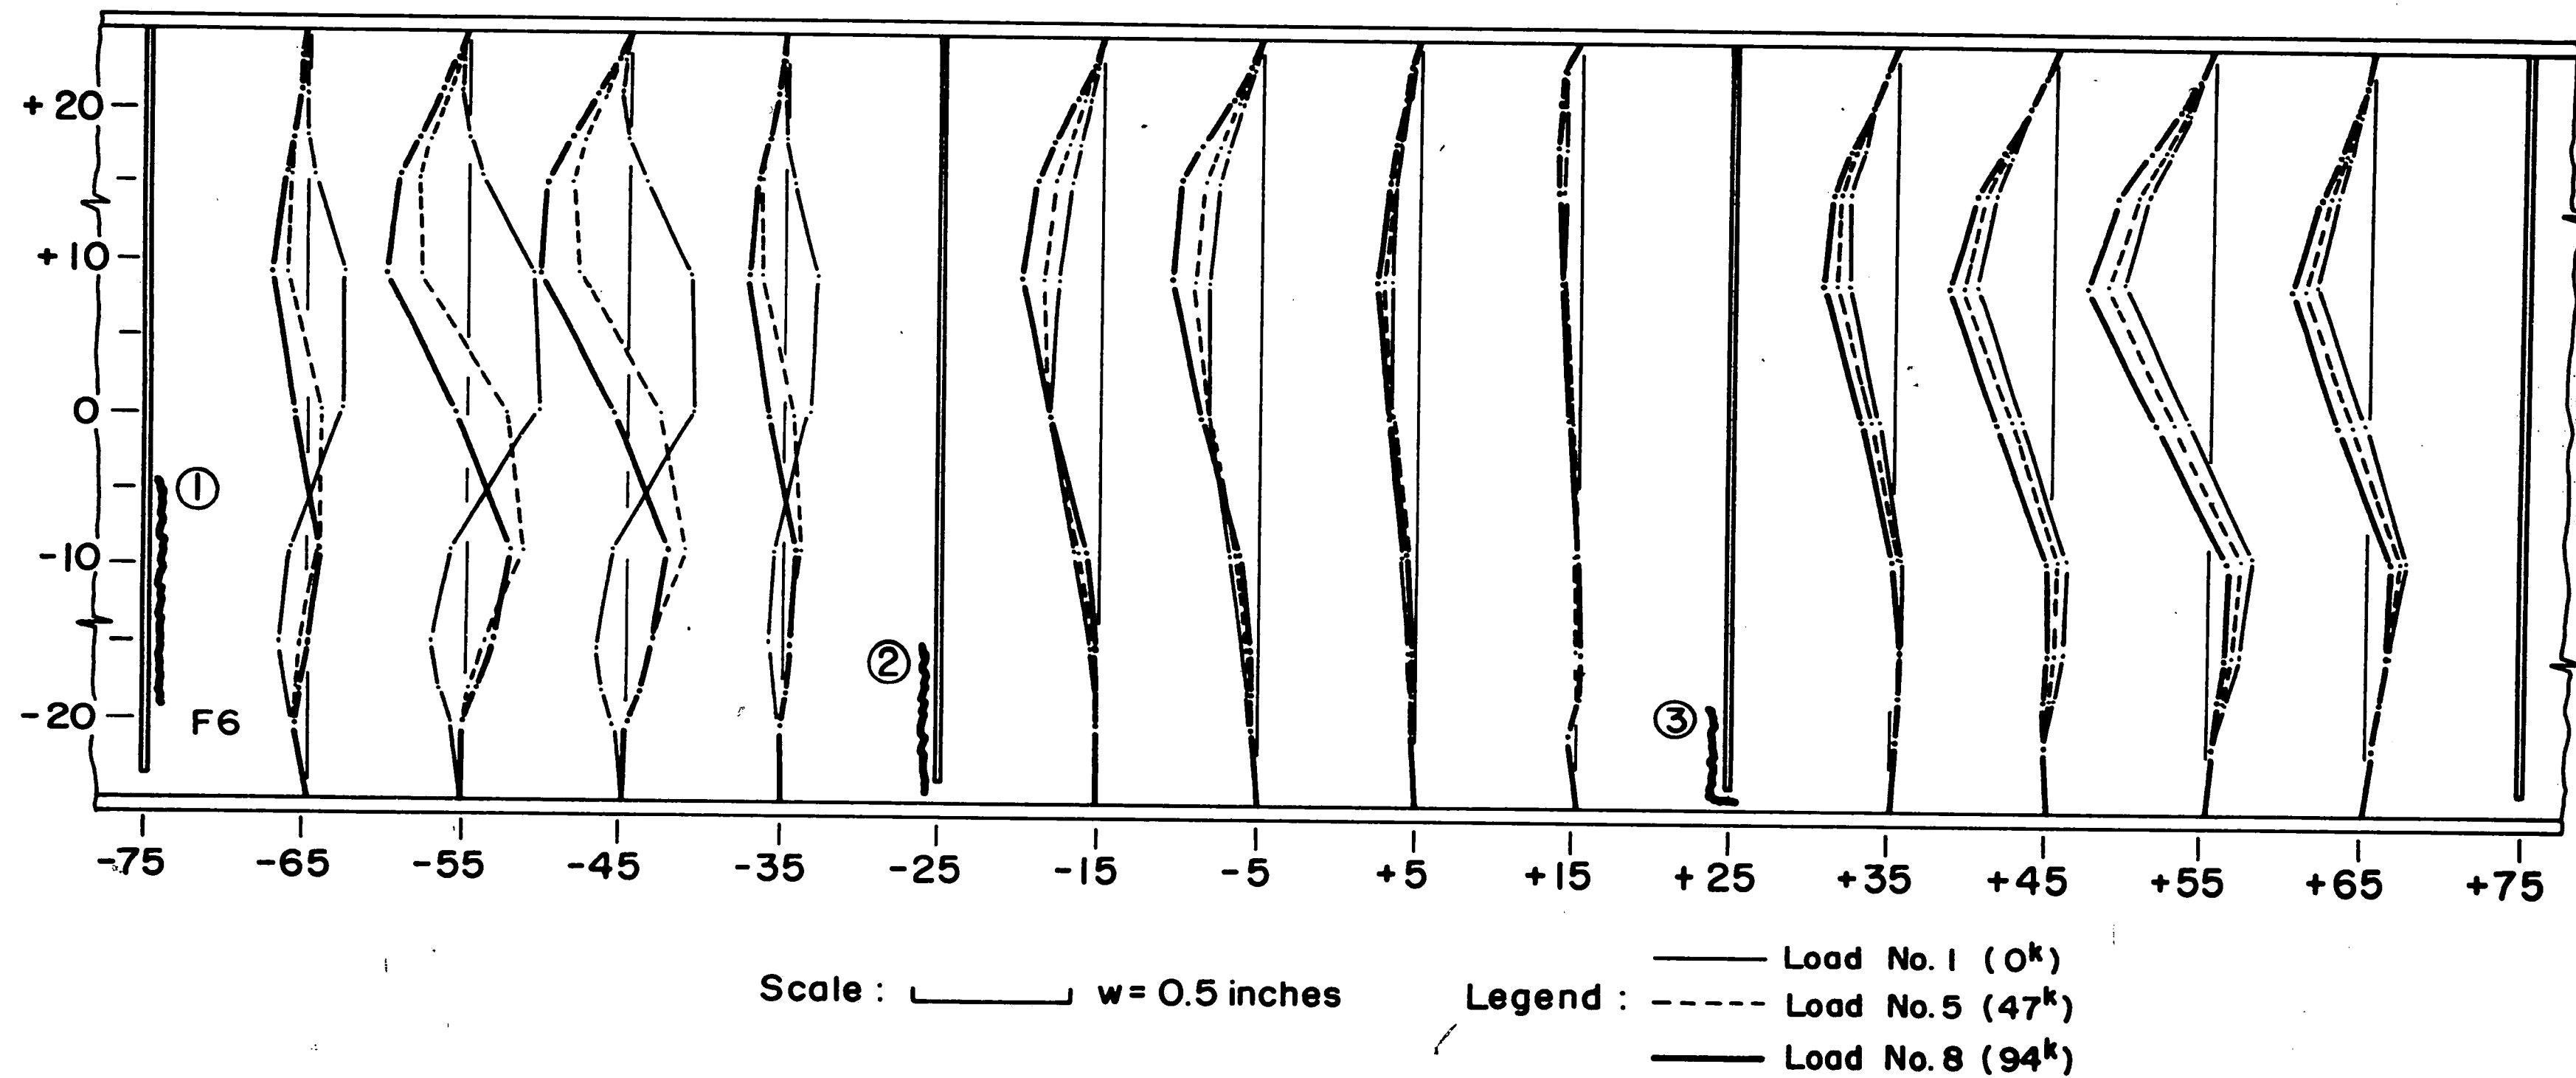
Fig. 10 Web Cross-Sectional Shapes, Girder F6

The deflected shape for panel 1, girder F6, differed from the common case in that large relative web deflections between the test loads occurred not only in the compression zone, but also in the tension zone (Fig. 10). The magnitudes of these movements were about 2-1/2 times the web's thickness for the compression zone and approximately equal to the web's thickness for the tension zone. Even at only a short distance (6-1/2") away from a stiffener ( $x = -75$ ), the relative deflections were found to be unusually large below the girder's neutral axis. The reason for such unusually large movements for this panel is the shifting of the deflected position of the web from one side of the vertical to the other during loading. This shifting movement did not take place for the other two test panels of girder F6, nor did it take place in any of the panels of girder F7 (Fig. 9).

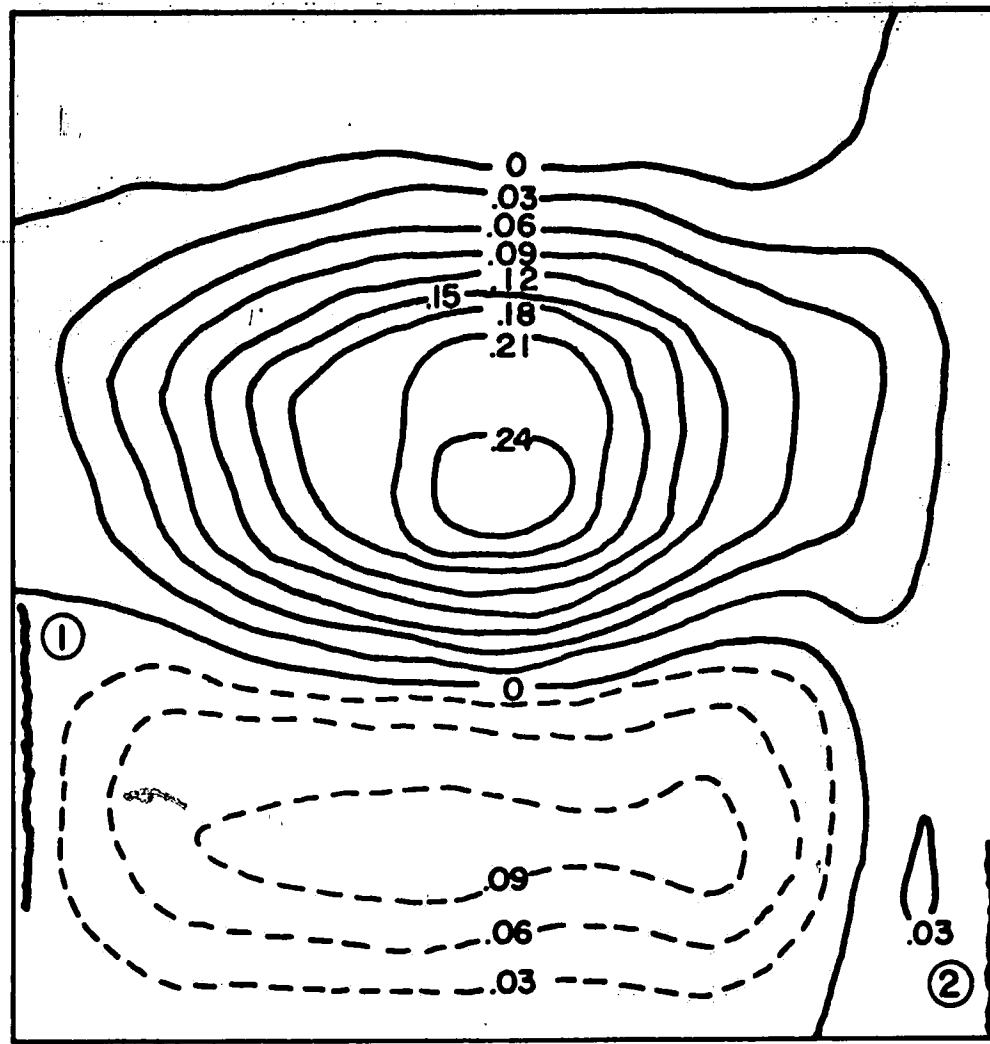
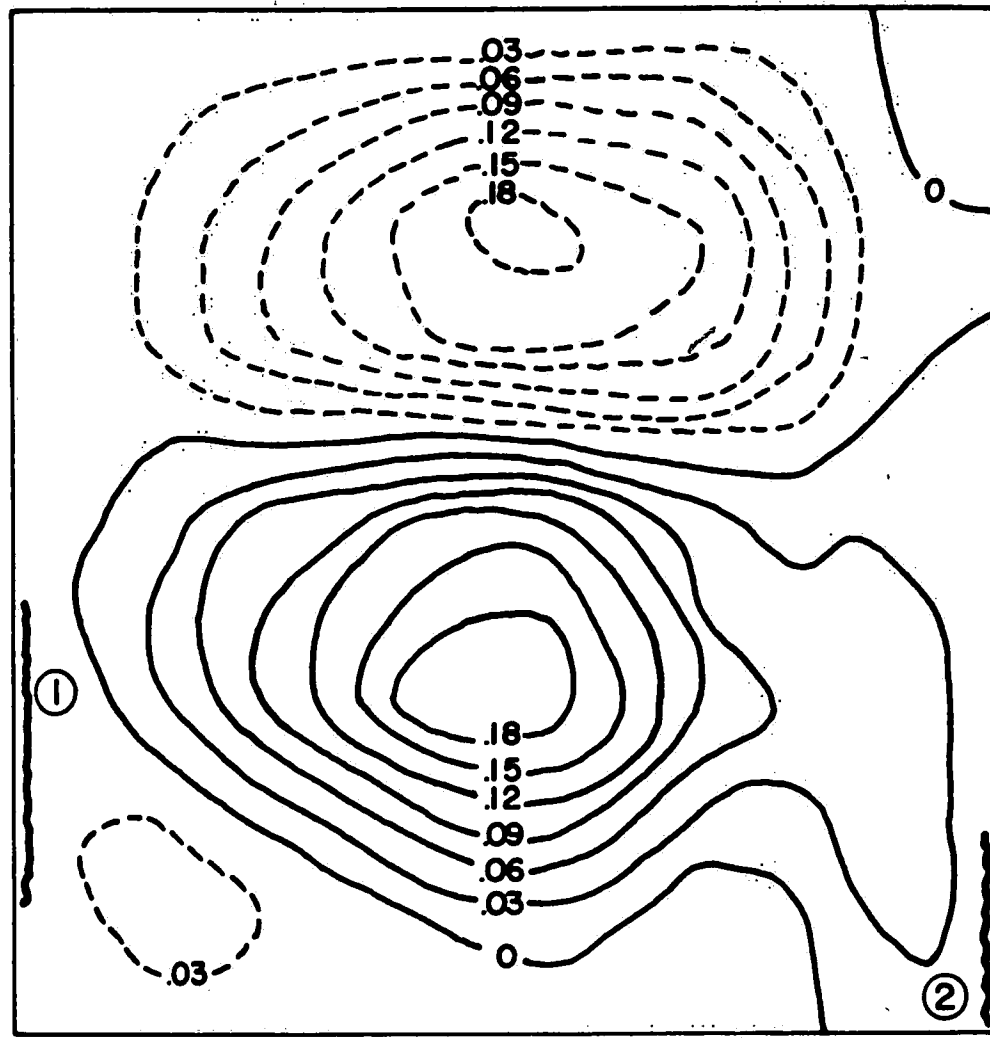
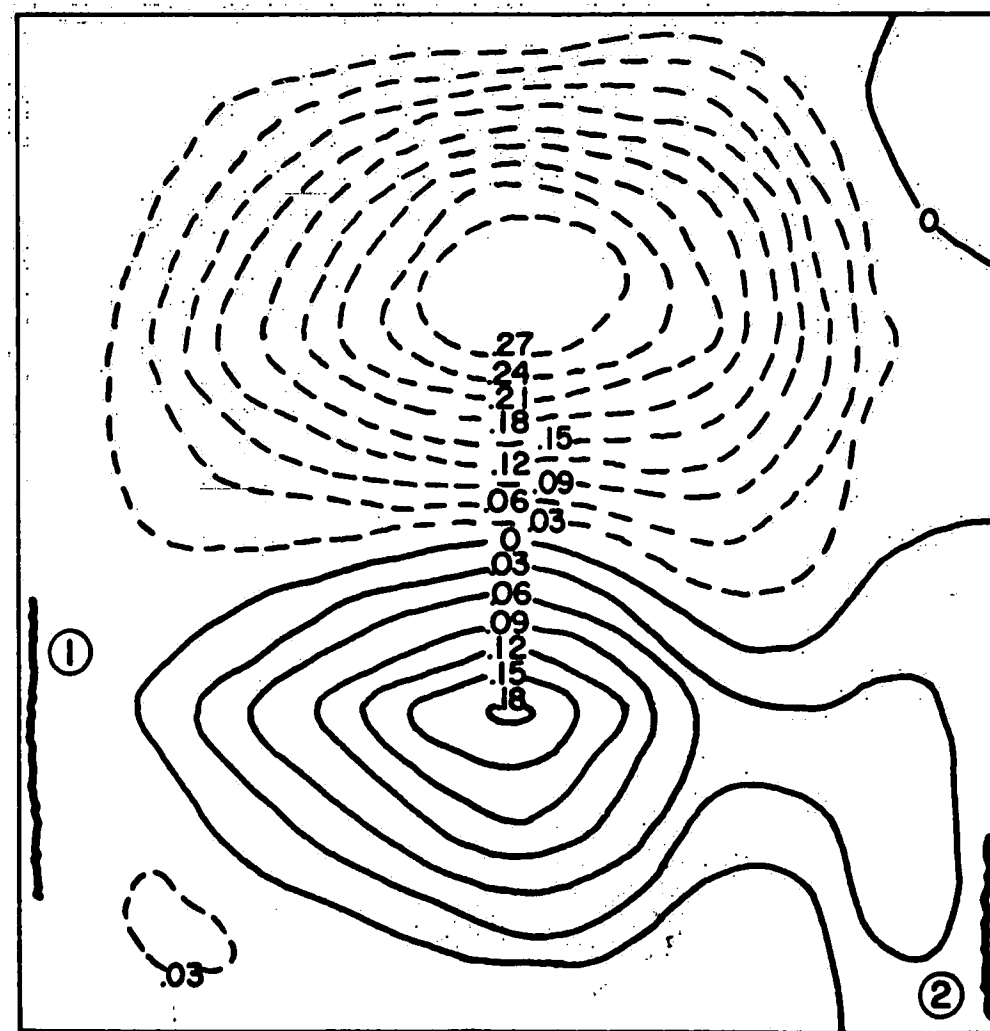
Fig. 12 Web Deflection Contours, Girder F6

From the deflection contours for panel 1, girder F6 (Fig. 12), the shifting movement of the web from one side to the other can clearly be observed. After the shifting between zero and 47 kips, the pattern of deflection was consistent, with only changes in the magnitude of deflection. Contrary to the common pattern of Fig. 11, intense contour lines appeared in the lower region of the panel, thus indicating relatively large web deflection in the tension zone. All these imply serious web movement, even near the boundary, and was observed so during testing. However, in the vicinity of Crack 2, the web almost remained stationary.
