# Fatigue tests of welded plate girders in bending

Joseph A. Corrado  
*Lehigh University*

**A Thesis**  
**Presented to the Graduate Faculty**  
**of Lehigh University**  
**in Candidacy for the Degree of**  
**Master of Science**

**Lehigh University**

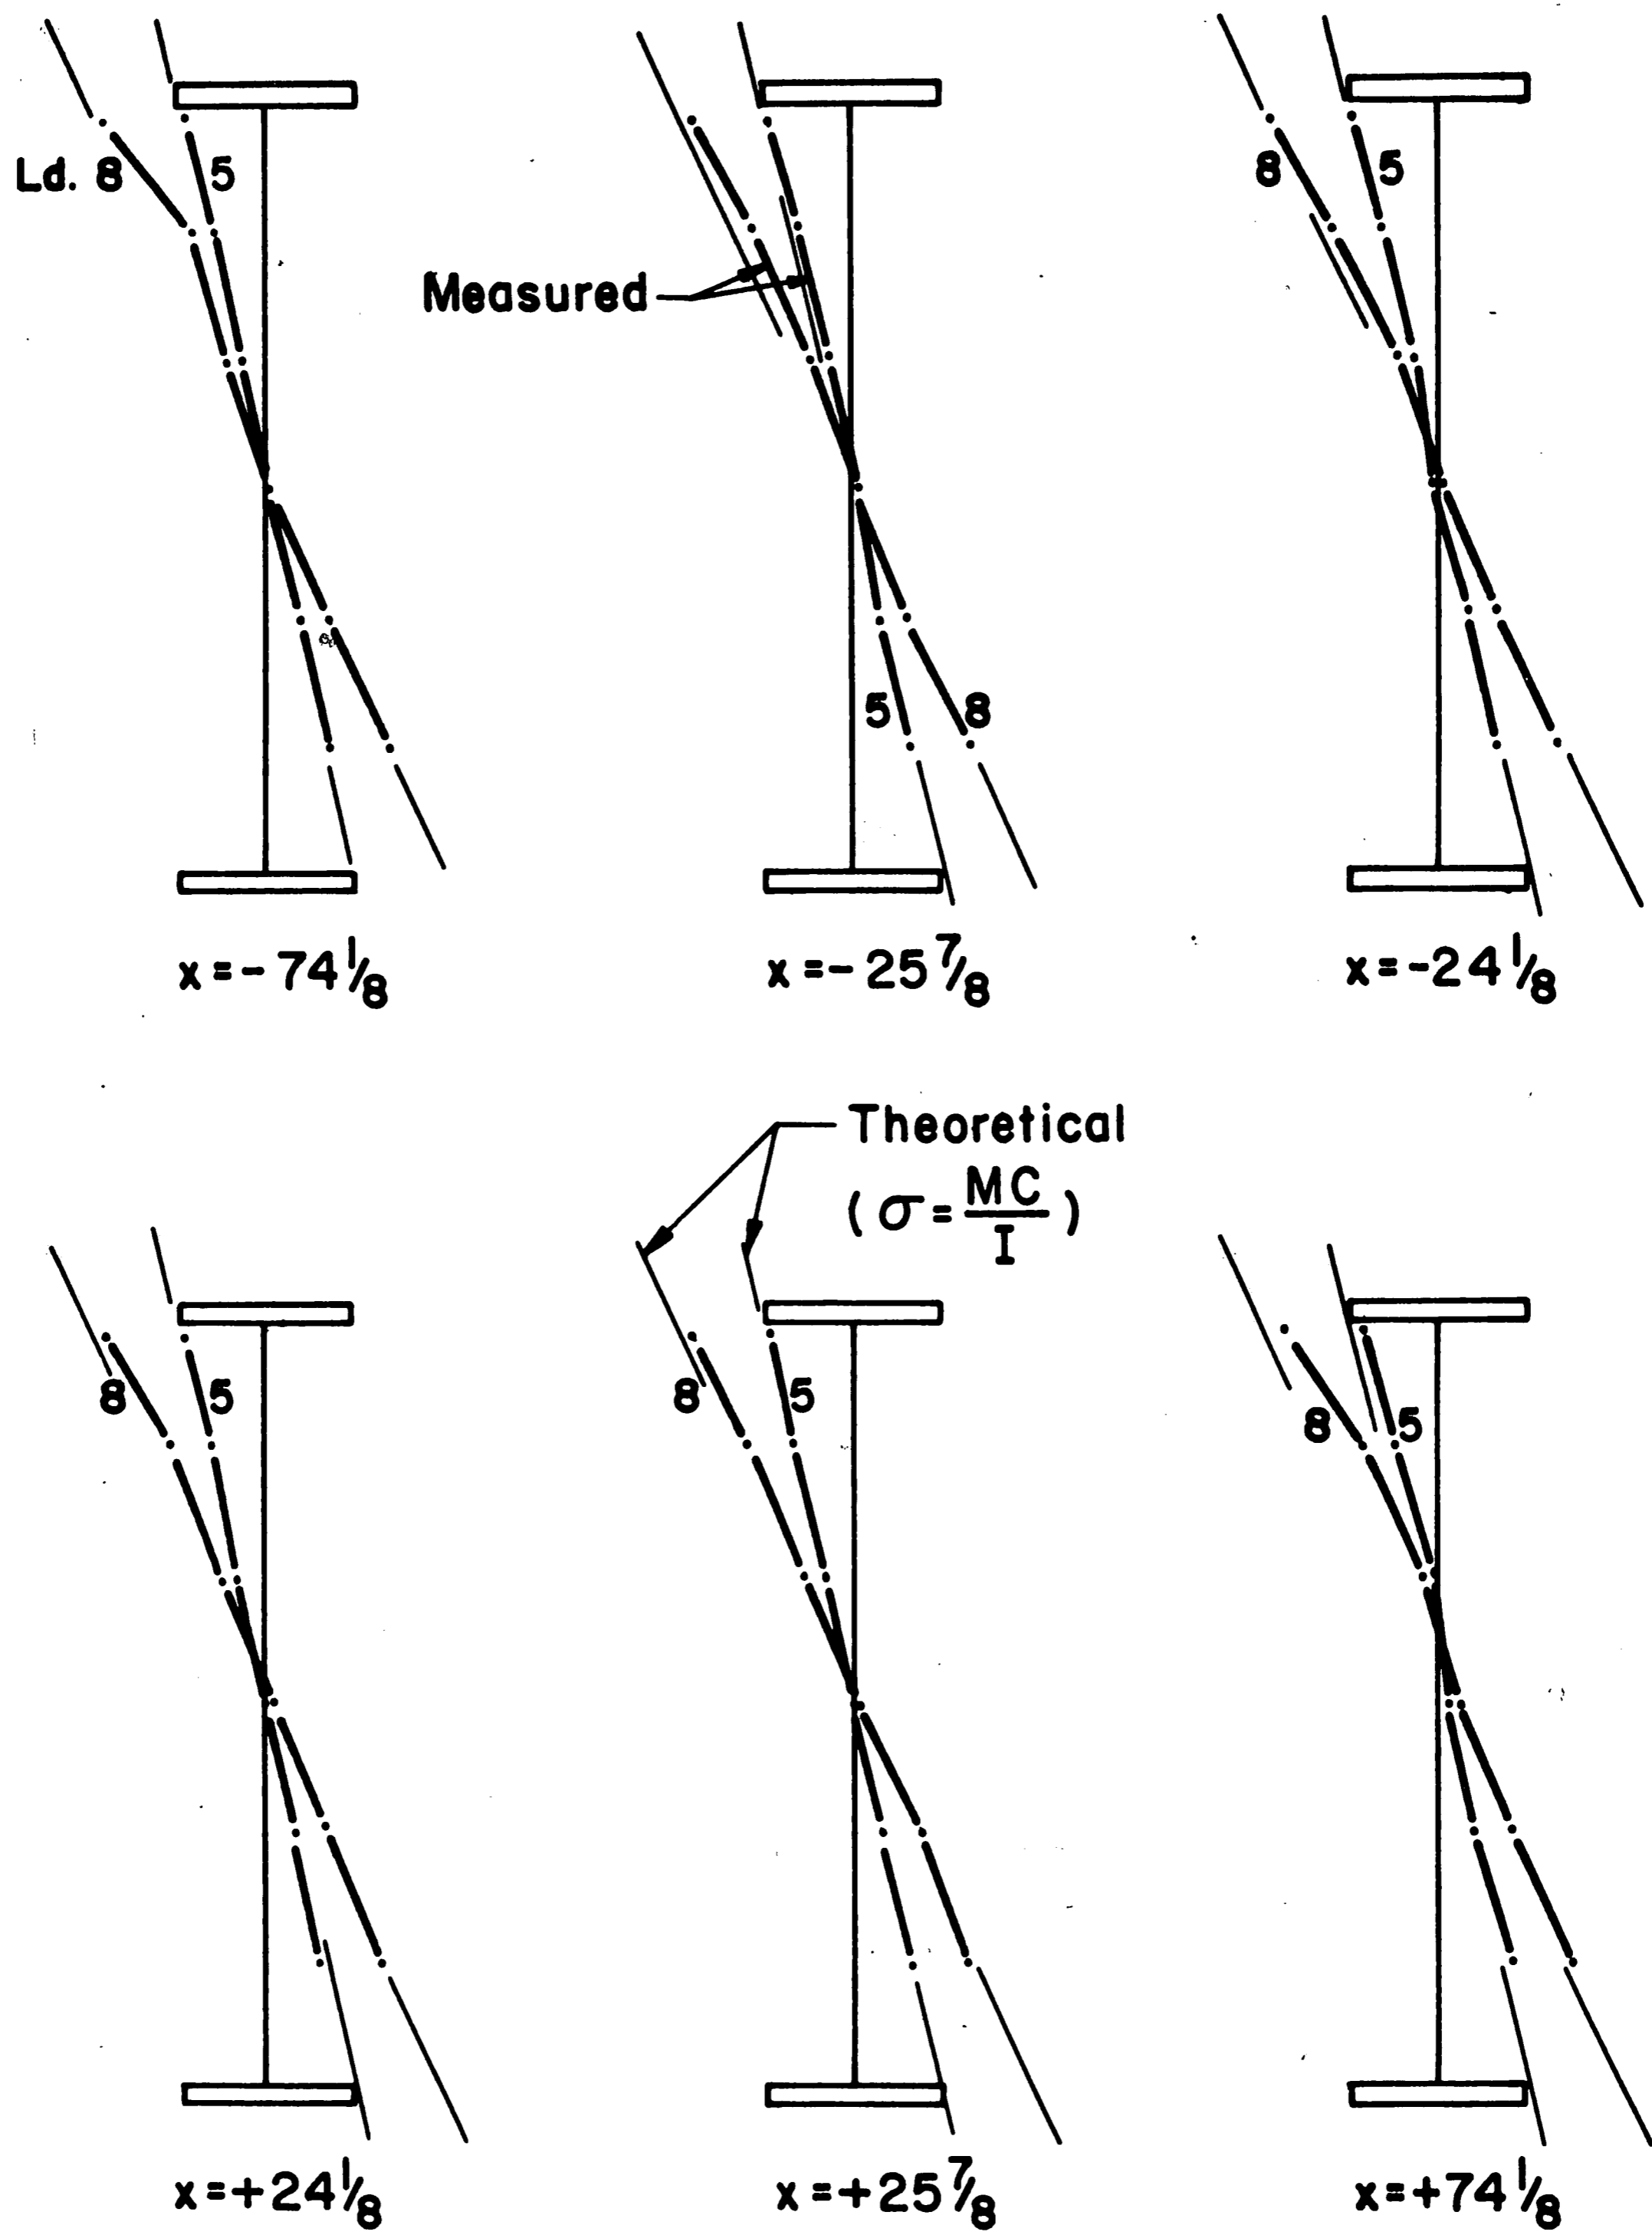
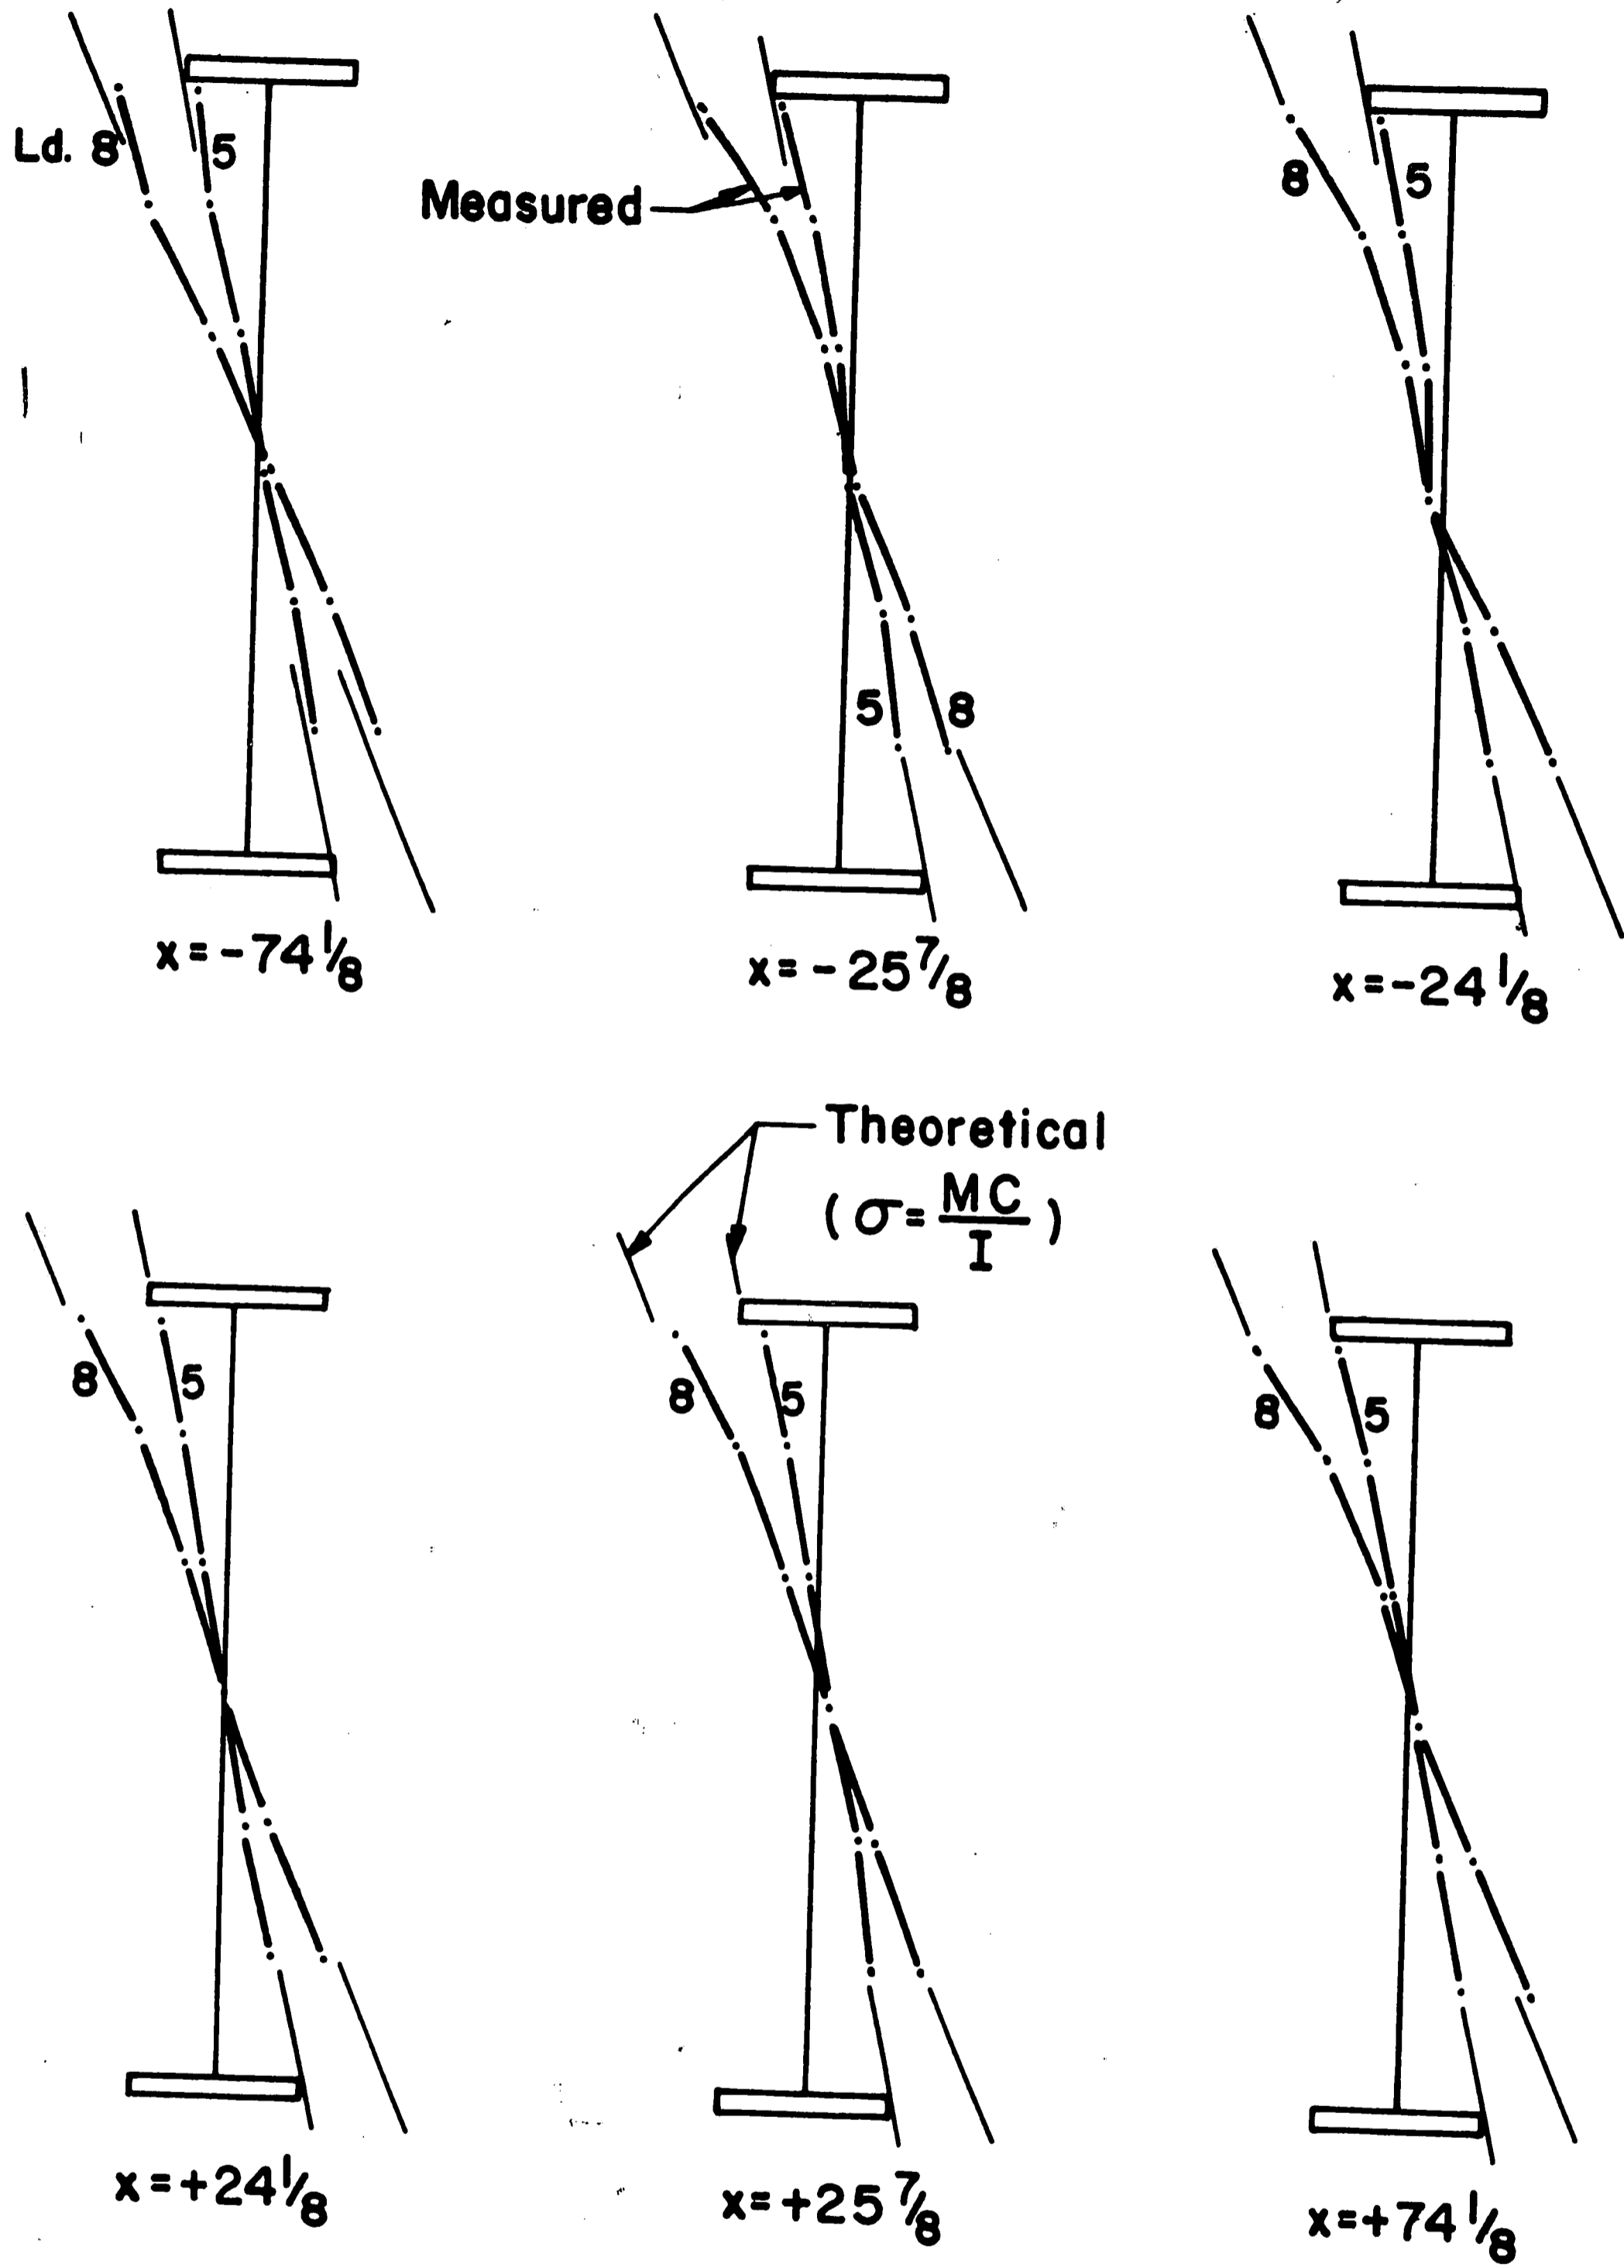
A review of the web membrane stresses, Figs. 16 and 17, reveals that at Cracks 2 and 3 of girder F6 and Crack 1 of girder F7 these stresses were about 16 ksi. Compared with the negligible secondary bending stress, it appears that the tensile membrane stress is dominant in the formation of fatigue cracks.

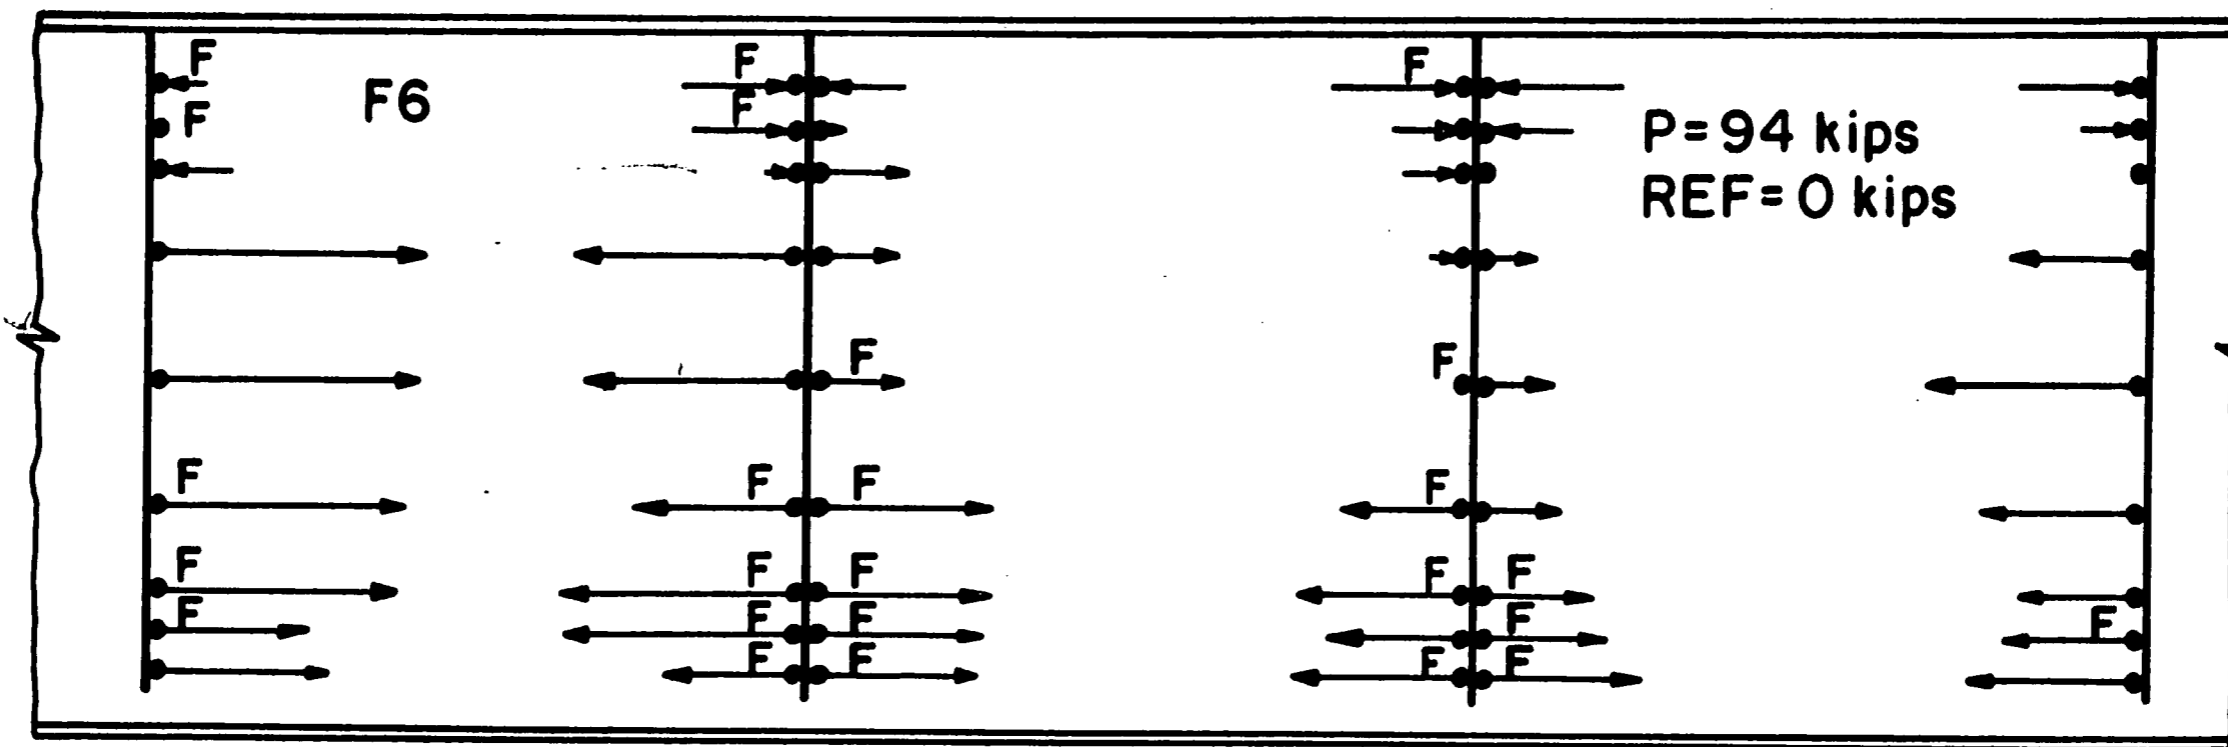
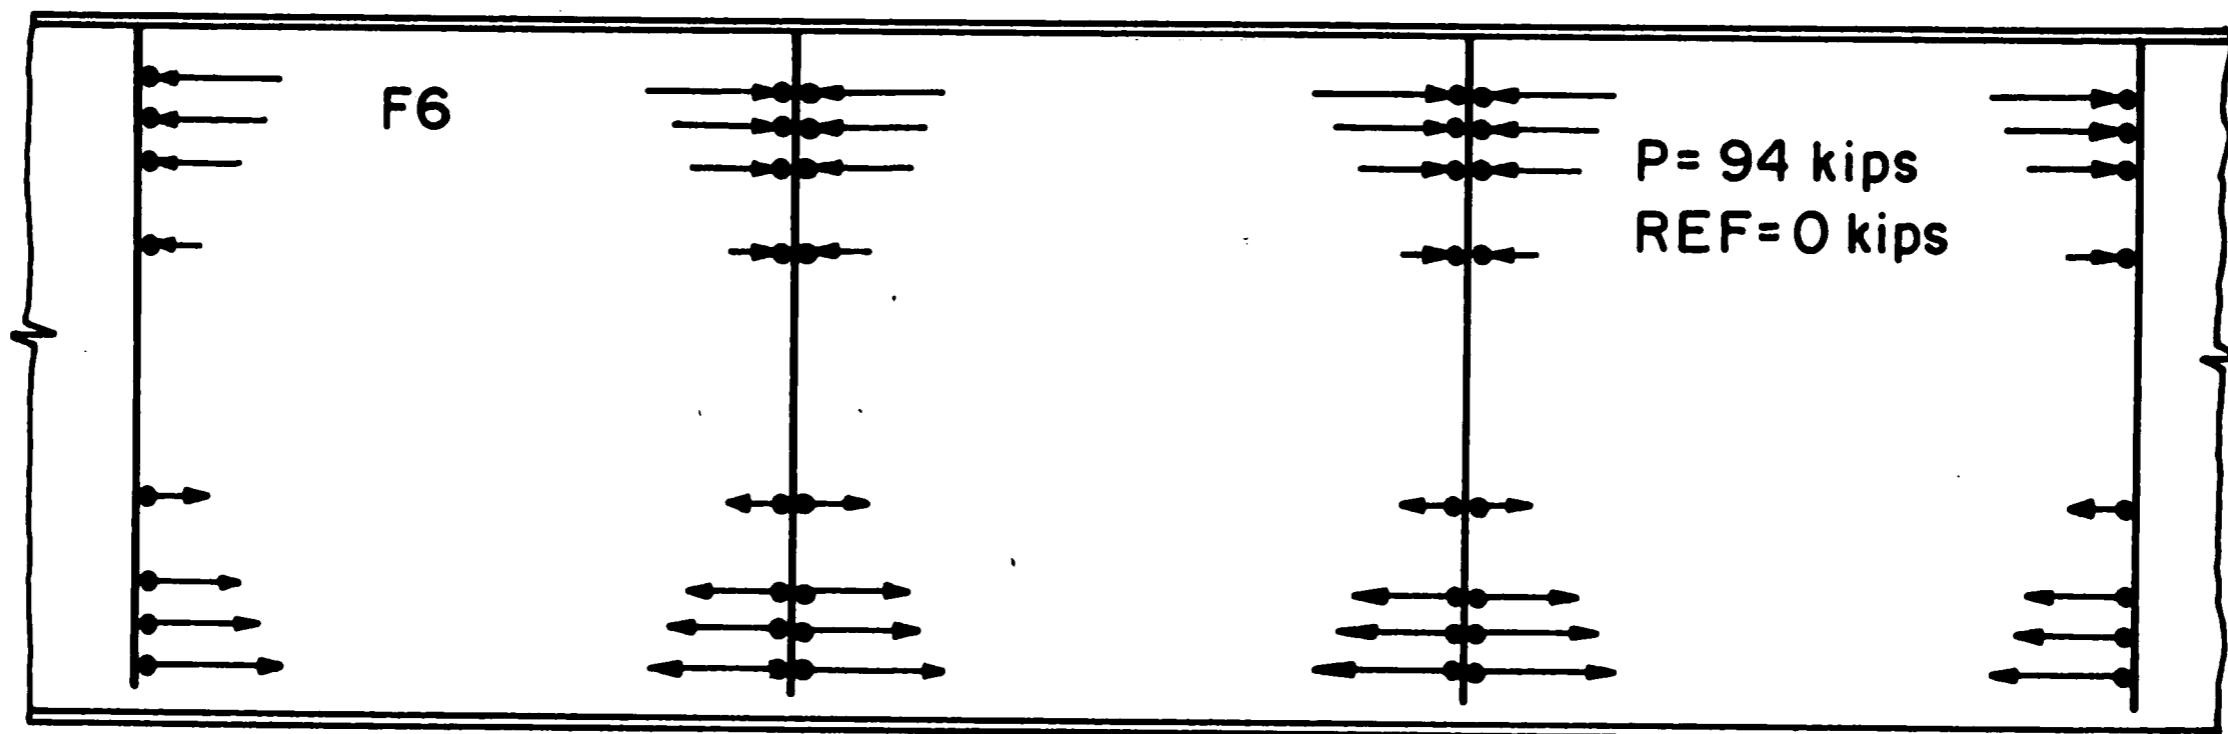
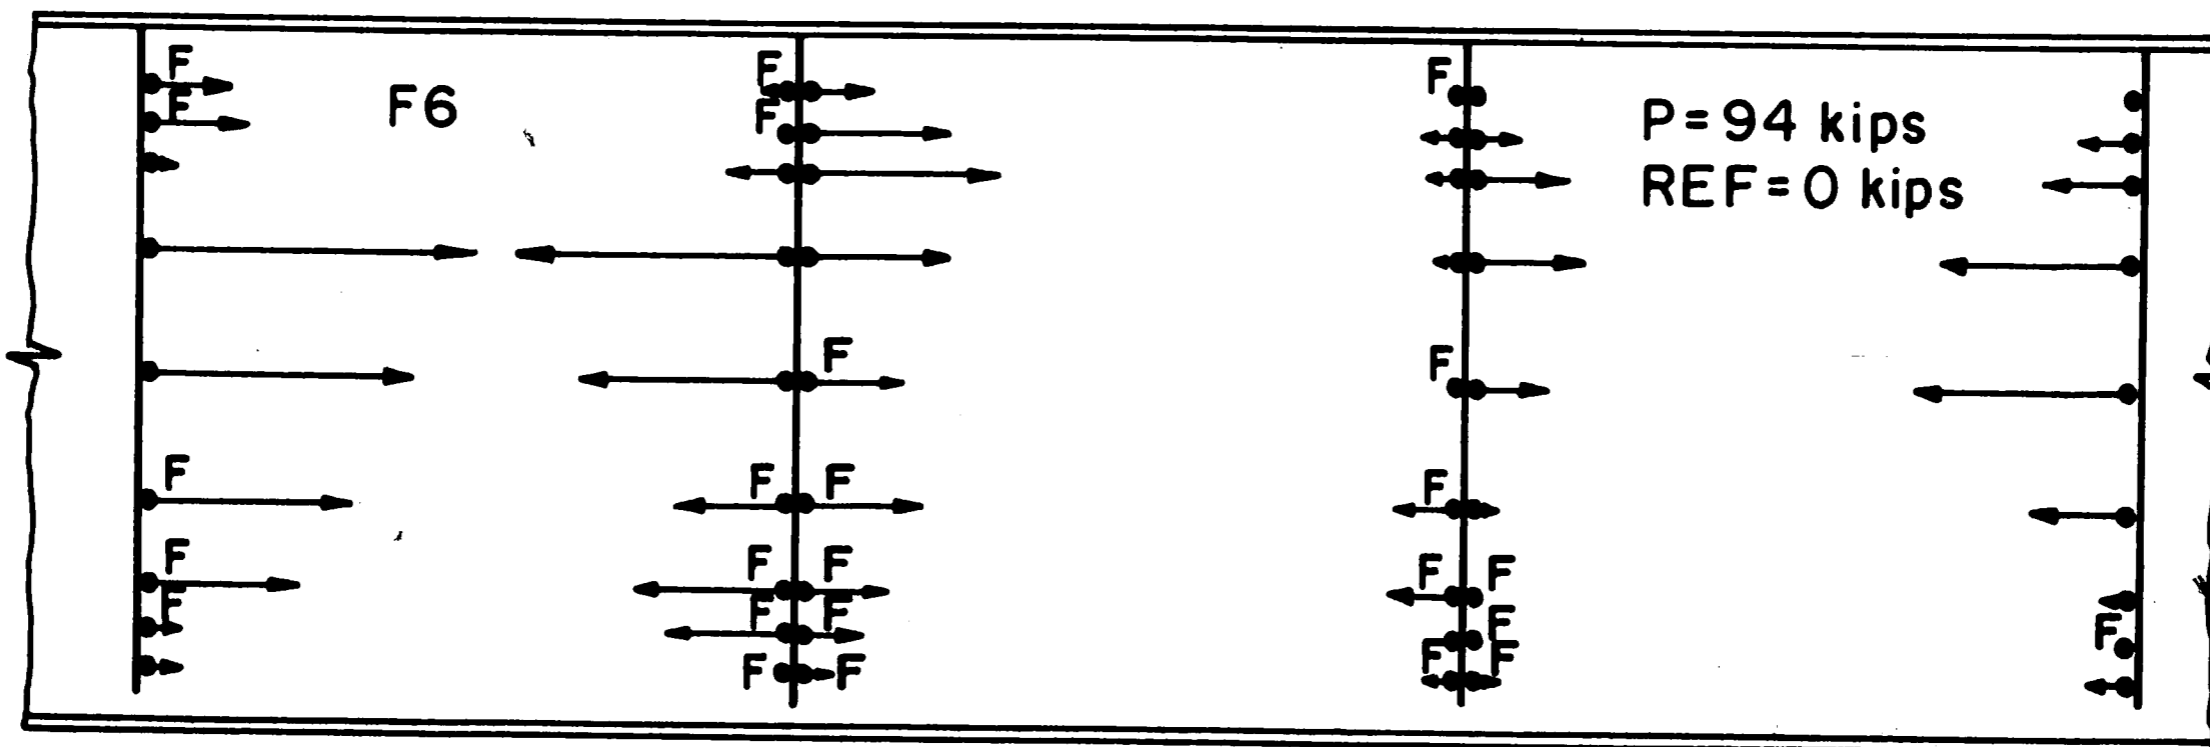
Fig. 20 Approximate Web Stresses Normal to the Boundary, Girder F6

From this, the secondary bending stresses were calculated at the toe of the fillet welds. These stresses are shown in Fig. 20 along with the approximate membrane ( $M_c/I$ ) and resulting surface stresses. The magnitudes of the plate bending stress for panel 1 were highest (25 - 35 ksi) in the upper part of the web, yet Crack 1 initiated about 9 inches below the neutral axis where the plate bending stress was about 20 ksi.

A further look at the stress picture in the vicinity of Crack 1, girder F6, indicates that the combination of secondary bending stress of about 20 ksi and tensile membrane stress of about 7 ksi resulted in a condition of stress which, most likely, was the cause of Crack 1. However, this condition does not seem to be the general case for bending girders, because large web deflections in the tension zone of the web are uncommon. Thus, in general, plate bending stress has little effect on the formation of fatigue cracks in plate girders subjected primarily to bending, whereas tensile membrane stresses have a dominant effect.
