International Conference on Case Histories in Geotechnical Engineering (2004) - Fifth International Conference on Case Histories in Geotechnical Engineering

Investigation of Structural Damage in a Corrosive Environment: A Case Study

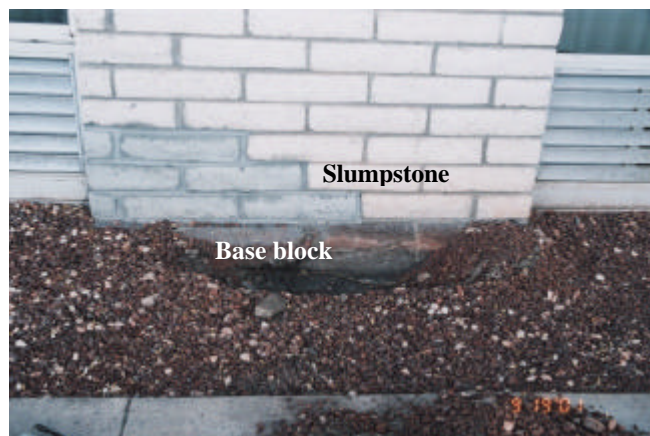
Of particular interest are the exterior shear walls along the east and west sides of the 4-story buildings. Figure 2 presents an overview of a typical exterior wall.

Fig. 2. Typical narrow exterior wall. Note that previous destructive testing had been performed on the left side of the wall.

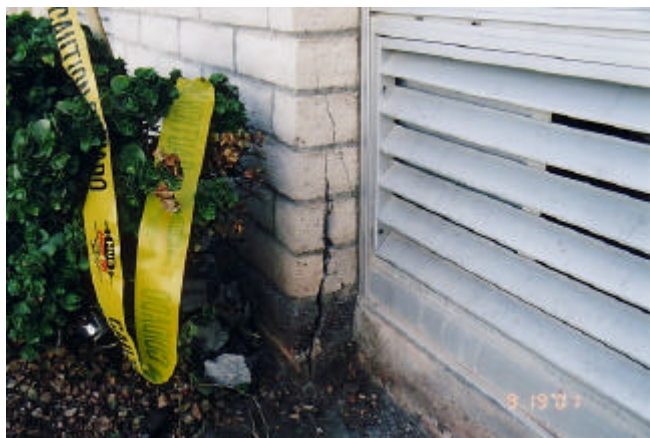
splitting) of the first few courses of block above the foundation level was reported subsequent to the October 16, 1999, Hector Mine Earthquake. The damage was noticed at the bottom, outboard ends of many of the walls, at or just above/below the soil line (Fig. 4).

Fig 4. Typical damage observed at base of slender CMU wall.

The cracks typically “daylight,” and are thus visually apparent, only at the wall ends (Fig. 4) and along the lowest mortar joint typically below grade and not visible without excavation.

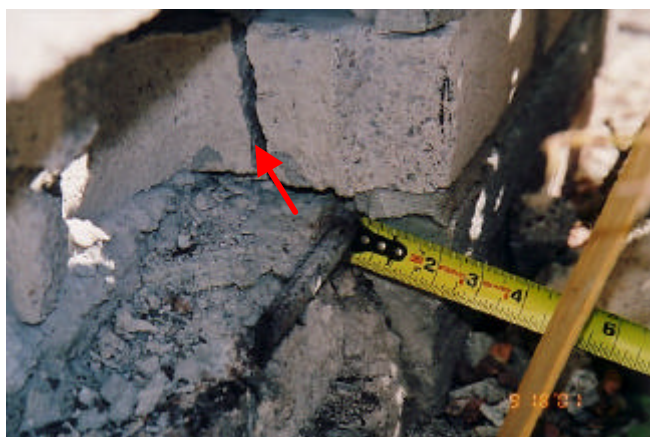
Further inspection revealed that the blocks were spalling (splitting) along a vertical plane parallel to and behind the front face of the wall (Fig. 5).

Fig. 5. Example showing existence of vertical crack in the central portion of a wall. The arrow points to the outer face of the block wall.

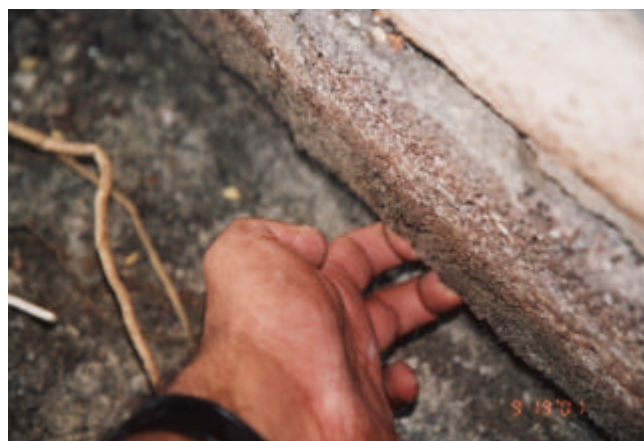
During the site investigation, the soil adjacent to the walls was excavated (depth ranging from less than a foot to 2-feet) to expose the base block in more than twenty locations around the perimeter of the buildings. It was noted that the cracking extended along the entire length of the wall in all areas where a source of water (sprinkler, spigot, drain, etc.) was identified in the immediate vicinity of the wall. The cracking was also observed along the non-slender north and south walls of the buildings. Figure 6 shows typical cracking noted in the base

Fig. 6. Typical cracking of base block. This condition was observed around the entire perimeter.

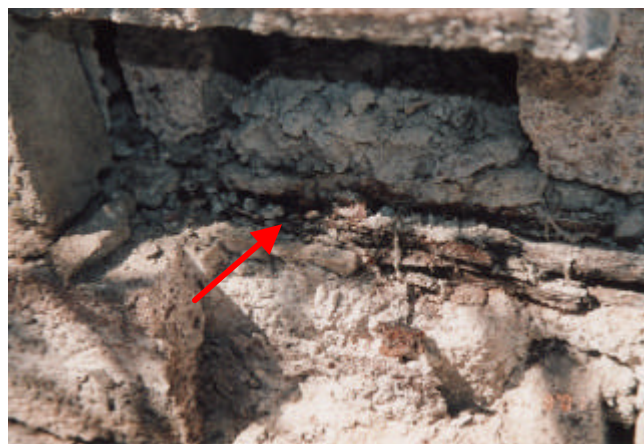
In all cases, the cracks and spalling of the CMU shells occurred at locations that exhibited significant corrosion of the reinforcing horizontal steel (Fig. 7).

Fig. 7. Example of severe corrosion of reinforcement in concrete. The arrow points to corrosion product as the original steel was completely corroded.

1. Splitting of the concrete block in all cases was associated with corrosion of the reinforcing steel. The volume of the corrosion product that is formed as the reinforcement corrodes is several times that of the original (uncorroded) steel. As the corrosion product expands, it stresses the surrounding concrete, eventually leading to cracking of the concrete block. In some locations the steel reinforcement was observed to be entirely corroded.

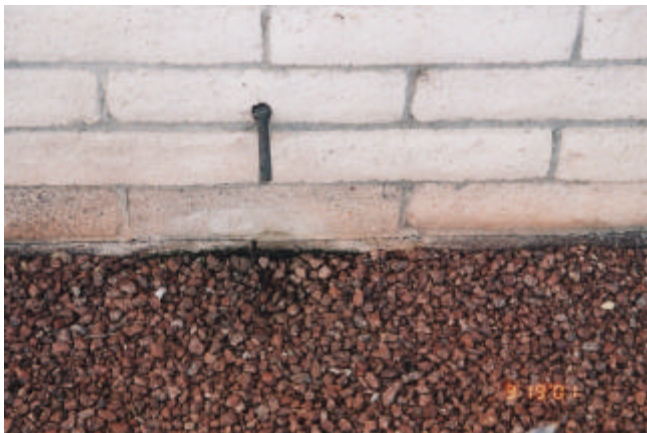
Sulfate ions in contact with concrete can cause the cement component of concrete to degrade, resulting in a more porous concrete (Fig. 13). This facilitates ingress of water, oxygen, and aggressive ions. The moderate levels of sulfates in the irrigation water are sufficient to cause mild sulfate attack. (ACI, 1992). Some evidence of sulfate attack was also noted in the petrographic analysis of the concrete samples.

Fig. 13. Example of deteriorated concrete located next to a source of water.
