Analysis of the communication anomaly during E-ST@R-2 mission operations

IAC-17.B4.3.3

ANALYSIS OF THE COMMUNICATION ANOMALY DURING E-ST@R-2 MISSION OPERATIONS

S. Corpino ^{a*}, F. Stesina ^a

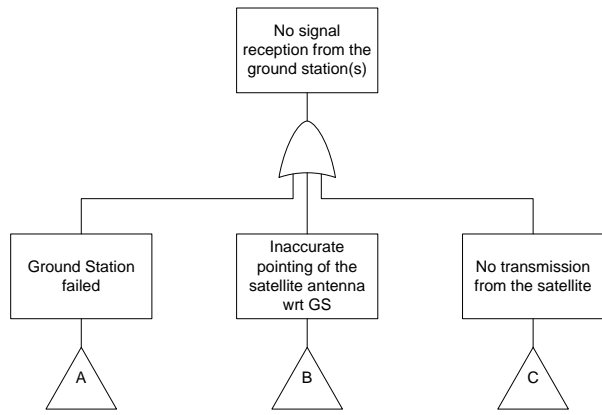
Fig. 3: FT for the top event “No signal reception from the ground station(s)”

To conclude, the absence of received signal on ground is mainly due to the bad pointing of the satellite to nadir and the high attenuations due to bad

connections, and by the temporary switch-off of the transmissions due to the activation phase activities. To mitigate the ARI-BRA GS problems, some corrective actions were implemented such as the accurate review of the connections and the change of some coaxial cables, the change of the antenna (YAGI 3-meters long with 16 elements), the insertion of a circular polarization switch with a higher quality component, and the re-calibration of the antenna tracking system. The “low S/N ratio” is due to 1) a failure of the radio-module, and 2) an incomplete radiation pattern and/or a low gain of the antenna.

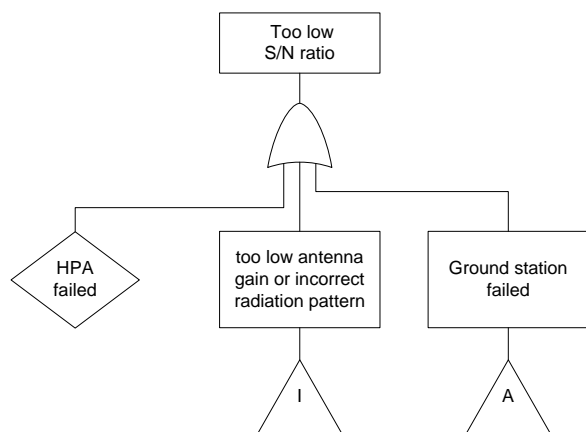
Fig. 4: FT for the top event “Too low S/N ratio”

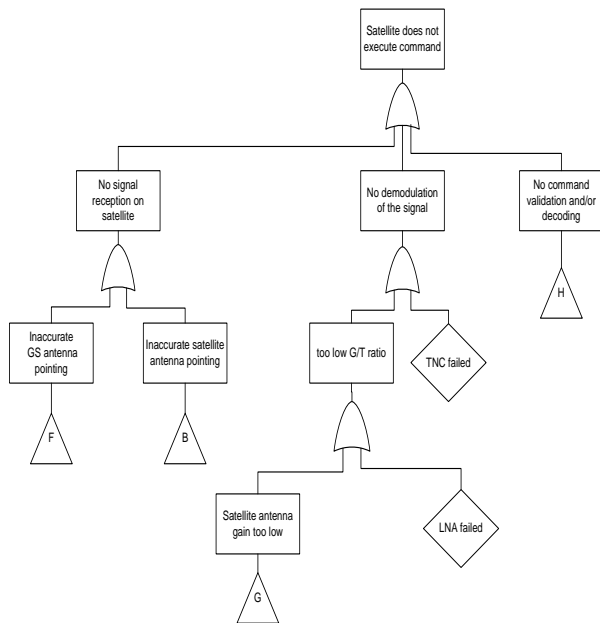
Fig. 5: FT for the top event “Satellite does not execute command”

To conclude, the main causes of the missed execution of the command is ascribed to the inaccurate pointing of the satellite and the low value of the G/T ratio. This cause is mainly due to low gain of the antenna generated by the faulty connection of the antenna with the COM SYS board and/or the missed or partial deployment of the antenna.

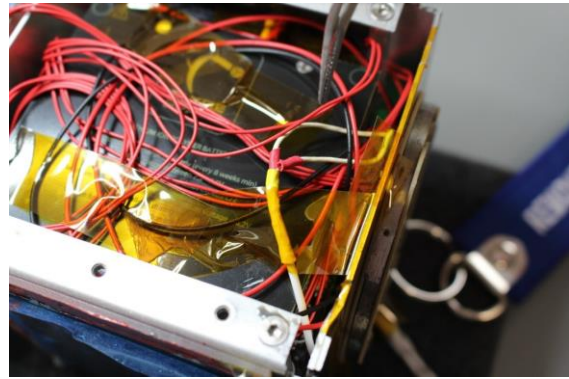
2. Incomplete radiation pattern can be caused by a faulty connection during the integration phase: a wrong connection between the coaxial cable and the two antenna pieces. Photos taken during integration (Fig. 6) show that two twisted cables are used to lengthen the connection in order to ease the integration. As these cables are not coaxial, this configuration does not behave as a transmission line, instead these cables cause a significant loss and, as consequence, the antenna has not a main lobe but several side lobes, that fall down power and reduce gain and beamwidth.

Fig. 6: Details of the antenna connection

To conclude, the bad connection between the antenna and the COM SYS board is considered the most probable cause for the difficulty to decode the AFSK packets because it introduces both a strong reduction of the EIRP and a wrong or incomplete radiation pattern with a smaller main lobe and higher number and strong side lobe.

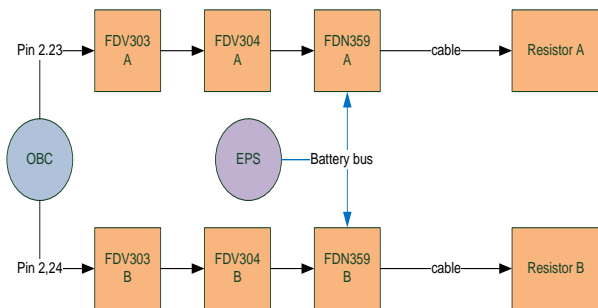
A second cause of incomplete antenna pattern and/or reduced antenna gain is a failure on the antenna opening circuit lines that prevents the antenna deployment. The antenna opening circuit (Fig. 7) presents a redundancy by design: two independent circuits (based on two cascades of three MOSFET) contribute to cut the fishing wire. This redundancy allocates a low probability of failure occurrence because it would mean that both lines failed either during the launch or in the first 30 minutes of the mission.

Fig. 7: antenna opening circuit block scheme

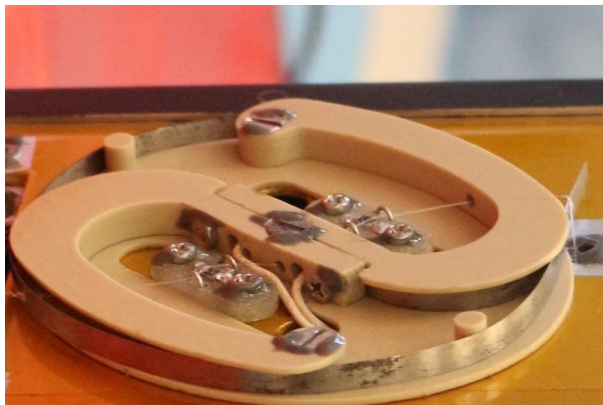
- An incorrect closing of the antenna on its support so that the fishing wire does not touch both the resistors contemporary. However, the picture in Fig. 8 taken immediately before the satellite integration in the P-POD, should exclude this event;
- The fishing wire was moved away from the resistors during the launch: the possibility of occurrence of this event could not be unwrapped.

Fig. 8: detail of the antenna system
