Evaluation of Safety Performance of Fractured Joints in Steel Truss Bridge

Abstract

The Ayeyarwady bridge (Yadanarbon) spans the Ayeyarwady river linking Mandalay suburb and Sagaing city, approximately 2000 feet to the north of the old Ava bridge. It is the first longest span steel Arch bridge in Myanmar and also the gateway to Yangon, Mandalay and any other regions in the country. It comprises two units of 2*112 m continuous steel truss and one unit of 3* 224 m continuous arch truss. The main bridge is 1125.8 m long, its approach on the Mandalay side is 347 m long and on the Sagaing side is 780 m. The carriageway consists of four lanes for motorized traffic and two footpaths for pedestrians on each side of the truss. The truss is 16 m wide, and the free headroom of the carriageway is 5.5 m. The pedestrian footpaths externally on both sides of the truss are 1.8 m. It is designed by China CAMC Engineering co.ltd (CAMCE) and constructed by Public Works of Ministry of Construction in 2001. Some DG suspenders were cracked at wind velocity of 35 miles per hour during erection and its suspender design have been changed after wind tunnel test in China. The construction work was complete

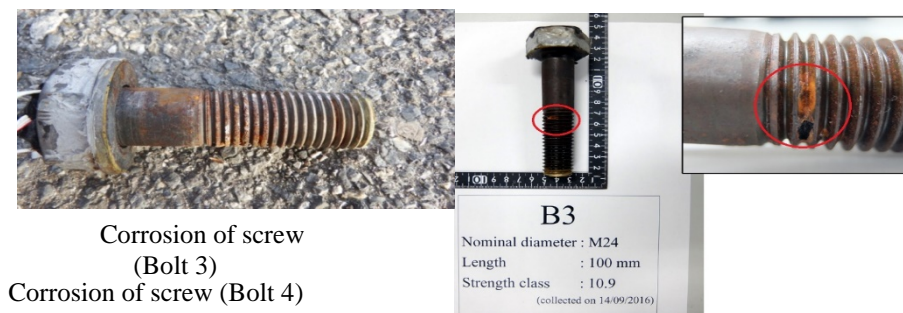
- The fundamental frequencies of some modes of the bridge were found to be around 1.4 Hz, 2.6 Hz and 3.2 Hz by converting the vibration data to FFT graphs (see Figure 5).
- The average values for the wind speed, temperature, relative humidity and atmospheric pressure were measured as 1.9 m/s, 32.6°C, 62.8%, 996 hPa respectively.
- Bolt axial forces are shown in Table 5. According to the Japanese standard and AASHTO, the introduced bolt axial force for bolt of which diameter is 24mm and strength class is F10T or 10.9 should be 238kN and 257kN respectively. Bolt axial force of Bolt 3 and 4 are less than the other bolts due to corrosion (see Figure 6).

Figure 6: Corrosion of high strength bolts

- Fasteners with dry, dirty, and rusty thread surface conditions do not install properly and result in inadequate bolt tension. In addition, high-strength bolts should be stored properly to avoid rust and contamination. The torque wrench for tightening bolts needs to be calibrated accurately before use.

- Pitting corrosion may be found at the locations where water can accumulate thus installing high strength bolts in rainy season should be avoided.
- Inadequate design considerations, material problems, insufficient preloading, loosening and excessive loads can all contribute to fastener fatigue.

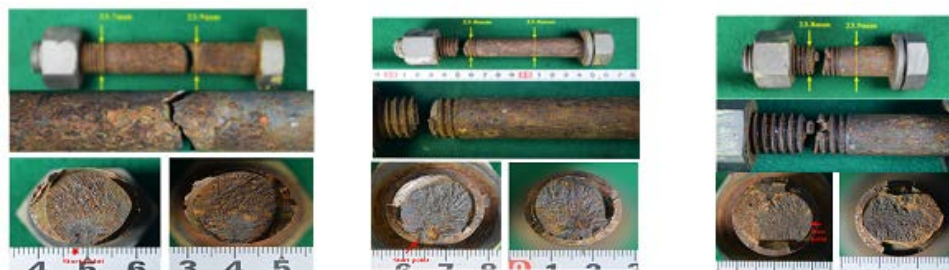
Radial fractures occurred in the cylindrical part of Bolt A and in the thread root of Bolts B and C.

These bolts show no conspicuous deformation, such as bending or a change in diameter.

Figure 8: Observation of appearance of high strength bolts

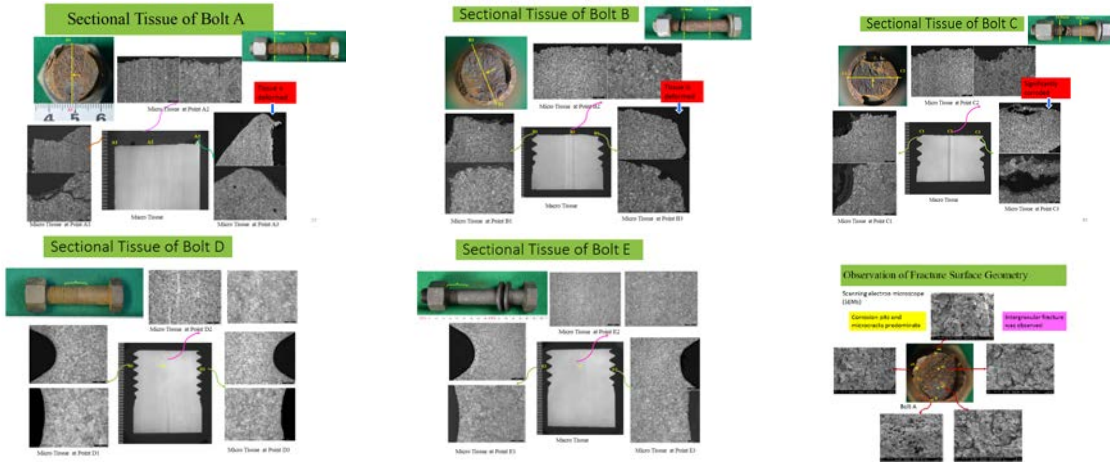
Although the fracture surface geometry is obscured by corrosion, intergranular fractures are present. A number of corrosion pits and microcracks can be seen.

Figure 9: Sectional tissue of high strength bolts

- Furthermore, the tissue is uniform and has no defects, such as large inclusions, that could become the starting point of fracture.
- These findings indicate that the damage to the hexagonal bolts was caused by delayed fractures.

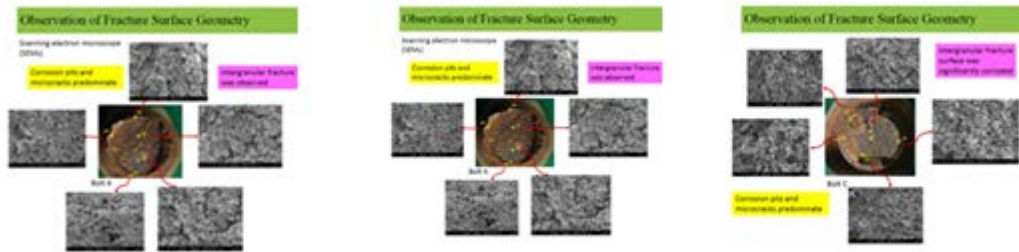
Fracture surface is completely rusted and a number of microcracks and corrosion pits are visible. Although some parts are obscured by corrosion, the fracture surface is chiefly that of intergranular fracture. This resembles the characteristics of a delayed fracture.

Figure 10: Observation of Fracture Surface Geometry

- Fracture surface is completely rusted and a number of microcracks and corrosion pits are visible. Although some parts are obscured by corrosion, the fracture surface is chiefly that of intergranular fracture. This resembles the characteristics of a delayed fracture.

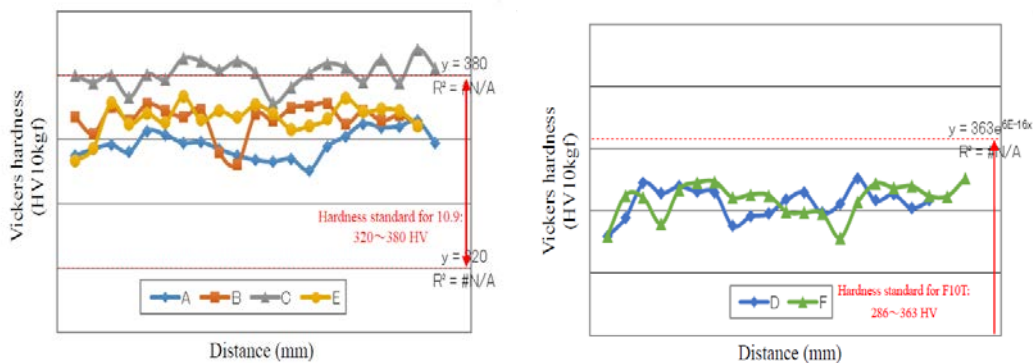
The hardness values for Bolts A-C and E are 352-388 HV. Only some of the hardness values for bolt C exceed the standard upper limit for the standard hardness values for the strength category of 10.9 (320-380 HV). The hardness values of Bolt D and F are 331-350 HV, which differ from those for Bolts A-C and E. The hardness values for the washers are 400-429 HV. The Standard hardness values for washers in the strength category of 300 HV range from 300 to 370 HV (washers from Bolts A-C ad E). Their values exceed the upper limit of the standard.

Figure 11: Hardness testing of high strength bolts

- Moreover, some of the measured values for Bolt C, one of the fractured bolts, exceed the standard upper limit (equivalent to the value of F11T). The measured values for Bolts A and B also are near the upper limit of the hardness standard for bolts in the strength category of 10.9.

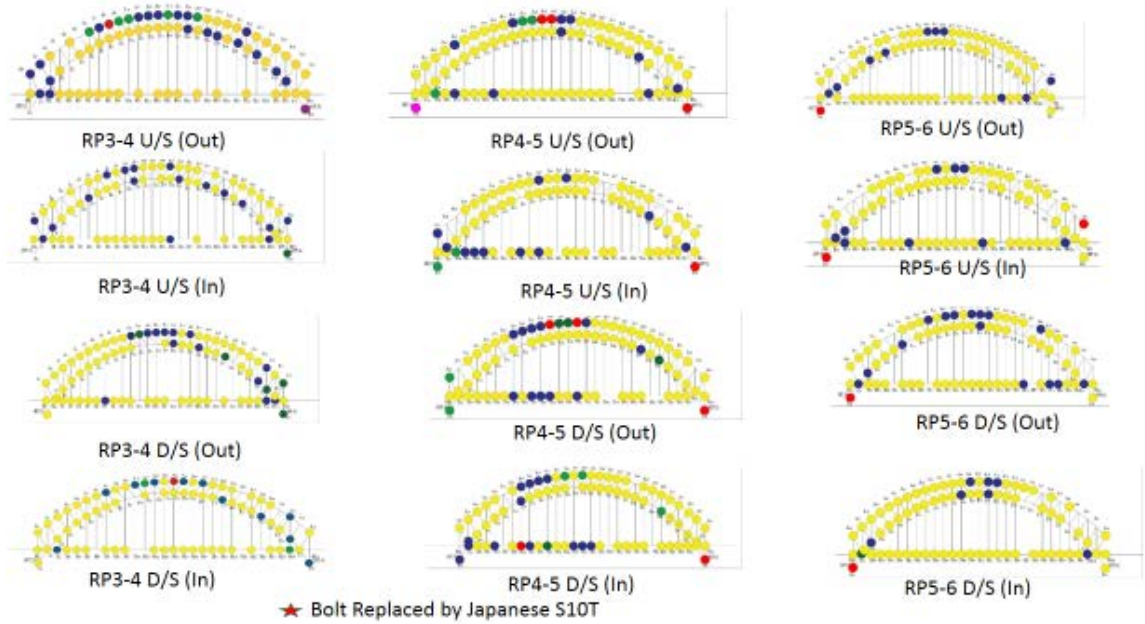
According to preliminary analysis of the quantities, location and picture of the fractured HSBs based on maintenance records [5], the fracture occurs in the whole bridge and at random, in disorder and at a wide range.

Figure 12: Damage pattern of fractured high strength bolts

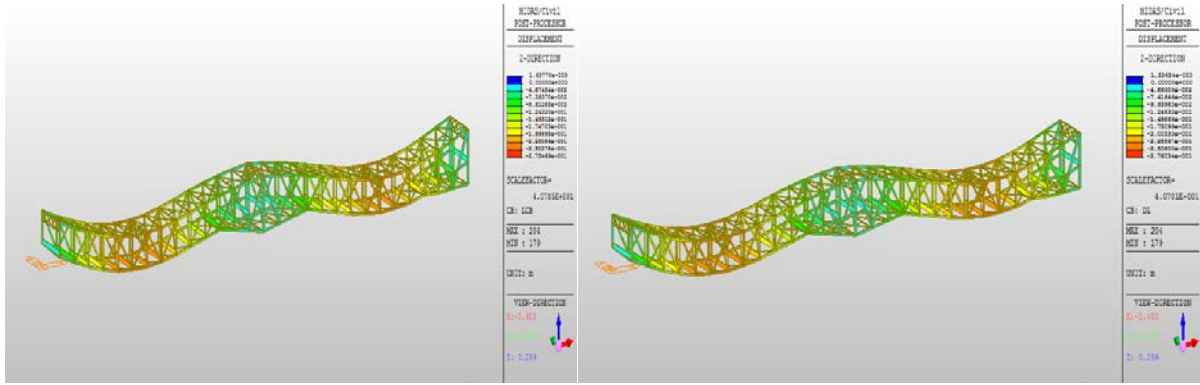
The maximum vertical (Z-Direction) deflections at mid span due to dead load and service load of truss bridge (Figure 16) is 0.27 m and that of arch bridge (Figure 17) is 0.3 m. Both are exceeding the allowable limits of L/360.

Figure 16: Deflection due to dead and service load of truss bridge

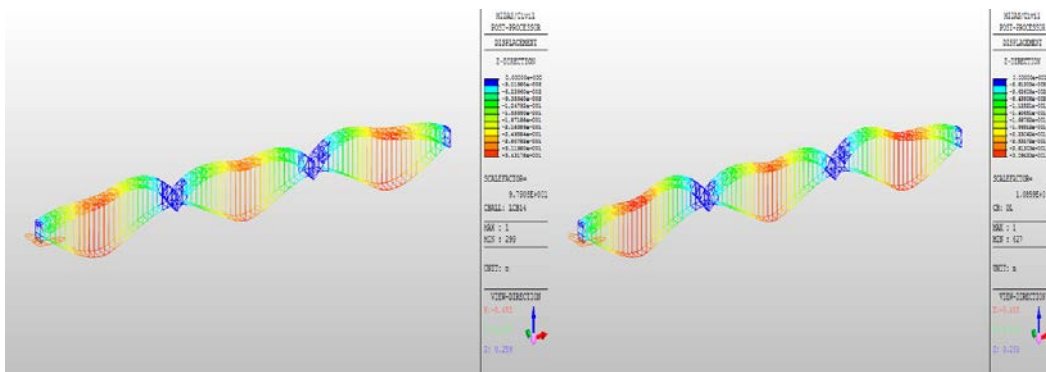
Figure 17: Deflection due to dead and service load of arch bridge

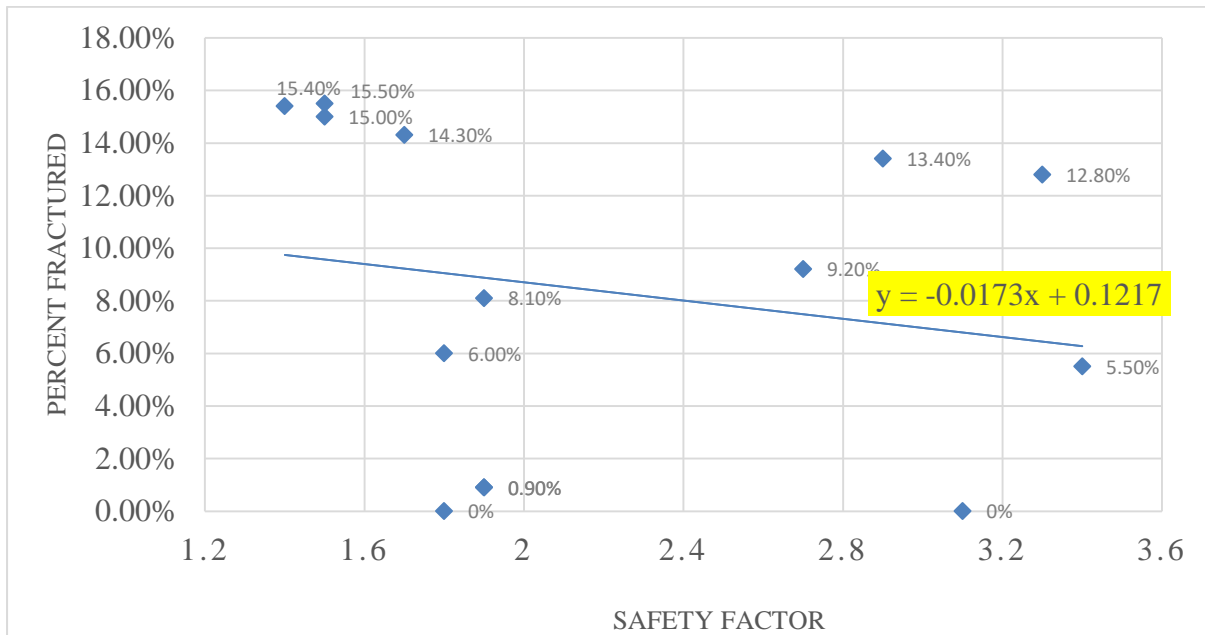
It can be seen that percent fracture decrease as safety factor increase (see Figure 21).

Figure 21: Safety performance of fractured joints

- Based on evaluation of safety factor of fractured joints, percent fractured relates to safety factor of joints and more fractured joints are occurred factor of safety less than 2. Safety factor of joints must be careful in connection design of steel bridge and safety factor should be at least 2.
