DAMAGES CAUSED BY 3/11 GREAT EAST JAPAN EARTHQUAKE ON COASTAL DRAINAGE PUMPING STATIONS ALONG SENDAI BAY

H. Tanji¹, H. Kiri¹ and T. Nakaya¹

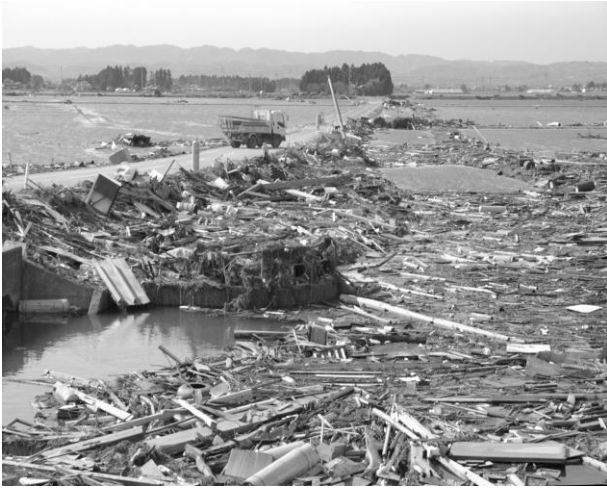
In 2011, the tsunami caused by the Great East Japan Earthquake struck low-lying land along Sendai Bay, destroying buildings and infrastructure. These coastal lowlands were equipped with drainage pumping stations (DPS) for urban areas and paddy areas, which were inundated by sea water. Photo 1 shows a view of the inundation of Fujisone pumping station on March 18, 2011. Although many dead bodies remained in the inundated areas, at that time the top priority to recover from the tsunami disaster was to drain the inundated areas. Normally, urban areas are located on higher ground than paddy areas, so the final drainage of inundation depends on pumping stations for paddy areas. However, all pumping stations in inundated areas were destroyed. Attempts were made to use small mobile pumps to reduce the inundation, and it took several weeks to remove the water from inundated areas.

Photo 1 Inundation after the tsunami

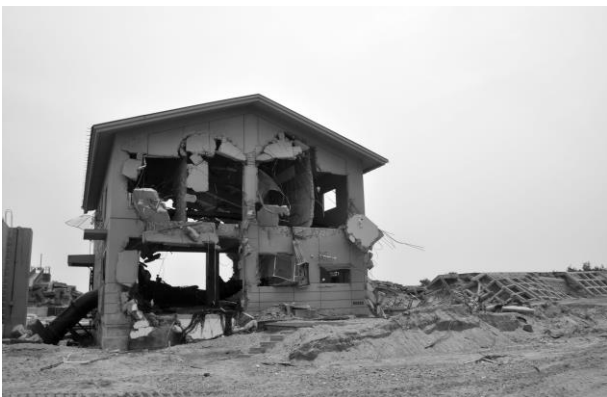
Photo 2 Hanagasa 2 DPS (RC)

RC is basically strong against tsunami. Some damage to RC occurred at Hanagasa 2 DPS shown in Photo 2. This DPS is located just behind a coastal bank, which is located just to the right of the DPS in Photo 2. This photo is taken from the land side facing toward the sea. DPSs in RC buildings are relatively strong because a DPS is equipped with a crane for pumps and the structure is relatively strong for a simple RC building. Photo 3 shows damage to Fujisone DPS. This RC DPS remained standing even though all neighboring buildings were destroyed.

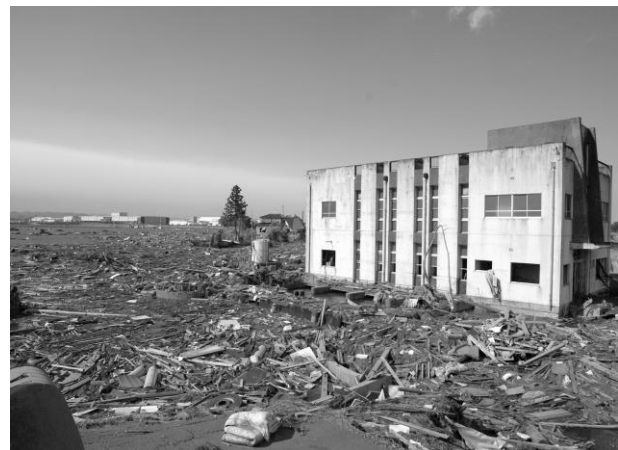
Photo 3 Fujisone DPS (RC)

Shuto (1993) showed that the windows of a building are weak points against tsunami. This tendency applies to DPSs too. In Photo 3, the windows were broken by the tsunami. To protect against tsunami damage, the structure of windows should be strengthened.

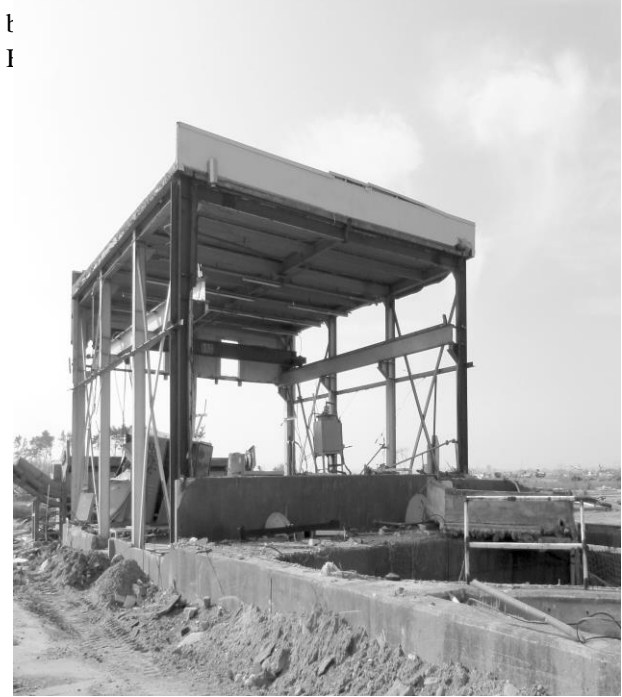
Another type of DPS structure is the panel structure. In a panel structure, a steel frame is constructed first and then panels are added onto the frames. These panels are weak against tsunami. Photo 3 shows tsunami damage at Ohori DPS. Except the ceiling boards, all panels were swept away and only the steel frame remained. A panel structure can be constructed quickly and easily, and so even new DPSs such as the Fujitsuka DPS are panel structures.

Photo 4 Oohori DPS (Panel)

The aim of this study was to clarify the tsunami height resistance of DPSs. From Fig. 4, an RC structure is strongly recommended for a DPS. Recently, to reduce the cost and construction period, some DPSs are panel structures. However, for resistance to tsunami, panel structures should be avoided.

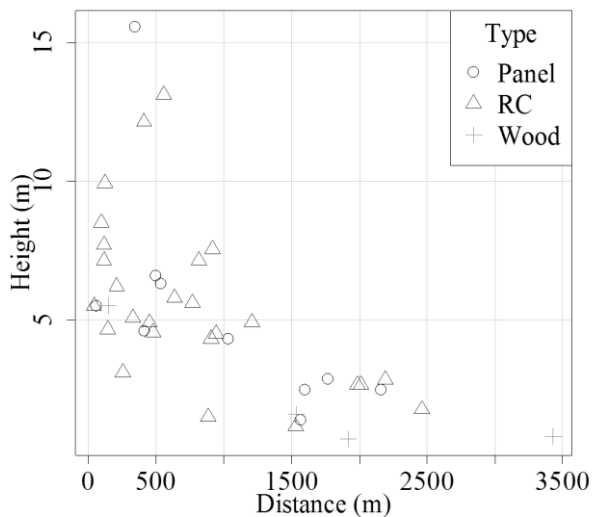
Fig. 2 Relation between tsunami height and distance.

Figure 2 shows the relation between distance and tsunami inundation height. If the distance is longer than 750 m, the relation is linear, but if the distance is less than 750 m, the tsunami height is unstable and the relation is complex. Tsunami height may change depending on the local landform and topography of the sea floor.

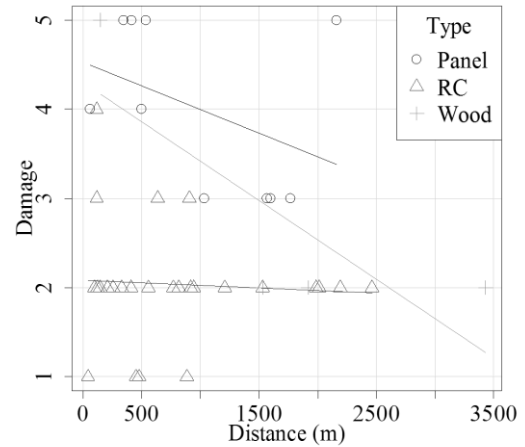
Figure 3 shows the relation between tsunami damage (intensity score) and distance. Severe damage (4 or 5 on Shuto’s scale) occurred within 500 m from the coast. Only one data of grade 5 is located more than 2000m from the coast. This pumping station is located at a lagoon of Torinoumi Lake. The distance shows that from the coast. But the actual tsunami struck Trinoumi Lake. Many DPSs are classified into scale 2. This shows that the strength of window structures is a key factor.

Fig. 3 Tsunami damage and distance.

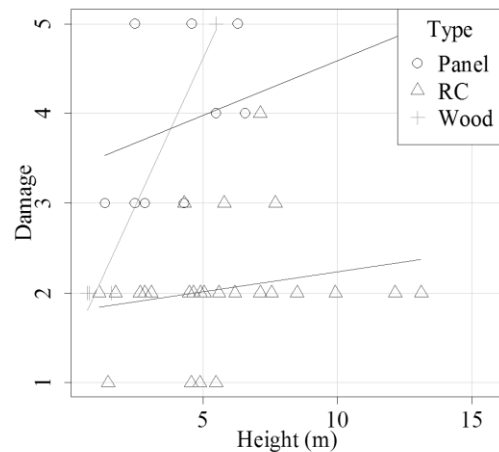
Table 3 shows Shuto’s tsunami intensity scale. Wood buildings are very weak against tsunami because they easily float. Figure 4 shows the relation between tsunami damage as intensity scale and tsunami inundation height. For wood, damage occurs even for buildings lower than 2 m. This tendency is similar to Table 3.

Fig. 4 Tsunami damage and height.

fragility functions. Even considering this bias, Fig. 4 shows severe damage for small inundation height of less than 1 m for wood and panel structures.

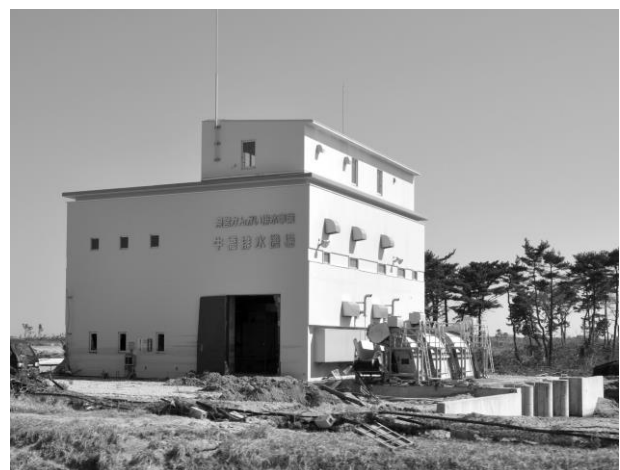
Photo 5 New Ushibashi DPS

Photo 5 shows the new Ushibashi DPS. The control room is on the third floor. On March 11, the tsunami reached the second floor. About 20 persons took refuge on the third floor. This DPS acted as a shelter from the tsunami.

When designing a DPS, if there is no nearby shelter, the additional function of the DPS as a shelter should be considered.
