# Economizer water-wall damages initiated by feedwater impurities

The main causes of efficiency loss in thermal power plants are boiler tube failures that diminish unit reliability and availability, and raise the cost of the electric energy. For that reason, the regular examination of boiler tubes is indispensable measure for prevention of future malfunctions of power units. The microscopic examination of economizer's inner wall microstructure, the analysis of chemical composition of deposit using X-ray diffraction (XRD) and scanning electron microscopy/energy dispersive spectroscopy (SEM/EDS) have been performed in a subcritical power plant. Stress corrosion cracking, pitting corrosion, destroyed protective magnetite layer, presence of magnetite and hematite in deposit and corrosive impurities within the cracks have indicated the effect of inadequate quality of feedwater that cannot entirely ensure reliable operation of the boiler. It may be stated that maintenance of present boiler does not provide its reliable operation. The extensive chemical control of water/steam cycle was recommended.

The review of inspection and maintenance records of 210MW power plant operating at subcri

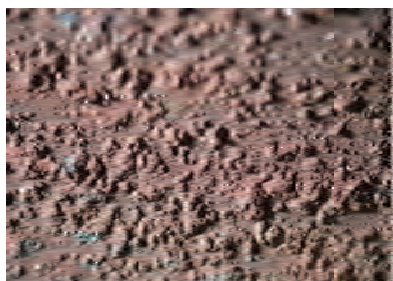
Six specimens were analyzed and results indicated that their internal surfaces are covered by scaled, scabrous, bulging and rugged deposit layer which is brown/reddish color. Metal surface was caved, crannied and holey. A representative specimen is shown on Figure 1.

Figure 1. Internal surface of economizer.

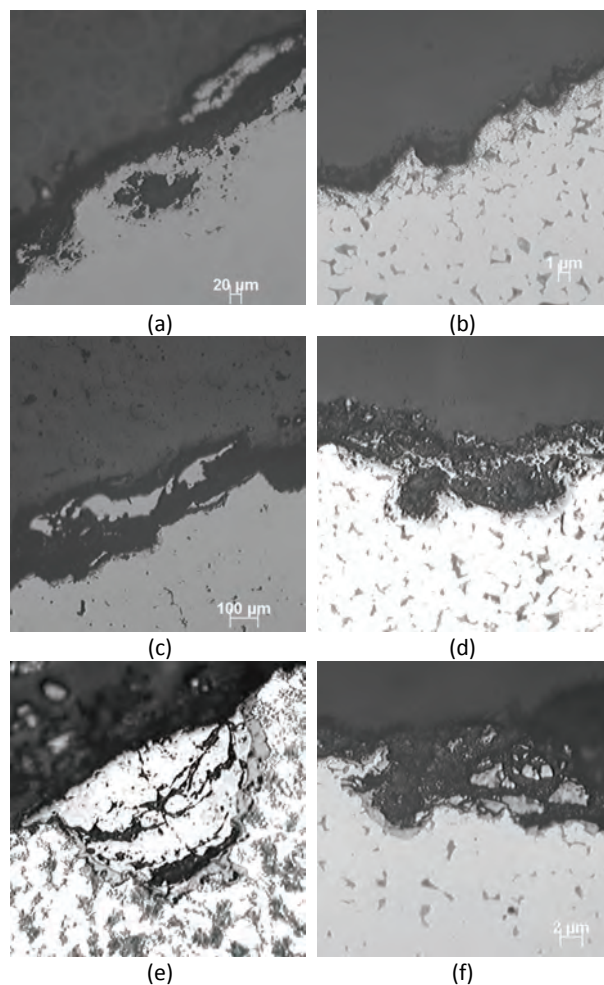
The microstructures of wall tube cross section for all specimens are presented on Figure 2. Distinctive feature of economizer's microstructure is presence of longitudinal cracks, approximately 50  $\mu\text{m}$  length in material, which were propagated parallel to the tube surface (specimens 1 and 3). It pointed at the stress corrosion effect. Due to the presence of cracks in the tube wall further exposure to the same environment and strain will lead to the growth of cracks and rupture of tubes. Even very small concentrations of certain highly active chemicals, like chloride, have a huge contribution to the uprising the stress corrosion cracking and usually leading to devastating and unexpected failure. Corrosion pits (specimens 2, 4 and 6) that were rec-

Figure 2. Cross-sectional view of specimens: a) specimen 1 with stress corrosion cracking, b) specimen 2 with corrosion pits, c) specimen 3 with stress corrosion, d) specimen 4 with corrosion pits, e) specimen 5 with cracks in oxide layer and f) specimen 6 with corrosion pits.

orded on microphotographs, clearly indicated that pitting corrosion took place in all specimens. Pitting corrosion could be attributed to the oxygen attack to the metal substrate. Microstructure analysis evinced destruction of the protective layer (specimen 5) that led to development of nonprotective scale localized on the internal tube surface. The precipitation of magnetite scale can increase the tube metal temperature and cause cracks and other deformations of metal construction [14–16]. Thickness of deposit layer varied between 13 and 160  $\mu\text{m}$ . Whereas analysis revealed excess of chloride in feedwater, one of possible explanations of developing nonprotective magnetite can be based on the mechanism of local formation of acid chlorides. Result of this process is pH drop, due to creating an acidic region with a high  $\text{Cl}^-$  concentration. Hydrolysable chlorides cause degradation in these zones of the protective film. The most likely cause of increased concentration of chloride in feedwater is hydrochloric acid (HCl)

utilized for regeneration of the ion exchange resins in condensate polisher. Consequently, the chloride concentration can be diminished by proper regeneration of polishing and water treatment plants and their accurate exploitation. Introducing of continuous on-line and daily laboratory monitoring of chloride in demi and feedwater by ion chromatography technique are also important measures for maintaining chloride below specified target values. Aside from that, the attention should be paid to the control and cease of condenser leakage that can be an additional source of chloride in feedwater. On the basis of obtain microphotographs, material microstructure was unmodified and consisted of ferrites and perlites.

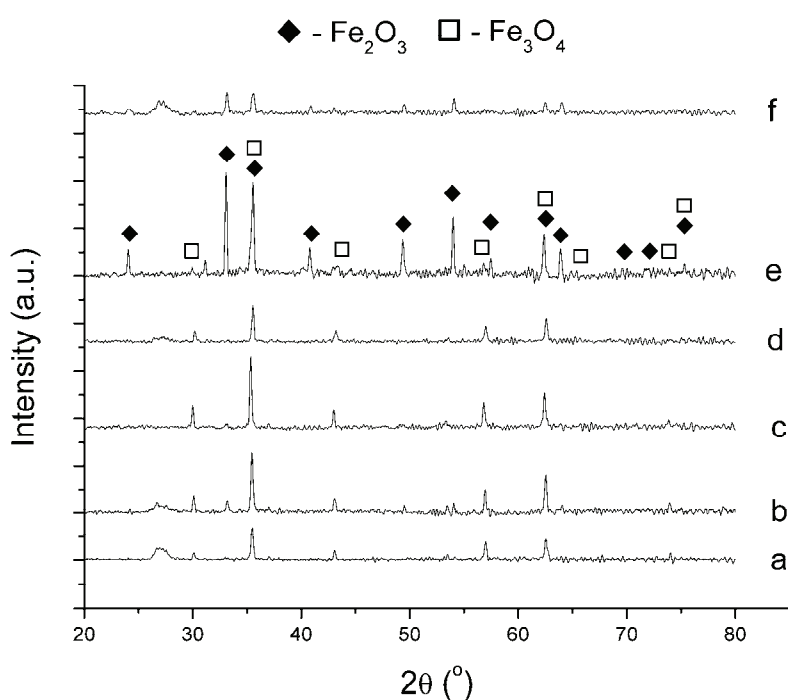
Structural characterization of deposit was made using X-ray diffraction (XRD). The main constituents of deposit from specimens 1, 2, 3, 4, 5 and 6 have confirmed to be magnetite ( $\text{Fe}_3\text{O}_4$ ) and hematite ( $\text{Fe}_2\text{O}_3$ ) (Figure 3). The deposit layer composition of specimens 5 and 6 consists of magnetite and prevalent amount of hematite. Iron oxides are typical steel oxidation products (9,14,17–19). However, the presence of hematite may indicate irregularity in the power cycle operation and high corrosion rate. Moreover, hematite does not provide corrosion protection and has lower electrical and thermal conductivity than magnetite. Hematite also might be carried over to the boiler tubes from other part of the system. Though magnetite is protec-

tive corrosion product, in present case its porous and brittle nature might have an adverse effect on the protection of the boiler tube surface. Porous magnetite rust can enhance the corrosion at the tube surface by acting as an active cathodic site and deploy under-deposited corrosion [20].

Figure 3. Diffractogram of specimens: a) 1, b) 2, c) 3, d) 4, e) 5 and f) 6.
