G. KOSEC, G. KOVAČIČ, J. HODOLIČ, B. KOSEC

ISSN 0543-5846  
METABK 49(4) 357-360 (2010)  
UDC – UDK 669.14.018.298:669.18=111

## CRACKING OF AN AIRCRAFT WHEEL RIM MADE FROM AL-ALLOY 2014-T6

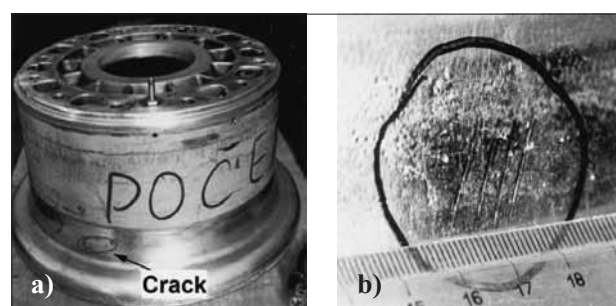
The crack (Figure 1) was revealed in a regular check up by the method of eddy currents. The crack was approximately 38 mm long and had propagated through the rim wall. Small pits over the entire rim/tire contact surface were revealed. A small number of corrosion pits were also observed by the naked eye. In the manufacture of tires a strong textile fabric net is incorporated. In worn-out tires the net is in direct contact with the rim surface. Therefore, high pressures result in pits on the rim surface.

**Figure 1** An investigated aircraft wheel with a crack (a), and the detail of crack in the rim (b).

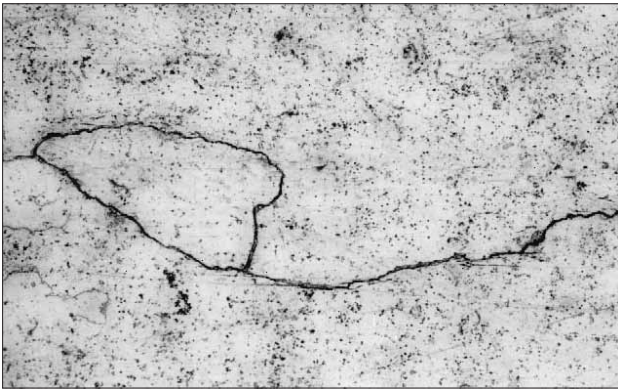
Figure 2 A branched crack (replica; OM) magnification 100x.

scope (OM). In some places of a branched crack, corrosion spots as seen in Figure 2 were also observed. A number of cracks were found, some of them merged into a bigger one. Small corrosion pits visible only by the microscope were found all over the rim surface. The morphology of corrosion pits was examined by scanning electron microscopy (SEM) (Figure 3).

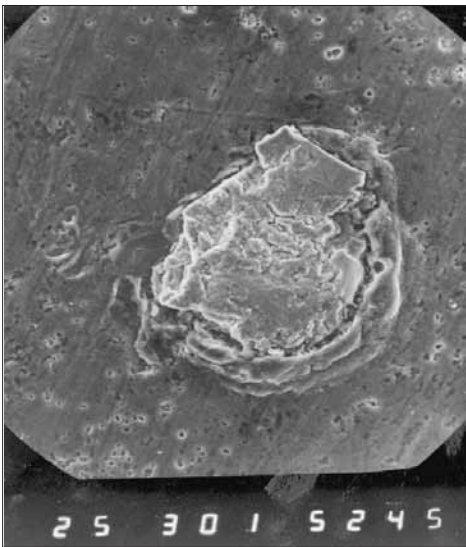
Figure 3 A corrosion pit on the rim surface (SEM); magnification 300x.

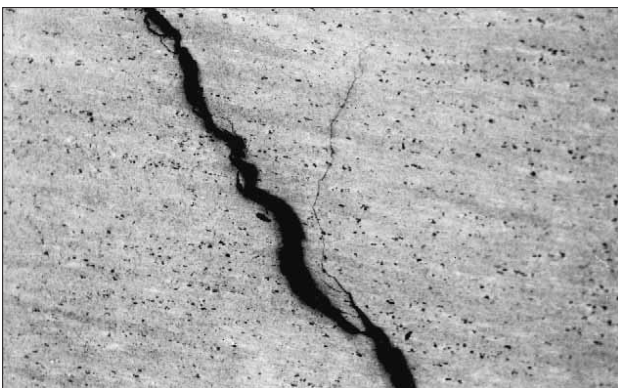
Figure 4 Parallel cracks (OM); magnification 100x.

First of all the ends of cracks were examined. Parallel cracks were also found in one of the metallographic samples investigated, as seen in Figure 4.

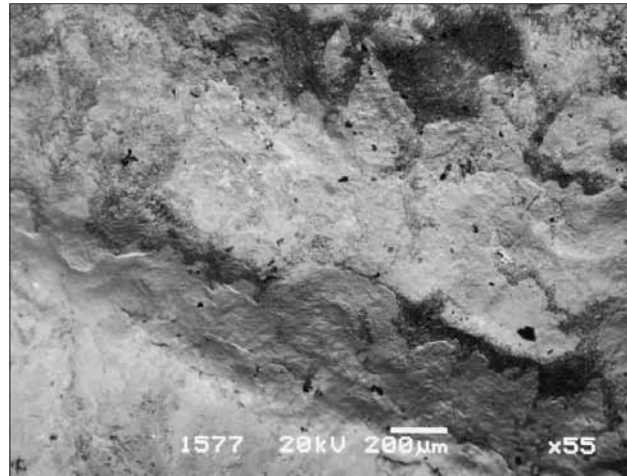
Figure 5 Fracture surface (SEM) analyzed by EDS; magnification 55x.

The material on the fracture surface of the sample presented in Figure 5 was chemically analyzed by energy dispersive spectrometry (EDS). The results obtained in different spots were different. The dark area in Figure 5 contains C, O, Cu, Al, Si, S, Ca, Mn and Fe, the gray area: C, O, Cu, Al, Si, S, Pb, Sn and Ca as seen in Figure 6, while the white area contains C, O, Fe, Cu, Al, Si, S and Mn. Typical elements in the fracture surface were sulphur and carbon originating most probably from tires.

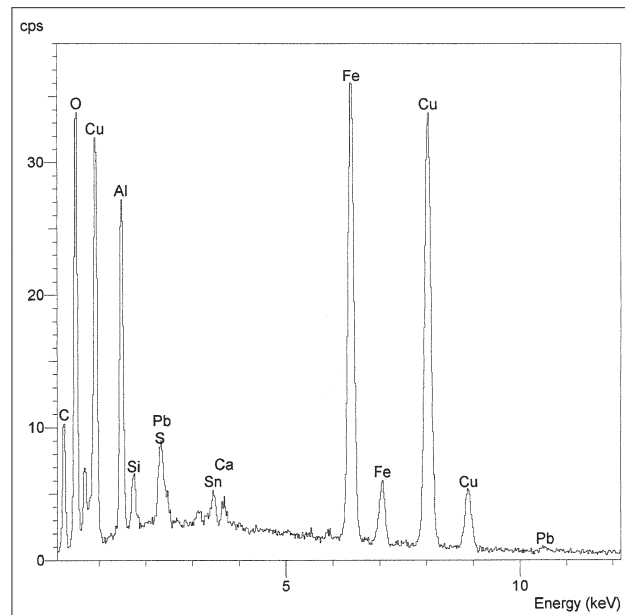
Figure 6 Qualitative chemical analysis of rim fracture surface (gray area in Figure 5) (EDS).

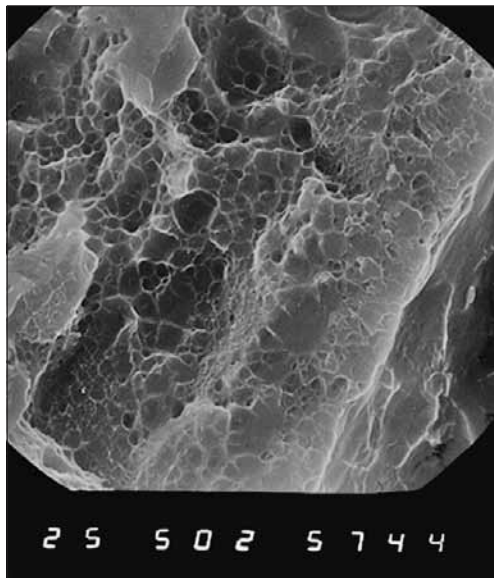
**Figure 7** Boundary between ductile and fatigue fracture (SEM); magnification 500x.

An investigated sample was broken to observe the boundary between ductile and fatigue fracture (Figure 7). Only immediate i.e. ductile fracture is seen in Figure 8.

It was determined that the crack of the rim investigated was a typical fatigue crack [16]. The crack was branched, and its size was lower than the critical which could cause immediate failure. It was not possible to determine the site of crack initiation. The presence of carbon and sulphur in the crack represents strong evidence that the crack was a fatigue crack. Carbon and sulphur deposited on the surfaces of the crack and the surroundings. Probably during landing and slowing down when the temperature of wheel rim and tire was sharply increased, resulting in partial dissociation of the tire.

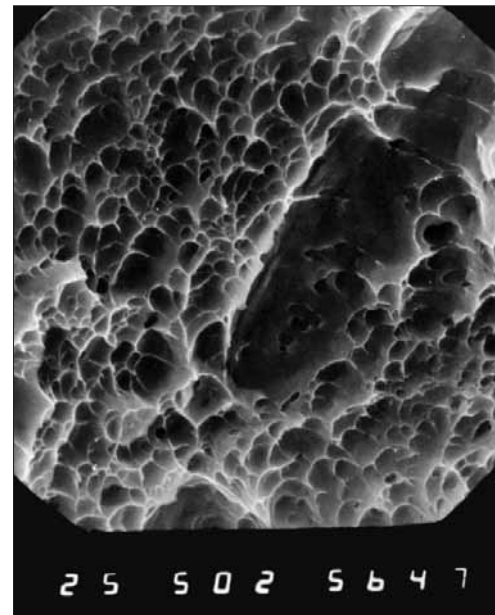
Consequently, carbon and sulphur gradually accumulated in and around the crack. Numerous pits on the rim surface were clearly seen. They were caused by the influence of mechanical factors, surroundings and increased temperature. The fatigue crack investigated most probably started from on these pits.

**Figure 8** Ductile fracture of rim over surface pits (SEM) magnification 5000x.
