The natech events during the 17 August 1999 Kocaeli earthquake: aftermath and lessons learned

S. Girgin

European Commission, Joint Research Center, Institute for the Protection and Security of the Citizen,
TP 361, Via E. Fermi 2749, 21027 Ispra (VA), Italy

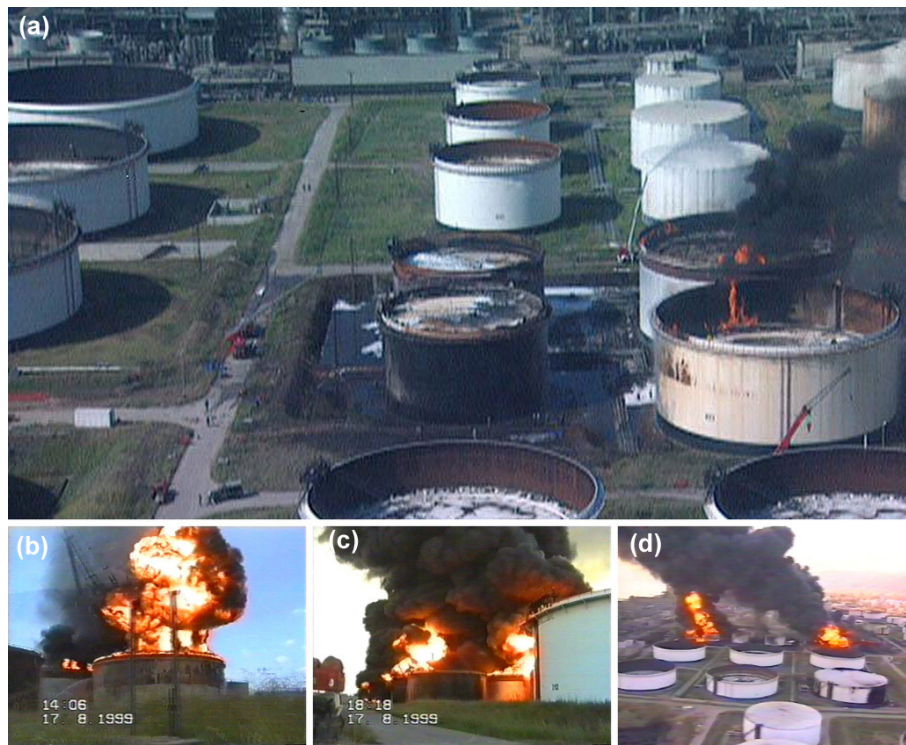
The third and the largest fire occurred at the naphtha tank farm, which is located approximately at the center of the tank farm area of the refinery. Four medium-sized floating roof naphtha storage tanks were ignited following the earthquake by sparking due to the bouncing of the floating roofs against the inner side of the tanks and subsequent metal-to-metal contact between the metallic seals and the tank walls. During the first phase of the fire, fire fighting teams were successful in controlling the flames with the limited resources that had to be distributed between Plant-25 and the naphtha tank farm fires. As shown in Fig. 1a, which was taken 7 h after the start of the fire, the fires at two tanks (in the center,

Fig. 1. The progress of the tank farm fire after the flange failure.

TK-241 (in the back) and TK-242) were completely extinguished and the remaining two (on the right, TK-202 (in the back) and TK-203) were under control. Later on, the flange at the bottom of tank TK-202 failed, probably due to fatigue caused by the excessive heat and structural deformation due to the earthquake. Naphtha inside the tank started to flow outside through the flange; this led to a jet fire and flames covered the tanks. Roof fires started again as can be seen in Fig. 1b ($t = 11$ h). The fire spread through an open ditch to the tank farm located south towards the processing units (Fig. 1c, $t = 15$ h). Eight tanks from this tank farm are visible in Fig. 1a behind TK-241 and TK-202 in a 2×4 arrangement. In this section of the storage area, the first two tanks on the right (fixed roof) and on the left (floating roof) were storing heavy vacuum gas oil (HVGO) and heavy straight-run naphtha (HSRN), respectively. Although affected on the outside very badly by the fire impingement, these tanks were not ignited. But two small naphtha tanks (TK-221 (last) and TK-222) located behind the HSRN tanks were engulfed by the flames and burned completely. The spreading of the fire is evident in Fig. 1d, which is oriented in a north-south direction from the right to the left.

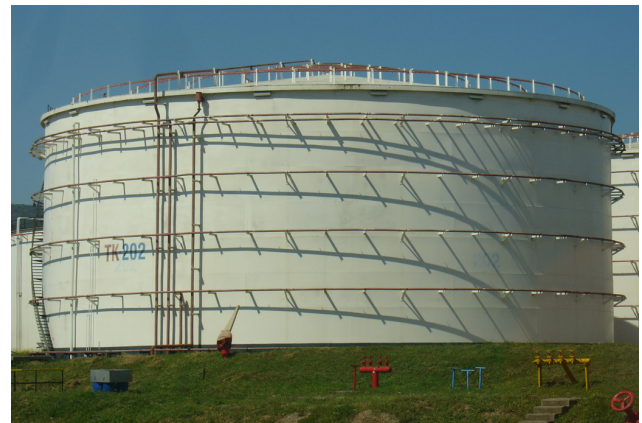
Fig. 3. Retrofitting on the naphtha tank TK-202 burned during the fire.

The burned naphtha tanks were floating-roof tanks with a single line of sprinklers at the top. They were reconstructed in the form of internal floating-roof tanks with advanced sprinkler systems around and over the tanks. Water cannons and foaming systems having in-situ foam stocks were installed next to each tank. The number of fire fighting hydrants was increased and converters were provided to improve the interoperability of internal and external fire fighting equipment. Embankments around the tanks were reinforced to prevent leakage to other sites in case of overflow. Improvements made at the tanks are illustrated in Fig. 3, where the retrofitted TK-202 is shown. Compared to the old tank shown in Fig. 1a, significant progress is evident. The resilience of the other tanks in the tank farm was also improved, although not to the same level as the naphtha tanks. Sprinkler systems were upgraded and foaming systems were implemented. Fifty fixed and 10 portable water cannons were installed. The bearing columns of spherical LPG tanks were reinforced. Gas and flame detectors were installed at the tanks and in the processing units. The water capacity for fire fighting was increased 5 fold and the fire water network within the refinery was enhanced. In order to make use of the sea
