APPLICATION OF EROSION-CONTROL MATERIALS AND SPONTANEOUS VEGETATION IN THE PROTECTION OF RESERVOIRS IN SOUTHERN AND EASTERN SERBIA

VJAČESLAVA MATIĆ and GORDANA ĐUKANOVIĆ

Faculty of Forestry, University of Belgrade, 11030 Belgrade, Serbia

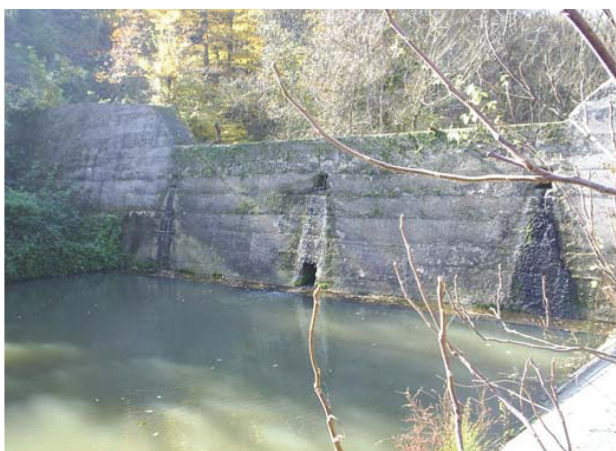
The applied concrete was of the MB 20 type and during the last 17 years there has been no damage, except on check dam number 4, on the river Bačevička Reka, where a crack was formed from the

**Fig. 1.** Check dam on the river Bačevička Reka (V. Matić).

sluice towards the check dam foundation due to minor scouring and slope instability.

The structures have remained undamaged, except for some minor and expected debris and scouring and a minor surface crack on check dam No. 4 on the river Bačevićka Reka. This good condition can be attributed to prior testing of the MB 20 concrete used in the catchment of the Grlšte Reservoir and the dense limestone from known quarries in that of the Selova Reservoir. The testing was performed in accredited laboratories according to valid international standards. Long-term monitoring of materials in the field confirmed their quality and durability, as well as the optimal and justified selection of ways to oppose destructive forces in the studied catchments.

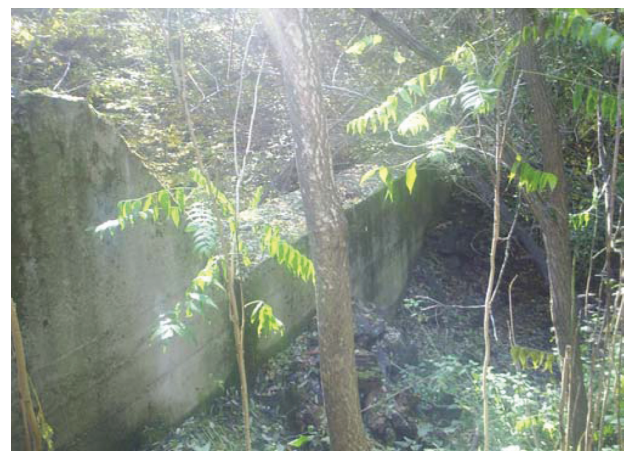
**Fig. 2.** Vrbovčić check dam (V. Matić).

The check dam in the stream Vrbovčić is in an exceptionally good state and is densely covered with vegetation. There is no erosion, and no traces of soil loss.
