STUDY OF CORROSION OF ALUMINUM ALLOYS OF NUCLEAR PURITY IN ORDINARY WATER – PART ONE

Effects of corrosion of aluminum alloys of nuclear purity in ordinary water of the spent fuel storage pool of the RA research reactor at VINČA Institute of Nuclear Sciences has been examined in the framework of the International Atomic Energy Agency Coordinated Research Project “Corrosion of Research Reactor Aluminum-Clad Spent Fuel in Water” since 2002. The study presented in this paper comprises activities on determination and monitoring of chemical parameters and radioactivity of water and sludge in the RA spent fuel storage pool and results of the initial study of corrosion effects obtained by visual examinations of surfaces of various coupons made of aluminum alloys of nuclear purity of the test racks exposed to the pool water for a period from six months to six years.

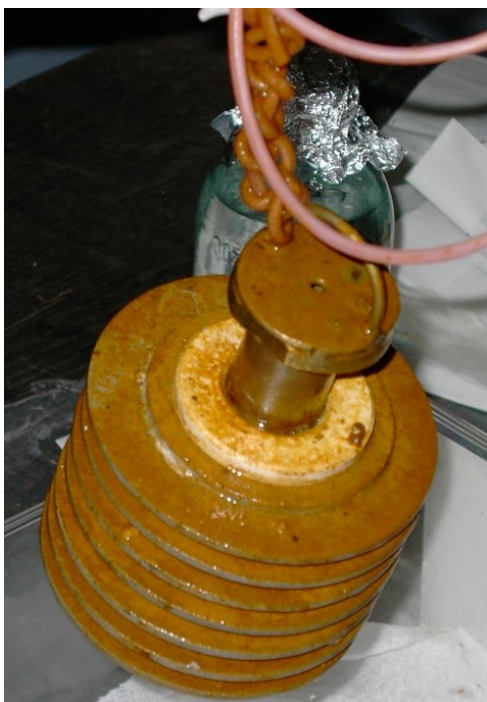
Figure 7. Rack#1/CRP-I after 72 months of exposition time

Rack#1 from CRP-I was received by the VINČA Institute in 1996 and assembled according to the IAEA instructions. It contains only the couples of coupons: smaller diameter aluminum alloy or stainless steel coupons at the top are coupled to aluminum alloy coupons at the bottom of the couple. The rack was exposed to the water in the basin no. 4 of the RA spent fuel storage pool for 72 months, from July 1996 to July 2002. It was taken out on July 30, 2002 (fig. 7) and temporarily placed in a glass beaker partially covered by pool water with the aim to obtain instructions for its disassembling and coupons cleaning from large quantity of sediments accumulated.

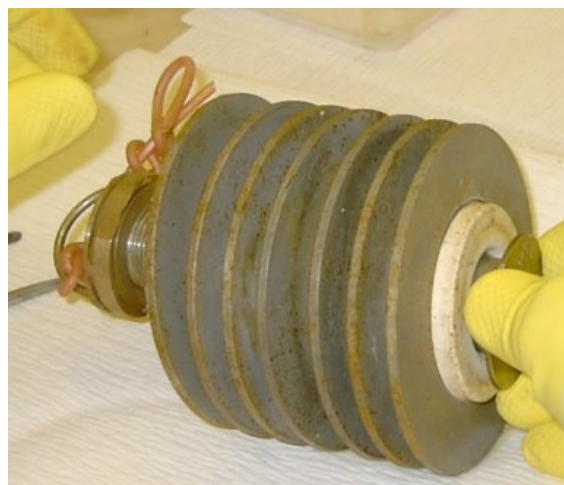
The initial visual examination of the Rack#1/CRP-I showed that the backside of the coupons was not covered by sediments (fig. 8) as it was the case at the front side of the coupons. The Rack#1/CRP-I was disassembled and all coupons

Figure 8. No sediments at the back side of coupons of Rack#1/CRP-I

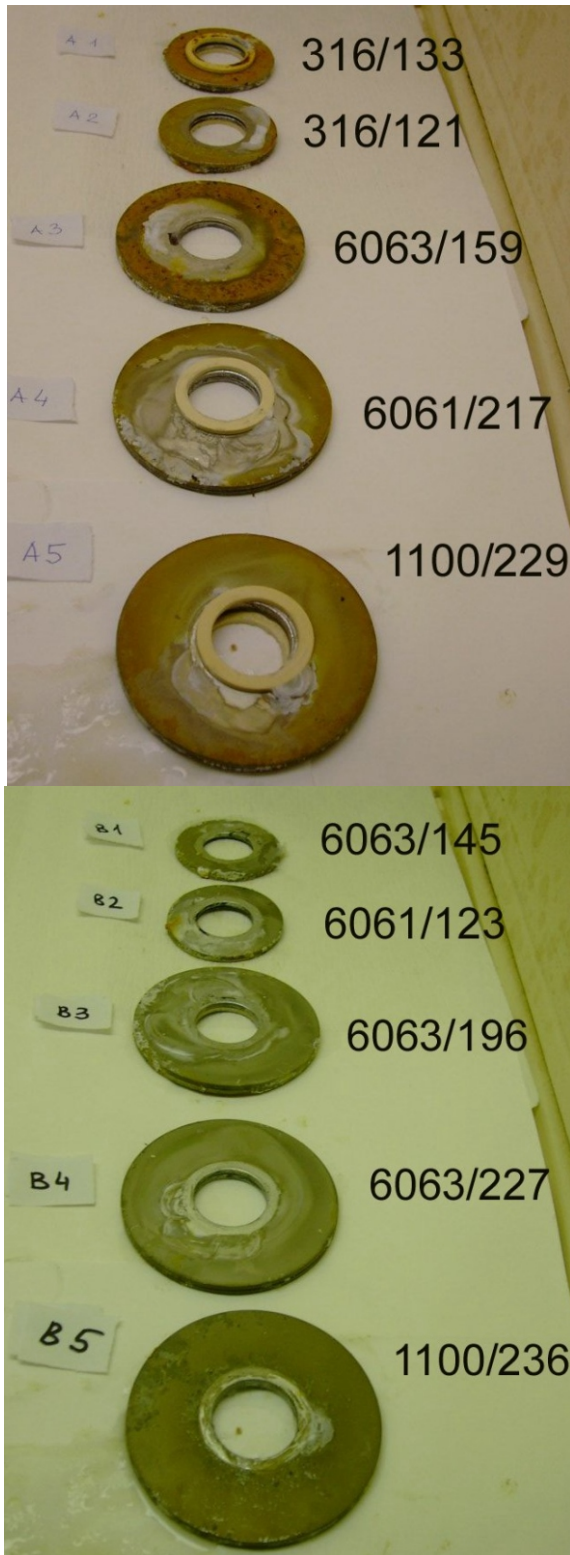
Figure 17. Front side (A) and backside (B) of coupons of disassembled Rack#2.1/CRP-I

Dark-red sediments covered the front side of coupons and effects of corrosion process could not be seen without cleaning surfaces. White sediments (like jelly-mushroom type sludge) at the front side of few coupons (fig. 18) and the supporter of the Rack#2.1/CRP-I were noted and collected for further analysis. Sediments did not cover the backside of the coupons and effects of corrosion process were noted. Pitting, as a main localized form of corrosion of aluminum in water, was seen at surfaces of all coupons, except one that was pre-oxidized during manufacturing process. Spots of different shades of gray and black color (assumed to be aluminum-oxide) were observed at coupons, too.

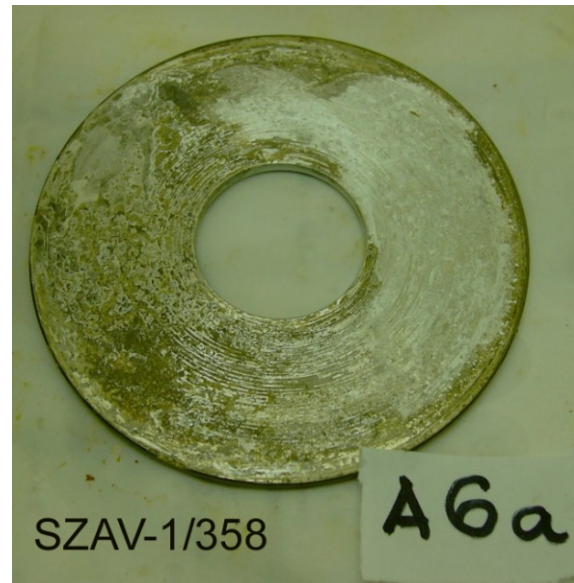
Figure 27. Crevice corrosion at the coupled side of coupon SAV-1/358

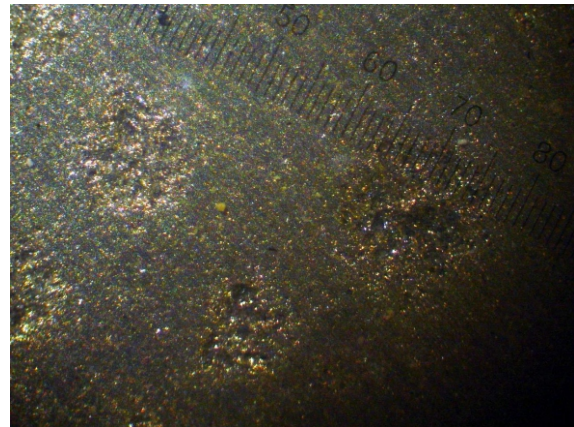
Figure 28. Deep pits at the top surface of coupon SAV-1/335 (magnification 10)

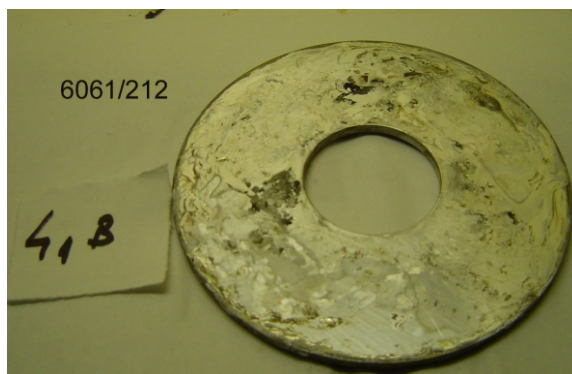
Figure 34. Crevice corrosion at the coupled side of coupon 6061/212

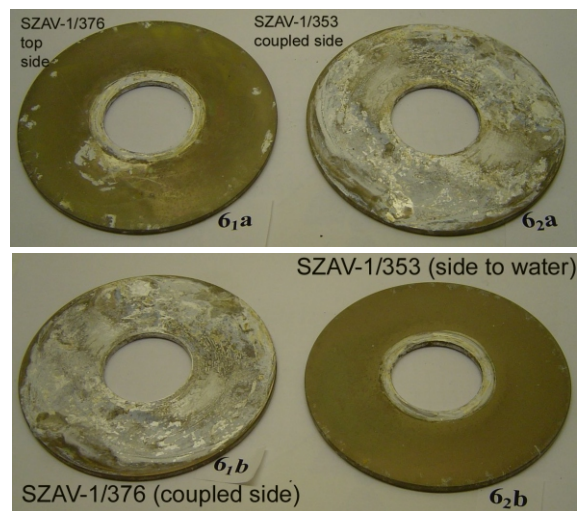
Figure 40. Crevice couples SAV-1/376 + SAV-1/353

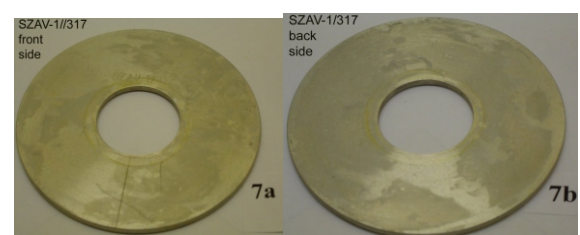
Corrosion effects were not discovered at coupon SAV-1/317 since it was pre-oxidized during manufacturing. It was scratched intentionally at the front side (shown at the left side of the fig. 41) during manufacturing process with the aim to study influence of mechanical damage to corrosion process. Visual

Figure 41. No corrosion observed at the single coupon SAV-1/317

and later microscopic examination showed that corrosion effects were not found at both surfaces or under the scratched line of the coupon SAV-1/317 or other aluminum alloy coupons that were intentionally pre-oxidized and scratched during manufacturing process.
