*Materials* **2014**, *7*, 1866-1879; doi:10.3390/ma7031866

## Surface Characterization of Retrieved Metal-on-Metal Total Hip Implants from Patients with Adverse Reaction to Metal Debris

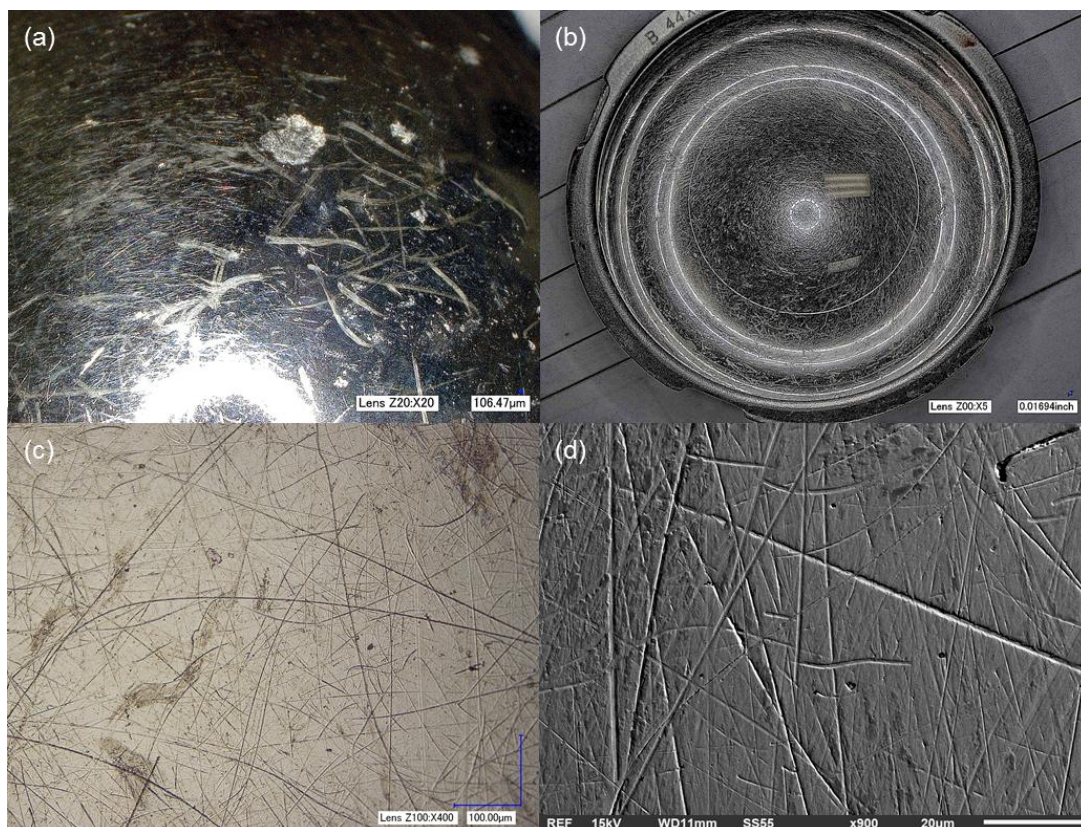
The four implants selected for the study presented ALTR at the time of surgical removal. All the implants consisted of CoCr MoM head-cup systems (Implants 2, 3 and 4) with the exception of Implant 1, which had a Ti6Al4V/CoCr head-cup combination. At the time of revision surgery, the head-neck taper junction was visually examined by the surgeon for any evidence of corrosion. Black debris in or near the taper junction was considered to be potential corrosion products, and the implant was recorded as having *in vivo* corrosion. Implants with no evidence of debris deposition near the head-neck taper junction, or if debris was deemed to be biologic in nature, were recorded as having no *in vivo* corrosion. Implant 1 was observed to have evidence of *in vivo* corrosion, at the time of revision surgery. However, upon microscopic inspection, the sample showed no evidence of corrosion features (pitting attack, etching, surface/bulk attack) on its surface. The articulation interface of the head and the cup was highly scratched as shown in Figure 1a,b.

**Figure 1.** Severe scratching observed in specimen 1: (a) femoral head and (b) acetabular cup of Implant 1. Deep scratches were revealed during the analysis, which led to the hypothesis of a large amount of particle generation *in vivo*; (c) optical micrograph demonstrating scratch depth; (d) SEM micrograph showing no features other than scratching. The surface was clean of biological or corrosion products.

The level of scratching on the head was quantified using the depth up microscope technique (Figure 1c). The total area scratched was  $671 \text{ mm}^2$  out of a total head surface area of  $3926 \text{ mm}^2$ . This results in approximately 17% of the surface of the head affected by scratching. Using the clinical information, an estimated area of material lost from the scratches per year of implantation was approximately  $152 \text{ mm}^2/\text{year}$ . Surface analysis, with the 3 different microscopy techniques, of the interfaces of this implant did not reveal any mechanisms other than scratching, as illustrated in Figure 1d. EDS analysis of areas that exhibited scratches showed similar composition to the areas of the implants with no characteristic damage ranging from 5% to 7% Carbon (C), 28% Chromium (Cr), 62% Cobalt (Co) and 3%–7% Molybdenum (Mo). Scratched and unscratched surfaces did not present a significant change in their elemental composition in all the specimens evaluated.

An individual analysis of each of the samples is necessary to characterize the different factors that lead to the formation of an ARMD. In the case of Implant 1, it was found that the cup had an abduction angle of 57° and a head of 44 mm in diameter. These characteristics classify the head as large and the cup abduction angle as outside of the *Lewinnek Zone* [17]. It has been reported that MoM soft tissue reactions are more likely to be found in hip prostheses with heads between 38 and 49 mm of diameter and with cup abduction outside of the *Lewinnek Zone*, which is defined between 5°–25° for anteversion and 30°–50° for abduction [17,21]. In a study of 2600 cases of hip resurfacings, Gross *et al.* [22] found a low incidence rate of pseudotumors, ranging from 0.1% to 1.8%. However, all of the failures that presented pseudotumors had small head components (less than 48 mm) and abduction angles greater than 50° [22]. Acetabular inclination is thought to be an important factor that contributes to increasing wear rates and metal particles, which increases the probability of developing a pseudotumor [21,23,24]. However, some studies have shown that there is not a significant correlation between metal serum levels and angle of cup inclination [25,26]. Thus, both studies acknowledge that accurate cup positioning lowers the possible risk of implant failure. The need for revision of Implant 1 was most likely due to its high cup abduction angle, which led to an uneven distribution of forces and stresses on the implant, inducing the observed scratching. The estimated surface area loss due to scratching (17%) is significant and may indicate that a high amount of metal ions and debris was released from this interface. Such an influx of foreign metal ions into the body may have led to the formation of an ARMD.

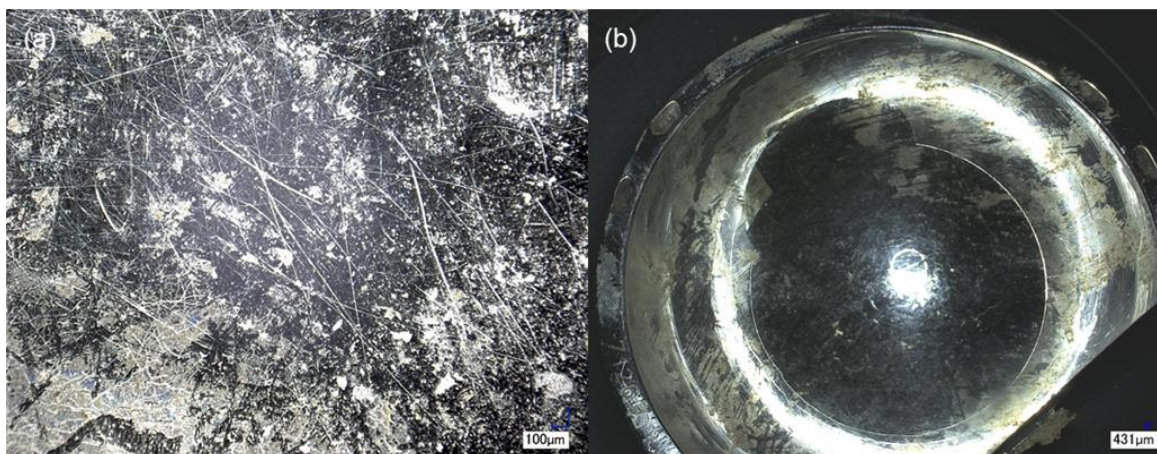
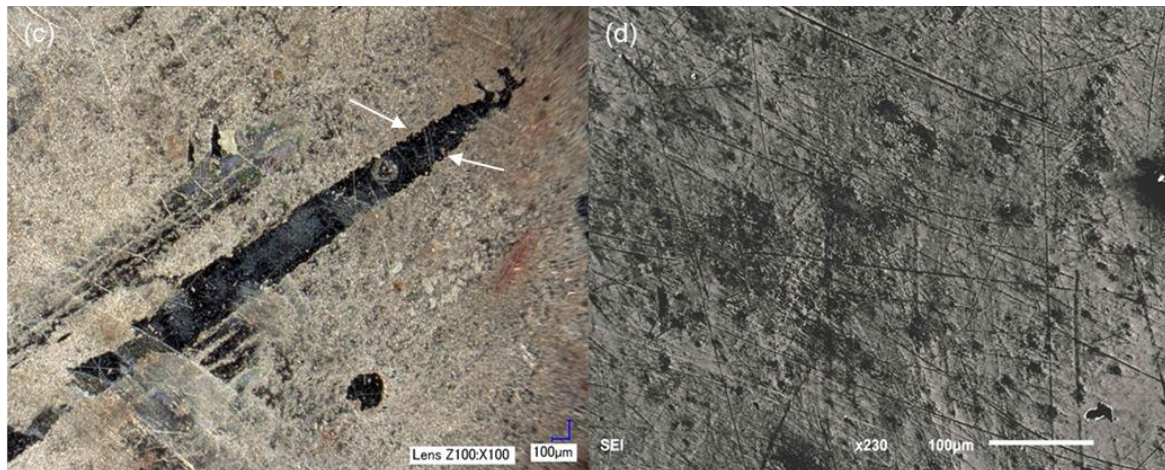
Implant 2 was recorded as having *in vivo* corrosion upon revision. Similarly to Implant 1, microscopic inspection, showed no evidence of corrosion features. However, this sample did present a large amount of debris on its surface, which appeared to be of biological origin and from wear of the top surface (delamination), as illustrated in Figure 2c,d. The level of debris was such that the head-cup ensemble was fixed in a non-rotational position. The nature of the debris was studied under SEM and EDS. A control section of the implant head with no deposition on its surface showed presence of 60% Co, 28% Cr and 5% C with traces of Mo and other trace elements. The analysis of a debris covered section of the implant showed 47% C presence, 8% Nitrogen (N) and 8% Oxygen (O); with only 23% Co and 12% Cr. In addition to these features, a large amount of scratching was observed in both the head and the cup. The results of the microscope analysis found a scratched area of the head of approximately  $1309 \text{ mm}^2$  in a total surface area of  $7971 \text{ mm}^2$ . This resulted in an approximate total area loss of  $350 \text{ mm}^2/\text{year}$  from the head-cup interface. The percentage of surface scratched on the head was 17.5%. No etching or discoloration of the interfaces of the implant was noted.

**Figure 2.** Surface condition of Implant 2: (a) optical micrograph of the scratched and debris covered surface of the head; (b) optical micrograph of the scratched surface of the cup; (c) optical micrograph showing areas of the head with high degree of biological deposition on the surface and delamination of top layers (arrows). A large amount of metal debris could be expected from this area of the implant; (d) SEM micrograph showing surface irregularities, scratches, and debris covering the surface of the head of Implant 2.

From studying the surface of Implant 2, the nature of the debris covering the surface of the prosthesis was likely biological, a probable result of bodily fluids entering the rotational areas of the implant. The reason for revision of Implant 2 is similar to the mechanism observed with Implant 1, likely related to its highly scratched surface (Figure 2) that released metal particles into the surrounding soft tissues, causing an inflammatory reaction and the development of ARMD. The scratching in this implant was characterized and resulted in a 17.5% of area scratched.

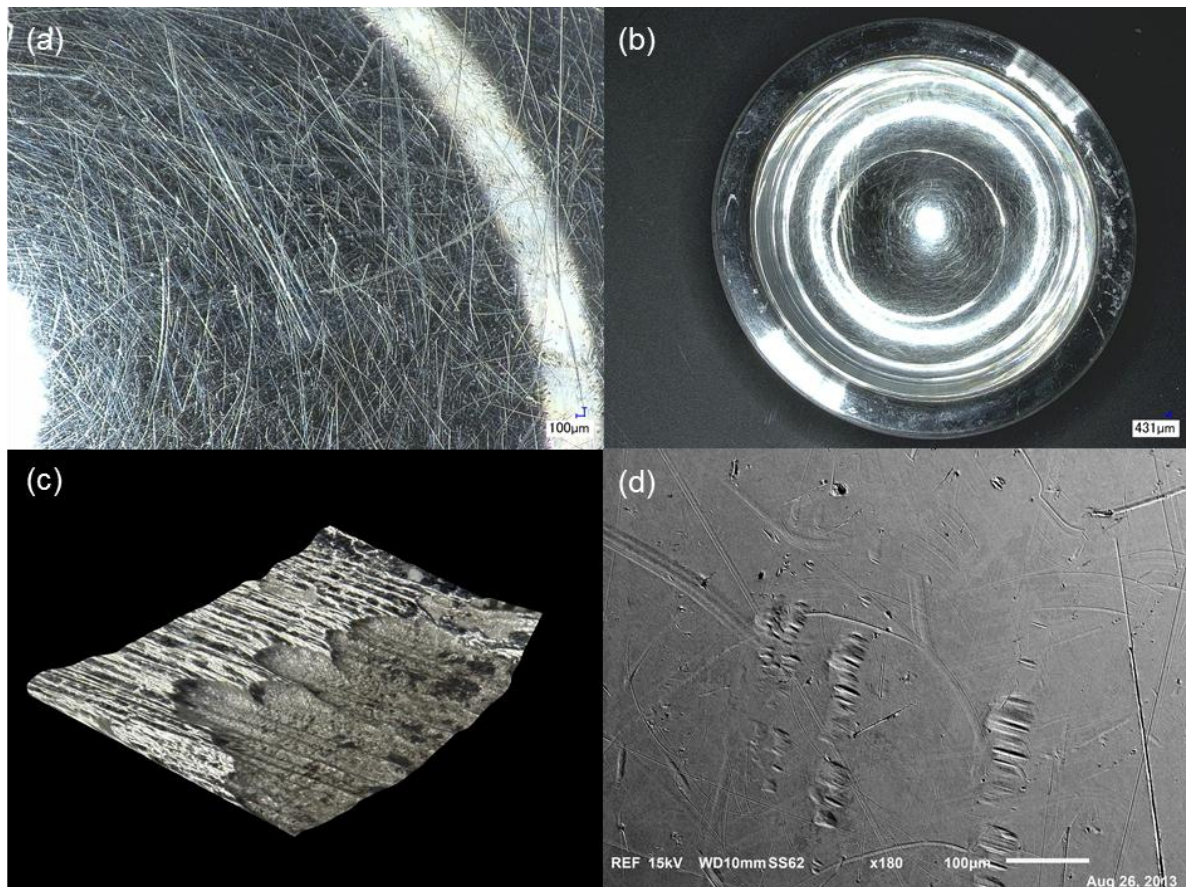
The study of Implant 3 under digital microscopy revealed severe scratching in the head and cup areas as demonstrated in Figure 3. The total scratched area was 322 mm<sup>2</sup> out of a total head area of 2532 mm<sup>2</sup>, which constitutes 12.7% of area scratched and an estimated area lost per year of approximately 29 mm<sup>2</sup>. This implant showed signs of *in vivo* corrosion at the time of surgery. Initial inspection revealed the possibility of corrosion in the implant's head-neck modular connection due to significant surface discoloration, which was evident in the implant neck (violet and yellow discoloration). SEM analysis of the female taper of the head showed delamination of the metal surface with exposure of the metal bulk as illustrated in 3D in Figure 3c. EDS results showed the presence of 30% Co, 20% Cr, 9% Mo, 21% C, 19% O and other elements, on the non-delaminated surface of the head-neck connection surrounding the corroded delaminated area. Some small traces of Titanium (Ti) (<1%) and Aluminum (Al) (~1%) were found in this area, which were originated from wear of the implant neck (Ti6Al4V neck fretting against the female taper of the head counterpart). Analysis of the surface exposed due to delamination showed the presence of 58% Co, 27% Cr, 6% Mo, 7% C and 1% O, which confirmed bulk exposure (Co and Cr rich) due to removal of the top oxide-film containing surface. Similar to the other two implants, there was no evidence of etching, discoloration or corrosion debris present in the head and cup couple analyzed. The corrosion was only found in the female taper; the rest of the implant (surface of head and inside of the cup) only showed signs of deep scratching similarly to the other implants discussed, as observed in Figure 3a.

**Figure 3.** Surface condition of Implant 3: (a) optical micrograph showing the scratched surface of the head of the implant; (b) optical micrograph showing the highly scratched interfaces of the cup; (c) 3D optical micrograph revealing delamination, bulk exposure and corrosion products on the surface of the modular connection of the head female taper; (d) SEM micrograph showing scratching and fretting marks on the surface of the head.

Upon investigation of Implant 3, optical microscope, SEM and EDS analysis confirmed the presence of corrosion on the female taper of the head-neck modular connection. The modular head-neck interface underwent fretting-crevice corrosion, which likely generated titanium ions and debris that deposited into the head-cup articulation accelerating wear [8], and in this particular case, leading to the formation of ARMD. The modularity of hip implants allows for small displacements in the individual modular connections that can induce fretting-crevice corrosion. It has been reported that main concerns related to head-neck tapers are their tendency for corrosion and accelerated wear, especially with mixed metals, thus releasing large concentration of particle debris [27,28]. A similar result was found in a recent case report that showed the formation of a pseudotumor in a 72 years-old patient as a result of corrosion and wear products that arose from the modular head-neck interface of a hip hemiarthroplasty [29]. In addition to corrosion observed in the head-neck area, the high level of scratching found on the surface of both the head and cup (Figure 3) also contributed to the formation of wear particles that resulted in the ARMD. The scratching level was quantified, as in the previous implants, revealing a 12.7% area scratched.

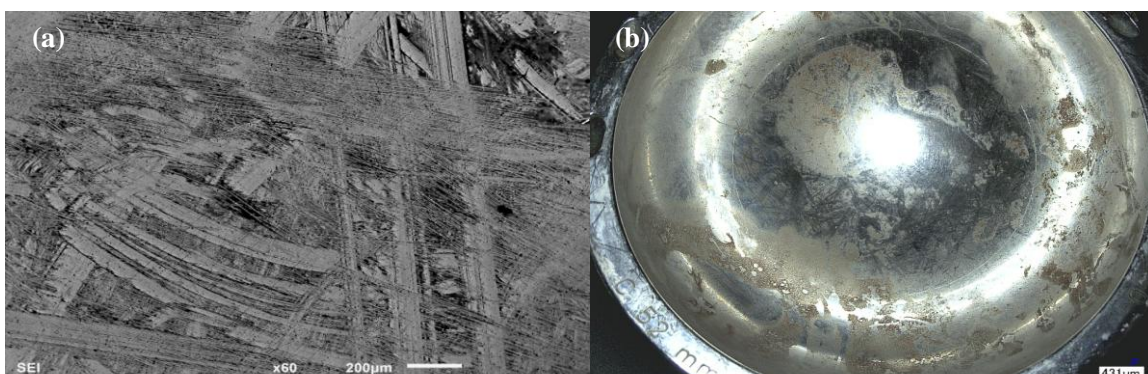
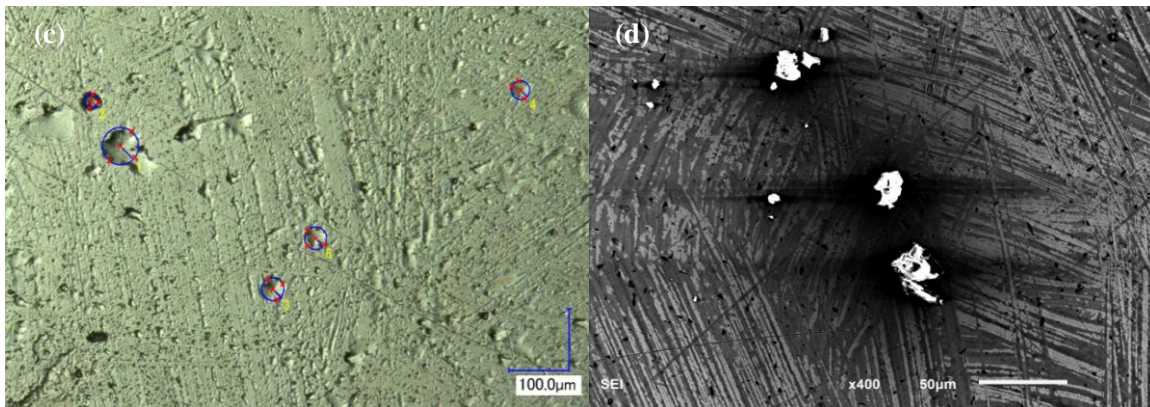
As in the previous cases, Implant 4 demonstrated evidence of corrosion at the moment of revision surgery. The microscopy study of this sample revealed deep scratching similar to that observed in Implants 1, 2 and 3, as illustrated in Figure 4. The level of scratching in this implant could not be quantified due to the fine and homogeneous distribution of the scratches (Figure 4a) throughout the implant making these indistinguishable from the non-scratched surface. Biological deposition similar to that observed in Implant 2 was found on the surface of both the head and acetabular cup. EDS analysis yielded similar results as observed in Implant 2. Other than severe scratching of the implant head and cup couple, there were no signs of surface cracking, corrosion, or etching in the analyzed areas of this specimen.

**Figure 4.** Surface condition of Implant 4: (a) SEM micrograph of the homogeneous scratching on the surface of the head; (b) optical micrograph emphasizing the debris accumulated on the surface of the cup, which was of the same composition as the debris accumulated on the surface of the head; (c) optical micrograph demonstrating the radius measurement tool in the digital microscope on irregularities found on the surface of the head; (d) SEM micrograph of another area of the head showing particles of biological nature.

In the case of Implant 4, SEM and EDS revealed similar results as in Implant 2, that the debris covering its surface was biological in nature, rich in C, O and N. Implant 4 had the lowest implantation time out of the other 3 samples, demonstrating that the formation of soft tissue reactions does not require extended periods of time of metal ion release into the body. The high level of scratching observed on the interfaces of this implant (Figure 4) could not be quantified due to the homogenous scratch coverage. The surface showed absence of any other features such as delamination, etching or cracks. None of the head-cup interfaces presented discoloration, fretting marks, bulk exposure, or cracks, which are features typically associated with fretting-crevice corrosion [30], confirming the absence of corrosion products on the articulation surfaces. Implant 1 had a Ti6Al4V cup in contrast to the other three implants that had a CoCr alloy cup. The Ti alloy is softer than CoCr, and therefore could be more susceptible to scratching than CoCr interfaces. However, qualitative measurements indicated that both alloys can be subjected to similar degree of scratching.
