CFD simulation of multiple dust explosion occurred in a flour mill

## CFD Simulation of Multiple Dust Explosion Occurred in a Flour Mill

Paola Russo <sup>a,\*</sup>, Achraf Tabib <sup>a</sup>, Michele Mazzaro <sup>b</sup>, Enrico Danzi <sup>c</sup>, Luca Marmo <sup>c</sup>

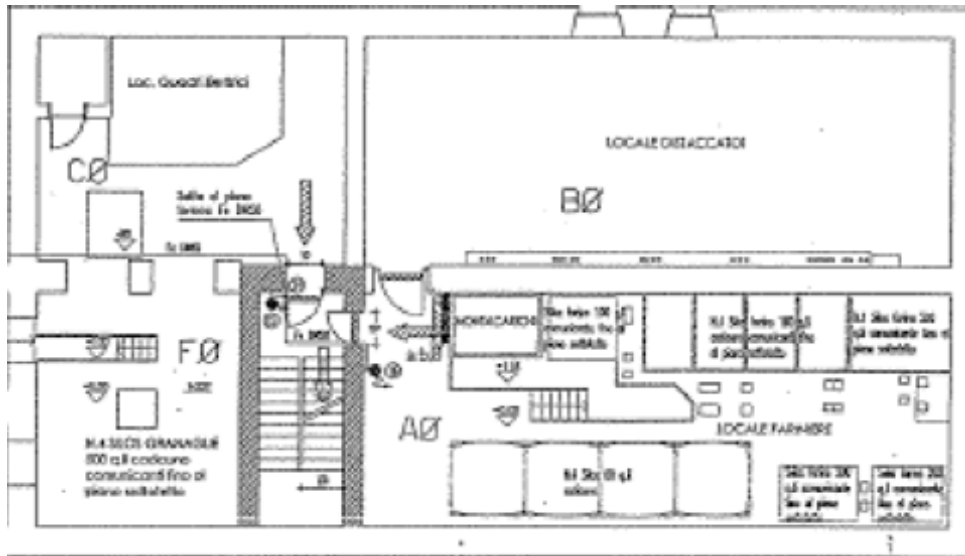
Figure 1. Plan of the basement of the main building.

In Figure 1, A and B are the areas of the main building of the mill which underwent a considerable, but not complete, collapse.

In the basement, the collapse of all the B rooms and of their equipment occurred. Most of the equipment (i.e. plansichters, mills, cyclones, cochlea and elevator ducts) was not burned by the fire. With regards to the walls, the north one collapsed, but the internal ones were only damaged. Also, the stability of internal staircase, which was found in its original position, was compromised.

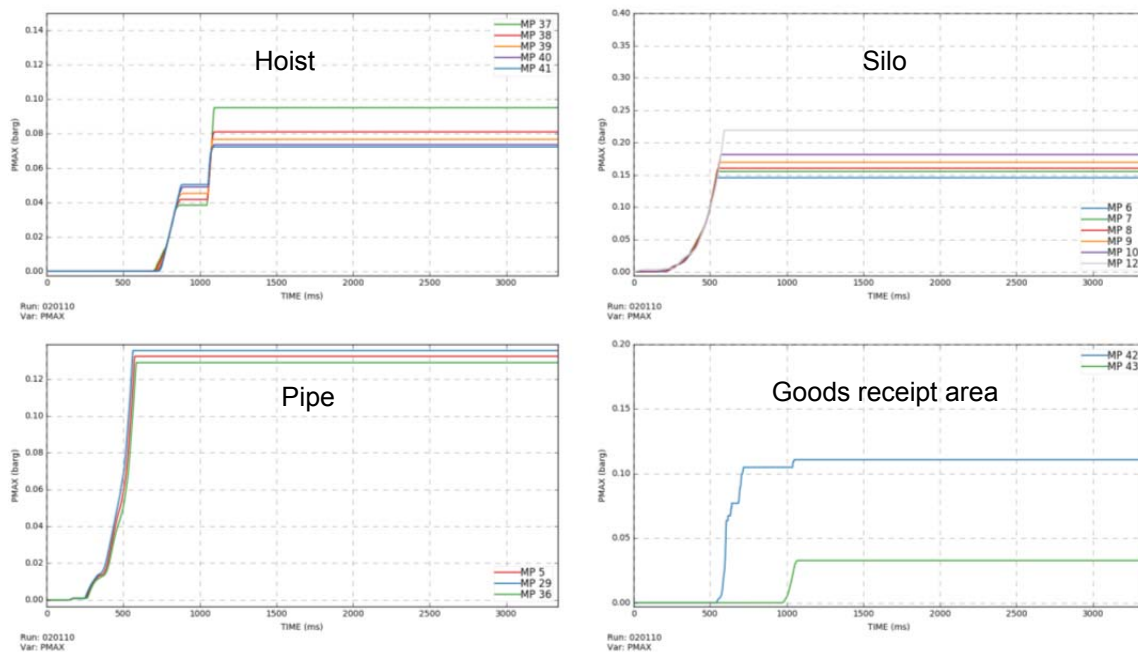
Simulations were performed for various scenarios with different levels of flour in the silo, concentration of dust and position of ignition. The overpressures predicted for each scenario in the different monitor points were compared with the failure pressure of the various objects. From the comparison, it was possible to define the scenario that is compatible with the damage observed after the explosion. It corresponds to the scenario with the silo only partial filled with flour (1/3 of volume), concentration of dust in the dust cloud of  $2000 \text{ g/m}^3$  (higher than the stoichiometric value) and the ignition at the top of the silo. Results of the simulations were reported in figure 5 for this scenario. They showed that it can predict: the collapse of the silo, because of the overpressure increase along the silo length from the top ( $P_{\max} = 0.15 \text{ barg}$ ) to the bottom of the silo up the failure value ( $P_{\max} > 0.20 \text{ barg}$ ). Moreover, it can describe the propagation of the blast wave into the pipe and, as consequence of the silo collapse, then in the goods receipt area, where the under-roof and of roof panels fell. The propagation of the blast wave to the hoist, from the top to the bottom, with the collapse of the hoist door ( $P_{\max} > 0.07 \text{ barg}$ ), and then to the basement where overpressure as high as  $0.27 \text{ barg}$  caused the collapse of the concrete floor (Figure 6) and consequently of the flour bins. The large amount of dust dispersed in the area, because of the poor housekeeping, ignited by the blast wave, was then the cause of multiple explosions occurred in the plant.

Figure 5.  $P_{\max}$  vs time in the monitor points located in the hoist, silo, pipe and goods receipt area.

The case study here analysed showed that ordinary and unusual operations, especially those of loading and unloading silos, bins, storage houses are the recurrent cause of uncontrolled explosions. Proper procedures should be defined when such operations have to be carried out in order to reduce the risk of explosions. Deflagration venting can reduce the impact of dust cloud explosions by controlling the release of the explosion energy. Damage to the remaining structure and equipment is then minimized. Good housekeeping in processing areas is important to prevent and mitigate dust explosions. In particular, to prevent secondary dust explosions, dust accumulation has to be minimized. Designing and maintaining equipment to prevent dust leaks, using dust collectors, eliminating flat surfaces and other areas where dust can accumulate, ensuring good housekeeping, and sealing hard-to-clean areas (such as the area above a suspended ceiling) can effectively prevent secondary dust explosions. Moreover, this paper demonstrates that computational fluid dynamics can be a valid aid to forensic engineering because it allows to discern the incidental sequence that is more adherent to the evidence. This despite the investigation must necessarily base the bases on a solid activity of evidence collection.

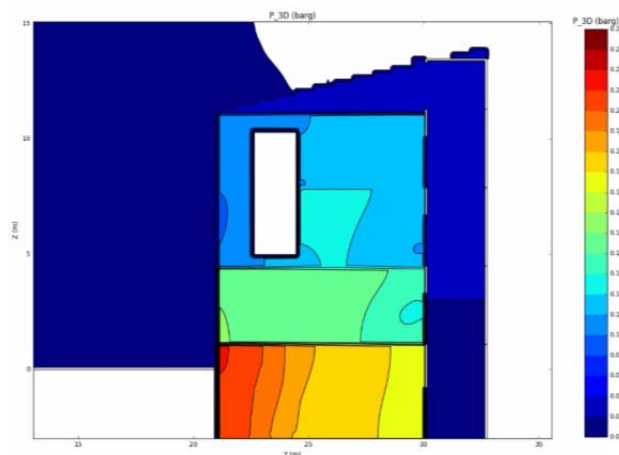
Figure 6. Map of  $P_{\max}$  reached in the hoist and in the basement (at 960 ms).
