Simultaneous monitoring of a collapsing landslide with video cameras

K. Fujisawa and J. Ohara

Public Works Research Institute, Japan

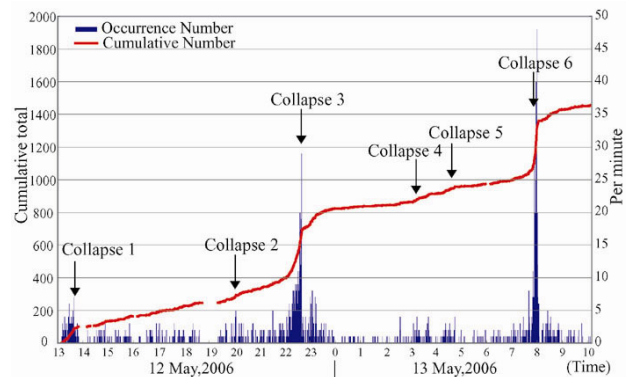
Fig. 3. Other events – falling rocks, slope collapses and fallen trees.

Figure 3 shows the count of falling rock events, slope collapses and fallen trees. Prior to the six major collapses, the frequency of these events steadily increased. The rate of increase was particularly pronounced prior to the two largest collapses (numbers 3 and 6).

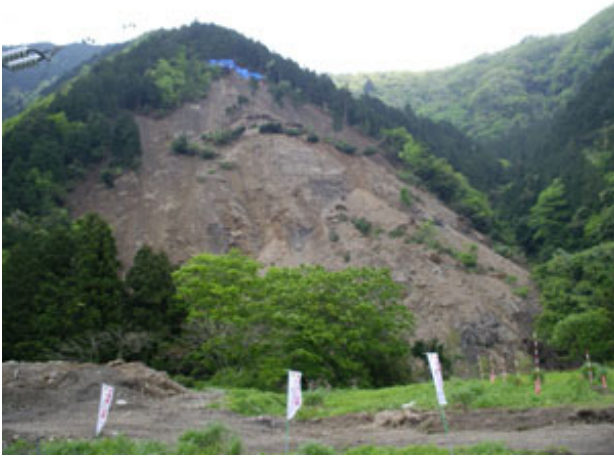
Fig. 5. General view of the landslide site (14 May 2006).

approximately 150 m in width by 135 m in height, with a volume of approximately 250 000 m³ (Fig. 5).

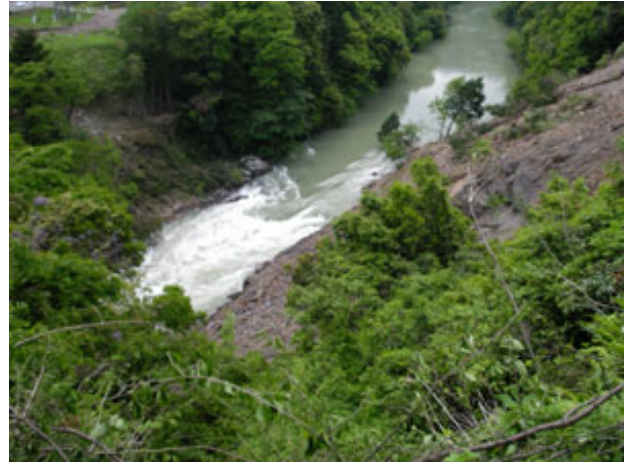
Fig. 6. Debris deposits in the river course (14 May 2006).

Image analysis, together with field measurements using a ground-based laser scanner after the collapse, indicated that the landslide produced a total of 50 000 m³ of debris. It flowed into the river during the landslide. As Fig. 6 shows, this blocked some two-thirds of the width of the river, and also caused damage to several local roads, but most of the landslide body remained on the affected slope.
