THE ANALYSIS OF CAUSES OF LORRY PISTON COMBUSTION ENGINE DAMAGE

The article deals with analysis of causes of lorry piston combustion engine damage. For documentation and analysis of causes was used macroscopical, microscopical and scanning electron microscopy. The analysis showed that the reason of fatal damage resides in production process of lorry combustion pistons which proved in implication of fatigue damage and subsequent burnout in two piston place.

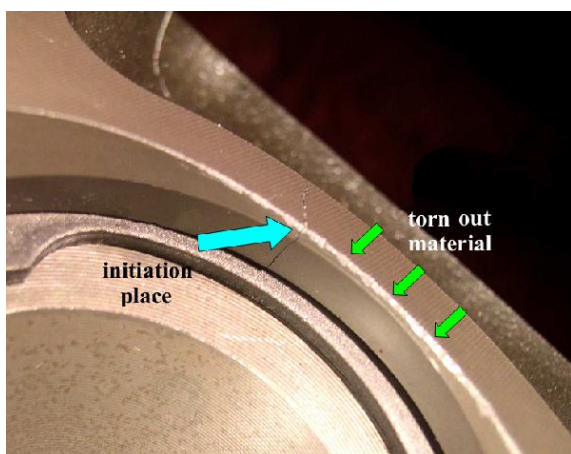
External cylindrical surface was worked on the base of morphology by roughly lathe-turning. Probably, cutting tool caused tearing out of material by wrong machining parameters in hole place for piston (Fig. 3) from hole edge for piston pivot (green arrows) in consequence relatively sharp and large notches were created at that place.

Fig. 3 Split off piston edge of pivot after machining
(full colour version available online)

On the base of carried out analyses it can be stated that the most probable cause of piston damage during exhibition process is caused by wrong machining parameters of external cylindrical piston surface. Parts of material were torn out in hole place for piston pivot during machining. This place is cyclically also dynamically strained during the activity of

The conclusion states that during whole production process conditions of individual technological operations are needed to respect. Not respecting of define conditions can lead to damage of component and it means to distinctive decrease of lifetime and actually to complete destruction of constructional unit which part is component [11].

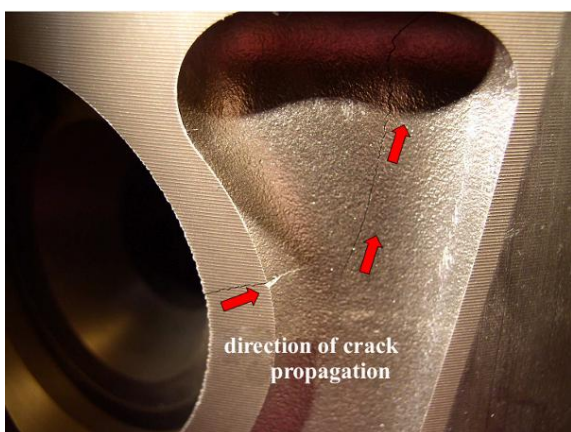
That way damaged hole edge had effect as the initiation place for formation of fatigue crack which after achieving hole for leading away excess oil from wipeable ring and subsequently propagated in its direction. That documents Fig. 4 where sudden change is seen in the orientation during crack propagation. Material is in the closeness of that hole weakened what enables its next propagation up to the active piston part. In this place high temperatures and pressure effect for material of piston. Fuel mixture was getting into material volume by the crack what caused also local melting down of fracture surface and by medium pressure caused its removal through crack and the weakest section out of piston material.

Fig. 4 Direction of fatigue crack propagation
(full colour version available online)

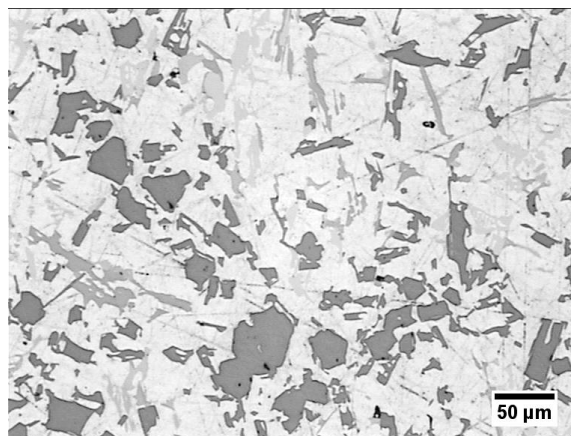
Fig. 5 Microstructure from active part of piston

Microstructure of piston cast was analysed in bottom, middle and active part of piston. In all three areas microstructure was formed by base matrix on the basis of aluminium solid solution, sharp-edge Si particles and interdendritic spaces were filled by eutectics. On the base of microstructure it can be stated that it is an alloyed hypereutectic Al-Si alloy [10]. Microstructure of active piston part is documented in Fig. 5, its middle part is given in Fig. 6 and bottom part of piston is shown in Fig. 7. Microstructural heterogeneity in individual piston parts is observed in photographs.

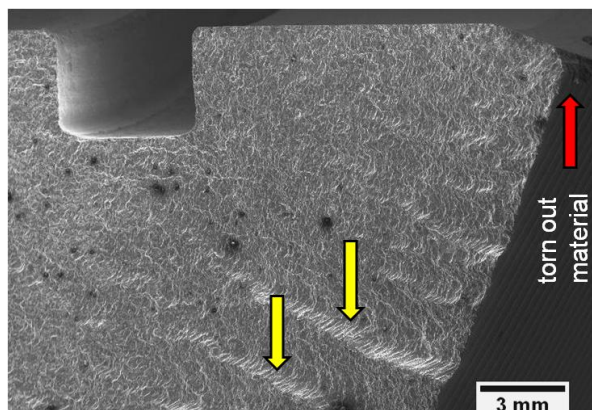
In Fig. 8 fracture surface in place of the fatigue crack initiation can be seen. Typical fatigue (relaxation) lines were observed in

fracture surface which proceeded from place of initiation fracture in this case from place where parts of material were torn out from surface during machining. Groove for safety ring of piston pivot was situated in left upper part of image.

Fig. 8 Surface fracture in place of crack origin, fatigue lines, split off material

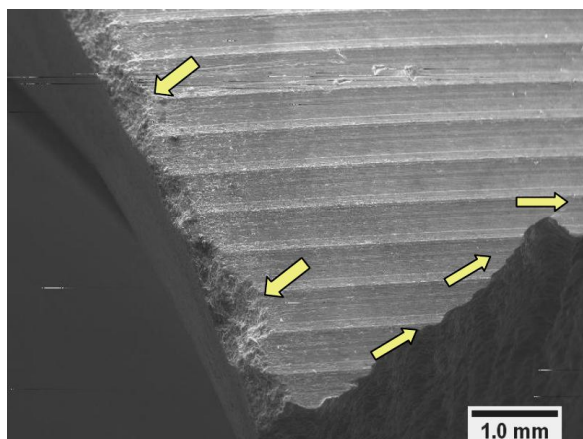
Fig 9 documents micrograph of external machined surface which contains tracks caused by cutting tool. Places were observed in edge (left) where material was torn out during machining of surface. Same damage (tearing out) was observed in opposite side of hole for piston pivot.

Fig. 9 Machined piston surface, split off material and fracture surface
