M. JOVANOVIĆ, L. KOSEC, B. ZORC

EXAMINATION OF WELD DEFECTS BY COMPUTED TOMOGRAPHY

Defects in metal arc gas (MAG) welds made in S235JR low carbon steel of 6 mm thickness were examined. A sample containing lack of fusion (LOF) and pores was examined by computed tomography – CT. The computed tomography examination was performed in order to define LOF size and position as well as dimensions and distribution of accompanying pores in the weld metal.

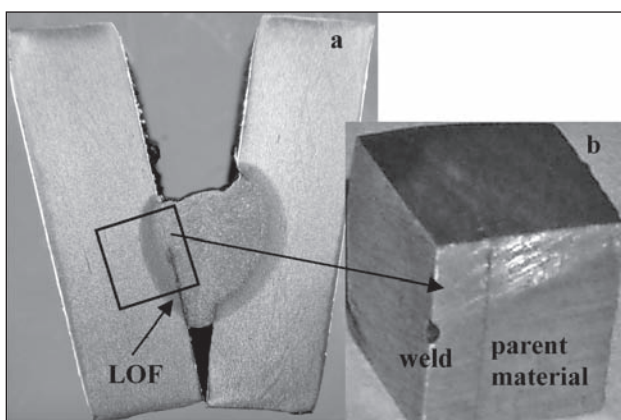
Figure 1 Specimens preparation: a) specimen for macrographic examination, b) test specimen for CT

Due to a limited radiation power several specimens with irregularities had to be cut out from the existing welded joint in form of a cube with a 5 mm side. The cutting position is given in Figure 1a, while the test specimen is given in Figure 1b. Afterwards, the specimens were examined by computed tomography – CT. For this purpose, the NANOMEX CT system of Phoenix X-ray Company was used. The system consists of a 160 kV nanofocus X-ray tube and a 16-bit detector with voxel accuracy of 16 μ m. Radiation of test pieces was performed at the tube voltage of 140 kV and current intensity of 70 μ A. Possibility of details resolution ranged within (200 – 300) nm. The X-ray tube power was 50 W.

Angle and depth of a weld groove are important LOF parameters. In case of smaller angles, a narrow gap prevents a proper access of the weld gun into the root of the weld. So the arc starts burning on the nearest face of the groove which was proved by Sony DCR-TRV740E digital camera recording on an 8 mm tape with a frequency of 25 snapshots/s. The molten mixture of parent and filler materials pours to the other face of the groove which prevents melting of the parent material in this part of the joint and results in a LOF in the lower part of the weld metal (Figure 1b).

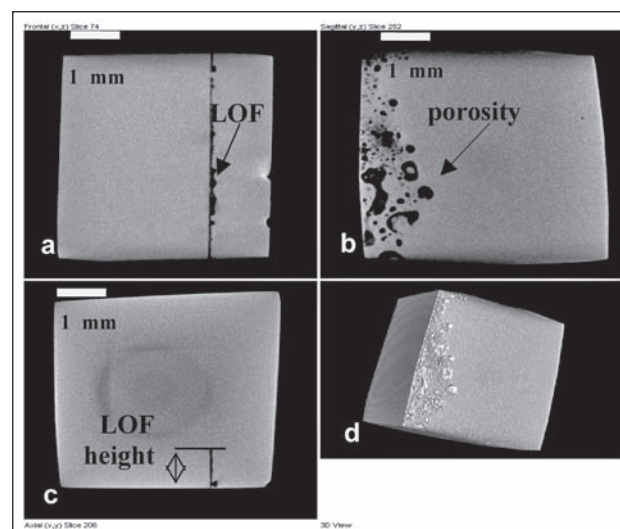
The results of CT examinations are given in Figure 2, which shows a 3D image and three projections of a test specimen with a clearly evident LOF and pores. Frontal image (2a) gives a LOF well evidenced along the whole length as well as its width change. Figure 2b is a tomogram of the surface where the LOF passes into porosity. Numerous pores of different shapes and sizes are visible. This image represents the basis of a geometrical analysis of the LOF and porosity.

Figure 2c shows the specimen from the top. The LOF and the accompanying pore are well evident. This view served for the profile of the LOF along the weld metal length. Figure 2d is a 3D image of the specimen.

Figure 2 Specimen image made by computed tomography: front (a), side (b), top view (c) and 3D image (d)

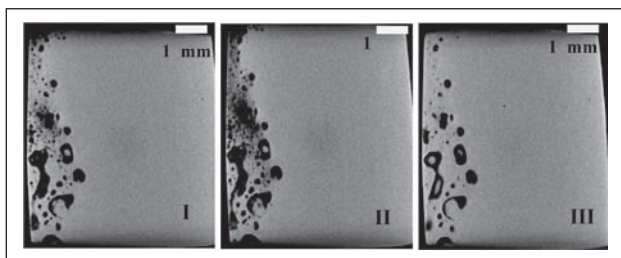
Figure 3 gives tomograms of a 3D CT image projection in different sections made from the direction perpendicular to the LOF plane. Dark surfaces decrease with moving away from the LOF plane (from I to III).

Figure 3 Projection on LOF plane

defect. By VGI program it was established that the width of this LOF was 0,1 mm. In sector images it can be seen that a great number of pores of different sizes and shapes are arising from the LOF area. All these pores are directed from the LOF plane to the molten pool which is another indirect proof that the parent material is not melting there. The tomogram section (Figure 3) gives an analysis of the pores diameter, cross section and length.

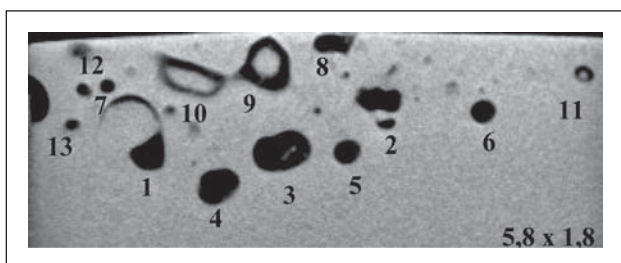
Figure 4 Dimensional analysis of porosity area (pores are numbered from 1 to 13)

The analysis was performed in a rectangle of 5,8 x 1,8 mm given in Figure 4 which represented approximately one fourth of the weld surface. Total height of the weld cross-section was 7,2 mm. Inside the rectangle, the share of the image darkness was measured in each individual section whereby the darkness represented an empty space (LOF or porosity). As it is evident from Figure 5, empty spaces (dark surfaces) were mostly found in the area of LOF at a distance of 0 to 0,1 mm, where the darkness share reached more than 40 %.

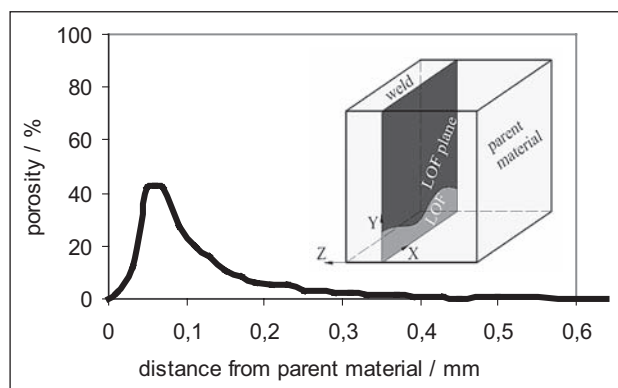
At a distance of 0,1 to 0,2 mm, the porosity or darkness share decreased from 20 % to 5 %. In this area the majority of pores disappeared. It is interesting that individual pores can reach into the molten pool even as far as 0,6 mm away from the parent material where the LOF occurred. Figure 5 gives a scheme of the LOF plane location with directions of individual axes which shall contribute to relevant understanding of LOF image analysis. In further tomograms analysis the top view given in Figure 3 was applied.

Figure 5 Change in porosity as per weld section

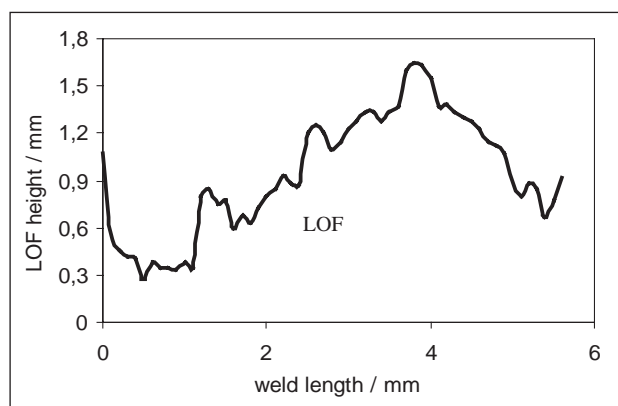
For each section, the LOF height as per weld length has been measured. In this way the LOF profile between the parent metal and the molten pool has been obtained (Figure 6). As it is evident, the LOF reaches up to 1,6 mm of the weld height at the most and up to 0,3 mm of the weld height at the least. Above the given line, full penetration with dilution of parent and filler materials occurred while under this line weak dilution resulted in a LOF. The size of pores accompanying the LOF, their

Figure 6 LOF profile between the molten pool and parent material

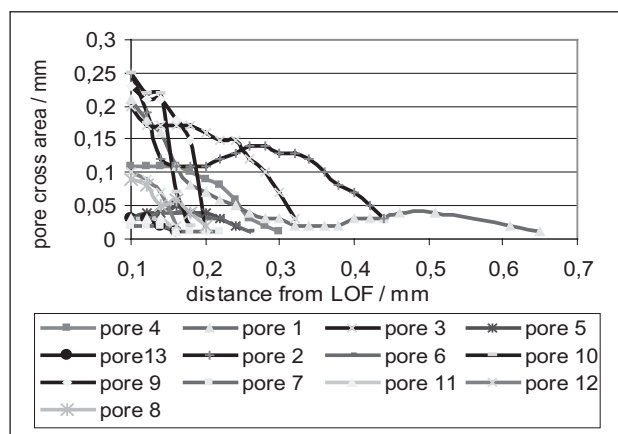
Figure 7 Size of pores inside a welded joint

- a) Pores with a cross-section greater than 0,2 mm². They were 5 of them altogether. 3 of them reached more than 0,3 mm into the weld metal. The remaining two were shorter than 0,2 mm.
- b) Pores with a cross-section of 0,1 mm². They were 3 altogether. One of them reached more than 0,3 mm into the weld metal. The remaining two were shorter than 0,2 mm.
- c) Pores with a cross-section smaller than 0,05 mm². They were 5 altogether and they were of different lengths; however, they were all shorter than 0,3 mm.

As it is evident, only pores with an initial cross-section above 0,2 mm² can reach a more explicit length (above 0,3 mm). Pores with a smaller initial cross-section are shorter than 0,25 mm.
