## Tribocorrosion damage of a Jethete M152 type stainless steel

### Abstract

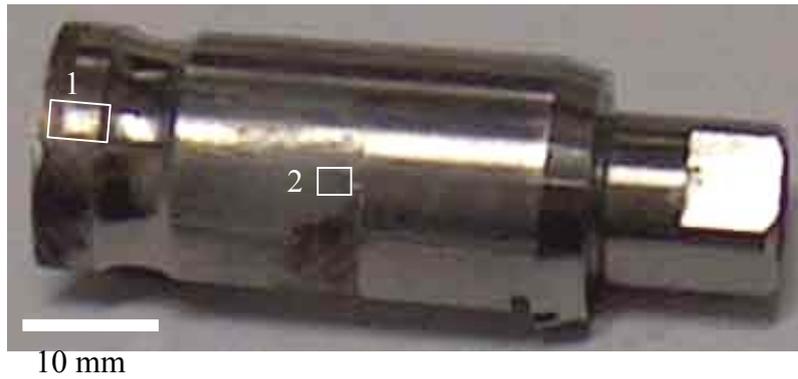
Fig. 1 shows a macrograph of an insert which failed in-service. There are several scratches from top to bottom, which were formed during assembly of the insert into the sleeve component. Heavy stains (dark red by visual appearance) were associated with these scratches, although some stains occur on the insert surface where no scratches exist.

**Fig. 1:** A photograph of a failed insert after service.

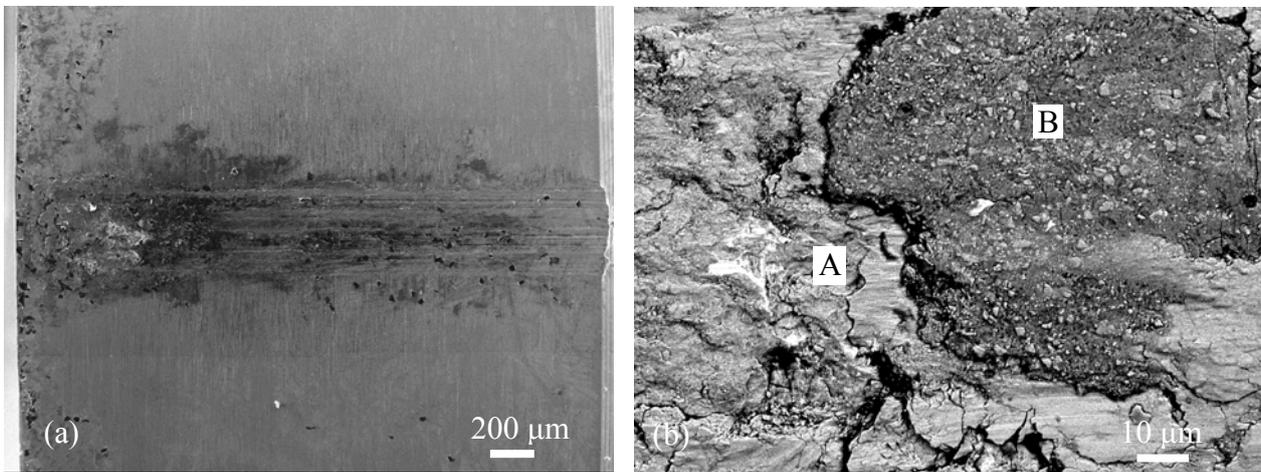
Fig. 2a shows a secondary electron image (SEI) of one corrosion area on the insert, which corresponds to area 1 in Fig. 1. It appears that corrosion products are occurring preferentially in the scratches. Oxidation is present around the vast majority of the circumference of the outer rim of the insert and it varies in length along the insert at different circumferential positions. However, there was no evidence that oxidation/corrosion occurred preferably at grain boundaries. The backscatter electron image (BEI) at higher magnification (Fig. 2b) shows two kinds of morphologies: one is relatively bright (area A) and covering a substantial part of the surface, and the other is debris-like (area B). EDS confirms that the chemical composition at both areas have high oxygen contents, and the ratios of (Fe + Cr) / O are about 0.77 and 0.66 respectively, see Table 2. Such oxidation products are similar to those found on Nd-Fe-B alloys [2], where a Fe<sub>3</sub>O<sub>4</sub> (magnetite) will form first and then transform into Fe<sub>2</sub>O<sub>3</sub> (hematite) under further oxidation (including a small amount of Cr<sub>2</sub>O<sub>3</sub>). Therefore, it can be concluded that serious oxidation occurs in the scratches formed during operation.

**Fig. 2.** SEM micrographs of area 1 of Fig.1 on the insert. **(a)** SEI at low magnification; **(b)** BEI at higher magnification.

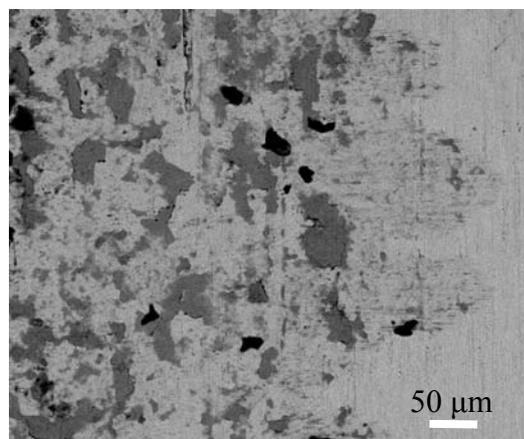
It was also noted that some oxidation products occur on the insert surface, that are not associated with scratches, as shown in area 2 of Fig. 1. The corresponding BEI micrograph is shown in Fig. 3. The areas of dark colour were determined to be oxidation products of Fe<sub>2</sub>O<sub>3</sub>. The black particles were carbon rich, which was assumed to be due to contamination from polymer products manufactured at high temperature.

**Fig. 3.** BEI micrograph of area 2 of Fig.1

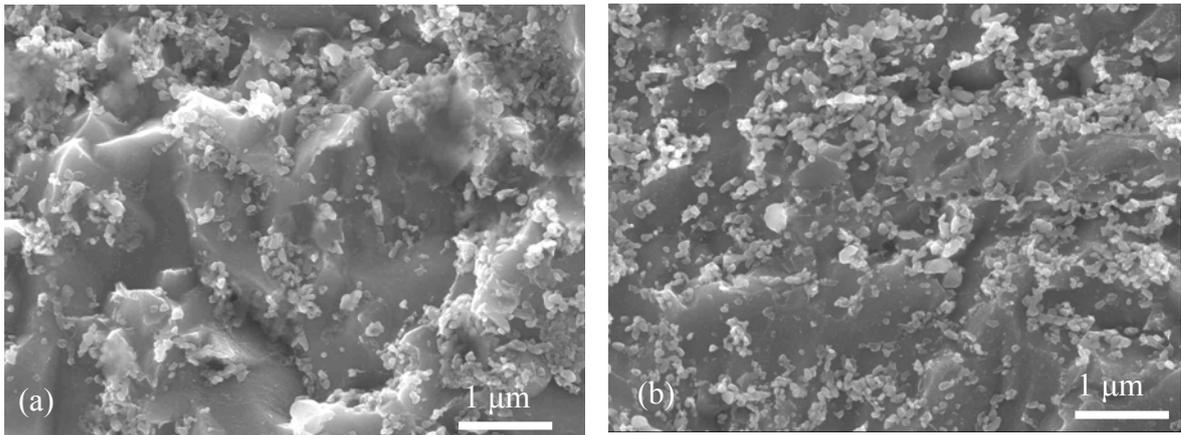
After etching, distinct particles in the range of 50–200 nm are visible in an insert which failed during service, as shown in Fig. 4(a). EDS in SEM shows that the particles are chromium enriched. To help determine when this chromium enrichment occurs, an as-manufactured insert was also investigated. A transverse section was prepared from this virgin material. The high magnification micrograph in SEM (Fig. 4b) shows that there are chromium particles in the same size range as the virgin material. This indicates that the precipitates are introduced in the heat treatments during production of the raw material.

**Fig. 4.** SEI micrographs from the centre of the transverse sections (a) insert that failed in service; (b) virgin insert (prior to service).

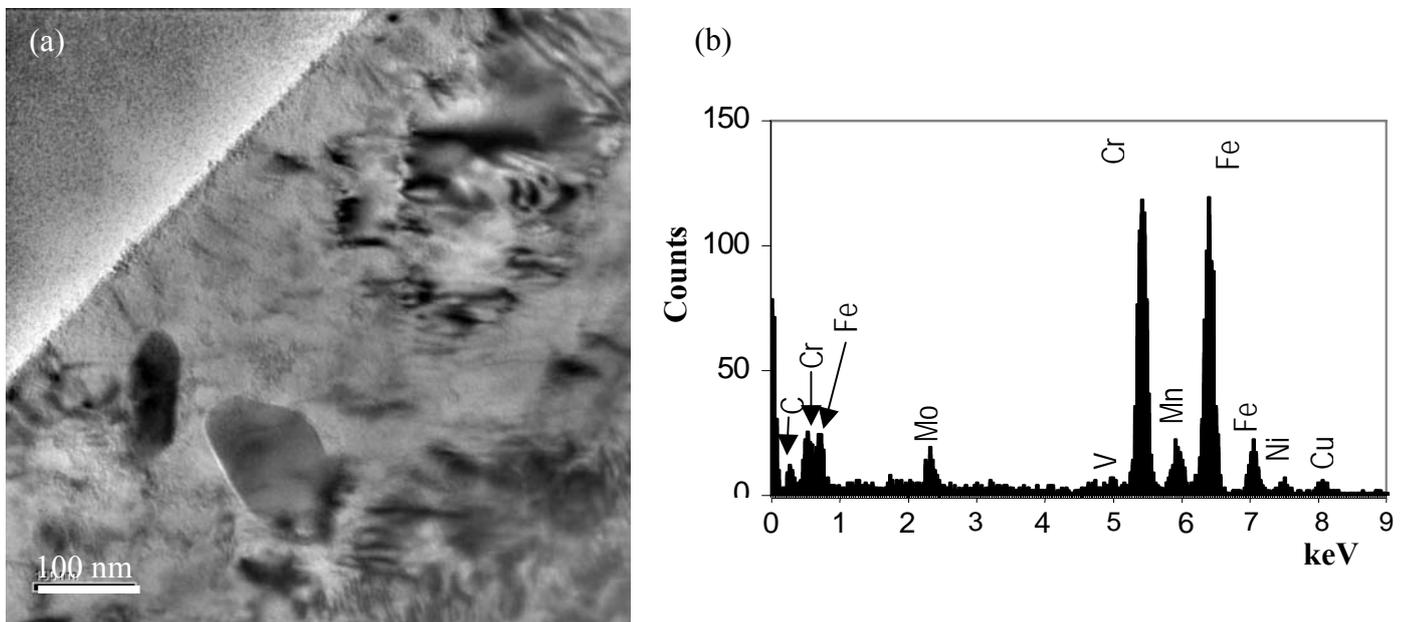
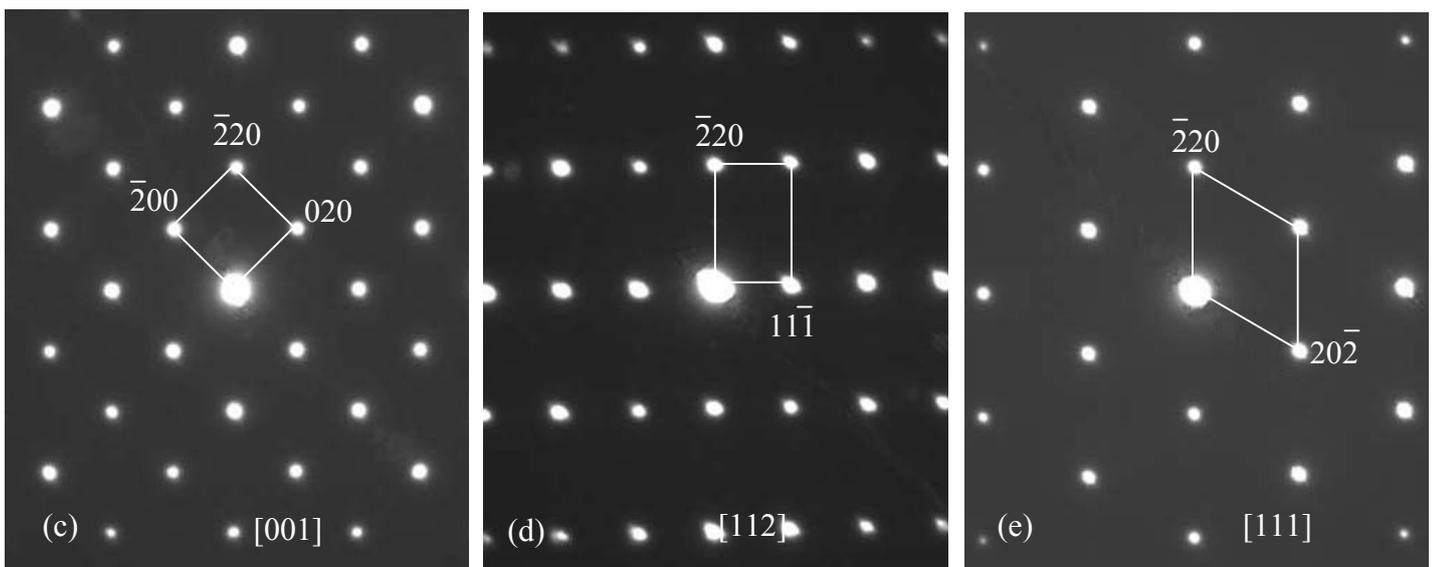
As X-rays activate an area (0.5–1.0 μm in steel bombarded at 15 kV) that is much larger than the dimension of the precipitates (50–200 nm), the composition of the precipitates cannot be determined accurately in SEM. The structure of these small precipitates is also difficult to identify by electron backscattering diffraction (EBSD) in SEM. TEM has therefore been utilised to analyse the structure information and the chemical composition of the precipitates. Fig. 5(a) shows two precipitates in bright field mode. The EDS spectrum in Fig. 5(b) confirms these particles are Cr rich, and also significant amounts of C, Mo, Fe and some V are detected. Table 3 shows the composition from EDS for one precipitate as well as the matrix. The composition of C is detected in variable from 13 to 20 at.%. Figs. 5(c-e) show three selected area diffraction (SAD) patterns of the precipitate. These are fully consistent with [001], [112] and [111] zones in a face-centred cubic (fcc) structure. No forbidden reflection was observed. The corresponding lattice parameter (*a*) was measured to be 1.07 ± 0.03 nm (using the Al matrix as a reference).

**Fig. 5.** TEM bright field image and the selected area diffraction pattern from the precipitates. (a) bright field image; (b) EDS analysis of the precipitate (c-e) [001], [112] and [111] diffraction patterns of the precipitate, respectively.

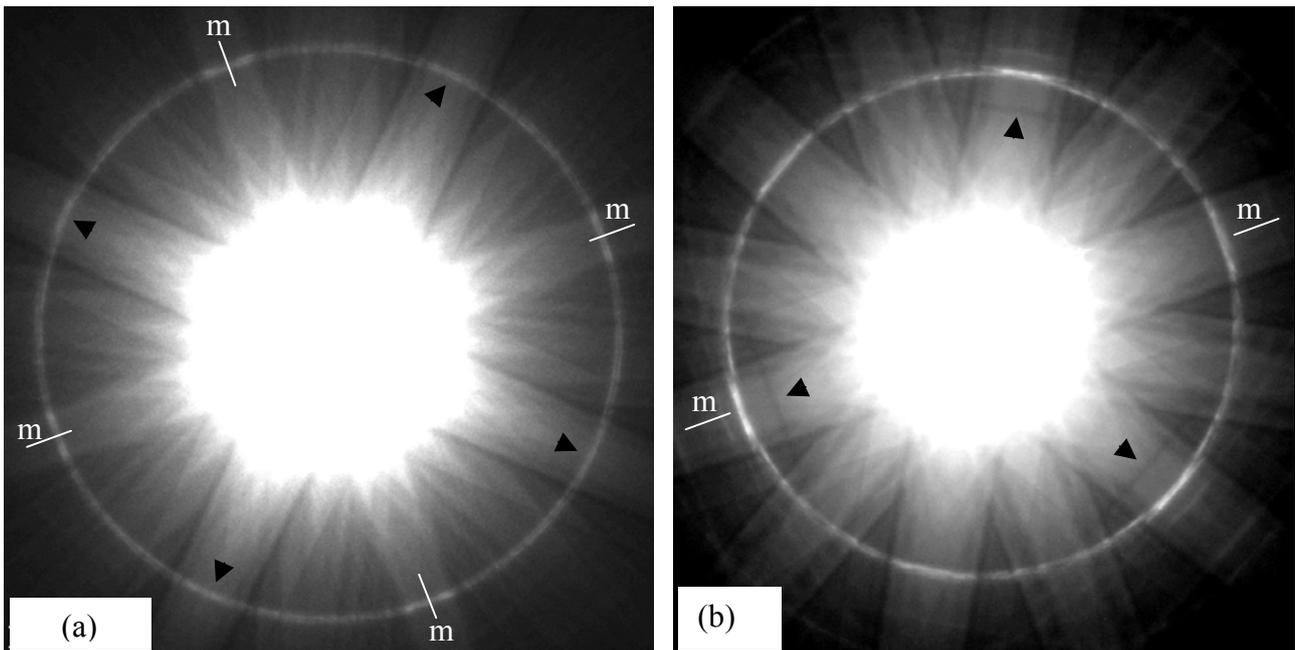
lines and zero-order-Laue-zone (ZOLZ) Kikuchi lines in the pattern as a whole. From the BF and WP symmetries of CBED patterns obtained from several prominent zone axes, it is possible to find one of 31 diffraction groups, and then the possible point group, based on Steeds and co-worker's work [3,4]. A [001] zone CBED pattern is shown in Fig. 6a. According to the principle of HOLZ line formation [5], HOLZ lines in BF disc correspond to those in higher order Laue ring, therefore the latter's symmetry refers to the BF symmetry. Kikuchi lines and bands show the ZOLZ symmetry. Consequently the symmetries of both Kikuchi and HOLZ lines represent the WP symmetry. As indicated by the arrow and  $m$  (mirror) in Fig. 6a, the BF symmetry and the WP symmetry both show 4-fold axis and mirror, i.e.  $4mm$ . The [111] zone CBED pattern is shown in Fig. 6b. Similarly, the symmetries of both BF and WP are  $3m$  because the HOLZ ring and the array of HOLZ-deficient Kikuchi lines show threefold symmetry with one mirror plane reproduced every  $120^\circ$ . The results are summarised in columns 2 and 3 of Table 4. Further possible diffraction groups and point groups can be deduced according to the work of Refs [3,4] as shown in Table 3. The point group for the precipitate, therefore, is  $m\bar{3}m$  as it satisfies the symmetries of both [001] and [111] zones. Combined with the Bravais lattices, it is possible to identify the space group of the crystal of  $Fm\bar{3}m$ .

**Fig. 6.** Convergent beam electron diffraction patterns of (a) [001] and (b) [111] zones, which are corresponding to the SAD patterns of Figs. 5(c) and 5(e), respectively. m represents a mirror symmetry.

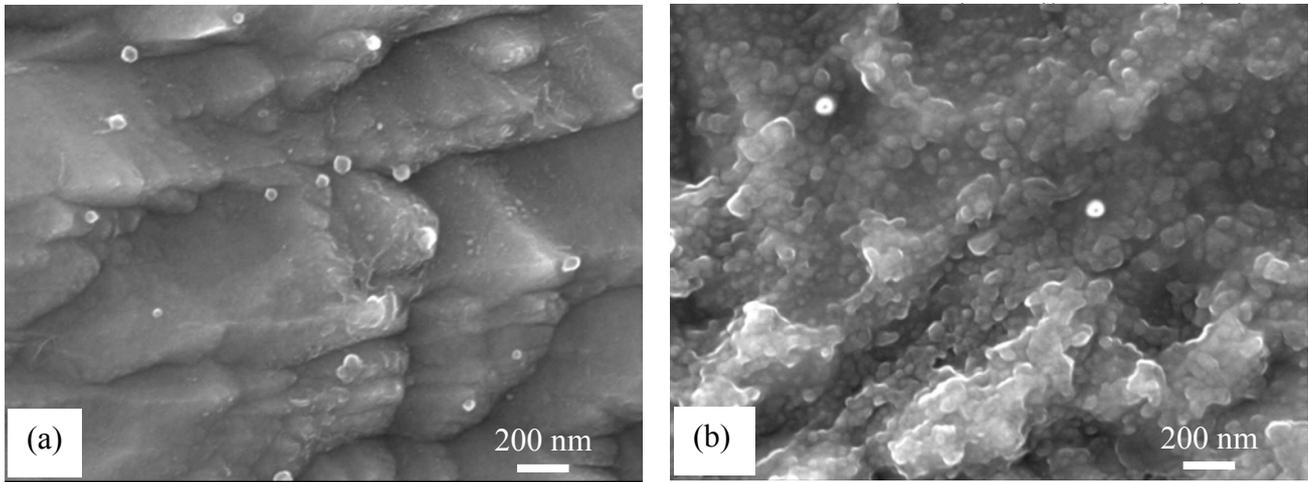
In fact, the precipitates could be as small as 10 – 20 nm in oil quenched samples as shown in Fig. 7(a). These precipitates will grow up to 50 nm after heating 560°C for 3h (Fig. 7b). Further SEM analysis of samples subjected to additional heat treatments show that precipitation depends on the cooling rate; the faster the cooling rate, the larger the precipitates that form. The precipitates could be avoided at slow cooling speeds, such as air-cooling (Fig. 8) although they might be formed in the further heat treatment.

Fig. 7. SEI micrographs of one insert after (a) solution treatment at 1050°C for 1 h, oil quenched and (b) further heat treatment at 560°C for 3 h.

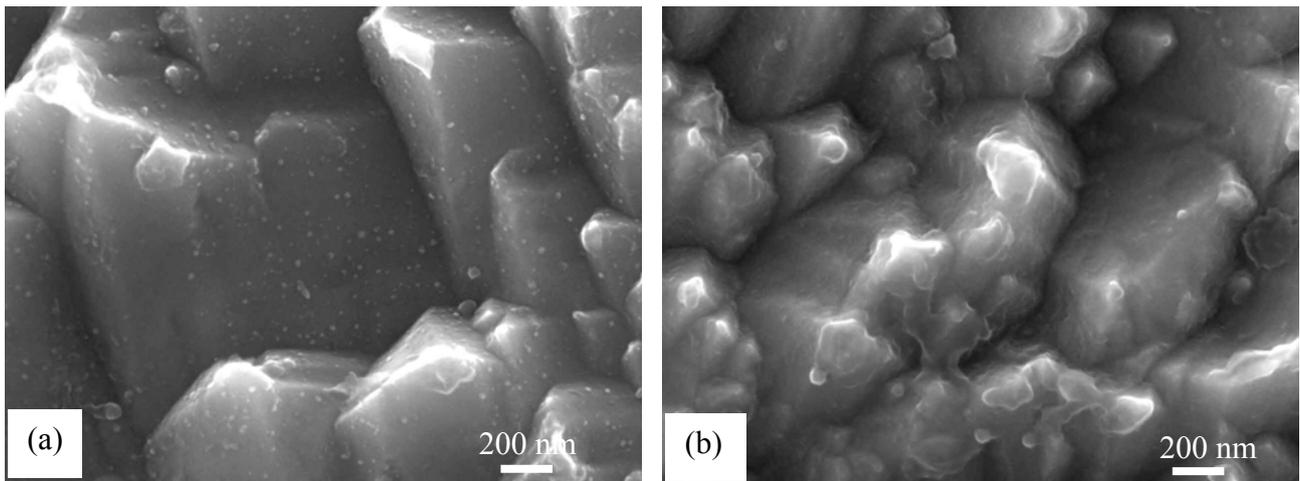
Fig. 8. SEI micrographs of one insert after (a) solution treatment at 1050°C for 1 h, and subsequent water quenching and (b) air cooling.
