Observations of MMOD Impact Damage to the ISS

James L. Hyde⁽¹⁾, Eric L. Christiansen⁽²⁾, and Dana M. Lear⁽²⁾

ABSTRACT

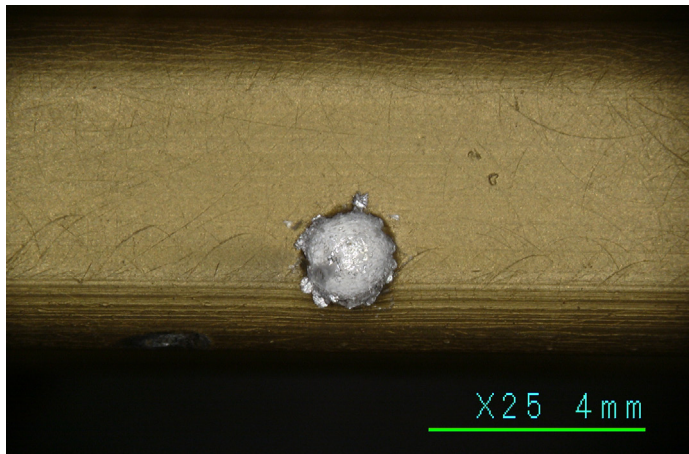
Fig. 1. MMOD impact crater on ISS handrail

Figure 1 illustrates one of the many MMOD craters observed on EVA handrails. Because the handrails are aluminum, the sharp edges that occur at the lips of the MMOD craters have caused cuts in the outer layers of EVA gloves and fingertips [6]. One cut glove example resulted in an early end to an EVA during the STS-118 mission (Fig. 11). Consequently, the EVA gloves were reinforced to reduce the risk of cuts from sharp edges of MMOD craters. In addition, a clamp was designed and used to isolate craters on handrails in highly traveled areas of ISS, such as near the airlock egress/ingress hatch. Figure 12 illustrates another MMOD crater found on a D-handle EVA tool that measured nearly 5 mm across. This tool had been stored on the ISS exterior, and was brought inside and repaired by the crew prior to use in March 2008, using adhesive tape wrapped around the MMOD damage.

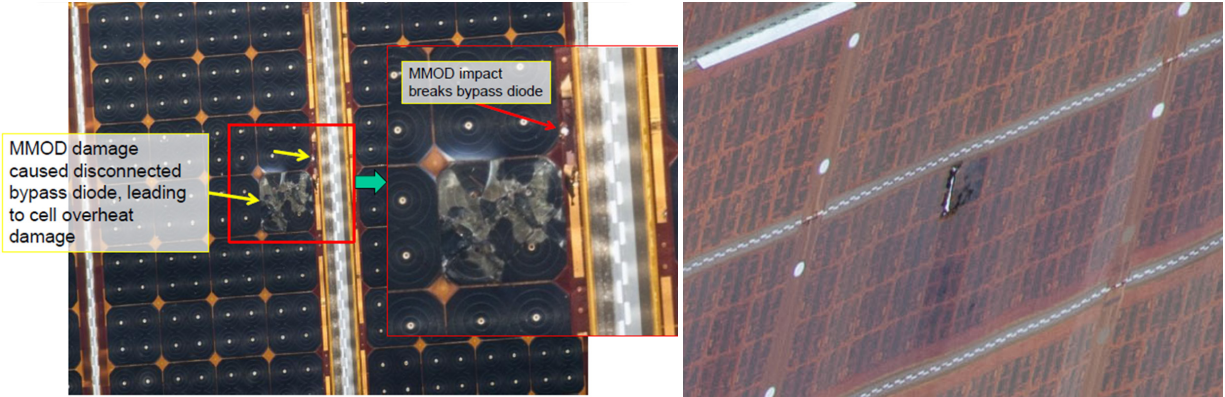
Fig. 8. Additional examples of ISS solar array overheating damage. On left, an MMOD strike caused a disconnected bypass diode resulting in loss of a string on solar array 2A panel 66. At right, an observed burn-through in solar array 3A panel 42; although no obvious MMOD damage is apparent, a failed bypass diode is a possibility.

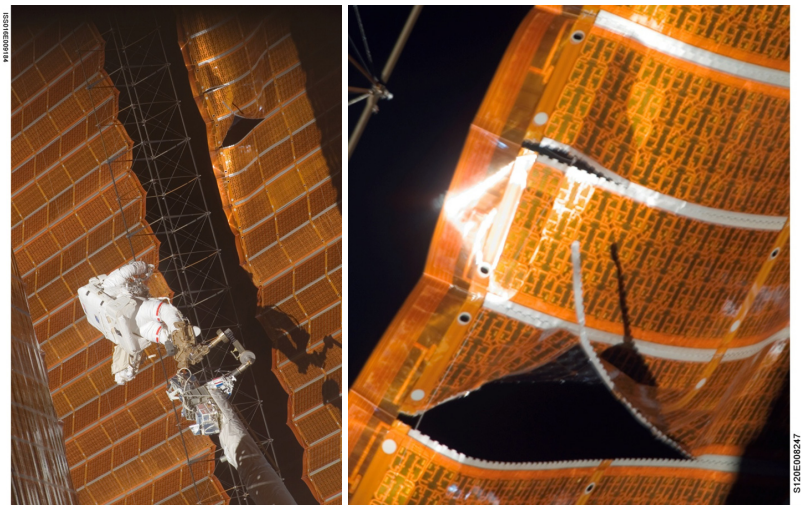
An even larger amount of solar array damage occurred from a small impact on a solar array guidewire. Figure 9 shows two large tears that developed in the 4B SAW when the solar array was being redeployed after being moved to its final location during STS-120 due to a snagged guidewire. EVA crew removed the snagged guidewire and installed “cuff-link” reinforcements to stabilize the array. The guidewire was returned to the ground where it was examined and clear evidence of MMOD impact was observed by the melted material found at the location of the snag (Fig. 10).

Fig. 9. During STS-120, two solar array wings were removed from the ISS Z1 truss and relocated to the P6 location. The 4B solar array wing tore in two places during redeployment due to a guidewire, which snagged in a grommet.

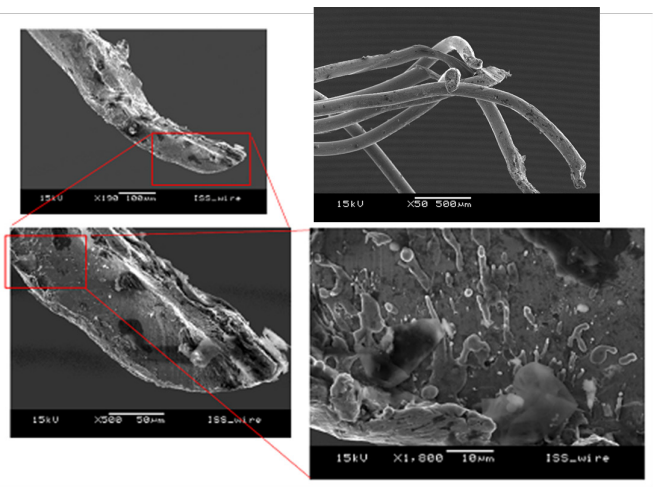
Fig. 10. The guidewire contains 21 twisted steel wires, seven (7) of which were severed. The lower images illustrate melted material at the ends of several of the severed wires, clearly indicating hypervelocity impact damage.

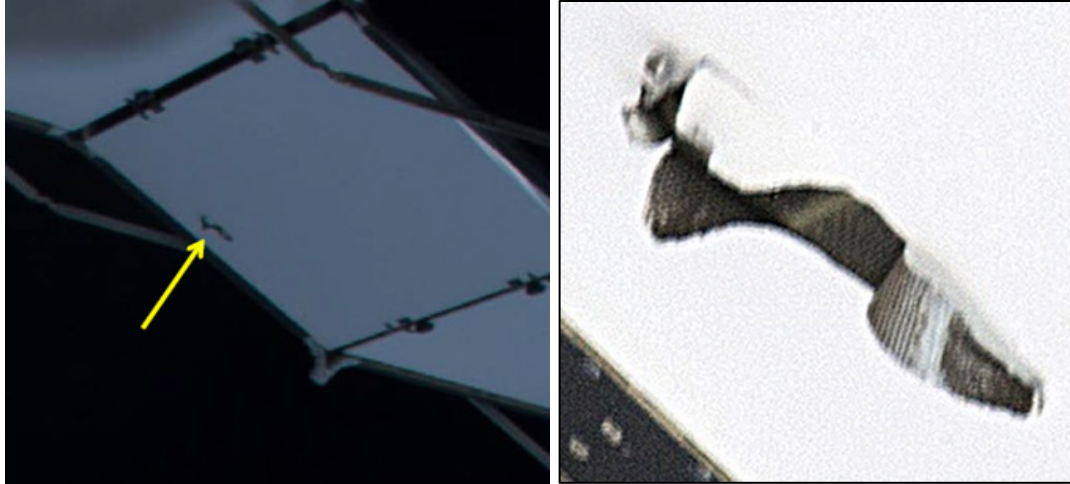
Fig.14. MMOD damage located on port photovoltaic radiator panel (exit damage).

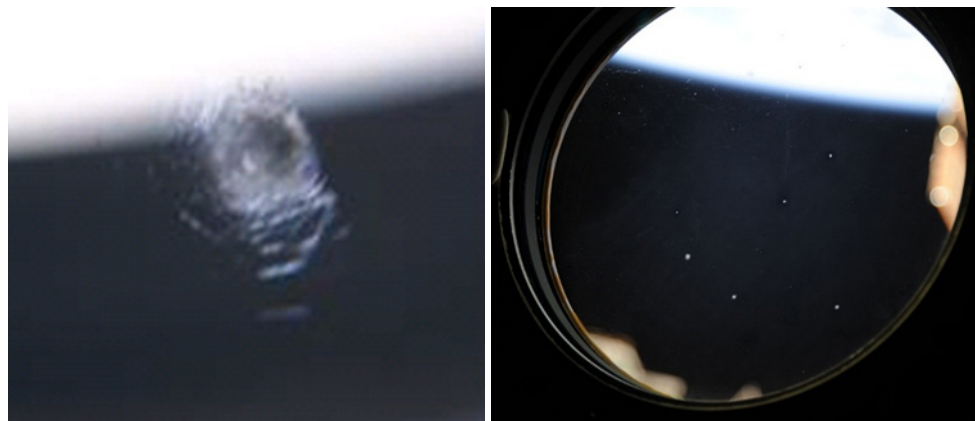
The current ISS configuration (late 2019) has 36 windows on nine different modules, usually consisting of multiple glass panes with the outer pane typically of silica glass. External shutters often (not always) protect the glass from MMOD damage [8]. MMOD strikes have occurred to the ISS windows leaving a crater on the exterior surface of the outer pane. None of these impacts have left more than a crater on the outer pane. Figure 15 shows a 3 mm to 5 mm diameter impact crater that occurred to window #7 on the Russian Service Module Zvezda.

Fig. 15. ISS window port on right. Service Module window #7 damage on left.

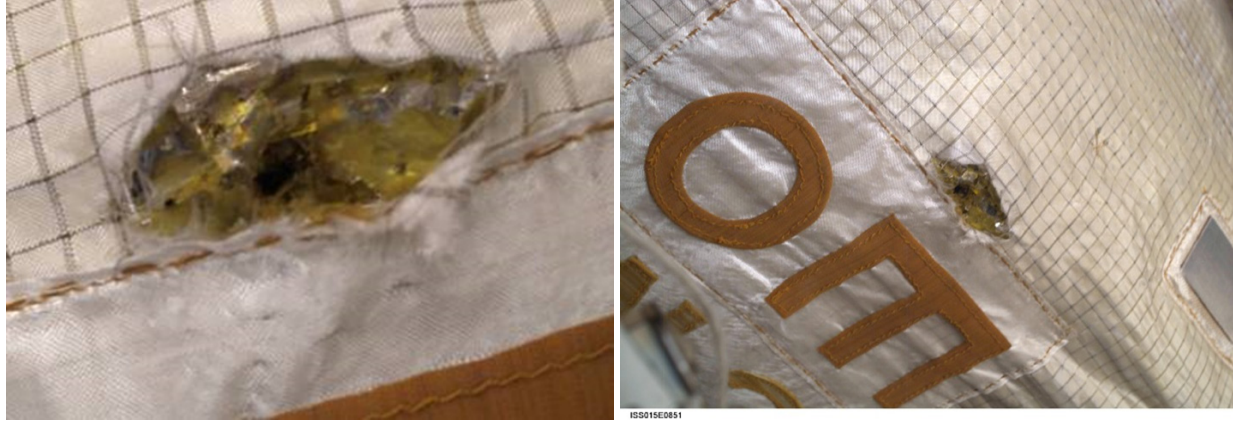
During Russian EVA-19 (7 June 2007), the crew reported MMOD damage to FGB thermal blanket over the forward compressor measuring 30mm x 60mm in the outer fabric cover of an multi-layer insulation (MLI) thermal blanket, and a 5mm x 9mm size hole in the underlying layers of the MLI thermal blanket (Fig. 16). Based on hypervelocity impact tests, the damage appears to be from an oblique MMOD impact of a millimeter or more in diameter.

Fig. 16. FGB compressor thermal blanket MMOD damage.
