# Hypervelocity Impact of Composite Overwrap Pressure Vessels

There is a limited amount of hypervelocity impact (HVI) data on pressurized composite overwrapped pressure vessels (COPV). In recent years, NASA has performed HVI tests to characterize impact conditions resulting in either leak or burst of the COPVs representative of spacecraft hardware. This paper reports on the results of 40 tests that have been conducted on several types of COPV configurations, pressurized by inert gas to near the vessels rated maximum expected operating pressure (MEOP). These tests were used to better understand COPV response under HVI conditions and develop ballistic limit equations (BLE) related to these tests.

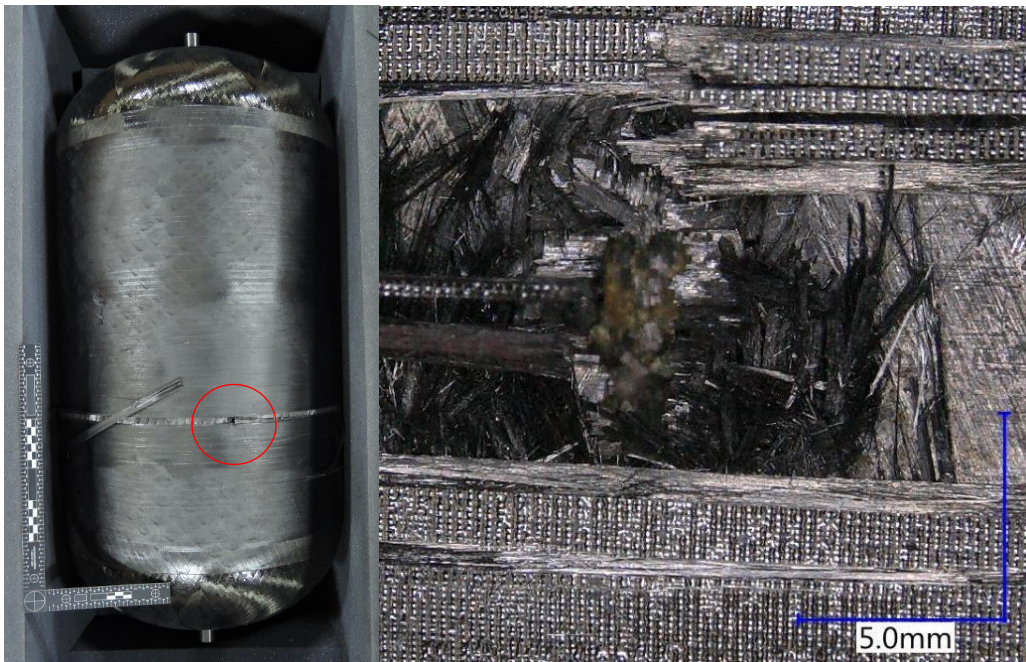
Figures 7 – 8 show the results of pressurized COPV (Type 3 tank) test HITF18435. This test illustrates a no leak.

Figure 7 Overall view of entry damage to front of sample (left) and close-up view of entry damage (right / damage located within red circle in adjacent image).

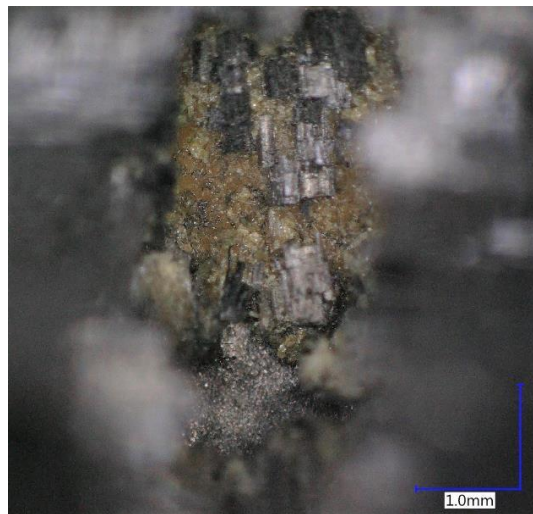
Figure 8 Close-up view of crater bottom.

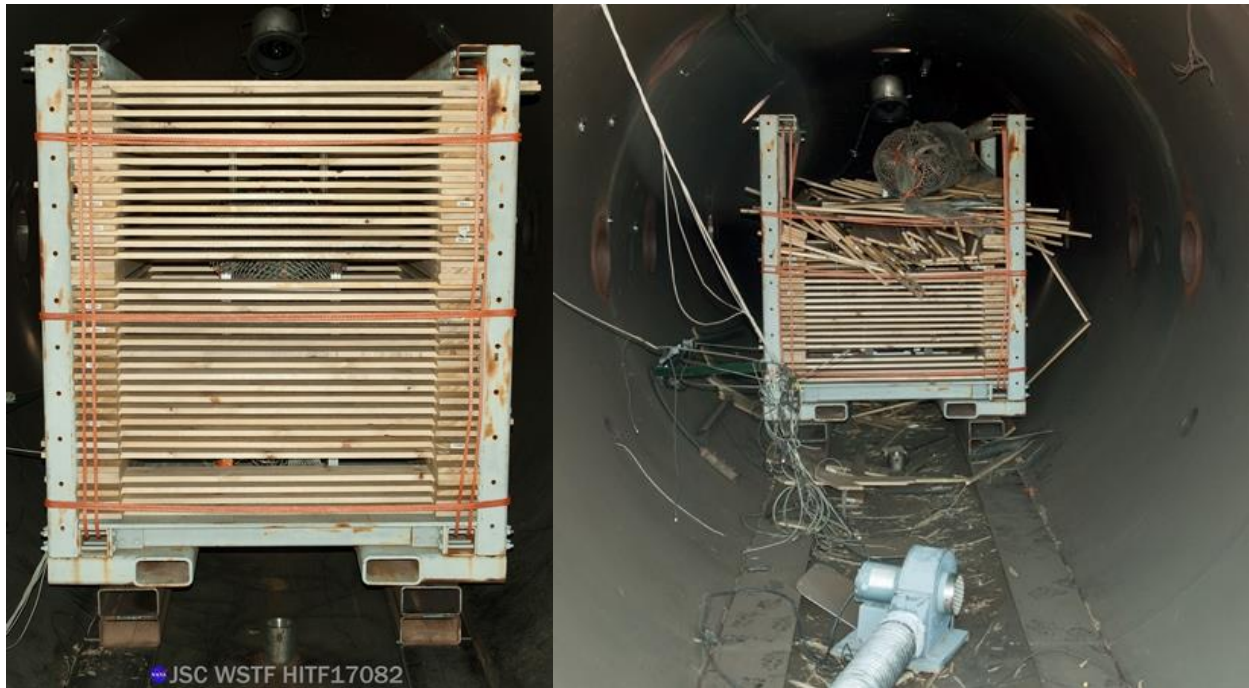
Figures 9 – 11 show the results of pressurized COPV (Type 2 tank) test HITF17082. This test illustrates that a leak or vent can produce extreme thrust. The COPV stayed intact (no rupture) but the leak caused the tank to pull free from the test fixture, break through the wooden protective shield around the COPV, impact against the target tank (leaving a shallow impression) and landing on top of the debris and remains of the test fixture.

Figure 9 Overall rear view of sample configuration within the target tank pre-test (left) and rear view of damage to sample configuration post-test (HITF17082), with debris scattered all along the target tank floor (right). Both images with wood blast mitigation in place.

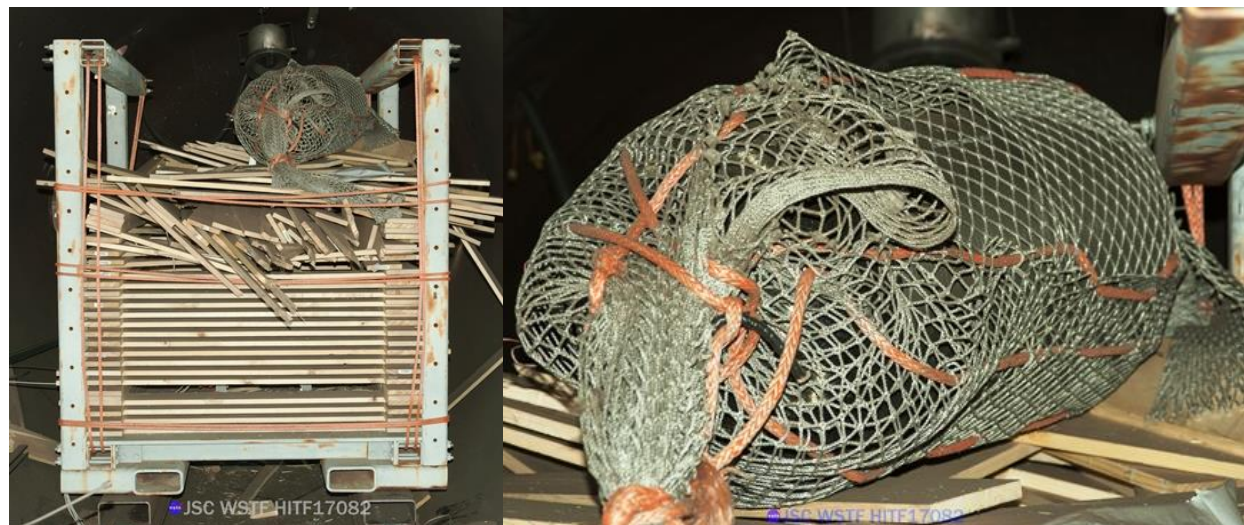
Figure 10 Close-up rear view of damage to sample configuration within the target tank post-test HITF17082 (left) and close-up of sample resting atop of wood blast mitigation (right).

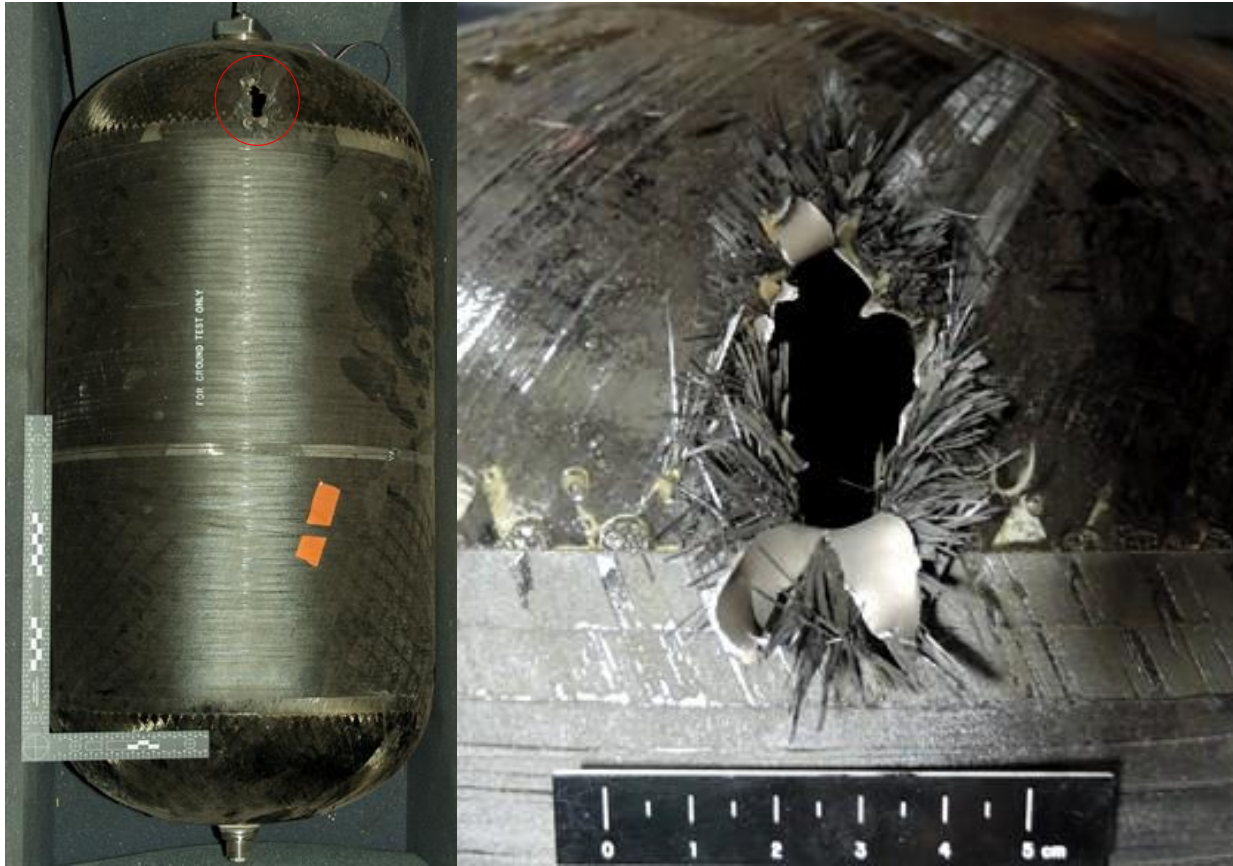
Figure 11 Overall view of damage to COPV tank (left) and overall view of entry damage (right / damage located within red circle in adjacent image) for HITF17082.

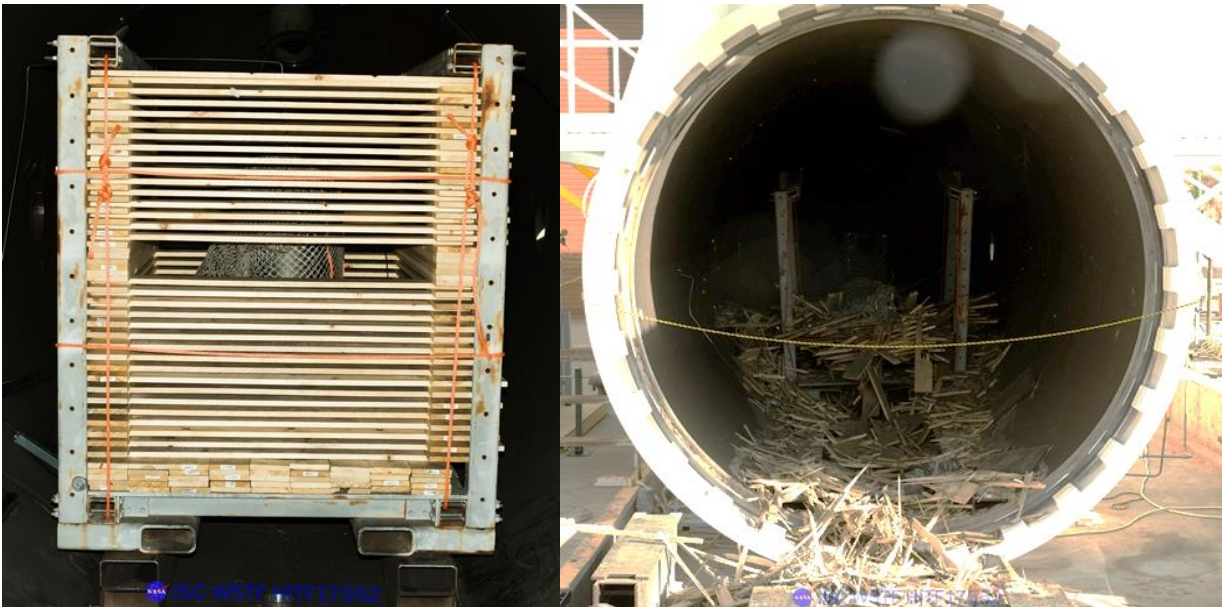
Figures 12 – 15 show the results of pressurized COPV (Type 2 tank) test HITF17552. This test illustrates how destructive a ruptured COPV can be.

Figure 12 Overall rear view of sample within target tank pre-test (left) and view of damage within the rear of target tank post-test HITF17552 (right).

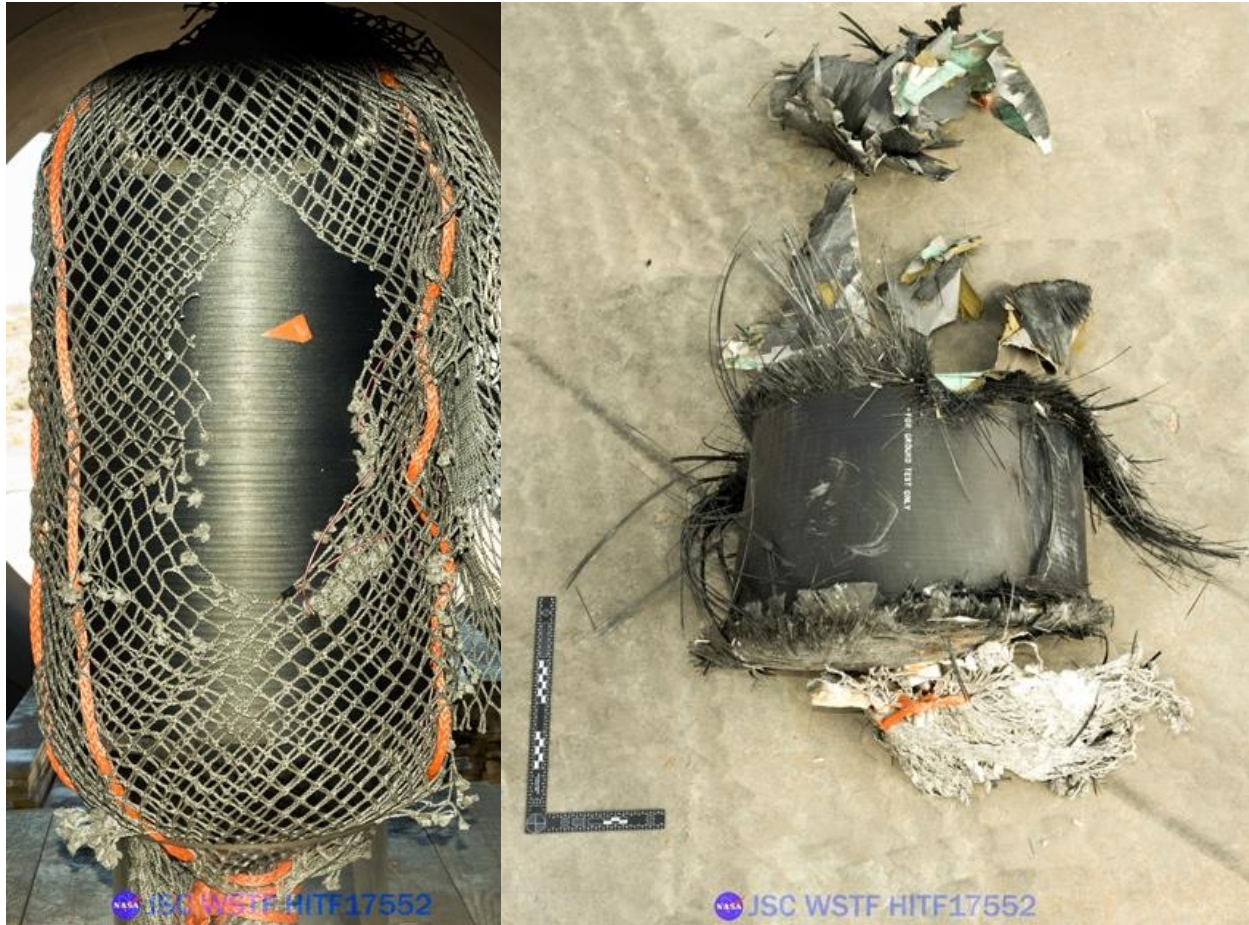
Figure 15 Overall front view of target within the target tank pre-test (left) and overall view of most significant COPV tank carcass remnants post-test HITF17552 on pad outside of target tank (right).
