APOLLO 12 MISSION REPORT

Mission Evaluation Team

NATIONAL AERONAUTICS AND SPACE ADMINISTRATION

March 1970

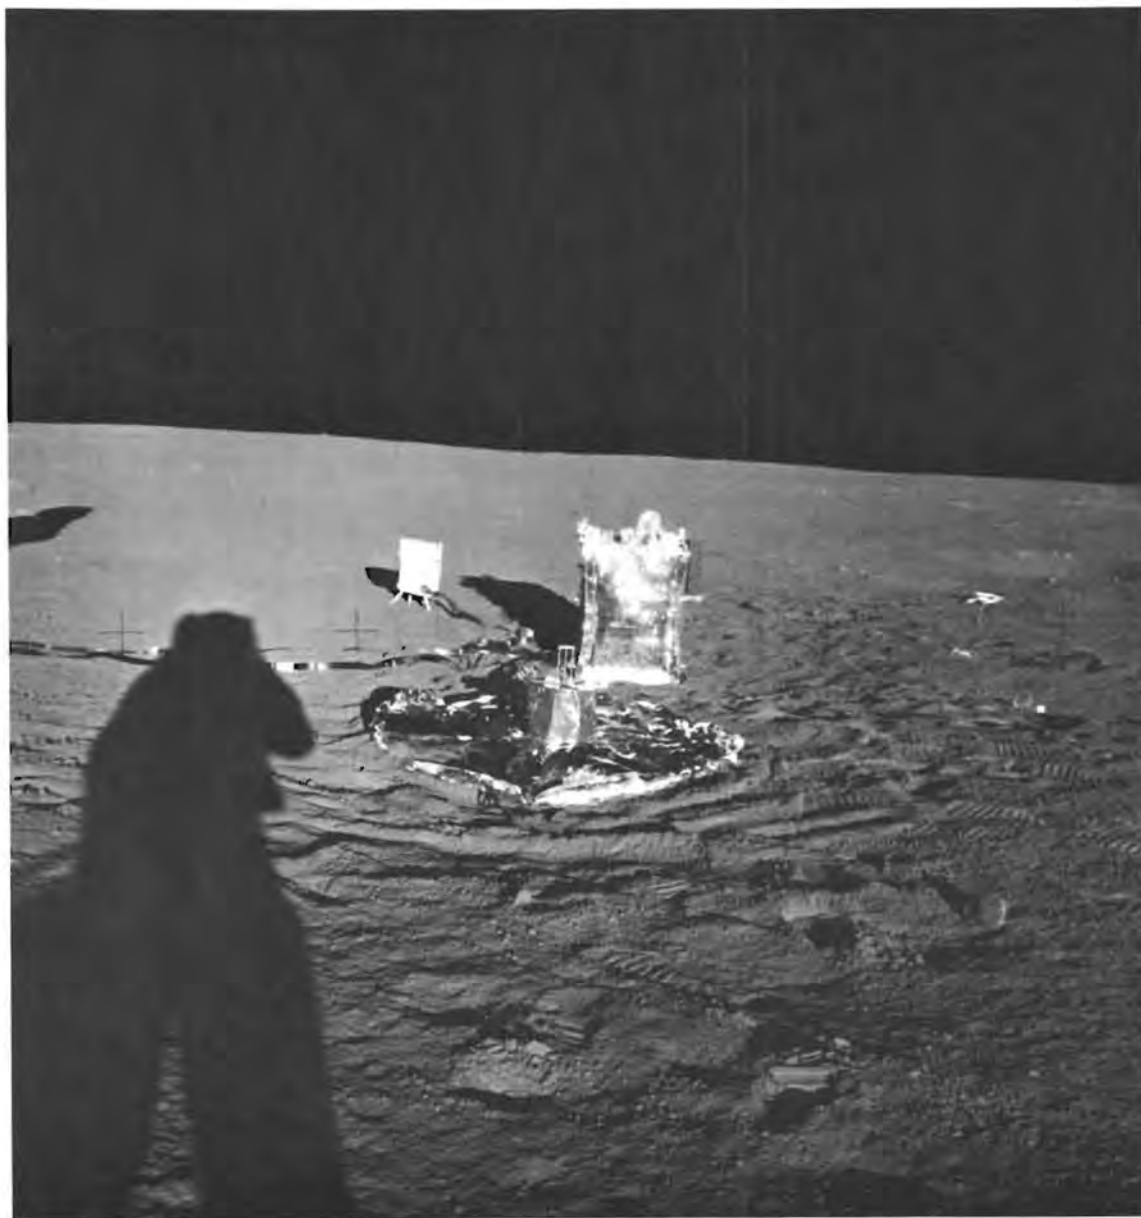
Figure 3-5.- Passive seismic experiment and the experiment central station in the foreground with the undeployed suprathermal ion detector experiment in the background.

The passive seismic experiment, shown in figure 3-5, has operated as planned with the exceptions noted. The sensor was installed at a location west-northwest from the lunar module (fig. 3-6) at a distance of 130 meters from the nearest footpad. The crew reported that tamping the surface material with their boots was not an effective means of preparing the surface for emplacement because the degree of compaction is small. Spreading the thermal shroud over the surface was difficult, because in the lunar gravity, the lightweight Mylar sheets of this shroud would not lie flat (see section 14.3.4).

The short-period vertical-component seismometer is operating at a reduced gain and fails to respond to calibration pulses. Detailed comparisons between signals observed on both the long- and short-period vertical-component seismometers has led to the initial conclusion that the inertial mass of the short-period seismometer is rubbing slightly on its frame. Nominal response is observed for signals large enough to produce inertial forces on the suspended mass which apparently exceed restraining frictional forces. The threshold ground-motion acceleration required to produce an observable signal cannot be determined accurately, but it is probably less than  $8 \times 10^{-4} \text{ cm/sec}^2$ , which corresponds to surface motions of 2 millimicrons at a frequency of 10 hertz. On December 2, 1969, a series of square-wave pulses were observed on the short-period vertical trace over a period of approximately 13 hours. The pulse amplitude was constant and was approximately equal to a shift in the third least-significant bit of a telemetry data word. These pulses are also observable on the records from the long-period seismometers, but with reduced amplitude. The problem is believed to be in either the analog-to-digital converter or the converter reference voltage.

The response of the long-period vertical seismometer to a calibration pulse was observed to be oscillatory soon after activation. In the presence of feedback, this effect can be produced if either the natural period of the seismometer is lengthened or the feedback filter corner period is shortened beyond design values. It is probable that the natural period of the seismometer was lengthened from 15 seconds to approximately 60 seconds as a result of vibration effects. Acceptable operation has

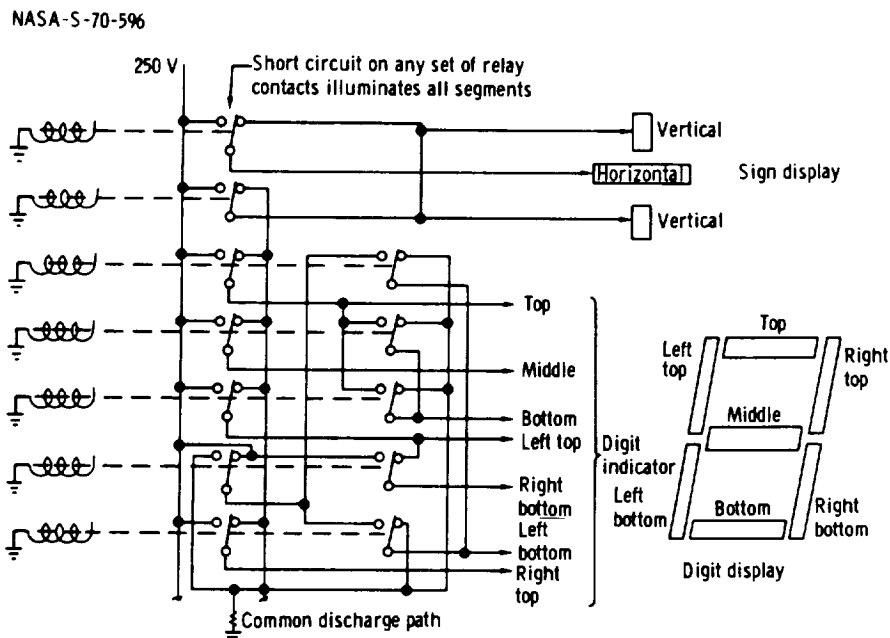
Figure 14-1. - Simplified schematic diagram of relay matrix.

The crew reported several intermittent, all-"8's" displays on the main display and keyboard assembly approximately 1-1/2 hours before launch, but no display malfunction occurred in flight. The display segments are illuminated by applying 250 V ac through the contacts of miniature relays, as shown in figure 14-1. When a segment is off, it is grounded through a resistor and the normally closed contacts of a relay to avoid residual illumination. The normally closed contacts of all relays are tied together; consequently, a short across the contacts of any one relay will apply the voltage to all segments of each display. The effect of the short in conjunction with the common discharge path is shown in figure 14-1 for a typical character and one sign. A short across the relay contacts will affect only the display function of the unit.

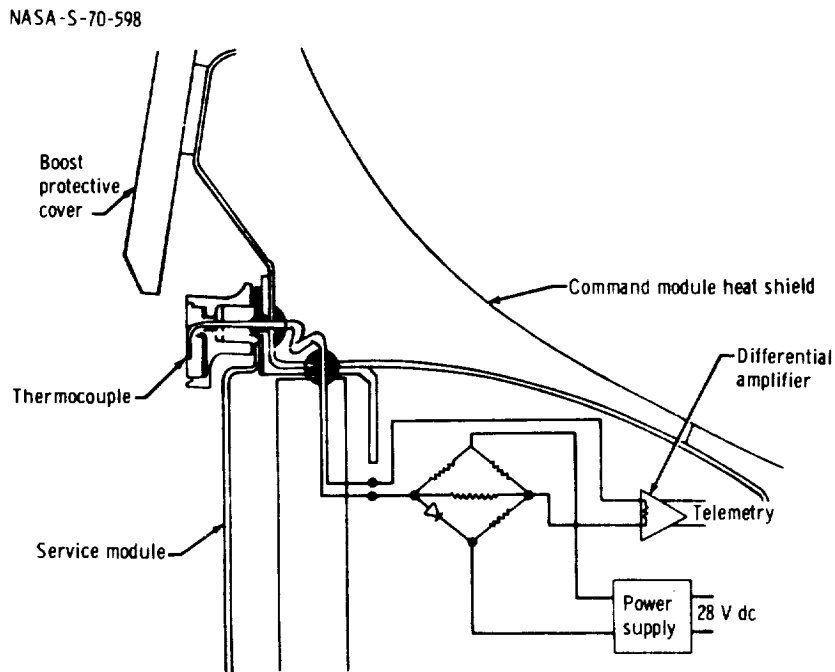
Figure 14-3. - Simplified schematic and location of a typical outer skin temperature sensor.

The service module outer surface temperature measurements use a chromel-constantan thermocouple and a reference junction. The reference junction is a bridge made up of three resistors and a temperature-sensitive diode (fig. 14-3). The resistors normally operate at about 0.020 ampere and will open in the region of 0.100 ampere. An open bridge resistor would drive the signal output off-scale high or low depending upon which resistor fails.

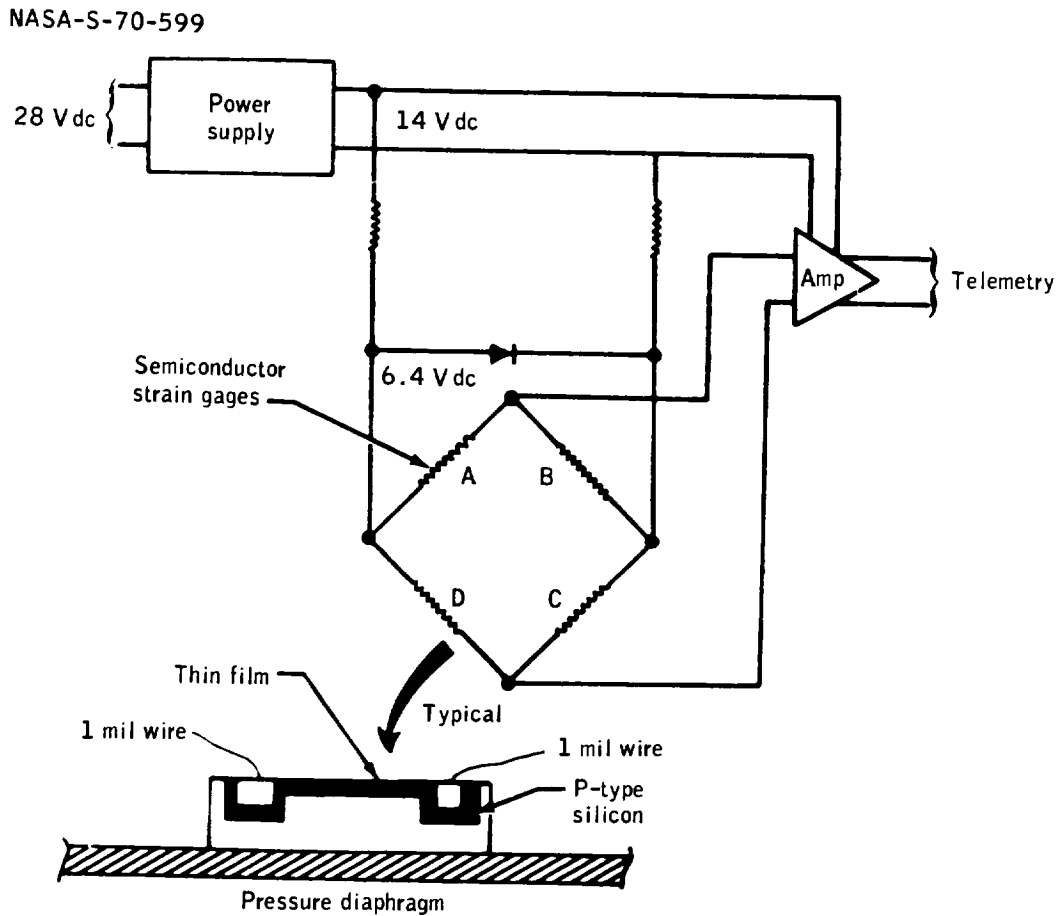
Figure 14-4.- Propellant quantity transducer schematic.

The reaction control propellant quantity measurements use semiconductor strain gages on a pressure-sensitive diaphragm (fig. 14-4). The semiconductors are a thin film type, and excessive current would probably damage their capability to operate as pressure-sensitive resistors. An alternate possibility is that the Zener diode, used to regulate the 14-volt supply to 6.4 volts, was burned out. Loss of this diode would explain the instrumentation symptom, which in all four cases was full-scale and unchanging.

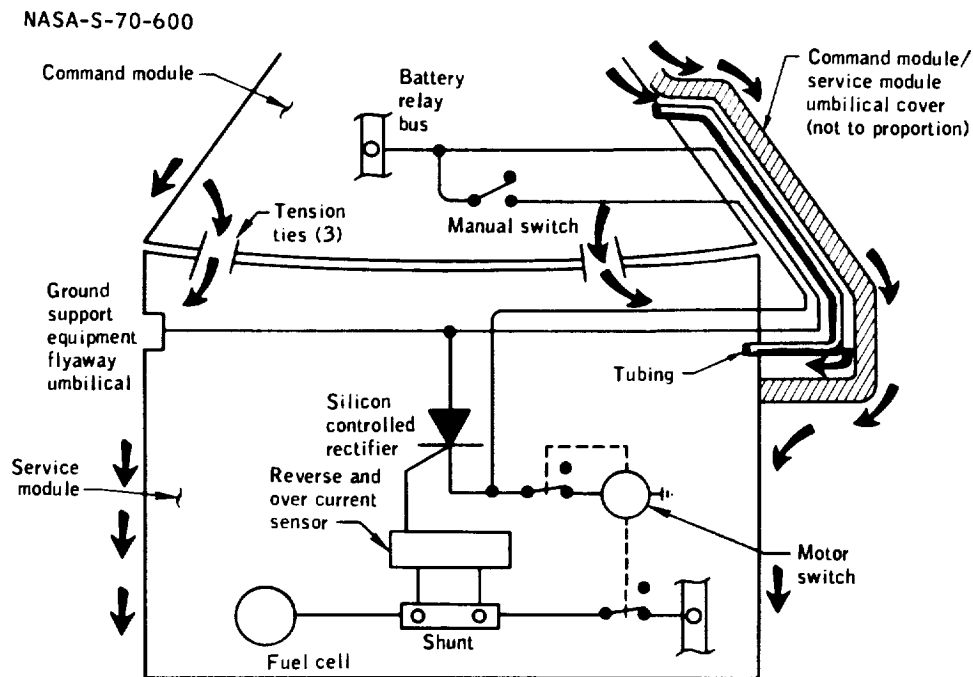
Figure 14-5.- Fuel cell disconnection circuitry.

The voltage transient that was induced on the battery relay bus by the static discharge exceeded the current rate-of-change characteristics of the silicon controlled rectifiers in the fuel cell overload sensors and disconnected the fuel cells from the bus (fig. 14-5). As a result, the main bus loads of 75 amperes were being supplied totally by entry batteries A and B, and the main bus voltages dropped momentarily to approximately 18 or 19 volts, but recovered to 23 or 24 volts within a few milliseconds. The low dc voltage on the main buses resulted in the illumination of undervoltage warning lights, a drop out of the signal conditioning equipment, and a lower voltage input to the inverters. The momentary low-voltage input to the inverters resulted in a low output voltage which tripped the ac undervoltage sensor causing the ac bus 1 fail light to illuminate. The transient that disconnected the fuel cells from the buses also caused the silicon controlled rectifier in the overload circuits to indicate an ac overload. At 2 minutes 22 seconds into the flight, the crew restored fuel cell power to the buses. All bus voltages remained normal throughout the remainder of the flight.

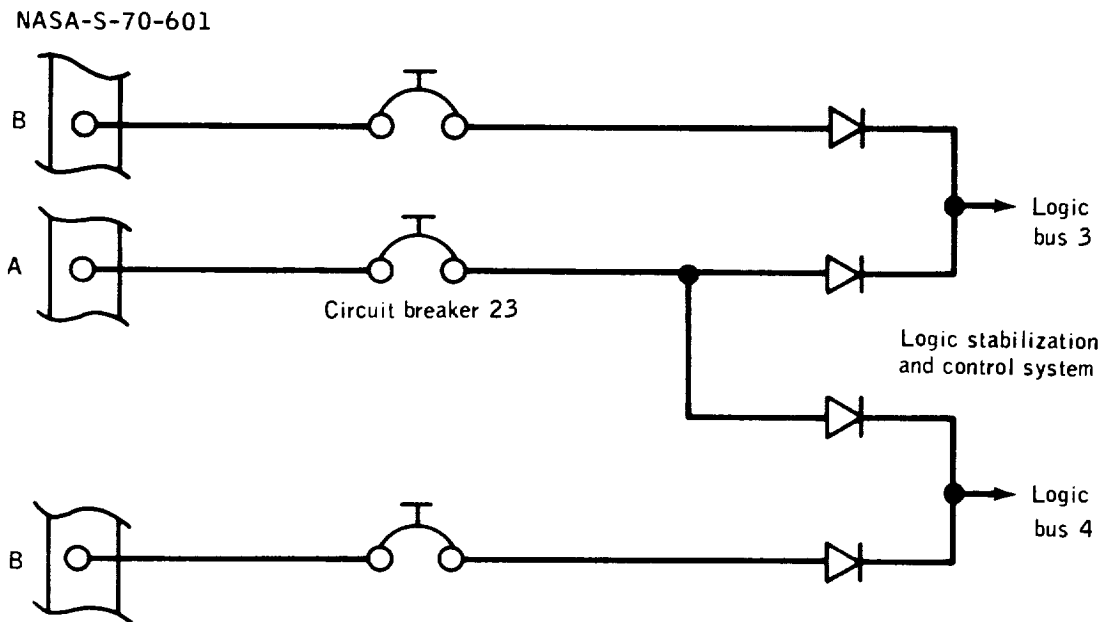
Figure 14-6.- Stabilization and control circuit breaker schematic.

it remained closed throughout the rest of the mission. Complete electrical and mechanical tests were performed and the results were normal. The circuit breaker and associated circuitry showed no cause for the breaker to have opened either because of launch vibrations or an electrical fault.

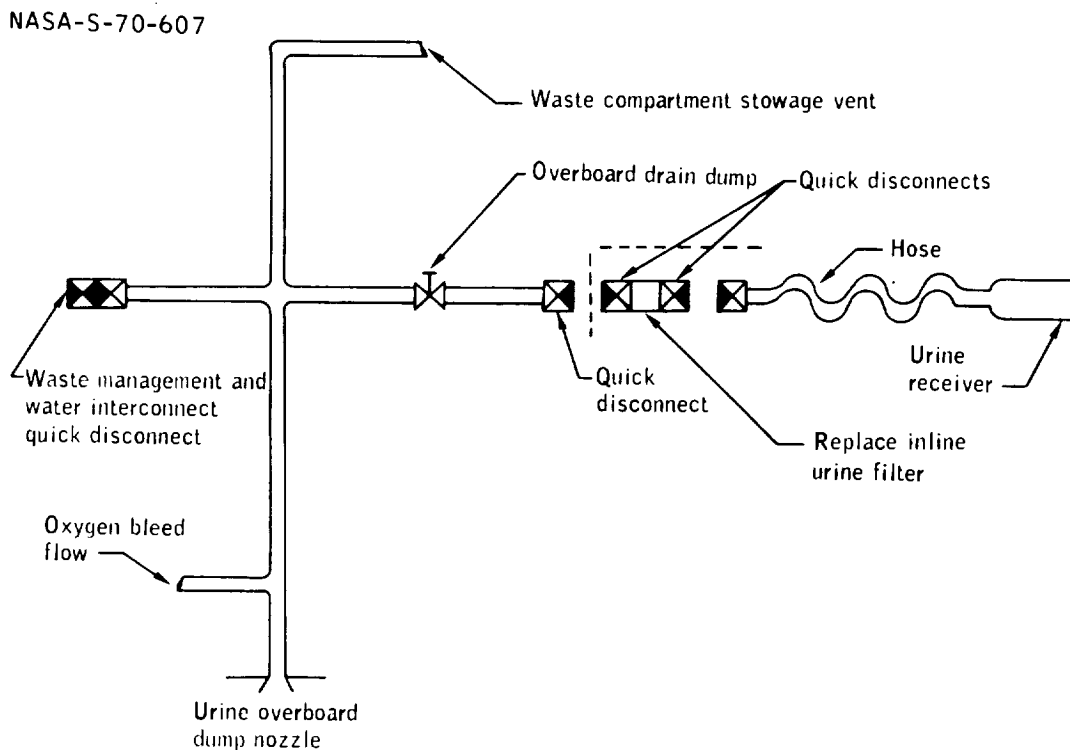
Figure 14-12.- Urine dump system flow schematic.

By about 215 hours, the crew reported that both urine filters had clogged and that the urine overboard dump system was being operated without a filter. The inline filter (fig. 14-12) clogged the day after the Commander and the Lunar Module Pilot returned to the command module from the lunar surface activity (day 7). The filter was then replaced by a spare unit which also clogged 2 days later. The urine dumping system operated satisfactorily without a filter for the remainder of the mission (approximately 30 hours).

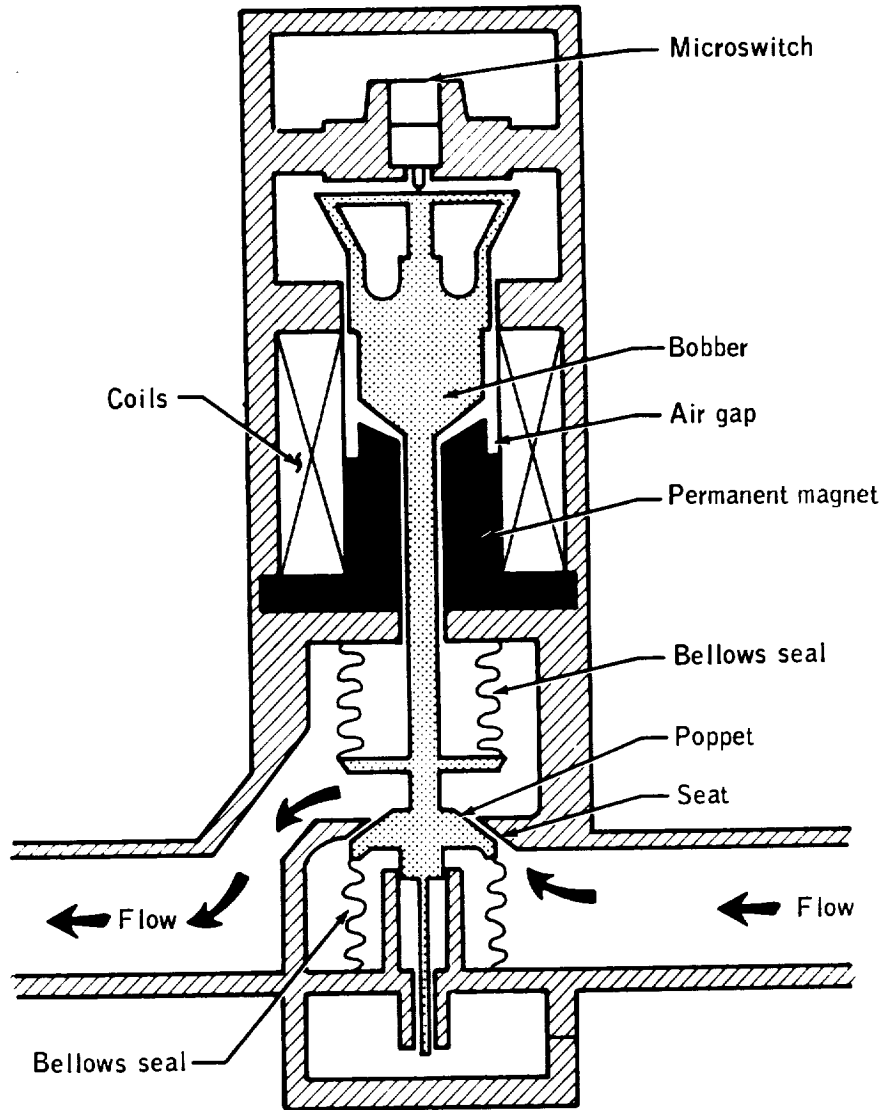
Figure 14-16.- Cross sectional view of reaction control system isolation valve.

When the oxidizer isolation valve was disassembled after flight, the inlet-side bellows had been deformed enough to prevent the valve from staying in the closed position. The bellows in the system 1 propellant

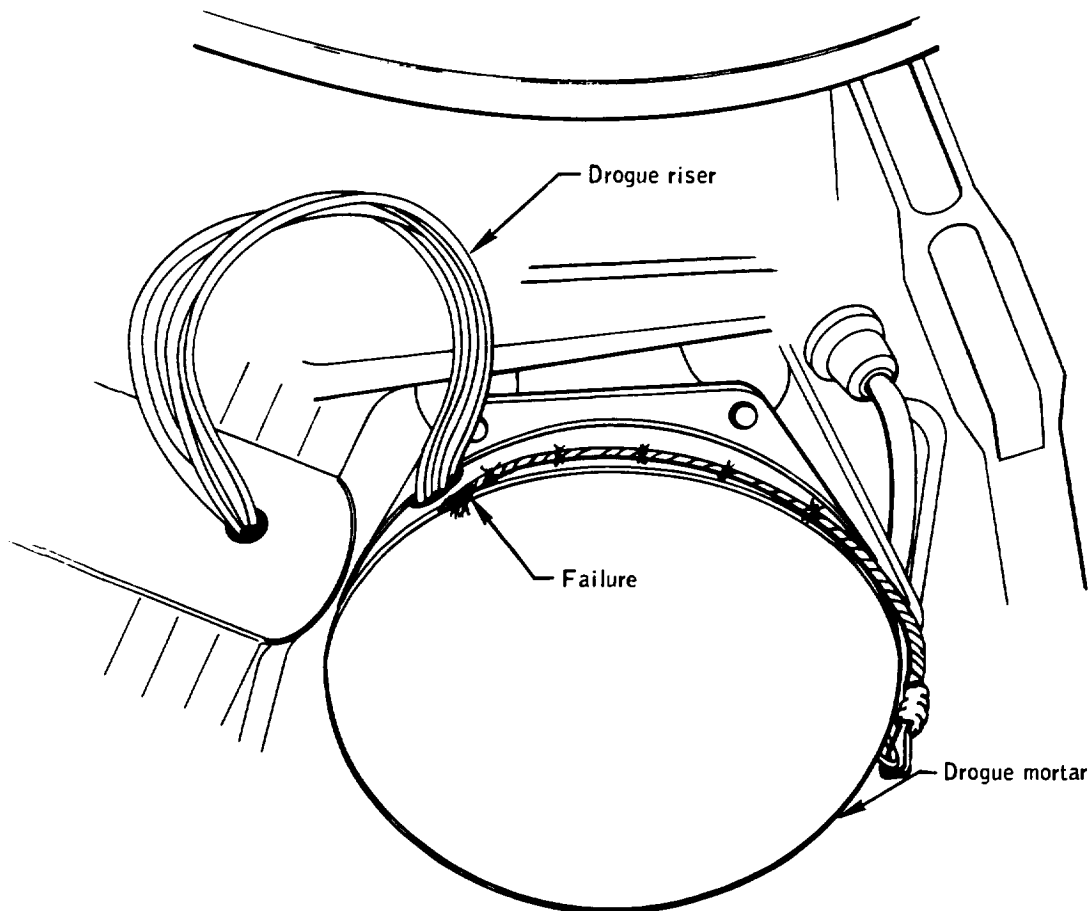
Figure 14-20.- Failed lanyard at right-hand drogue mortar.

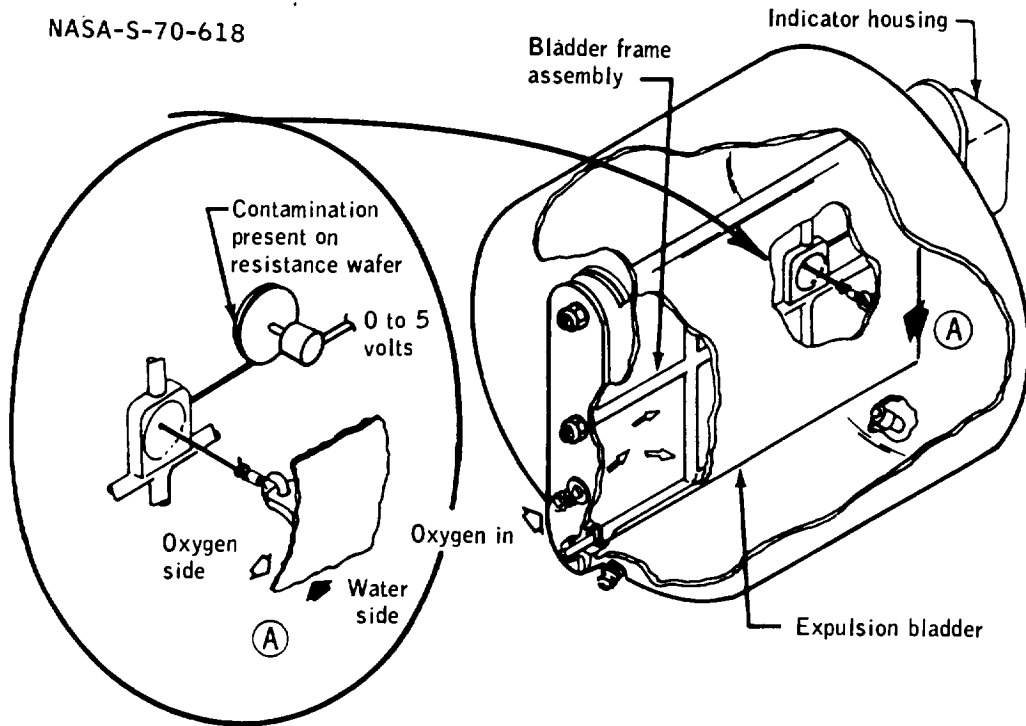
Figure 14-23.- Area of failure in erratic potable water transducer.

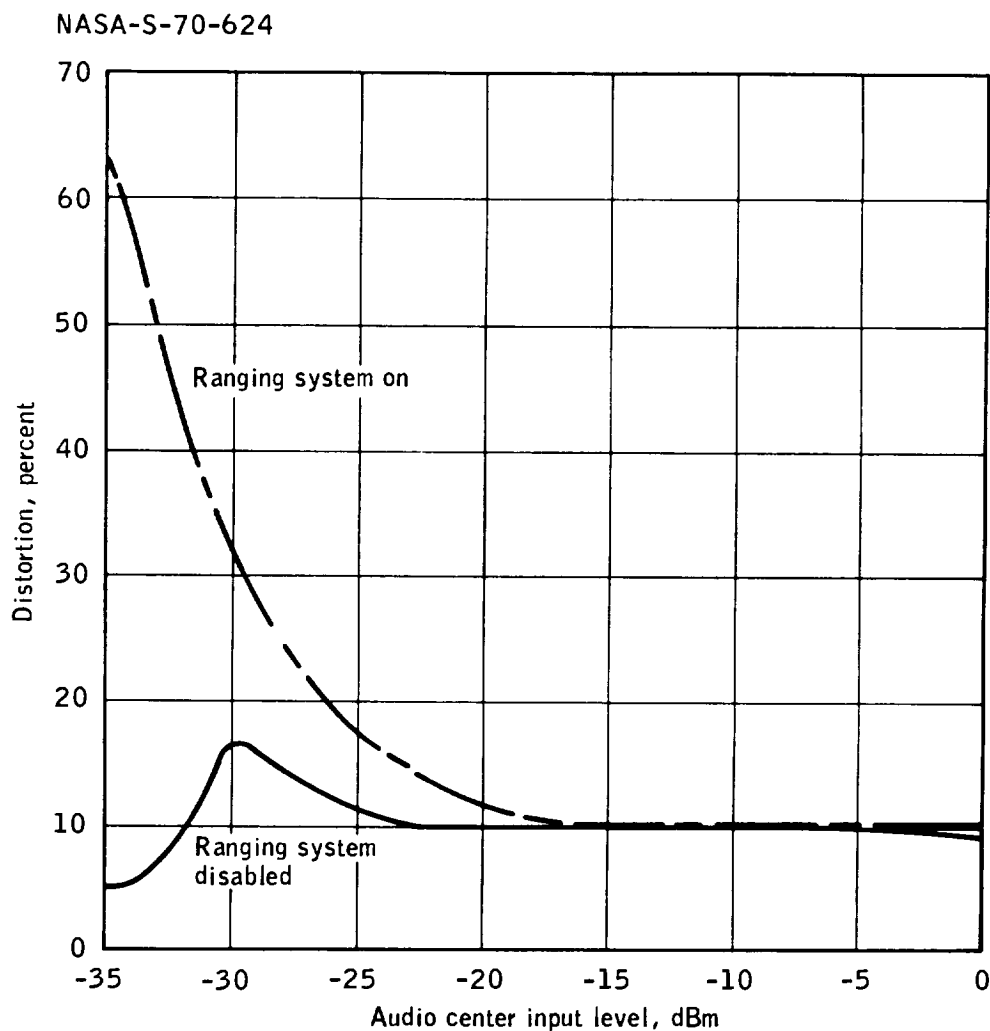
reduced level can then cause a voice-operated dropout of the voice operated transmitter. Such dropout did not occur at this time, because the Command Module Pilot was using the push-to-talk mode. Figure 14-29 shows the percent distortion of the lunar module received signal versus the command module audio center input, both with and without ranging. The curve shows that, in the ranging mode as the input level to the audio center decreases, distortion of the received signal increases significantly. This distortion cannot be directly related to intelligibility, but it does indicate that system performance is degraded by the low input levels.

Figure 14-29.- Lunar module received VHF audio distortion.

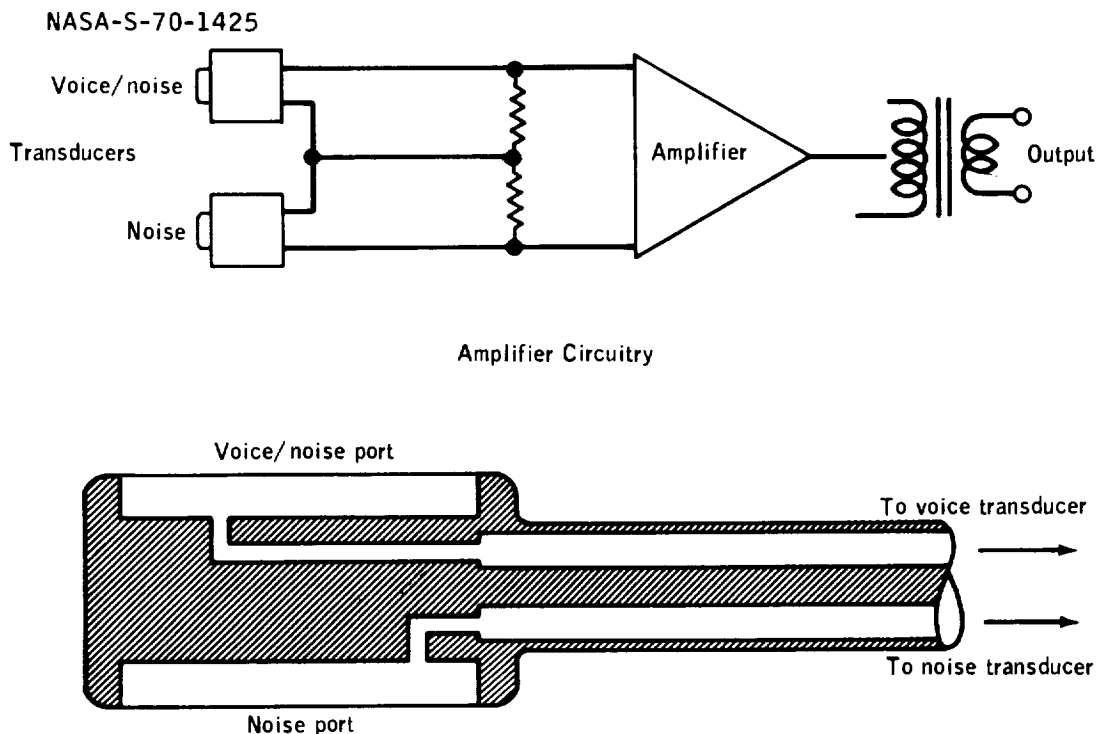
Figure 14-30.- Headset microphone voice/noise ports and amplifier circuitry.

The headset microphone was designed to provide noise cancelling through mechanical spacing of the voice-capture and noise-cancelling ports (fig. 14-30). The output of the microphone amplifier is the amplified difference between the voice and noise transducer outputs. Therefore, with improper microphone placement, voice transmissions also enter the noise port, partially cancel transmissions entering the voice port, and thereby reduce the overall voice output level.

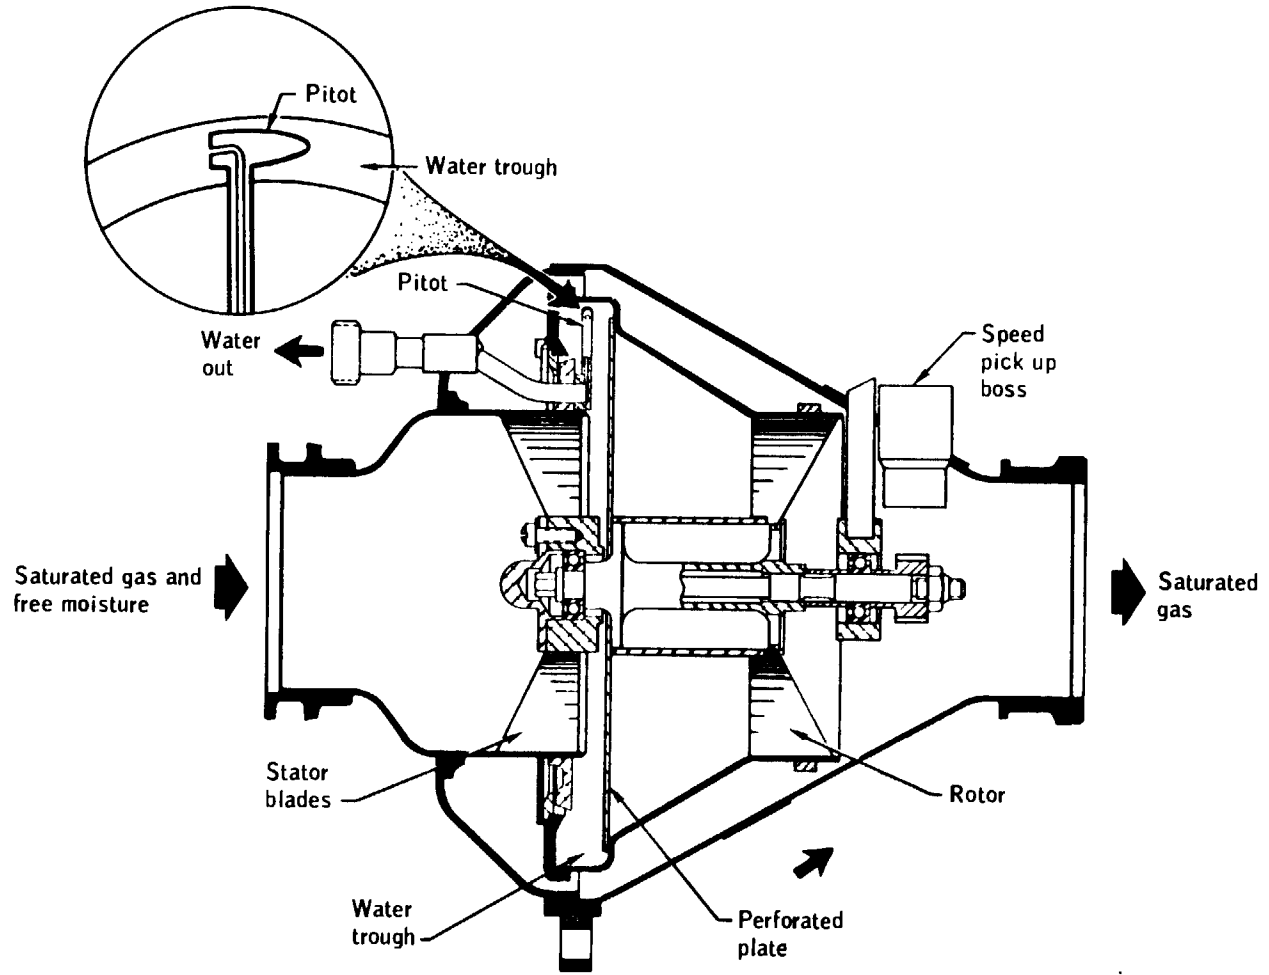
Figure 14-31.- Water separator and pitot configuration.

The water separator speed indication was above the upper limit (in excess of 3600 revolutions per minute) for about 50 percent of the mission. Since the water separator is a gas-driven centrifugal pump, this high speed indicates a higher than normal gas flow through the separator. Tests have shown that, at separator speeds in excess of 3700 revolutions per minute, water splashing occurs at the pitot tube (fig. 14-31) allowing water to bypass the separator.
