EXPERIENCE IN IN-SITU REPAIR WELDING OF STEAM TURBINE SHROUDS AND BLADES

S.K. Albert, V. Ramasubbu, C.R. Das, A.K. Bhaduri, S.K. Ray and Baldev Raj
Metallurgy and Materials Group, Indira Gandhi Centre for Atomic Research, Kalpakkam 603 102, India

Abstract

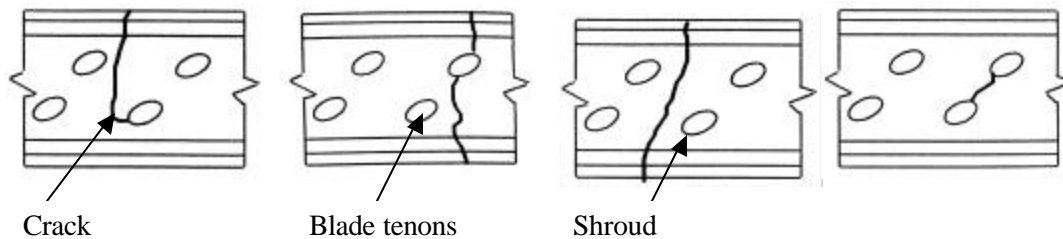
Fig. 1(a): Schematic of the type of cracks observed in the shrouds of stage-III LP turbine

Although the causes for the frequent cracking of the steam turbine shrouds and blades have not been analysed systematically, it has been observed that the cracks often originated from the tenon holes in the shrouds or lacing holes in the blades, (Fig. 1), without any indication of gross plastic deformation near the crack. In addition, minor variations in the grid frequency from 50 Hz can significantly increase the vibration levels during operation of the turbine. These suggest that the cracking could have been caused due to high cycle fatigue. Hence, it is important to study the performance of the repair-welded joints as also of the shroud/blade material under high-cycle fatigue conditions in order to increase the level of confidence of the repair-welding procedure adopted.

The first task for executing the actual repair is the removal of the existing crack by careful grinding. In the case of the shrouds, many cracks were observed to have initiated from the tenon holes. Hence, the blade tenons were partly ground off to expose the crack completely. The blade tenons were then subsequently built-up to their original shape by re-welding and

machining. After removal of the crack, Dye Penetrant Testing, (DPT), was carried out to ensure complete removal of the crack. Subsequently, using fine grinding tools, a weld groove with a groove angle of about 70° was prepared for weld deposition.

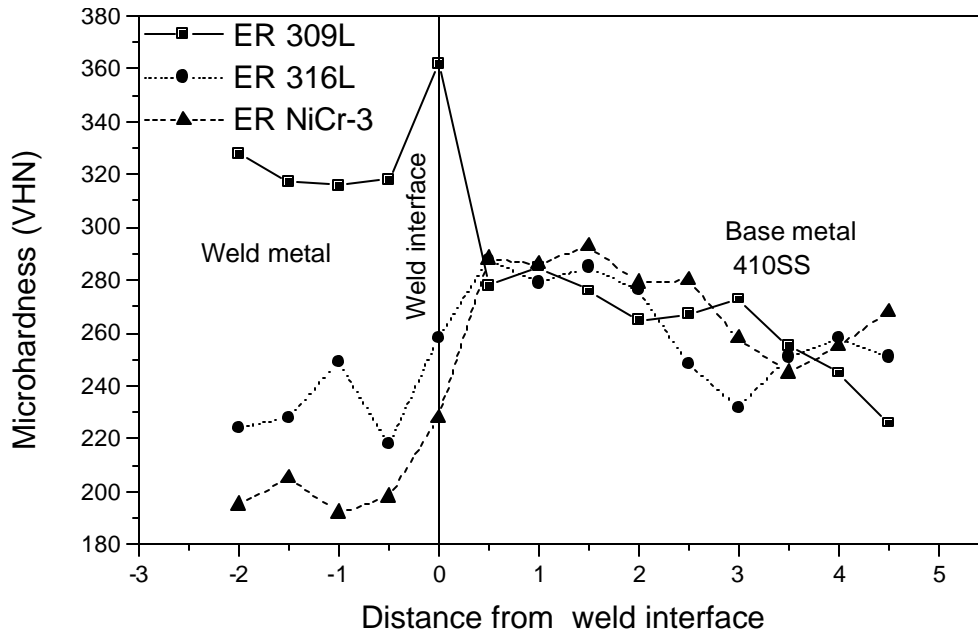
Fig. 2: Hardness profile after 873K/1h PWHT across the fusion line for welds prepared using three different welding consumables during procedure development.

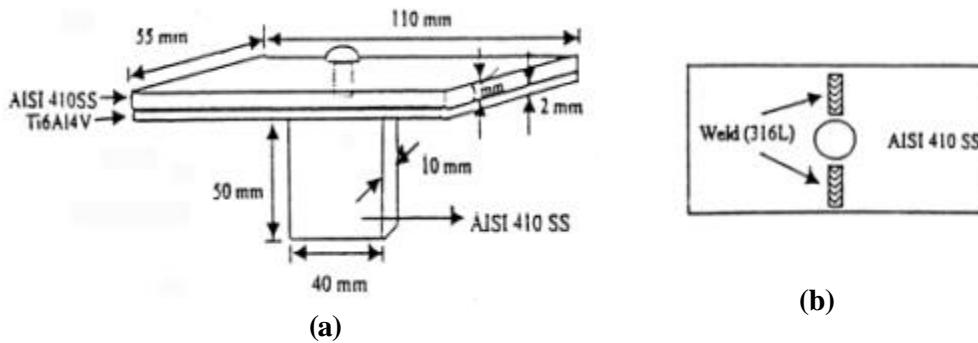
demonstrate that during repair welding, no inadvertent welding of the shroud piece with either the blade or the understrap takes place. For this purpose, a mock up assembly that simulates the presence of understrap, blade and tenon hole in the shroud, as shown in Fig. 3(a), was prepared. Welding was carried out using the optimised parameters on top of this assembly as shown in Fig. 3(b) and it was possible to successfully demonstrate that repair welding can be carried out by a skilled welder without causing any damage to both the understrap and blade by carefully controlling the welding parameters.

Fig. 3: *Mock-up for welding of the shroud at a location where blade and understrap are riveted: (a) mock-up assembly; and (b) top view of the assembly after welding.*

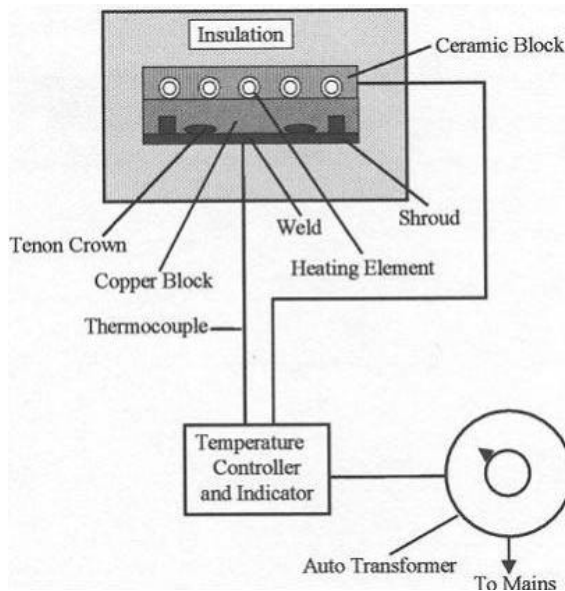
Fig. 5(a): Schematic of the heat treatment set up used for localised in-situ PWHT of a shroud repair weld

transfer to the weldment. Good insulation all around the heater and the location of the heat treatment were employed to minimise heat loss to the atmosphere. A schematic of the heat treatment set-up employed for localised in-situ PWHT is shown in Fig. 5(a), and a typical on-site heat treatment cycle used is shown in Fig. 5(b). A similar set-up was used for PWHT of the repair welds of the blades. As the repair weld was in a relatively flat portion of the blade, it was possible to remove the blade from the turbine for repair, and thus both repair welding and PWHT was much easily executed for the blades than for the shrouds.

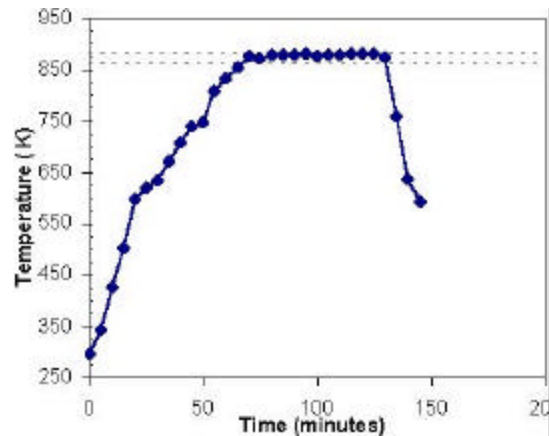
Fig. 5(b): A typical heat treatment cycle employed during onsite localised PWHT of a repair weld

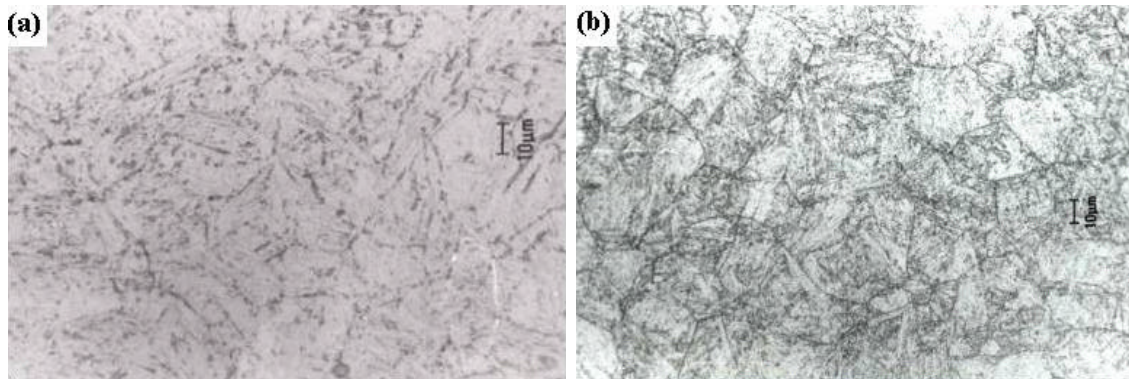
As mentioned earlier, the repair welding procedure was qualified using AISI 410 SS pipe material and not on actual shroud or blade material. Hence, microstructural examinations and hardness measurements on the actual shroud welds in the as-welded and PWHT conditions could not be carried out during the procedure development stage. Further, during actual repair welding, it was not possible to measure the hardness of the HAZ of the repair welds. However, confidence with respect to success of the repair welding procedure would be significantly better with the availability of HAZ hardness data in the as-welded and PWHT conditions on the actual shroud/blade material. During one of the repair welding operations, an actual shroud piece was made available for carrying out welding and subsequent laboratory investigations. A weld pad was prepared using this shroud piece employing the same welding parameters that were employed for the actual repair. One part of this welded test-piece was retained in the as-welded condition, while the other part was subjected to PWHT similar to that employed during the actual repair welding, and microstructural examination and hardness measurement were carried out on these two test-pieces. Figure 8 shows the microstructures of the HAZ in the as-welded and PWHT conditions. The microstructure of the HAZ in the as-welded condition (Fig. 8a) consists of fully untempered martensite, while that after PWHT (Fig. 8b) shows substantial tempering of the martensite with its microstructure being similar to that observed in the in-situ metallographs of the actual repair-welded shroud (Fig. 6). The

Fig. 8: Microstructures of the HAZ in the actual shroud material examined in the laboratory: (a) in as-welded condition and (b) after 873 K/1 h PWHT

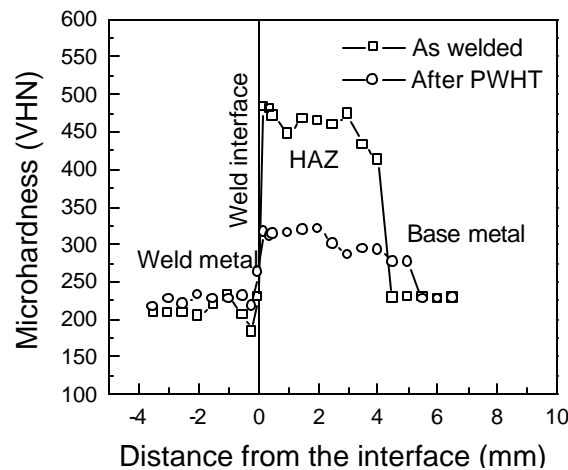
microhardness profile across the weld/base metal interface before and after PWHT (Fig. 9) shows that the hardness of the HAZ decreases from above 450 VHN in the as-welded condition to about 300 VHN after the 873 K/1 h PWHT, thereby confirming the adequacy of the PWHT carried out on the repair-welded shroud.

Fig. 9: Microhardness profile across the weld/base metal interface in the actual shroud material: (a) in as-welded condition and (b) after 873 K/1 h PWHT
