Proceedings of National Irrigation Seminar on Micro to Megha: Irrigation for Prosperous Nepal, 13-14 July, 2011, Department of Irrigation, Lawalakhel, Lalitpur, Nepal.

Seepage analysis underneath the headwork of Chanda Mohana Irrigation Scheme, Sunsari, Nepal

Santosh Kaini, MSc¹, L.G.Hayde, PhD², Bart Schultz, PhD³, Miroslav Marenc, PhD⁴

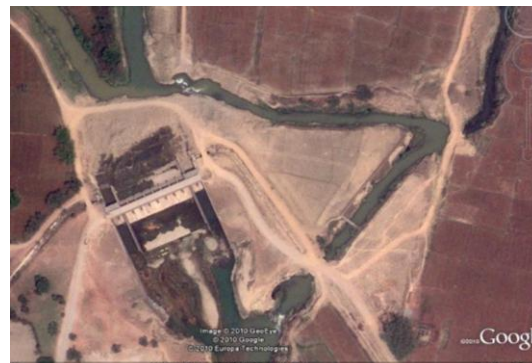
Figure 2: Layout map of CMIS after failure(Google-Earth, 2010)

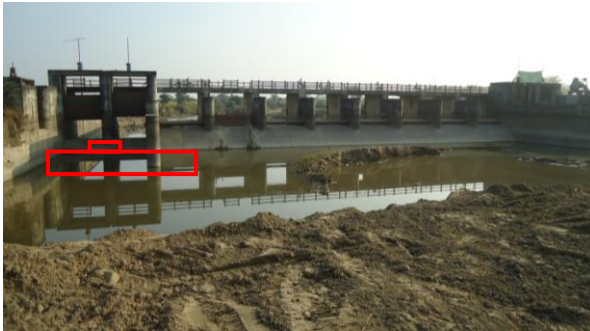
It was seen that the weir structure with its under-sluice had piping problem where water was seeping through downstream floor. The boiling at the downstream was seen. It had created big hollow at the upstream floor near the left divide wall in under-sluice portion and the upstream floor was cracked and settled (Prasad, 2010).

According to the engineers involved in that scheme, the settlement had an area of about 5 m x 3 m at the upstream of under-sluice portion. After diverting the water into the Jala Khola, it was noticed that the height of hollow was about 2 m and the hollow was beneath the foundation of abutment wall too. Furthermore, the hollow was also formed not only towards divide wall but also towards the downstream portion as well. The connection of hollow along upstream of weir portion near divide wall, divide wall, under-sluice portion and abutment wall was observed. The red rectangular area in Figure 3 shows the hollow formed area at upstream floor. The settlement of abutment wall also observed. Due to this, the gate of under-sluice portion was also tilted towards east. In addition to this, the gaps in the joints of the bridge deck were also increased due to the settlement of floor and abutment wall and this is shown by red rectangles in Figure 4.

Figure 3: Hollow formed area at U/S floor

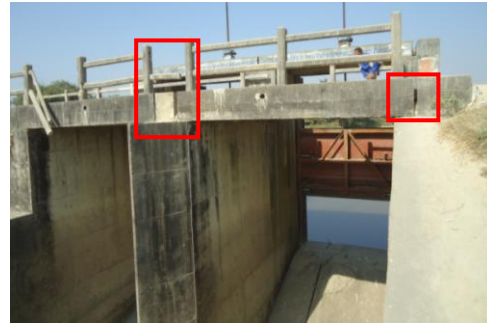
Figure 4: Increased gap in bridge deck slab joints

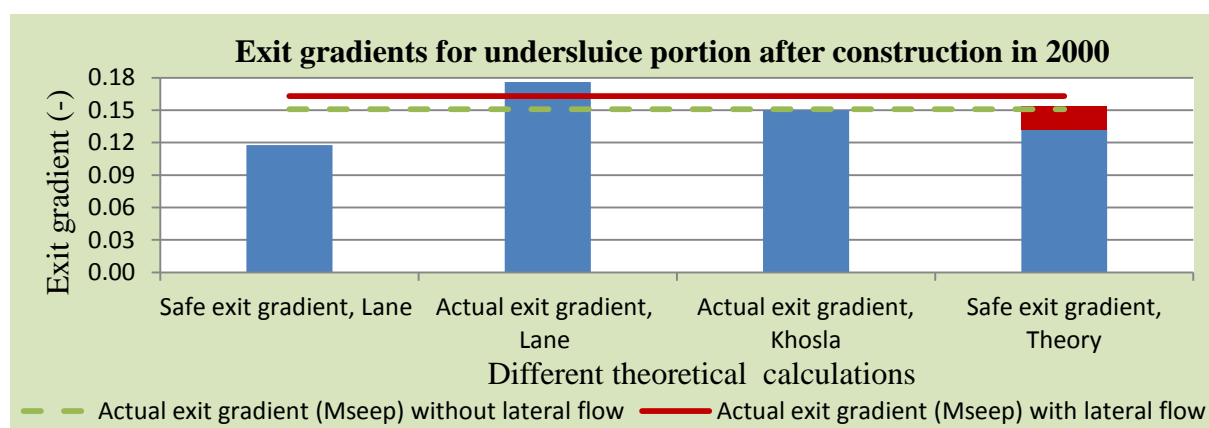
Lower limit = $(1-0.48) \times (2.78-1)/7 = 0.132$ (considering safety factor of 7)

Upper limit = $(1-0.48) \times (2.78-1)/6 = 0.154$ (considering safety factor of 6)

Figure 12: Comparison of exit gradients for under-sluice portion under Scenario-I

The exit gradient as per Lane is also greater than his safe recommended exit gradient. The red dark shaded area in Figure 12 for safe exit gradient, Theory is the maximum permissible exit gradient. Although the lower values of exit gradient are safe for structure, it increases the cost. The red shaded area is the range for economical constructions with safe structure. This shows that exit gradient without lateral flow is within the maximum safe limit. Exit gradient by Khosla does not consider the effect of lateral seepage flow. So, it is lower than the actual exit gradient. The actual exit gradient without lateral flow is almost same with the exit gradient by Khosla. As the maximum limit of safe exit gradient was exceeded with the lateral flow into the under-sluice portion, the structure might have failed due to piping action in 2000 during the commissioning period.

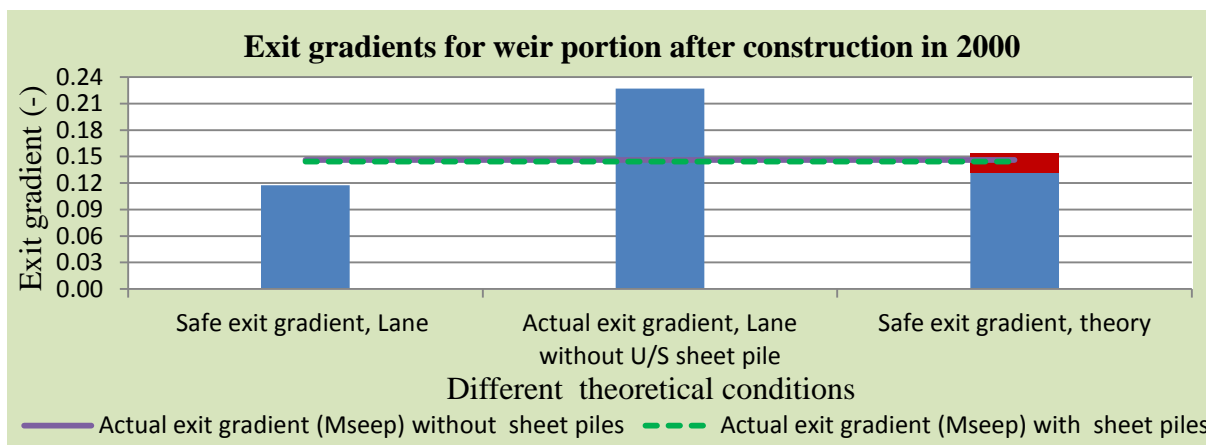
Exit gradients for weir portion are shown in Figure 13. It shows that the upstream sheet pile does not have vital role in reducing the exit gradient. It might be because of the bottom level of upstream cut-off wall and bottom of upstream sheet pile is only 0.60 m. The exit gradient, Lane is higher than recommended by him. The exit gradient from model is within the maximum theoretical permissible limit. Although the exit gradient is not much affected by the absence of upstream sheet pile, it might have provided a path for the seepage water to flow from weir portion to under-sluice portion. Since the residual head at the weir portion was greater than the residual head at under-sluice portion, the absence of upstream sheet pile might have become a favourable condition to flow seepage water into under-sluice portion. This was reflected at site as well at 2010 failure condition as hollow beneath the structure was expanded from under-sluice portion to the weir via this location.

Figure 13: Comparison of exit gradients for weir portion under Scenario-I

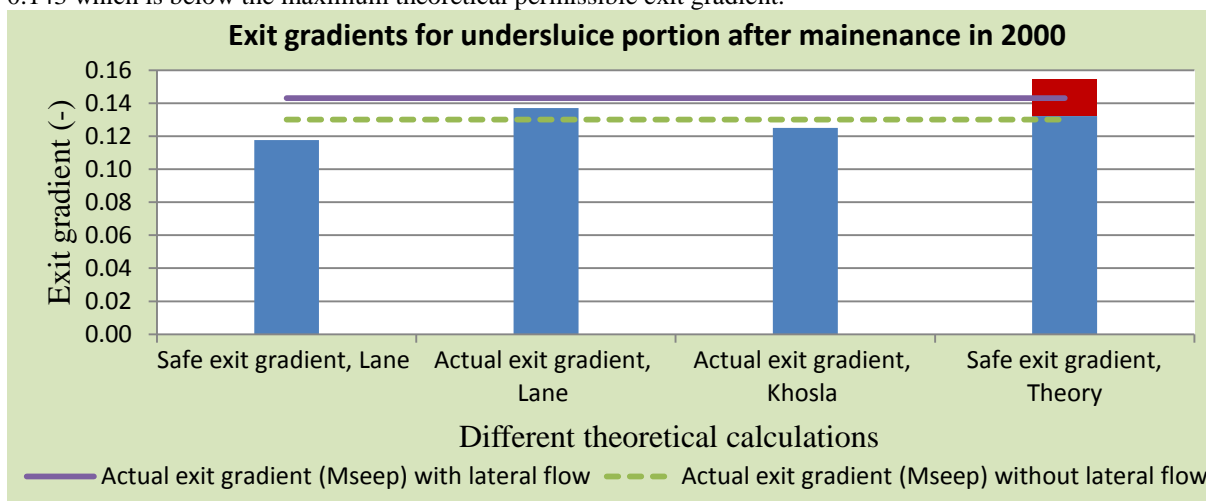
Figure 14: Comparison of exit gradients for under-sluice portion under Scenario-II

Figure 14 shows that the exit gradient according to Lane is greater than his safe recommended exit gradient. The actual exit gradient without considering lateral flow is slightly higher than exit gradient by Khosla. Both exit gradients are less than permissible theoretical exit gradient. Actual exit gradient with considering lateral flow is within the maximum theoretical permissible limit. As the maximum limit of safe exit gradient was not exceeded, the structure was safe. This result supports the site condition as the structure was functioning until 2009 after maintenance works in 2000. This shows that safe exit gradient by Lane assumes a higher safety factor.

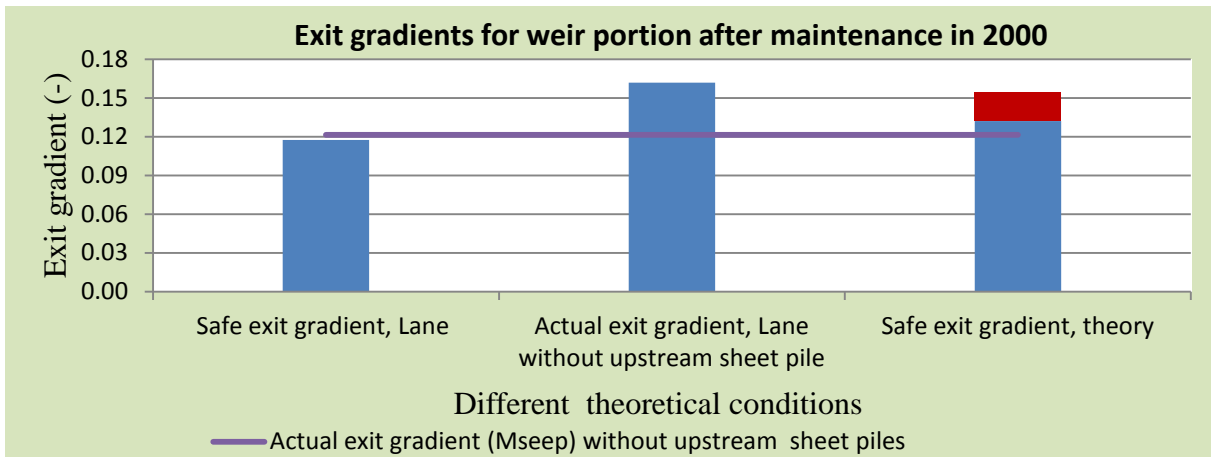
Figure 15: Comparison of exit gradients for weir portion under Scenario-II

From Figure 15, it is clear that the exit gradient, Lane is higher than recommended by him. In contrast, the exit gradient from model is within the safe theoretical permissible limit. It highly supports the site condition because the structure was functioning until 2009 after maintenance carried out in 2000. This illustrates that safe exit gradient by Lane assumes a high safety factor.

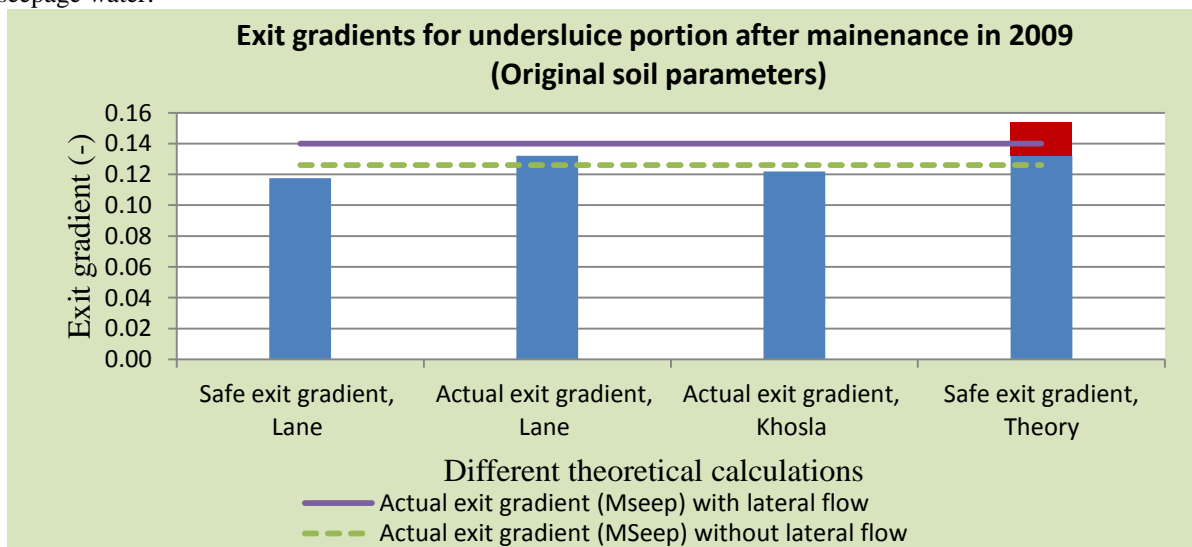
As shown in Figure 16, the exit gradient should have decreased after maintenance in 2009 if the soil parameters were same as previous in 2000. An exit gradient by Khosla (0.122) is slightly lower than the exit gradient by MSeep without considering lateral flow (0.126), both being less than permissible theoretical exit gradient. The lateral seepage discharge and actual exit gradient might be $2E-5 \text{ m}^3/\text{s}$ and 0.140 respectively. Failure in 2010 should not have occurred in this situation as the exit gradient, 0.140 was within permissible limit. But, the headwork failure was seen in 2010 which indicates the change in soil parameters due to sub soil erosion by seepage water.

Figure 16: Comparison of exit gradients for under-sluice portion for Scenario-III (Original soil parameters)

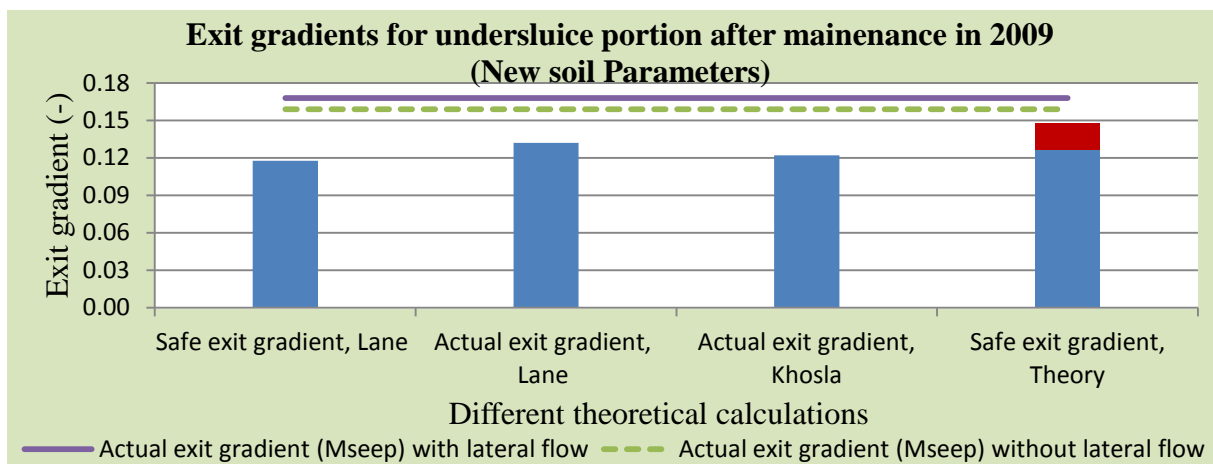
As a result of lateral flow, the head is increased and thus the exit gradient is increased to 0.168. Figure 17 shows that the exit gradient according to Lane is slightly greater than his safe recommended exit gradient. The exit gradient by MSeep without considering lateral seepage flow is much higher than exit gradient by Kholsa. This is due to the fact that Kholsa theory does not consider the effect of change in soil parameters like hydraulic conductivity, porosity. So, there is no change in exit gradient by Kholsa. Exit gradient with lateral flow (0.168) is above the maximum theoretical permissible limit (0.148). At site, the structure was failed in 2010 because of the exit gradient exceeded the maximum limit of safe exit gradient.

Figure 17: Comparison of exit gradients for under-sluice portion for Scenario-III (New soil parameters)

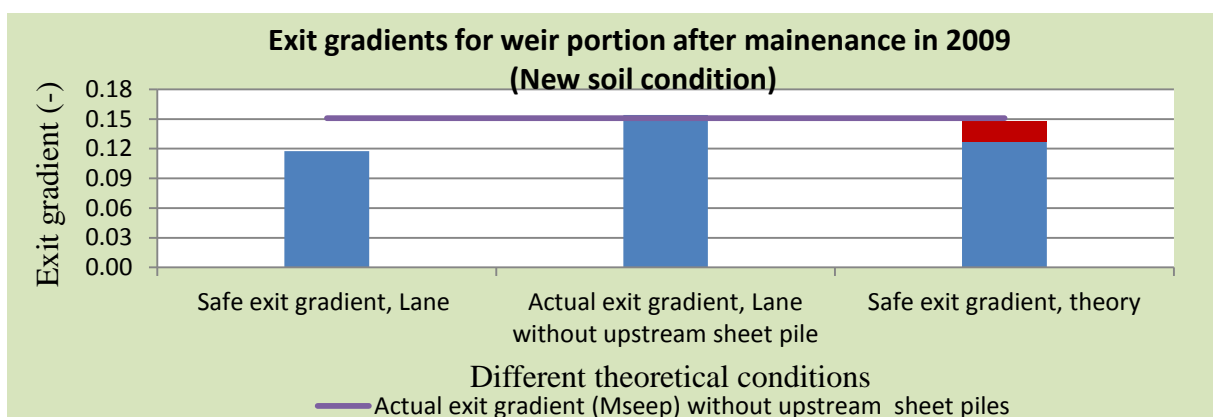
Exit gradients for weir portion are shown in Figure 18. The exit gradient, Lane is higher than recommended by him. The exit gradient from MSeep (0.151) is also higher than the maximum theoretical permissible limit (0.148) which made the structure fail in 2010.

Figure 18: Comparison of exit gradients for weir portion for Scenario-III (New soil parameters)

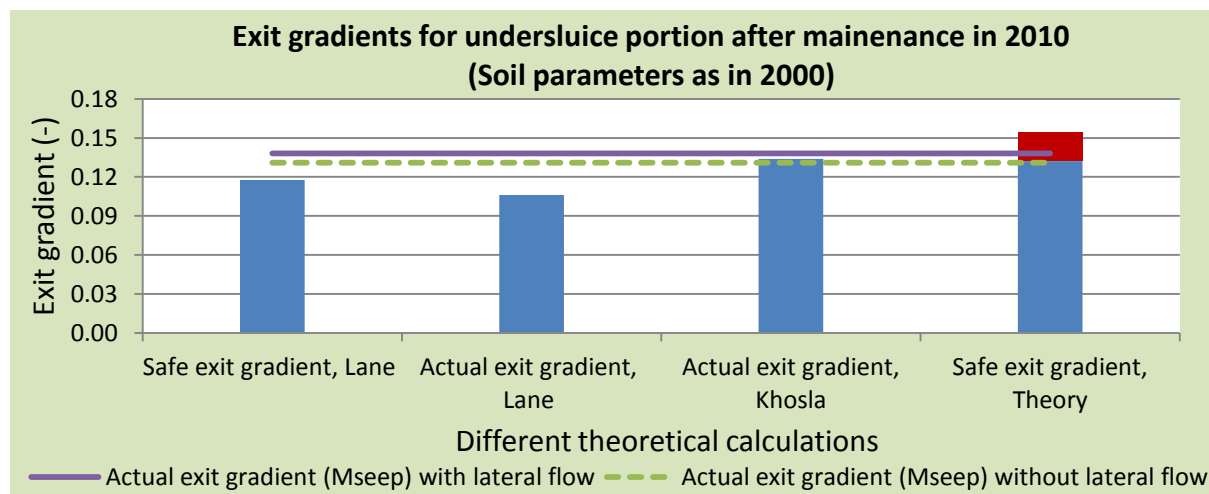
After the maintenance work of 2010, the hydraulic conductivity and porosity of sub soil decreases. Different exit gradients for under-sluice portion are shown in Figure 19 considering the soil parameters might have reached into original condition as in 2000. The graph shows that the structure is safe if the soil parameters have reached into original condition as in 2000. The structure is safe for all exit gradients. The exit gradient by MSeep without lateral flow (0.131) is almost same with exit gradient by Khosla (0.134) as the soil parameters are taken as in 2000. The exit gradient with lateral flow is 0.138.

Figure 19: Comparison of exit gradients for under-sluice portion for Scenario-IV (Original soil parameters)

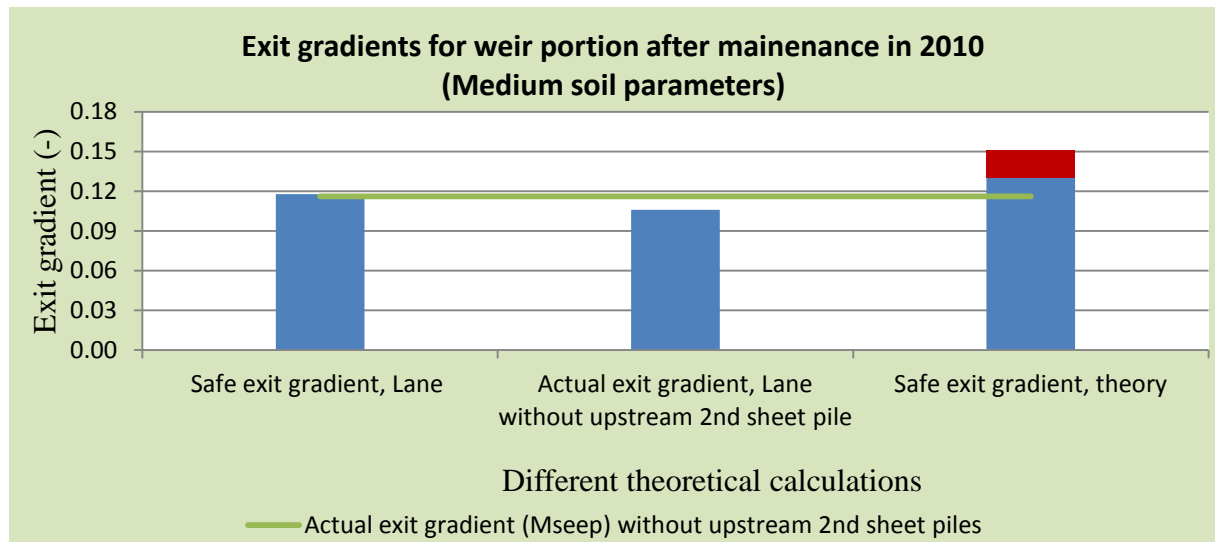
Figure 21: Comparison of exit gradients for weir portion for Scenario-IV (Medium soil parameters)

Figure 21 shows that exit gradient by Lane is less than the recommended exit gradient in the weir portion. In addition, exit gradient from MSeep is also less than theoretical permissible exit gradient after maintenance in 2010. This shows that further maintenance works are not needed for weir portion. So, no maintenance works are suggested for weir portion.

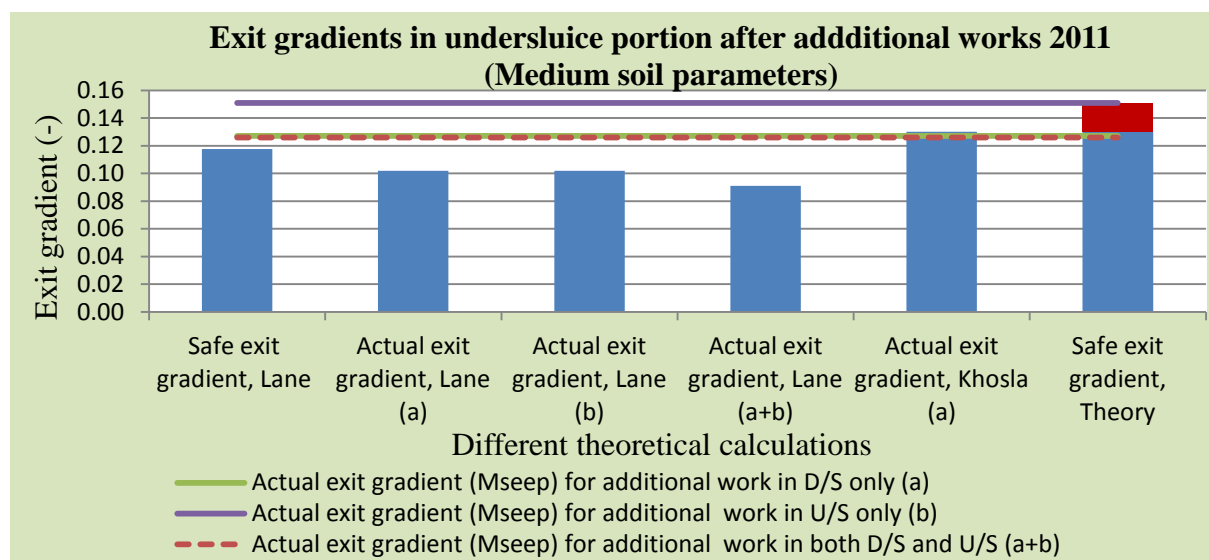
Figure 22: Comparison of exit gradients for under-sluice portion for Scenario-V

Figure 22 shows that there is no significant reduction in exit gradient due to additional work in upstream portion. The sheet piles at upstream mainly reduces pressure at the upstream floor. The upstream pile has little effect in reducing the pressures at the downstream portion as the spacing of the upstream and downstream sheet piles is generally much more than the range of influence of either (Khosla *et al.*, 1962). This argument is supported by Figure 22. As the additional work in upstream as well as in both upstream and downstream is not effective to reduce the exit gradient, it will be more economical to implement additional work in downstream portion only. Therefore, additional impervious downstream floor and sheet pile is necessary for the safety of the structure.

2. The results from the MSeep model suggested that the current ongoing maintenance work is not still safe from failure of headwork. Therefore, the findings of the research strongly recommend to have an additional impervious floor of 9 m with sheet pile of 4 m depth at of the downstream of the headwork.
