High temperature boiler tube failures – Case studies

S. CHAUDHURI and R. SINGH

National Metallurgical Laboratory, Jamshedpur - 831 007, India

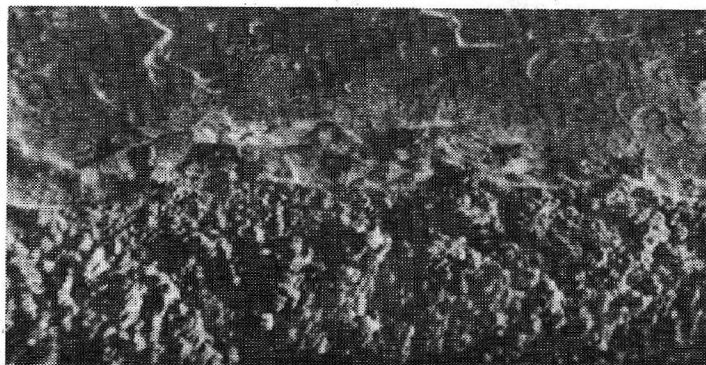
Fig. 1 : Extensive damage on outersurface of a failed reheater tube

The tube had suffered extensive damage on the outer surface in the form of pits. The dimension of the pits at some places were as big as 40 mm x 10 mm with a maximum depth of 2 mm. The pitted surface bore brownish colour in contrast to the damage free surfaces of the tube. The latter bore usual black oxide. The failure had occurred after about 24,000 hours of service life.

Ash particles of low fusion point can fuse and stick on the tube surfaces at such temperatures. It may be noted that alkali metals along with S and Fe can form ash with fusion temperature as low as 620°C . The fuel oil used for the support can also cause this problem if the oil contains corrosive elements like V and S. Tube wall thinning due to sticking of fly ash particles is primarily responsible for the failure of the reheater tube.

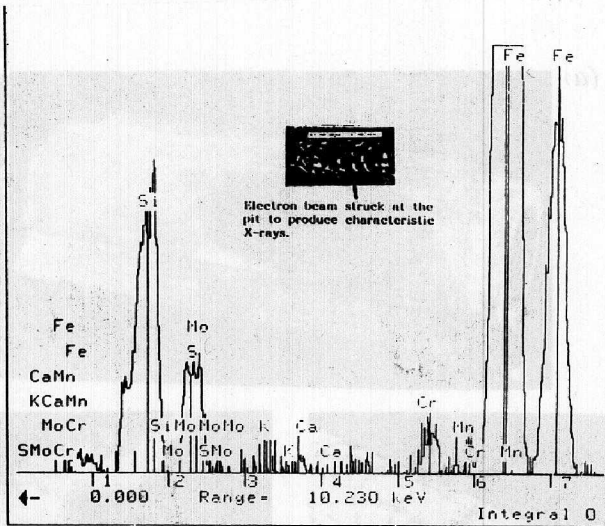
Since the tube showed extensive pitted surfaces, x-ray microanalysis using SEM was carried out on the pitted surfaces to ascertain the presence of corrosive elements. The results of the analysis are given in Fig. 2. The presence of highly corrosive elements like K and Cl were observed. The other elements present in the pitted surface as evident from Fig. 2 were Ca, Si and S. The presence of these elements suggested that the attack was caused by the fusion of ash particles. Such attack usually occurs due to :

Fig. 2 : Presence of corrosive elements (Si, S, K etc.) on pitted surface of reheater tube

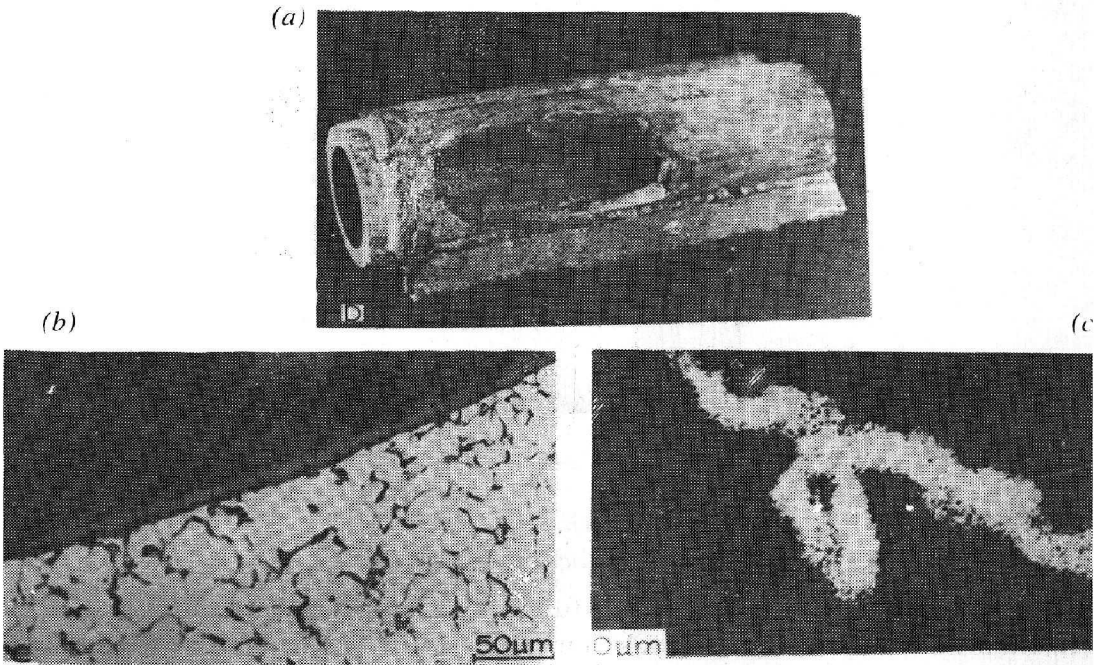
Figure 3(a) shows a failed carbon steel tube. The outer diameter and thickness of the tube are 45 mm and 4.5 mm respectively. The fracture was of the brittle window type, without the fish mouth appearance which is a characteristic of over heating failure. Visual examination showed a substantial degree of corrosion on the water surface leaving a rough area in the vicinity of rupture. Microstructural examination of a cross section through tube wall, as shown in Fig. 3(b), revealed decarburisation and extensive discontinuous intergranular cracking. The presence of laminated oxide layer (Fig. 3(b)) and concentration of chlorides at the interface between oxide and metal at the base of corrosion pits (Fig. 3(c)) are also evident from microstructural examination. The combination of water side corrosion (oxidation), decarburisation and intergranular cracking, as observed in this case, led to the conclusion that the tube had failed because of hydrogen damage involving the formation of methane by the reaction of dissolved hydrogen with carbon in steel

Fig. 3: (a) Brittle window type fracture of a carbon steel tube, (b) Microstructure, through tube wall near rupture, revealing decarburised metal and extensive discontinuous intergranular cracking and (c) Microstructure revealing chloride distribution at the interface between oxide and metal at corrosion pits.

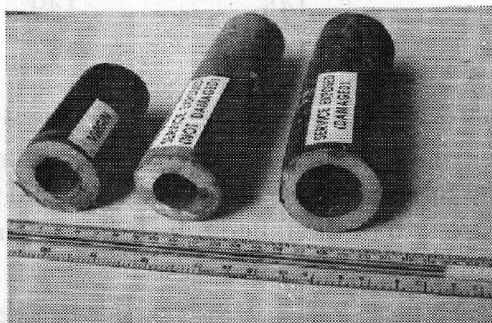
Fig. 4 : Virgin, undamaged and failed final superheater tubes of a 500 MW boiler

The chemical composition of the failed and virgin tube, reported in Table 2, indicates that the chemistry of both tubes meets the ASTM specification. The outer diameter of the failed tube was found to be 49.2 mm against the original diameter of 44.5. The most significant point in this case is the gross circumferential expansion of the failed tube upto about 19%. Such an extensive expansion cannot be expected under normal operating condition within a short span of service exposure of about 100 hours.

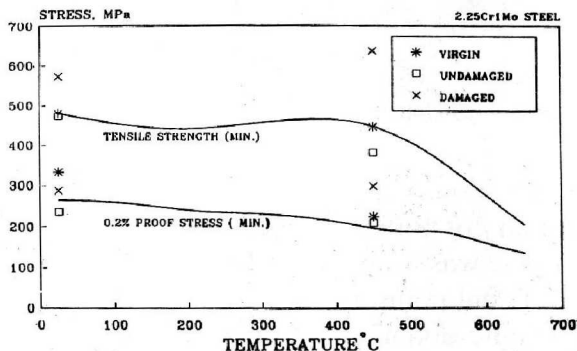
The tensile properties of all tubes, as shown in Fig. 5, revealed that irrespective of test temperature all the tubes meet the minimum specified properties of 2.25Cr–1Mo steel. The tensile strength of the failed tube is, however, significantly higher than that of the other tubes.

Fig. 5: Tensile properties of virgin, undamaged and failed final superheater tubes of a 500 MW boiler

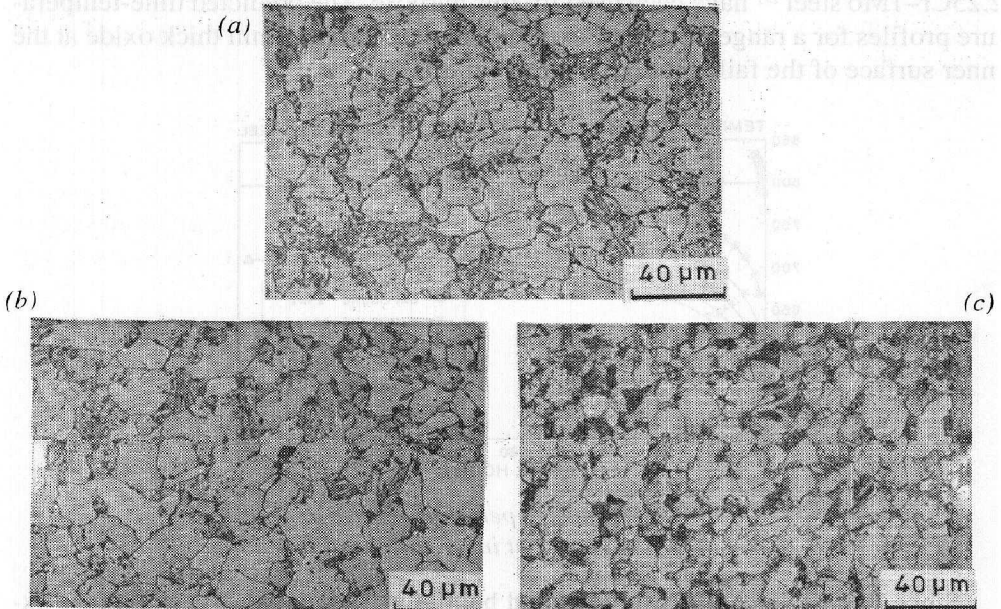
The microstructures of virgin (Fig. 6a) and undamaged (Fig. 6b) tubes are almost similar, consisting of ferrite and tempered bainite. In contrast the microstructure of the failed tube (Fig. 6c) showed the presence of freshly formed bainitic areas. Besides, the oxide scale thickness on the inner surface of the failed tube (Fig. 7a) was found to be several folds more than that of the undamaged tube (Fig. 7b). In the failed tube the oxide scale thickness was of the order of 0.25 mm.

Fig. 6 : Microstructures of (a) Virgin tube consisting of ferrite and tempered bainite; (b) Undamaged tube consisting of ferrite and tempered bainite and (c) Failed tube showing freshly formed bainitic areas

All the above observations can be reconciled in a situation only if the temperature had exceeded the lower critical temperature which is reported to be about 800°C for 2.25Cr-1Mo steel.

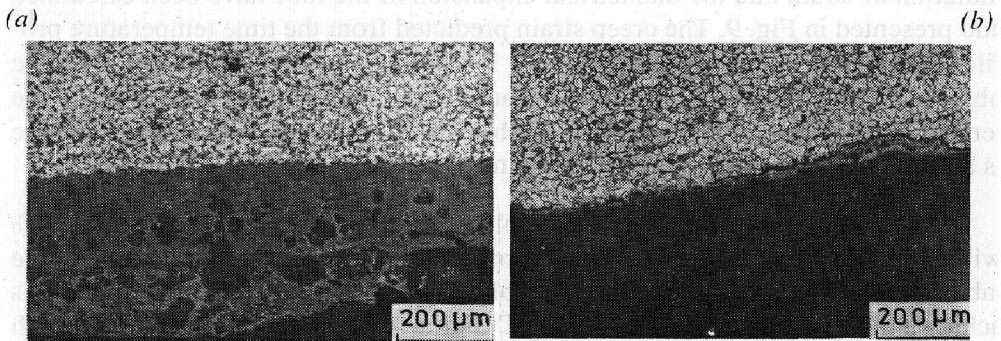
Fig. 7 : (a) 0.25 mm thick oxide scale at inner surface of failed tube and (b) Insignificant oxide scale at inner surface of undamaged tube

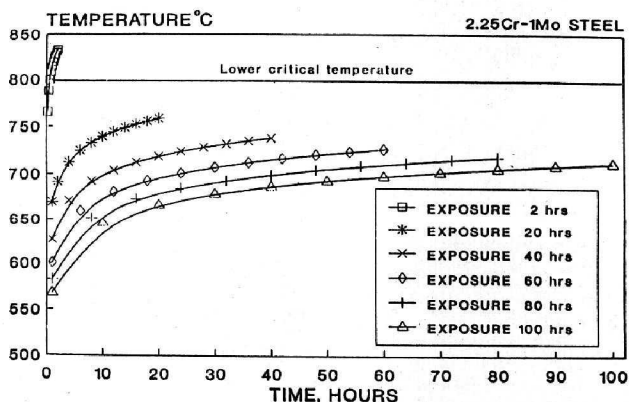
In order to predict the extent of temperature excursion beyond the critical temperature some detailed analysis was made based on oxide thickness as obtained on the inner surface of the failed tube. Published kinetic data on oxide scale growth of 2.25Cr-1Mo steel [5] have been used for this purpose. The predicted time-temperature profiles for a range of service exposure to develop 0.25 mm thick oxide at the inner surface of the failed tube are shown in Fig. 8.

Fig. 8: Predicted time temperature profiles to develop 0.25 mm thick oxide layer at inner surface of failed tube.

Since the presence of freshly formed bainite is indicative of temperature excursion beyond the lower critical temperature, the most probable profile that the tube experienced is the one having an exposure of 2 hours, the maximum temperature being 830°C . Corresponding to each time-temperature profile (Fig. 8), accumulation of strain and the diametrical expansion of the tube have been calculated and presented in Fig. 9. The creep strain predicted from the time temperature profile for 2 hours exposure comes to about 1% which is indeed quite lower than the observed value of 19%. It is mainly because the existing material database in the temperature range of 500°C to 600°C has been used for extrapolation. Clearly there is a need to collect creep data at temperatures beyond 600°C .

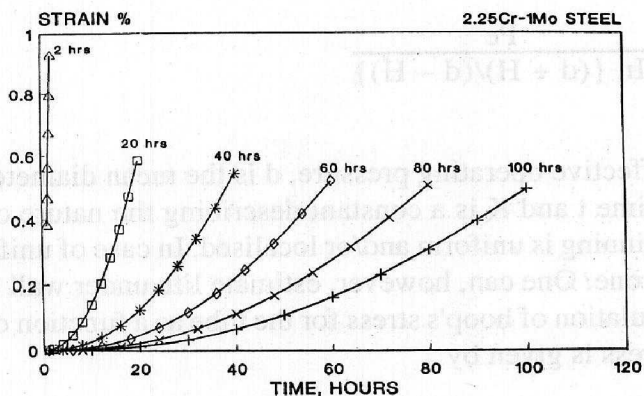
In order to ensure whether it is possible to achieve a creep strain of about 19% within a short time at 830°C , a short term creep test has been carried out in the laboratory. Based on this it has been established that a creep strain of about 16% is achievable in less than 2 hours at 830°C and at a stress level of 30 MPa which represents the hoop stress corresponding to the maximum operating pressure of 185 kg/cm^2 for the tube in question. This, therefore, conclusively proves that the

Fig. 9: Predicted creep strain corresponding to time temperature profiles shown in Fig. 8

failure of the tube took place due to short term overheating to a temperature of about 830°C. Partial choking of the tube by some foreign material could be responsible for such overheating. The other tubes, however, did not suffer any heavy temperature excursion beyond 650°C.

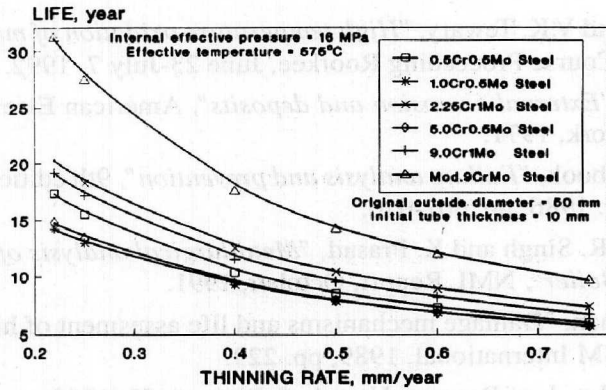
Comparative study following this showed that for a wide range of thinning rate and tube wall thickness, the longest life and resistance to creep damage is achievable in modified 9Cr–1Mo steel, followed by 2.25Cr–1.0Mo Steel (Figs. 10-11).

Fig. 10 : Influence of wall thinning rate on creep lives of several alloy steels

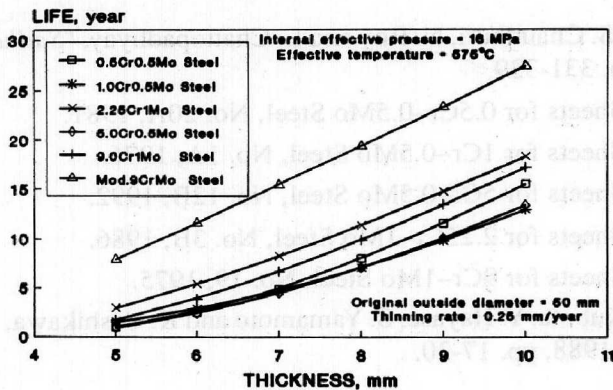
Fig. 11 : Influence of tube wall thickness on creep lives of several alloys steels
