# Liquefaction Incidents of Mineral Cargoes on Board Bulk Carriers

**Michael C. Munro and Abbas Mohajerani**

Liquefaction is a frequently occurring problem taking place when transporting wet granular solid bulk cargoes on board bulk carriers. Liquefaction of a solid bulk cargo can occur when excessive dynamic loading, induced by rough seas and vessel vibrations, is transmitted to the cargo. From 1988 to 2015, there have been 24 suspected liquefaction incidents reported, which resulted in 164 casualties and the loss of 18 vessels. The objective of this study is to investigate the collective causes of liquefaction of solid bulk cargoes on board bulk carriers in order to make recommendations to prevent future incidents from occurring. This was achieved by analysing the seven available investigative reports relating to the incidents, focusing on the key findings and exploring the effect of excess moisture within the cargo. This study has placed significant emphasis on the importance of preventing ingress of water into the cargo during transportation, loading, and storage. Recommendations have been given, based on the key findings from the reports, to reduce the potential for liquefac

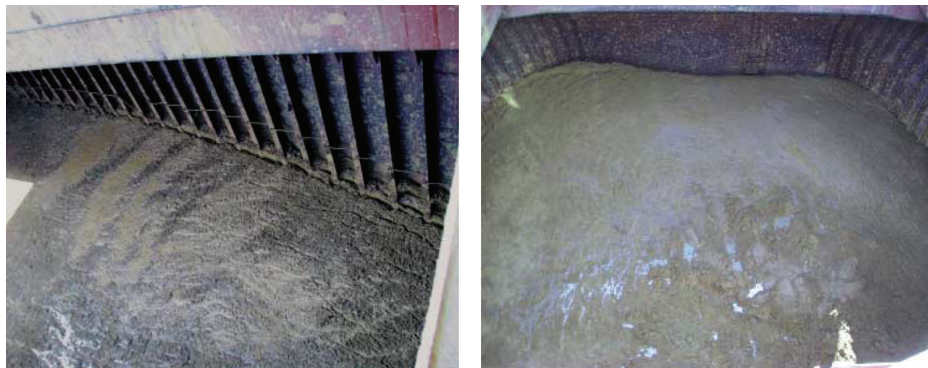
A little before 2200 the Padang Hawk suddenly developed a 15-degree list to port. After reducing speed and altering the course to bring the wind and sea onto the port quarter, crew were sent to check the hatches and the state of the main deck. After noting that nothing was out of place, the crew opened access hatches to each of the holds. They found that the cargo of nickel ore in all the holds, except hold number 5, had settled and shifted to port. The cargo in the first three holds appeared to be semiliquid, "like melted ice cream," as one of the crew described it. Two images of the nickel ore in hold number 1 of the Padang Hawk can be seen in Figure 5 [25].

FIGURE 5: Images of the nickel ore in hold number 1 of the Padang Hawk [25].

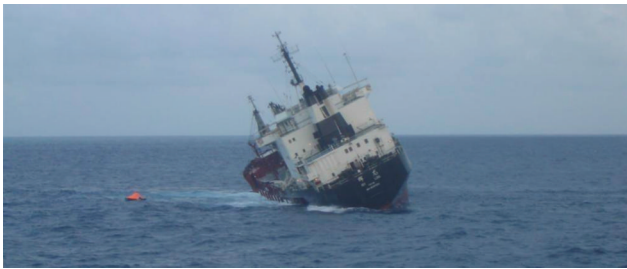
- (2) After investigating the probable causes of the accident, it is believed to be the liquefaction of the fluorspar cargo inside holds numbers 1 and 3. The flow state of the fluorspar cargo might have caused the vessel to list, capsize, and sink.

FIGURE 8: Hui Long listing severely to port after suspected liquefaction of the cargo of Fluorspar [29].

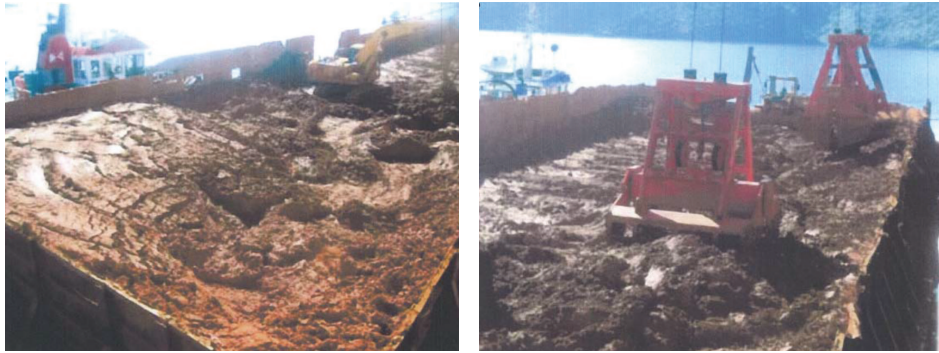
FIGURE 15: Photographs submitted to the head office by the Master of the condition of the nickel ore cargo at the time of loading at Kolonodale, Indonesia [26].

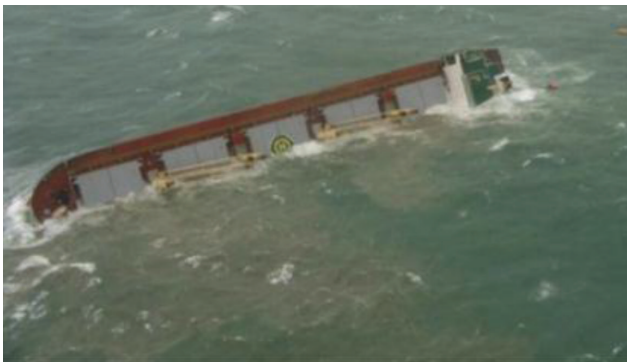
FIGURE 21: View from rescue helicopter as the Trans Summer listed 45 degrees to port [30].

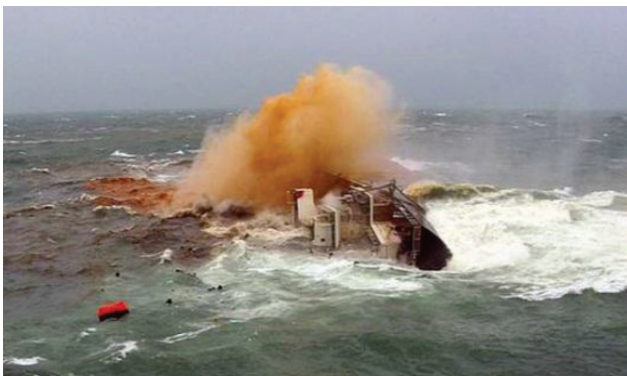
FIGURE 22: View from rescue helicopter as the Trans Summer listed 90 degrees to port [30].

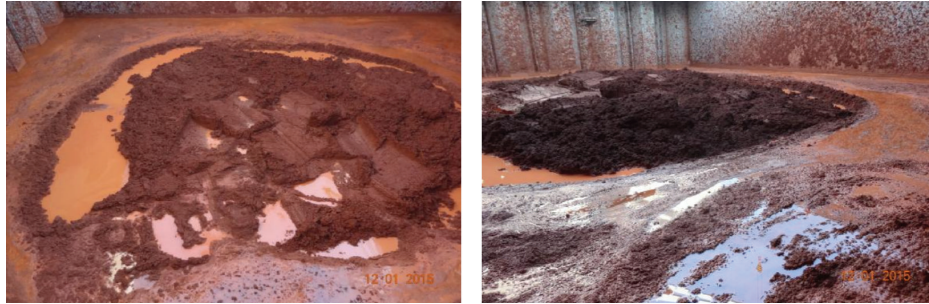
FIGURE 28: View of bauxite cargo in hold number 4 of the Orchid Island after voyage from Kuantan, Malaysia, to Qingdao, China [28].

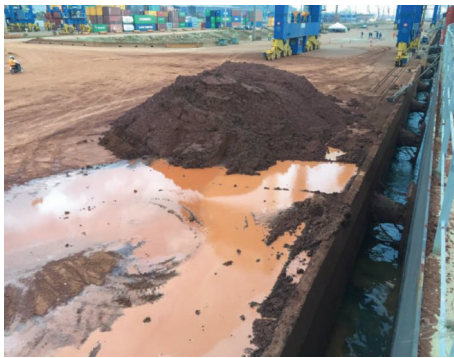
measures to protect the cargo on shore from further rain were not effective in preventing further wetting. The absence of an independent inspection resulted in the cargo being loaded without its physical properties and moisture content being verified against the parameters of the IMSBC Code schedule or the cargo declaration form.

FIGURE 29: Bauxite cargo quayside exposed to the elements. Photo taken from the Medi Okinawa at Port of Kuantan, Malaysia [28].
