Visualisation and evaluation of structural characteristics and problems of a Classical Ottoman bath

Ö. Çizer & M. H. Turan

Within this frame; a Classical Ottoman bath [5] in Seferihisar, İzmir is studied in this paper. The monument, which repeats the traditional construction technique and material usage in its region, presents composite usage of material. Walls out of rubble stone, brick and mortar put together in a random order are peculiar to this region [6]. The historical 'horasan' plastering applied in the bath is also an important value of the building. The visualisation techniques for these compositions of structural materials and covering ones have been searched. An analytical presentation of material groups and single materials involved in the construction of each building component has been chosen. First, structural characteristics and problems were marked on the measured drawings at the site. Further basic measurements necessary for this marking were taken. Abstraction techniques of the graphic discipline were referred, while developing appropriate illustration techniques. The visual documents or 'maps' produced at the end of this site work were revised in the office.

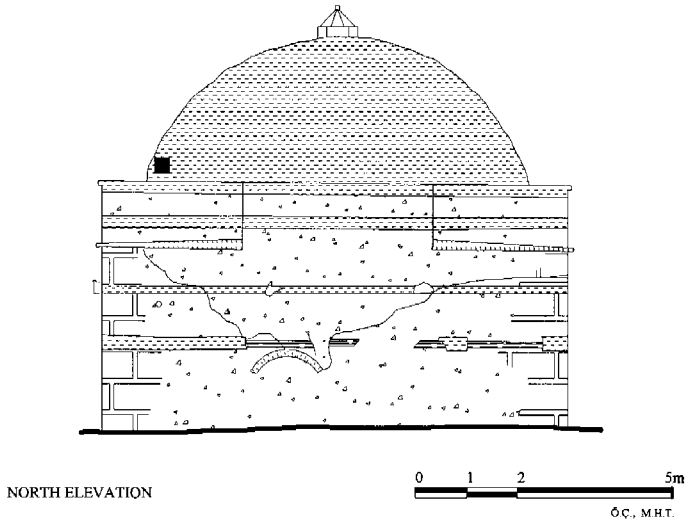
Figure 7. Visualisation of construction techniques and material of the north wall.

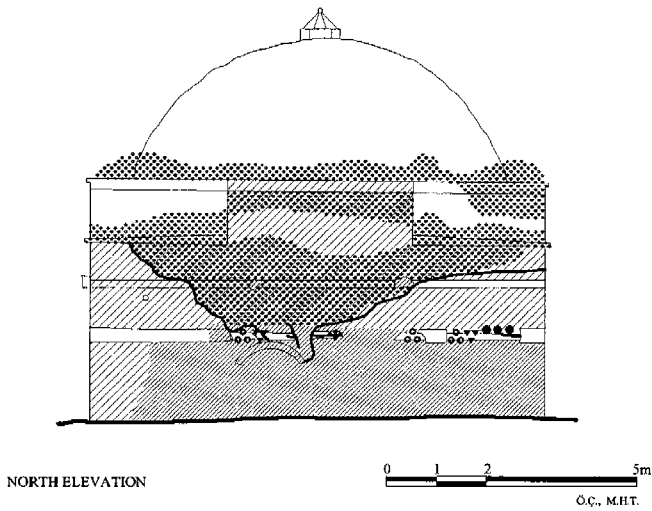
has the highest quantity of this type of deterioration (Figure 3). Especially up to the level of 150cm, loss of stone is considerably extensive. Especially, granular disintegration in the mortar leads to the loss of mortar, which is in fact the main cause in the loss of stone. In this north wall, another material deterioration is in the form of loss in the material group of brick and mortar that covers the timber beam. This gives rise to the deterioration of timber beam and timber clamps by being exposed to weather conditions (Figure 4). Deposits form the second group of material deterioration. This type of deterioration is in the form of plant formation, microbiological patinas and discoloration. Plant formation is observed at the highest quantities especially on the superstructure and walls. North wall is the one that has this deterioration type at maximum quantities. Microbiological patinas are on the surface of the interior walls where rain water penetrates through the cracks and open light holes on the domes and vaults (Figure 5,6). Discoloration is due to wetting by rain water.

Application of this visualisation technique has exposed the structural failures of the bath as follows: It has been clarified that material deterioration plays an important role in the formation of structural failures. Loss in the course of brick and mortar, which protect timber beam against atmospheric conditions, is the primary cause of partial loss, cracks and discoloration of the timber beam in the north wall. What is more, loss of stone and mortar observed along the below level of the same wall threatens the structural stability of the wall. It is believed

that these types of material deterioration are effective in the formation of cracks on this north wall.

Figure 8. Visualisation of structural failures and material deterioration of the north wall.

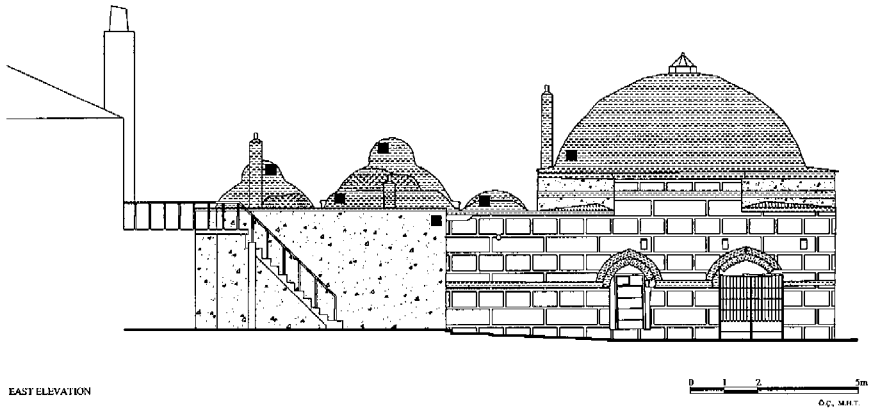
Figure 9. Visualisation of construction techniques and material of the east wall.

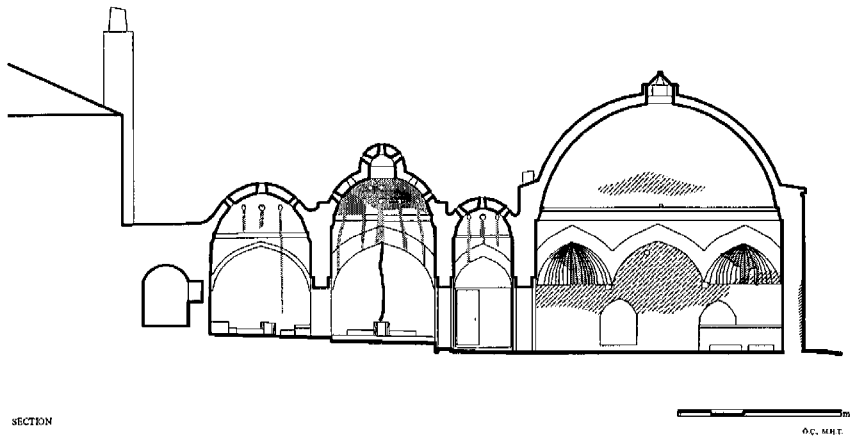
Figure 10. Visualisation of structural failures and material deterioration of the longitudinal section.
