## **Characteristics of Stains on Elevated Roads in Urban Area**

**Hidetoshi OMATSU\* and Yasuo HINO\*\***

### **Synopsis**

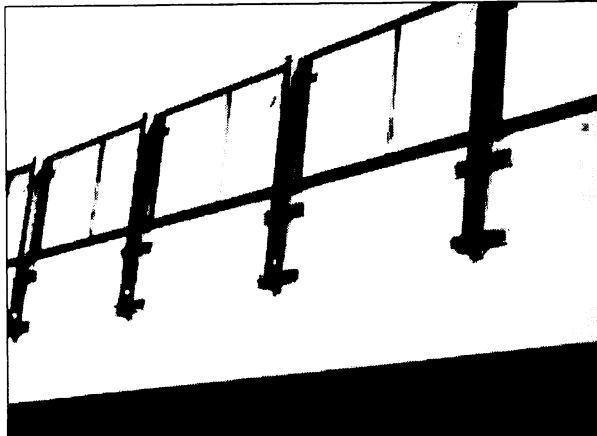
Linear stains were observed under the umbo, like the strut of the soundproof walls and the road signs.

**Photo 1** Example of linear stains observed under the strut of the soundproof walls

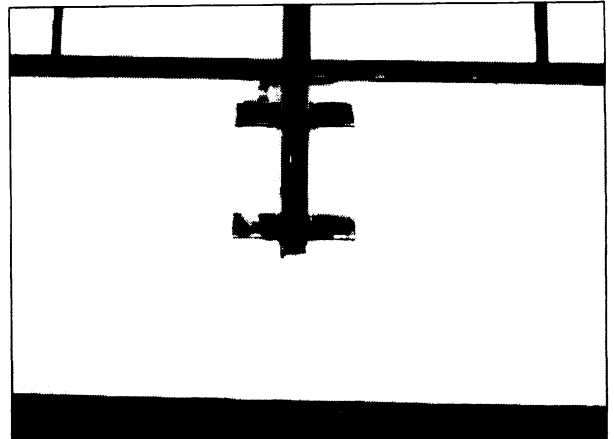
**Photo 2** Example of linear stains observed under the strut of the soundproof walls (enlargement of Photo 1)

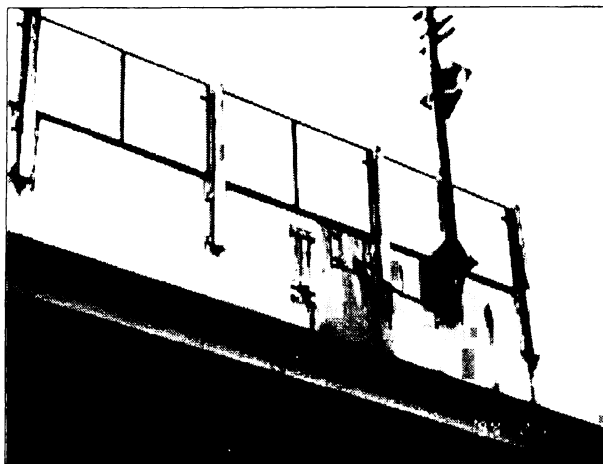
**Photo 3** Example of linear stains observed under the strut of the road signs
