# ASSESSMENT AND EVALUATION OF THE REPAIR OPTIONS FOR THE TORROJA INSTITUTE WINTER GARDEN

O. Río & J Mateo  
CSIC-UPM  
CISDEM  
Serrano Galvache, 4  
28033-Madrid  
Spain  
[rio@ietcc.csic.es](mailto:rio@ietcc.csic.es)

**KEYWORDS:** crack repairs, masonry shell, unreinforced brickwork, Torroja, FE analysis

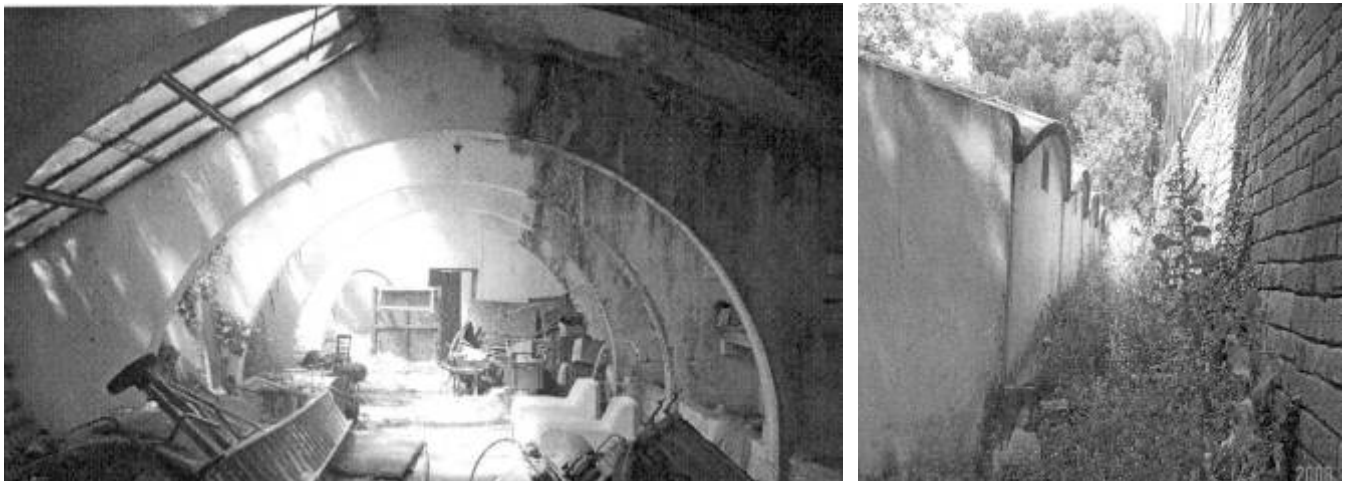
Figure 4: Aspect of the Winter Garden and surrounding area in 2008.

As mentioned, the building went through a long period of neglect. The result was a deterioration of the roof's water-proofing (Fig. 9) and some corrosion of the metal frame of the glazing. There is a clear presence of dampness at the fabric, especially towards the back side, probably accelerated by lack of maintenance of the gutters. The pattern of these cracks and the effect of the moisture decreases along the axis of the building in the East-West direction, towards the area of the natural land fill.

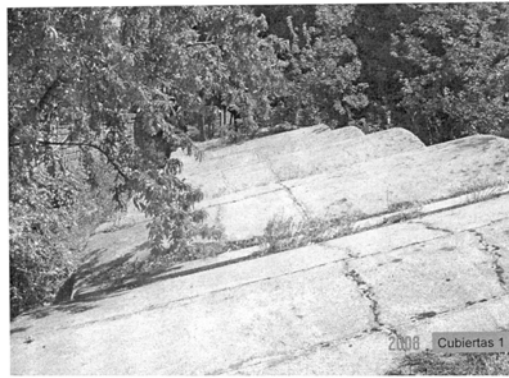
Figure 7: External aspect of the vaults

The degradation of the joints at the vaults led to water ingress to the arches and the weakened bond between the bricks caused cracks on the vaults and hinges at the crown of the arches towards the spandrels and the back side, partially buried in the natural slope. There are some pronounced cracks in the longitudinal axis of the shells (Fig. 9) and spread is prevented probably due to the mutual constraint of the adjacent bays along the arches (Fig. 2) and the diaphragm action at the back. Transverse (hoop) cracks are also apparent, mainly along the bed joints of the brickwork (Fig. 9) but the extrados also shows a series of cracks also closer the longitudinal apex (Fig. 7).

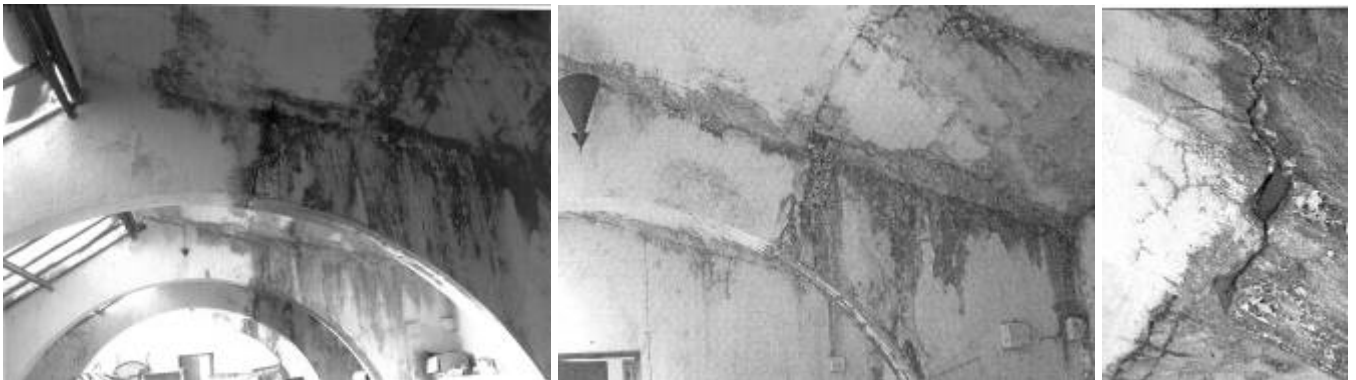
Figure 8. Damages observed on the arches: first or easternmost arch (left), last or westernmost arch (middle), detail of the main crack in the first arch (right).

Regarding the masonry arches, they present a main crack that runs in general through the whole cross-section off the keystone towards the north wall and other smaller ones in the area in between. Although they appear in all the arches, their size and especially width is decreasing towards the west end (Fig. 8). Similarly, the extent of the damage due to moisture penetration decreases when moving from east to west.

The separation between the vault and north wall can be clearly observed along the different bays (open areas between arches), while the typical cracks, which usually appear on the corner of windows at ground settlement, only appear on the bays located on the eastern part of the building (see differences in Fig. 8).

As far as the deformation of the arches is concerned, the asymmetric crack pattern is due to the higher weight of the vault (at the N side in Figs. 4 and 8) and the water ingress that has caused the decay of the mortar joints next to the spandrels. There may also be more complex interactions between the arches and the vaults and a more detailed analysis of the behaviour is carried in the next section in order to get more insight to the distribution of the loads.

The deformation of the vault spreads further into the arch and the area of the crown deforms relatively higher. The distribution of the radial stresses (S11 in Fig. 13) shows higher tensile forces in an area that coincides with the location of the main cracks, as they appear in Figs. 4 and 8, therefore it is reasonable to justify the damage observed.

The understanding of the crack pattern and the dynamics of deformation permitted the planning of the strengthening works in the essential areas, as part of the rehabilitation of the building. At the start of the works, the entire brickwork was essentially stripped down completely from the render and this allowed the crack pattern to be better surveyed. Then, all the mortar joints were cleared in order to ensure that all degraded material was removed. All minor cracks were filled and the joints were repointed. The major structural repair was to stitch the main crack in each arch using a metal plate in the direction that the hinge is expected to open (Fig. 14).

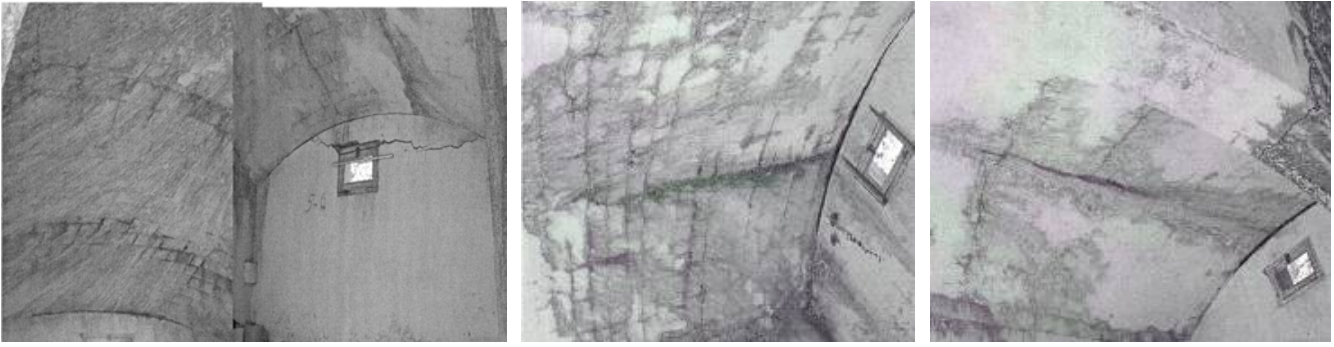
So far as the roof barrel vaults are concerned, they present cracks along the east-west axis mainly on the north half of the vault (Fig. 9) as also perpendicular cracks located next to the arch elements (Fig. 8) and along the main axis of the vault. Similar to the arch damages, their size decrease towards the west end of the building. Moisture damage follows the crack pattern but does not decrease so much, and is greater on the middle vault, being more pronounced as cracks at the mortar joints.

Figure 9: Damages on the vaults and their N wall end. From left to right bays 1, 2, 3 and 5 (Oteiza 2008)

The structure sits also on the slope so differential movement could have destabilised the containment of the bays in the longitudinal direction, as also the changes in the crack pattern show (Fig. 9). Settlement could have also increased the deformation around the windows of the wall in bay 2 (Fig. 9), which could have originated from the detachment of the vault from the wall (S11 in Fig. 13).

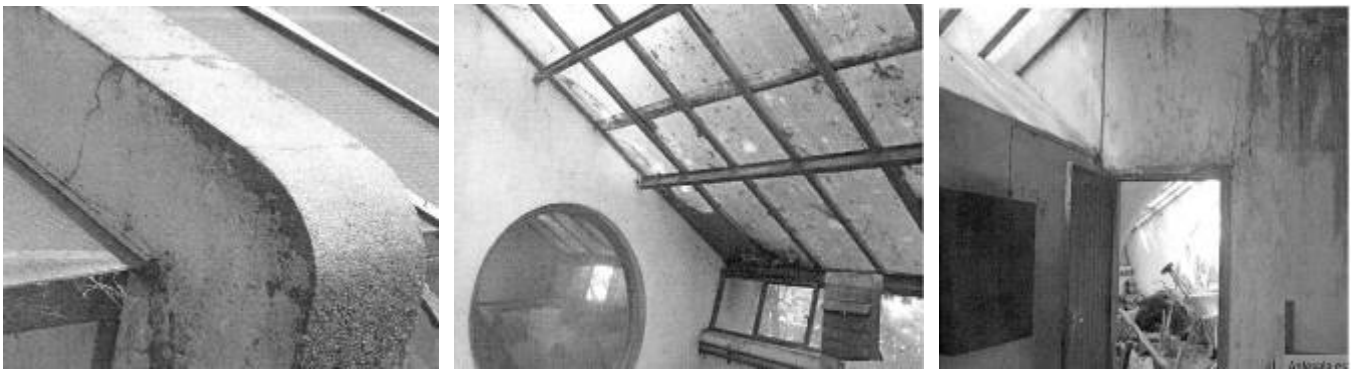
No significant damages were observed on the structural elements near the windows with the exception of those where the south wall joined the glazing (Fig. 10). A large number of glass panels were broken; the steel structure had deteriorated and water tightness sealant was nonexistent. The doors and window frames of the north wall also showed damage signs.

Figure 10. Other damages: main arches, window structure, interior of the east end

The surrounding areas were cleared from overgrowth and the planting bays close to the wall were removed, while all drainage was refurbished. Once the integrity of the structure was restored, thermal insulation and a waterproofing screed was applied on the vaults. In the interior, a new single-coat render was applied. So far as the metal frame of the windows is concerned, all the mullions were cleaned and the

glass panels that had not been damaged were placed once again. The damaged ones were replaced with reinforced glass that was distinct from the original panels and for this reason two entire bays were glazed this manner. In addition, the most damaged metal mullions were protected from the ingress of water. Eventually, the building at the end of the works is the very pleasant multi-functional space that was planned (Fig. 15).

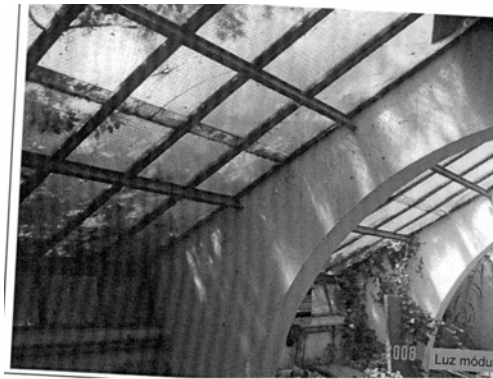
The small size of the building and the modest loads that were expected to act did not require a demanding structural scheme. Due to the orientation of the building, the temperature variations on the steel frame that holds the glazing could have caused significant expansion, which would need to be accommodated or isolated from the arches and vaults. The vaults shed their weight and thrust on the transverse arches/ ribs and they are also supported upon a wall at their back (North) end (Figs. 4 and 11). Most probably the structure was empirically sized by Torroja and he would rely upon experienced bricklayers who still had the knowledge of building arches and shallow vaults, as the techniques were widely used in Madrid until the 1960's (Moya 1993).

Figure 11: The attachment of the mullions on the arches at bay 1

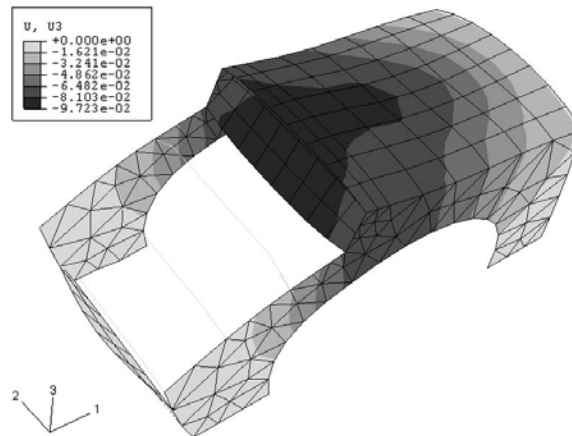
The analysis shows the high reserves in strength of the form under the ideal conditions considered here. The deformation of the model in Fig. 12 shows a higher concentration of vertical displacement at the inner end of the vault, above the lintel of the window, but the values are overall small, to a maximum of 0.1 mm. A study of the distribution of the stresses at the extrados of the vault (Fig. 13) shows the middle strip of the vault cantilevers towards the window (axial tensile stresses S11 at both ends), while in the hoop direction (S22) the tensile forces appear along the edge with the arches. The latter tensile forces are higher along those edges and this is where the cracks are expected to start if a high load is considered to act. The overall values however are small (maximum 130 kN/m<sup>2</sup> or 0.13 N/mm<sup>2</sup> in the hoop direction), while max compressive stresses are about 0.3 N/mm<sup>2</sup>, i.e. well below the assumed strength.

Figure 12. Deformation and deflections of the FE model for bay 3 (in mm)

The degree of safety is quite large, as also the serviceability margins (0.1/3080, compared to acceptable limits of 1/250). It is unlikely therefore that failure can occur due to excessive weight on the structure, whether dead or imposed load (like snow or blocked rainwater). Small cracks under these conditions are

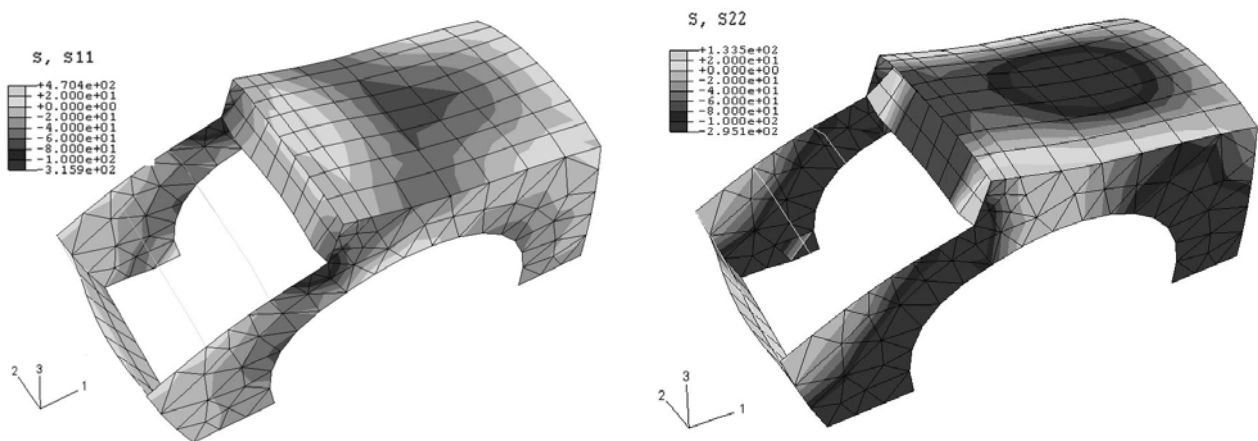
Figure 13: Loads at the extrados of the vaults in bay 3 in the axial (S11) and hoop direction (S22) in kN/m<sup>2</sup>. Stresses S11 have a radial direction in the case of the arches.

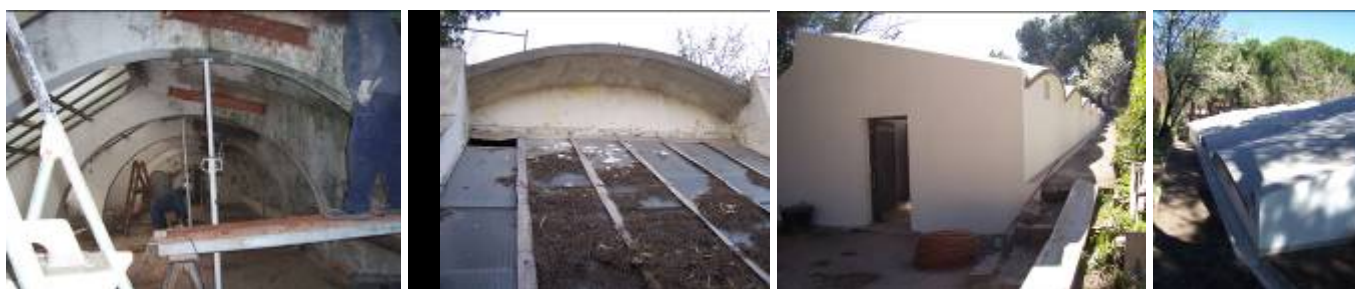
Figure 14: Different stages of repairing and cleaning of the building and the surrounding area.
