Earthworks Risk Assessment on a Heritage Railway

Martin Crapper, Michael Fell and Imad Gammoh

School of Engineering, The University of Edinburgh, UK

Accepted for publication in Proceedings of the ICE Geotechnical Engineering on 19th March 2013

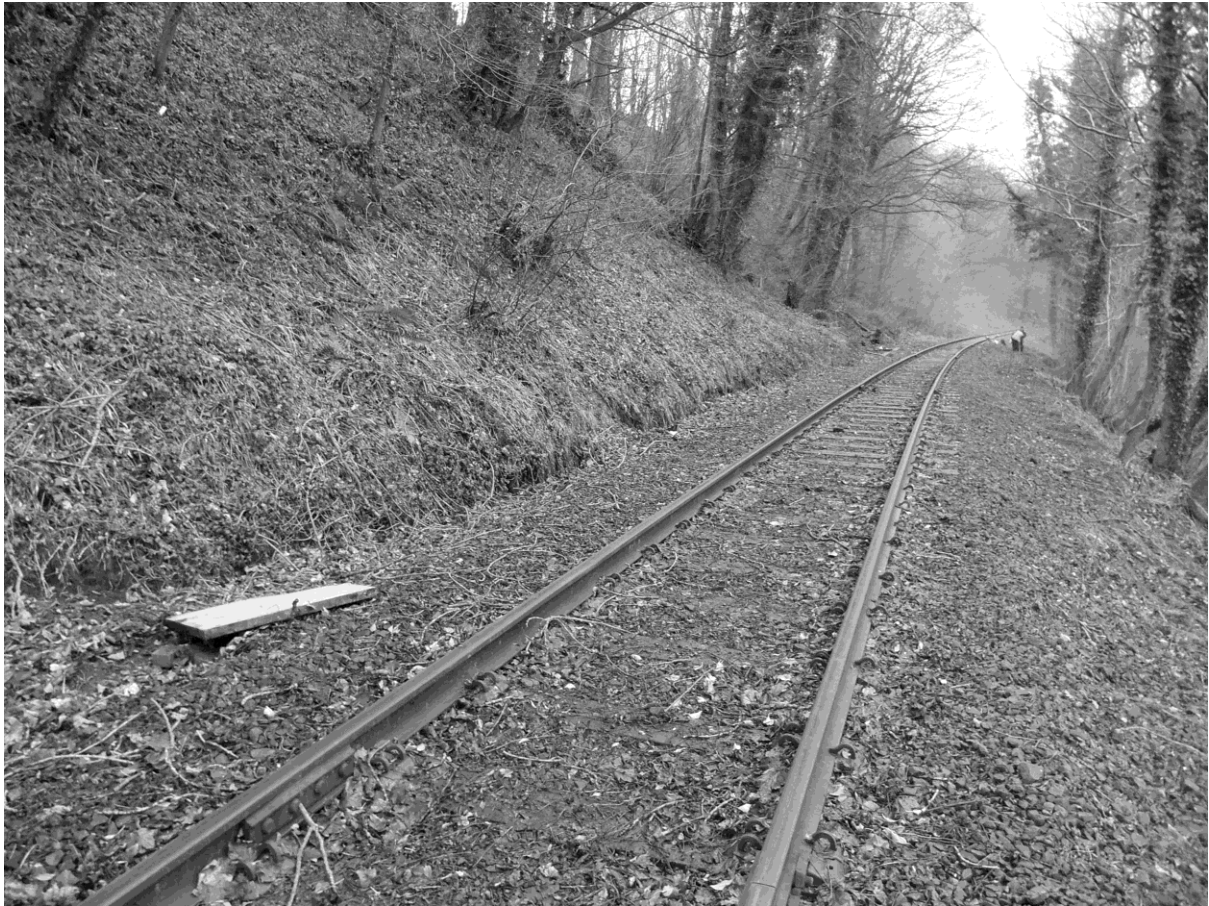
For one and a half miles of its length, the line occupies the side of a steep escarpment close to the Forth Estuary between Bo'ness and Grangemouth, with the track supported on the north side by steep earth embankments, typically 15m high, and cut on the south side by soil and in some places rock slopes up to 10m high. (Figure 2). Thereafter the line turns south, passing through some moderately deep cuttings and over two further sections of embankment before reaching the mainline junction at Manuel.

Figure 2: The Bo'ness and Kinneil Railway showing typical cutting and embankment structure

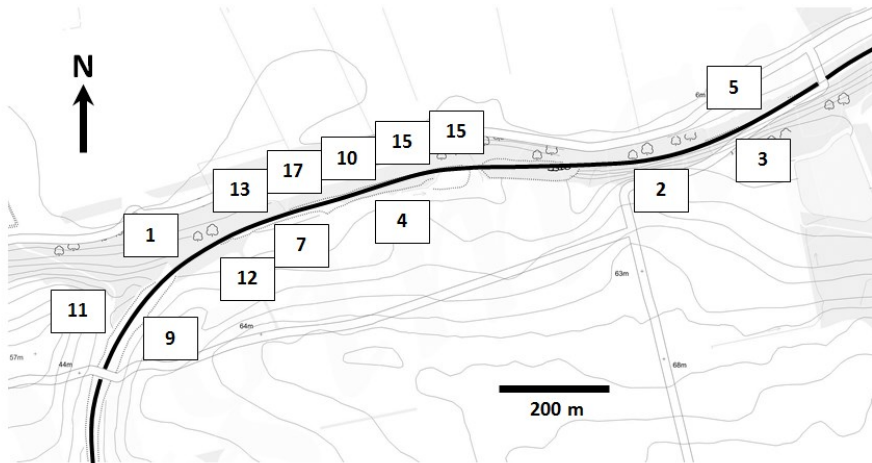
Figure 3: Earthworks Prioritization based on Network Rail weightings

In order to prioritize possible interventions on the B&KR earthworks, the prioritization toolkit was applied using all the original NR scheme unaltered. The main results of this analysis are shown in Figure 3, in which the prioritization of earthworks is indicated by the large boxed numbers, with 1 indicating the earthwork section with the highest priority for monitoring and possible intervention. Some areas have equal priority, and thus the same number appears twice; the priorities shown are not all consecutively numbered, as some of the priorities between 1 and 17 were on sections of the railway not covered by the figure.

In this result, the top priority is at a location where there has been previous disturbance due to excavation for an oil pipeline crossing in the 1980s, and the consequence includes possible impact on the pipeline. This therefore appears to make sense. However, many of the next priorities are cutting sides on the south side of the railway. Applying engineering judgement, the prioritization of these areas makes much less sense, since examination on site, together with the experience of some small past failures suggested that the cutting sides could collapse with no significant consequence to third parties, there being only woodland or agricultural land on the top side of the cutting. There is also a wide area by the line side to accommodate any debris, and if any debris did fall on the rails, the visibility for train crews was generally sufficient to achieve a controlled stop in the distance available given the 20mph maximum line speed in the area.

On the other hand, the embankment slopes given the 10th, 13th, 15th and 17th priorities had poor SSHIs and engineering judgement suggested that any failure here could have major impact on the railway. This would include undermining the track formation, severing the line and causing all income-generating operations to cease, as well as presenting a safety risk to trains and in some cases to owners of domestic property positioned below the railway.

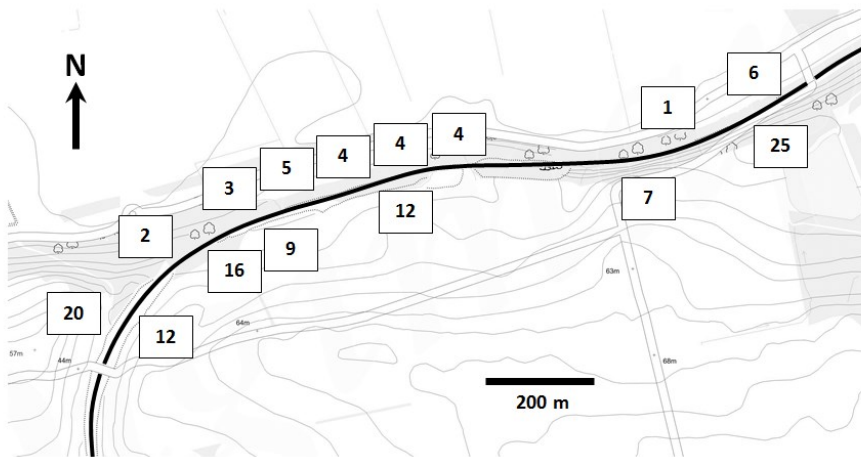
Figure 4: Earthworks prioritization based on Heritage Railway weightings

The revised priorities are indicated in Figure 4. They now tie in much more effectively with engineering judgement, the high, steep and sometimes wet embankment slopes north of the railway being given the highest priorities. If damaged, these embankments would potentially undermine the line, perhaps in a way not immediately noticeable from the driving cab of an approaching train, and they might result in collapse onto line side property. The resulting disruption would entirely remove the railway's access to an income stream either from sale of passenger tickets or revenue associated with rail tour movements for which mainline access from Bo'ness Station is required.
