## 1            **Structural integrity monitoring of onshore wind turbine concrete foundations**

### 7            **Abstract**

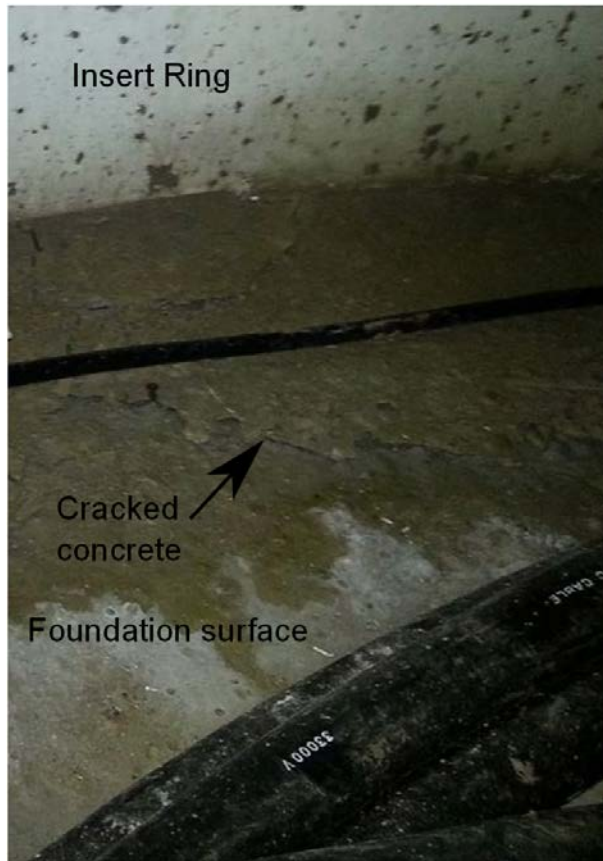
76 The onshore wind turbine concrete foundations with embedded ring shown in Fig. 1 are widely  
77 used around the world. These types of foundations are the subject of this study with respect to  
78 vertical movement. Several wind farms were visited to identify the main cause of this vertical  
79 movement using Endoscopic filming through boreholes created in the foundations. The  
80 Endoscopic filming showed significant voids filled with water under the flange of the embedded  
81 ring. Significant erosion was also observed on the upper side of bottom flange due to the uplift  
82 forces placed on the foundation by the rotor. These voids have caused excessive vertical  
83 movement of the ring, leading to concrete cracking (Fig. 2) and failure of the water proofing  
84 system.

314 Fig. 2 Cracked concrete foundation as a result of excessive displacement of the embedded ring.  
315

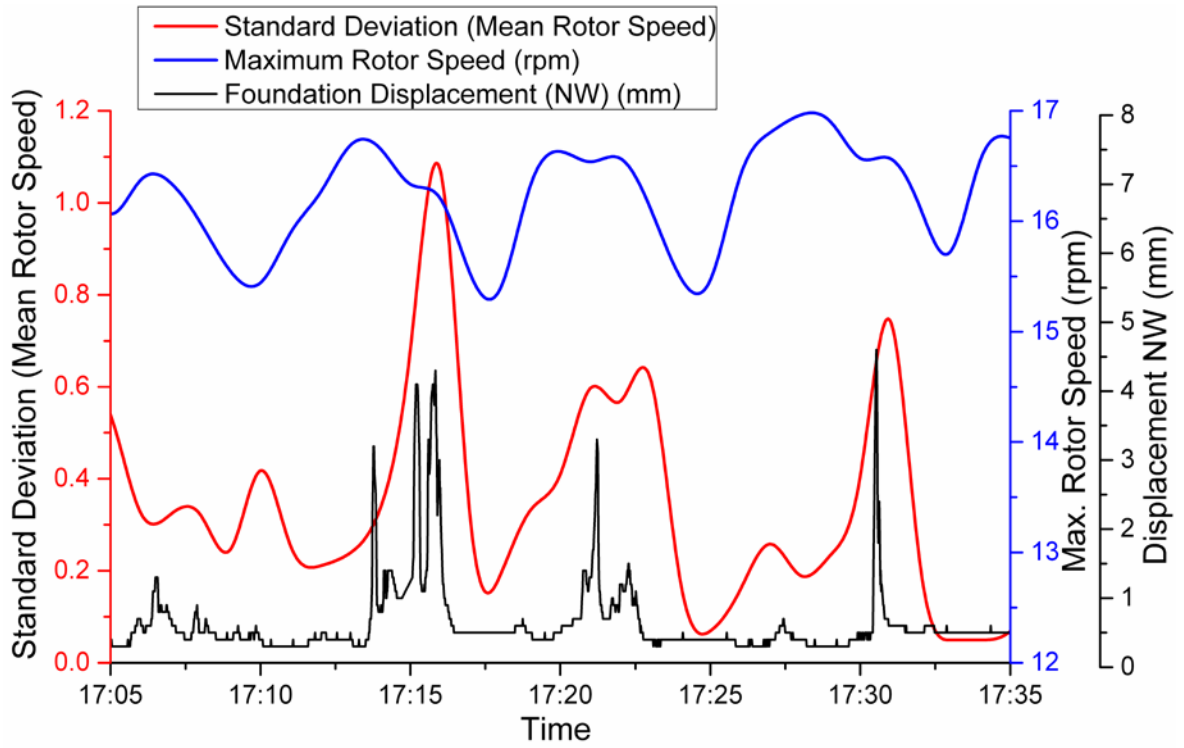
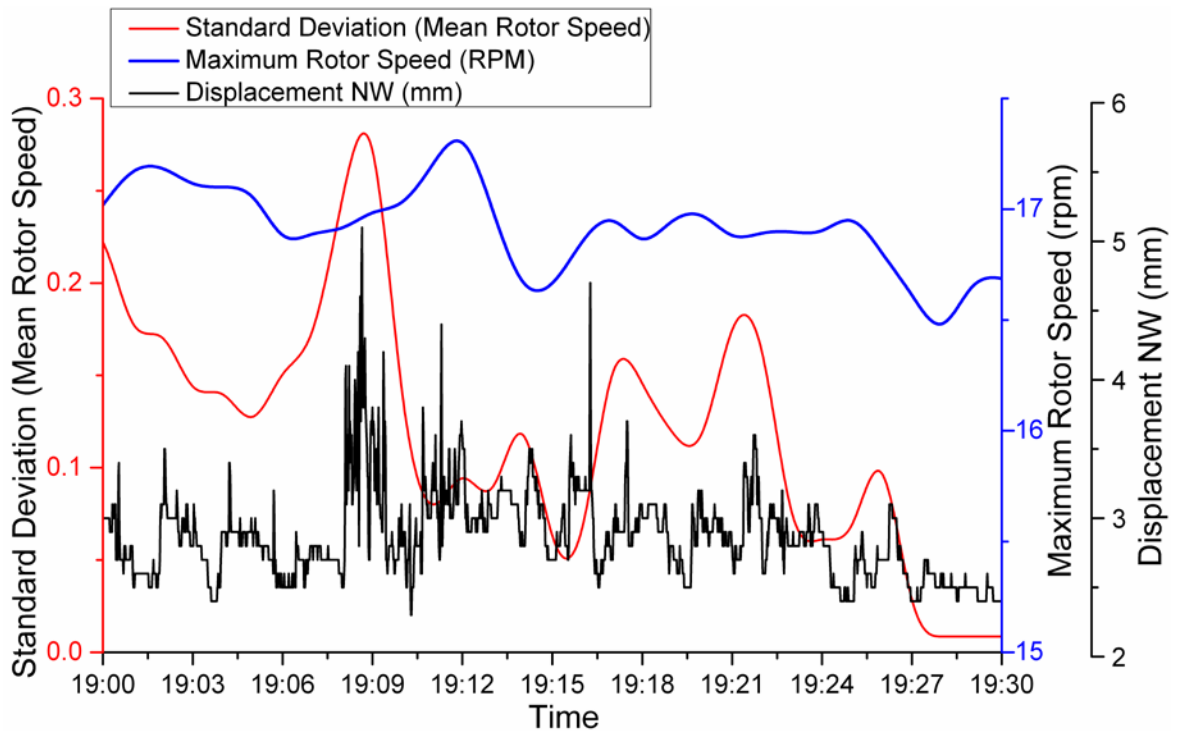
144 Fig. 5a depicts the structural response of the embedded ring subjected to dynamic loading during  
145 the turbine operating conditions over a period of 30 min. As can be seen, large drop offs in the  
146 maximum rotor speed were observed. This was due to the drop in the wind speed. The standard  
147 deviation of mean rotor speed exhibited peaks higher than 0.6, suggesting a period of turbulence.  
148 The spikes in the ring displacement occurred in line with the standard deviation peak. This  
149 means that during periods of turbulent wind, the rotor is subjected to sudden acceleration and  
150 deceleration. This sudden change in the momentum resulted in the ring lifting and falling of the  
151 embedded ring. This suggests that the embedded ring experiences vertical displacement during  
152 sudden acceleration and deceleration of the rotor resulting from the change in the wind speed and

153 direction. Vertical displacement could also occur during shut down and start up events as this  
154 produces sudden acceleration and deceleration of the rotor. Figure 5b shows a number of peak  
155 displacements up to 5 mm. In this case, some of the peaks appeared to be related to the rotor  
156 speed standard deviation e.g. turbulence, whilst others, such as at 19:12, appeared to be related to  
157 the maximum rotor speed peaks.

413 Fig. 5. Effect of rotor speed on the vertical displacement of the embedded ring.

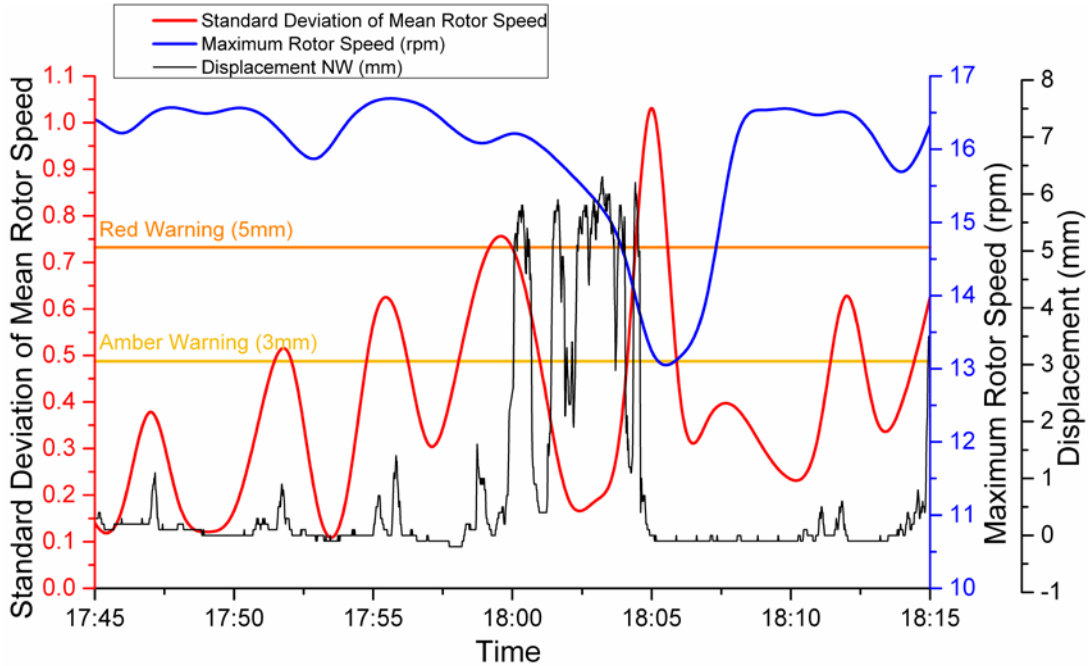
158 As shown in Fig. 6, the embedded ring experienced significant vertical displacement at  
159 high wind speeds. Serious displacement was deemed by the operator to be any movement over 5  
160 mm in magnitude. Most of the vertical displacement was witnessed in the rising direction with  
161 the tower settling back downwards after rotor speeds stabilised. A significant period of  
162 displacement over approximately 5 min was observed between 18:00 and 18:05. The amber and  
163 red warning lines at 3 mm and 5 mm respectively indicate the warning bands required by the  
164 operator for analysis. At 18:01 there was a large drop off in the rotor speed, which triggered  
165 large upward then large downward displacements of over 5 mm, breaching the red warning line.  
166 Five small displacement peaks between 0.5 mm and 1.5 mm were also observed. Each of these  
167 peaks correlated with the rotor speed standard deviation peaks as shown in Fig. 6.

428 Fig. 6. Effect of high wind speed on the vertical displacement of the embedded ring.

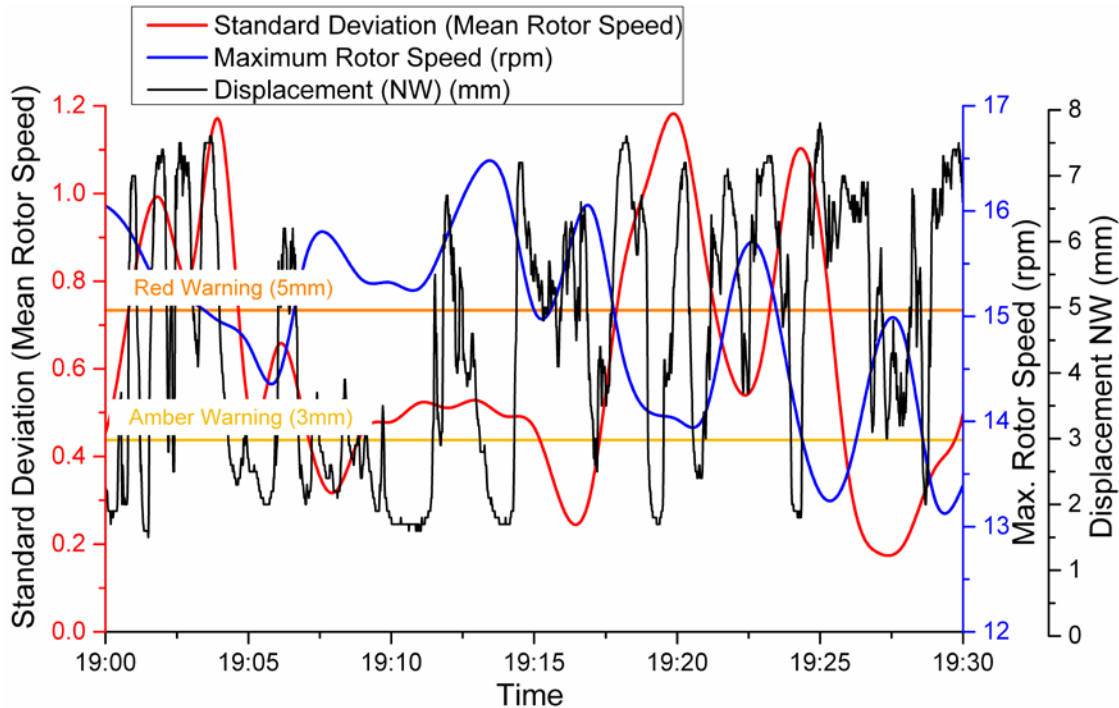
168 High wind speeds also resulted in significant vertical displacement of the ring as indicated in  
169 Fig. 7. This illustrates one of the many variable periods of displacement observed during the  
170 monitoring period. As can be seen, rising and falling of the ring around 7 mm through 6  
171 prescribed cycles were observed over a period of 15 min. The overall displacement pattern  
172 correlated roughly with the maximum rotor speed peaks and troughs as well as with the mean  
173 rotor speed standard deviation peaks. It is clear that there was a significant ring movement  
174 tracking the significant fluctuation in the rotor speed, particularly between 19:18 and 19:25, with  
175 a full cycle occurred approximately every minute. This cyclic (rise and fall) movement would be  
176 evident to an observer on site. The displacement during this period travelled through all three  
177 warning bands, resulting in red warning alerts, which would result in a warning alarm.

444 Fig. 7. Cyclic vertical displacement of the embedded ring as a result of high wind speed.

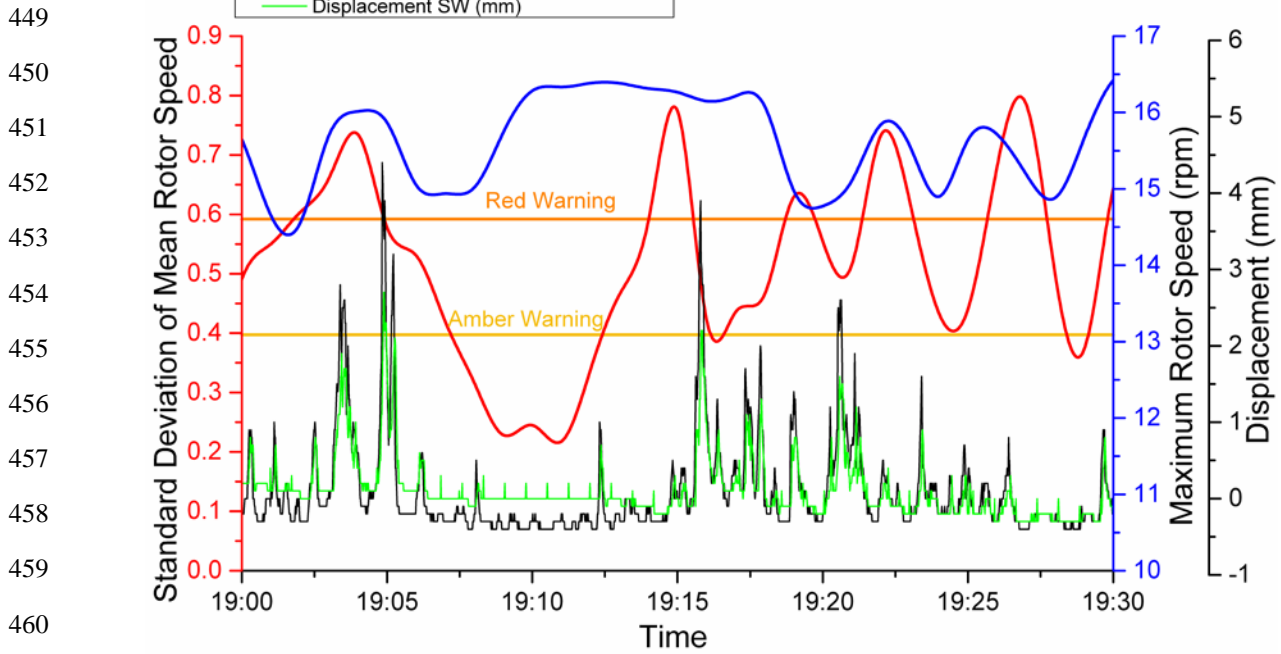
448 a)

181 rpm and 16.5 rpm. As previously discussed, the displacement peaks correlated approximately  
182 with periods of the high mean rotor speed standard deviation. The NW and SW sensors picked  
183 up exactly the same movements. However, the sensor NW, orthogonal to the wind direction,  
184 recorded larger displacements at every peak. This was the result of the wind direction and  
185 ultimately the position of the rotor. It is likely that the side where the wind hit will be pushed up  
186 a little but the greatest vertical movement was observed in the side where the rotor is rotating  
187 upwards as a result of the uplift force experienced on the NW side of the foundation.

475 Fig. 8: Effect of wind direction on the vertical displacement of the embedded ring a) comparison  
476 between NW and SW sensors, b) comparison between NW, SW and SE sensors during a major  
477 change in the rotor speed.

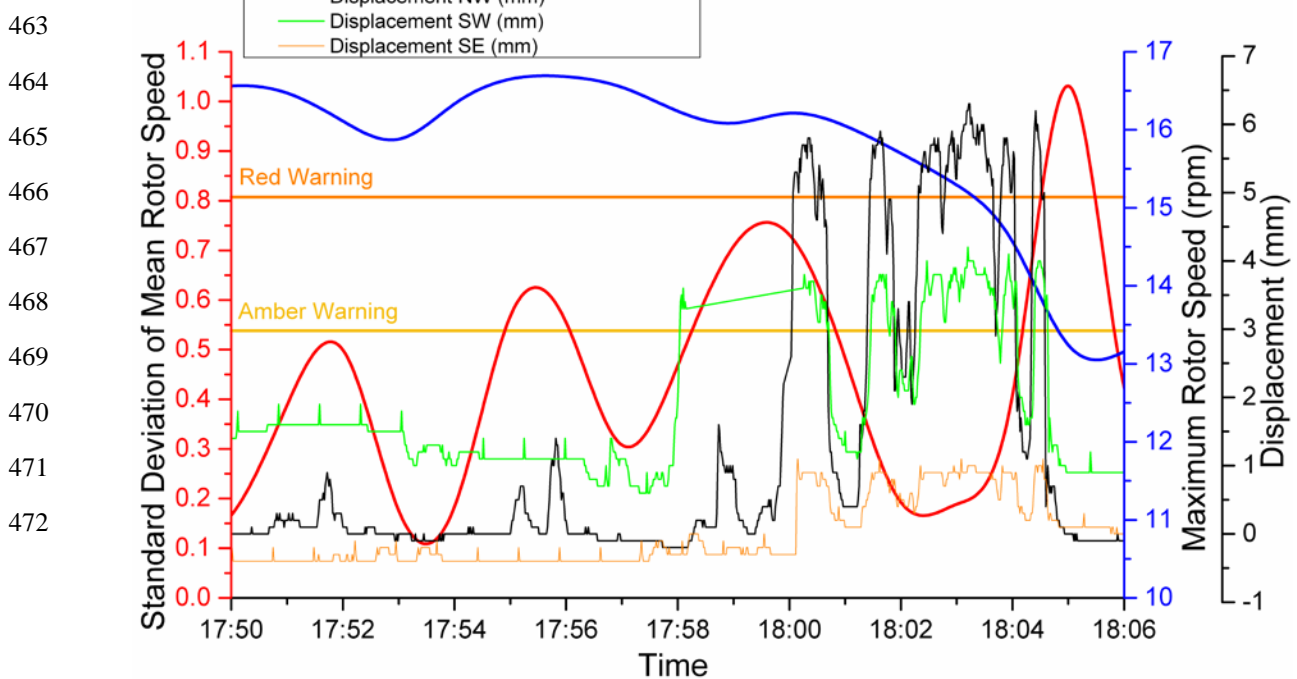
462 b)

188 Figure 8b shows the displacement recorded by the NW, SW and SE sensors during a major  
189 dip in the rotor speed. The NE sensor provided a corrupted signal. It appeared that the  
190 displacement was variable around the circumference of the ring as a result of the wind direction  
191 and the rotor uplift forces. The NW side of the ring exhibited higher displacement as compared  
192 to SW and SE sides. The response of the sensor in the SE corner was slightly below zero much  
193 of the time suggesting that the foundation has eroded allowing a negative displacement below the  
194 level the sensors were set at.
