NASA/TM-2016-219217

# Emergency Locator Transmitter System Performance During Three Full-Scale General Aviation Crash Tests

*Justin D. Littell and Chad M. Stimson  
Langley Research Center, Hampton, Virginia*

July 2016

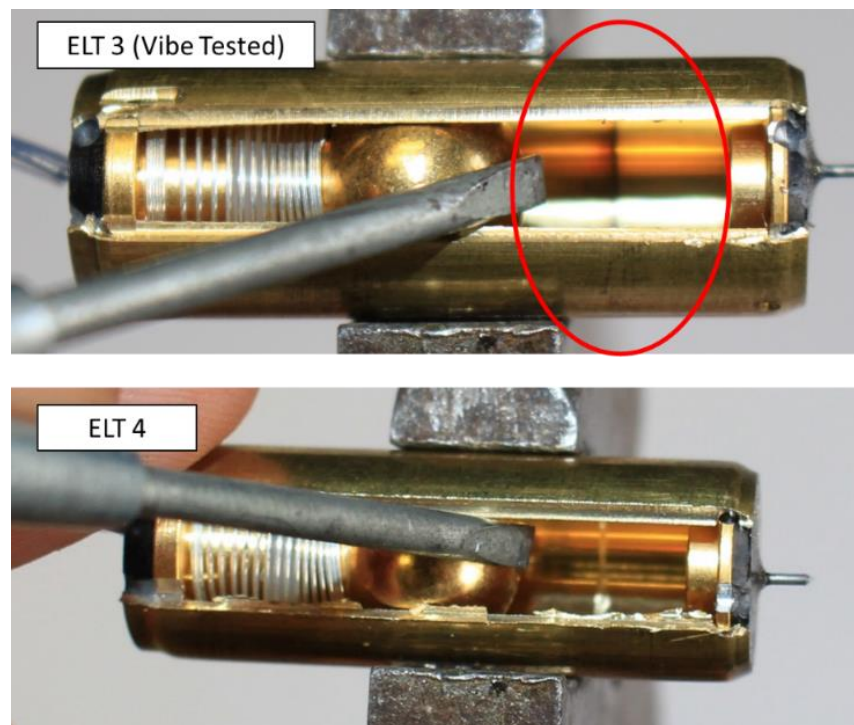
Figure 17 – G-switch comparisons between ELT beacons 3 and 4 for Test 1

As Figure 17 shows, wear from the vibration tests did create a marked location inside the cylinder (highlighted), and noticeable discoloration on the compressive side (left) of the marked line. This location is where the ball diameter would rest when not under compressive (or impulsive loading). It was not determined whether the spring stiffness changed due to the vibration testing; however, the automatic activation performance of ELT 3 was noted to have changed throughout that test series with a higher cross-axis sensitivity and altered in-line sensitivity. Further details regarding the entire vibration test series will be provided in the comprehensive report published after the conclusion of the study [1]. Other than the noticeable line and discoloration, there were no additional noticeable differences between the g-switches for ELT beacons 3 and 4.

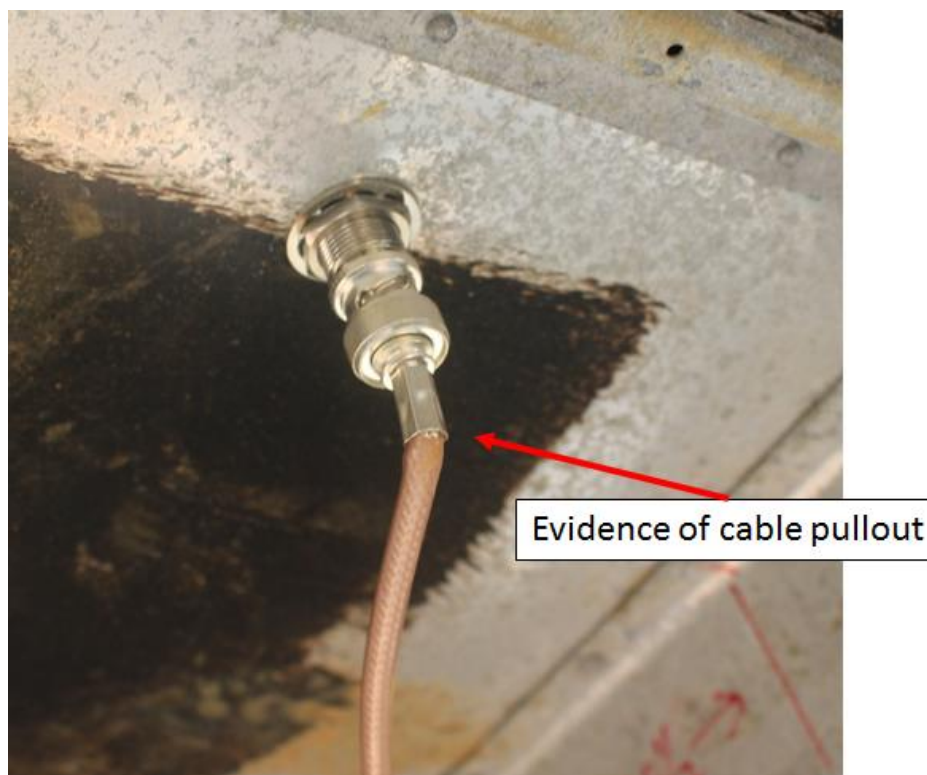
Figure 22 - Test 2 ELT 4 antenna connection

Since the ELT beacon failed to automatically activate, the test procedure called for a self-test to be performed at the aircraft, immediately following the crash test, before any configuration changes occurred or equipment was disturbed. The self-test was successfully conducted via the remote switch, indicating that the connection between the ELT beacon and remote switch was intact and functional. The self-test produced an error code indicating “High VSWR or High Current,” according to the owner’s manual.

While inspecting the ELT antenna connections on the airplane back in the preparation hangar, it was discovered that the antenna cable had partially pulled out of the end fitting on the end terminating at the antenna. Note that the cable run between the beacon and antenna for this particular ELT did not follow the best practice guideline suggestions. Figure 22 shows the connection post-test. Furthermore, when connected to a beacon tester during further post-test checkouts in the preparation hangar, the beacon successfully passed the self-test, manual shake test and manual activation test.

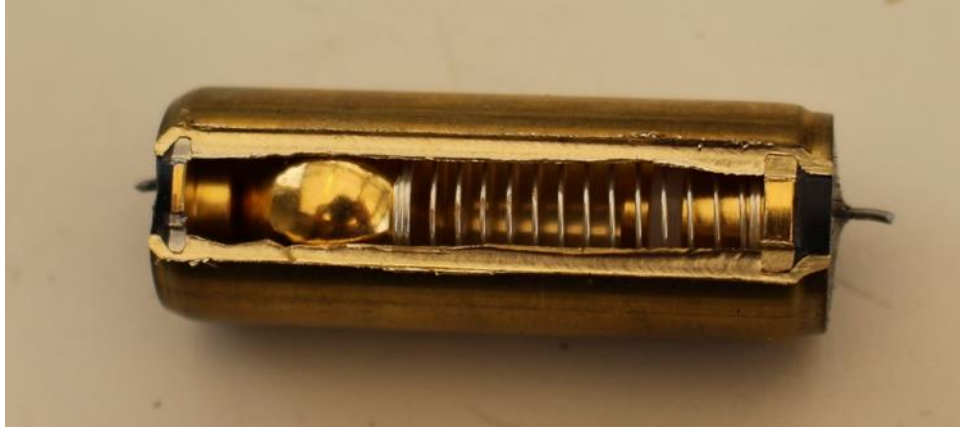
Figure 24 – G-switch assembly for ELT beacon 4 on Test 2

All ELT beacons were disassembled post-test, after functional checkouts had been completed, with the focus being on ELT 4. The crash sensing unit, in this case a mechanical g-switch, from ELT beacon 4 was removed and the sidewall of the cylinder was carefully cut away. Figure 24 shows the disassembled g-switch.

Post-test visual inspections of both the disassembled ELT beacon and g-switch revealed no obvious mechanical defects which would cause the beacon to fail to activate. With the sidewall partially removed, the ball was moved to compress the spring without any noticeable obstruction. The performance issue on this ELT at this time is unexplained.

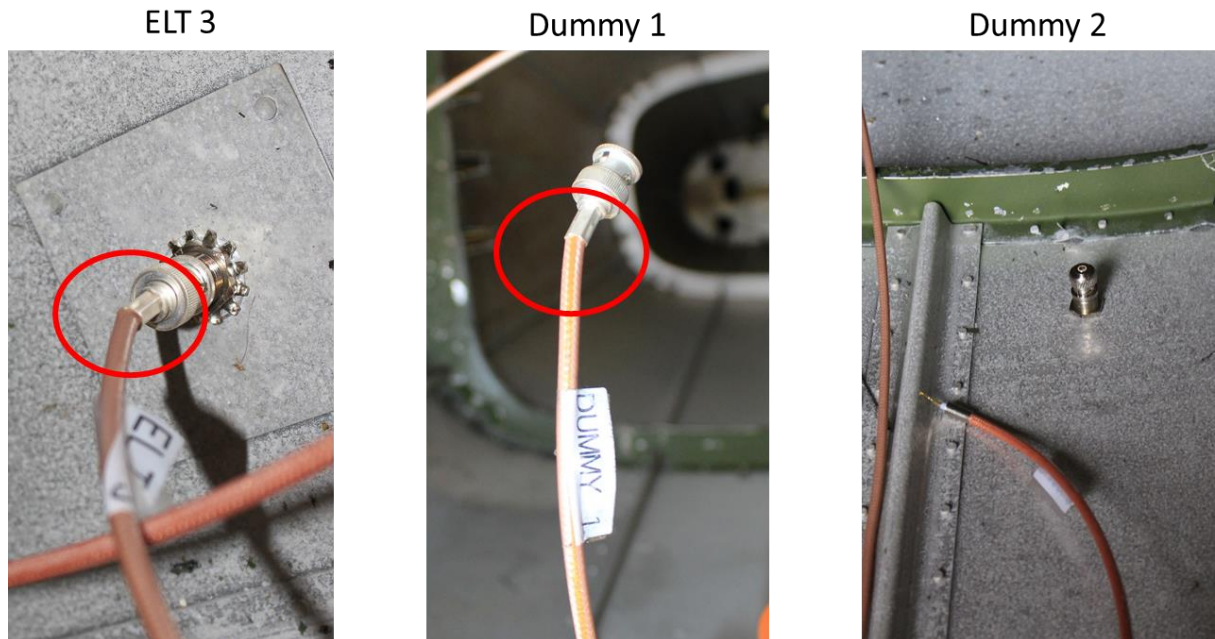
Figure 30 - Antenna cabling failures for Test 3

Antenna cabling connections showed signs of damage for three out of the six total connections. ELT 3 contained the only cable from the live ELTs that showed signs that the internal cable had partially detached from the end fitting. However, it did not prohibit the transmission of the distress signal to the satellites. The two dummy ELT connections showed much worse damage. Dummy connection 1 cabling was intact, but the end connection had displayed noticeable pullout from the end fitting. Dummy connection 2 cabling sustained even more damage. The end connection was still attached to the antenna; however, the cable had pulled out and physically separated. If this had been a live ELT connection, the beacon would not have been able to transmit the distress signal via the external antenna. The cable/antenna connection failures are shown in Figure 30.

When examining the cabling layout diagram in Figure 27, the three connections that failed are the only ones that had crossed a production break between the cabin and tail of the airplane. The connections failed due to the large amount of deformation which occurred in the tail after the fracture initiated during the crash sequence. The long length of these connections was intentional, and specifically made in an attempt to magnify the failure response exhibited in Test 2. All other cable runs were made as short as practical, with one exception made for ELT 4. The cable spanned the entire tail length, originating from the beacon in the forward tail to the antenna in the rear tail. The loads measured from the dummy ELT cables are plotted, and shown in Figure 31.

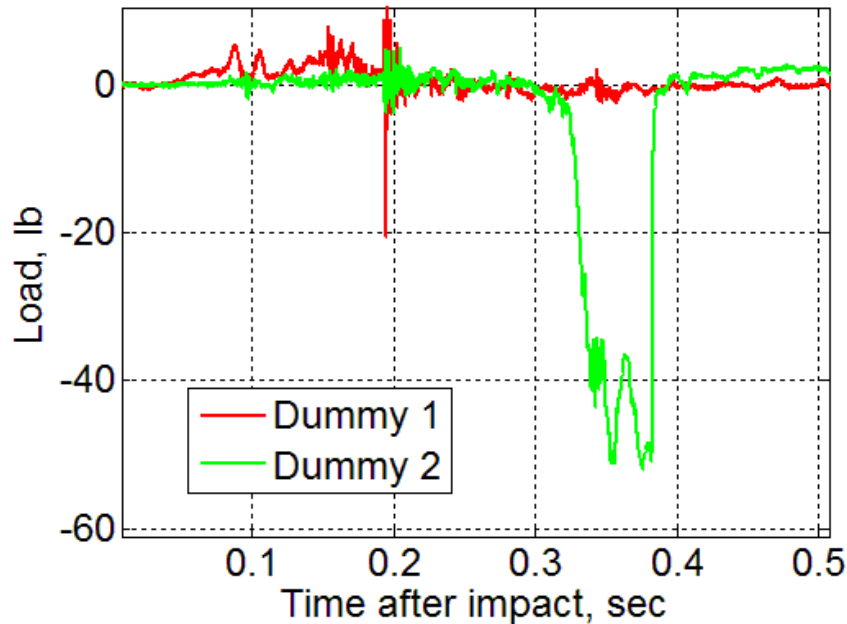
Figure 31 - Test 2 dummy antenna cable loads

At first glance, the negative loading in Dummy ELT 2 creates a cause for concern. The sign convention used for these tests indicates a tensile load to be a positive value and a compressive load to be a negative value. A pullout load would indicate a tensile loading condition, while a compressive load is somewhat nonsensical due to the lack of capability of the cable in sustaining a compressive load. However, posttest inspections determined that pulling on the cable from an angle of greater than 90 degrees applied relative to the load cell orientation caused a compressive load to be read in the load cell due to the bending moment.

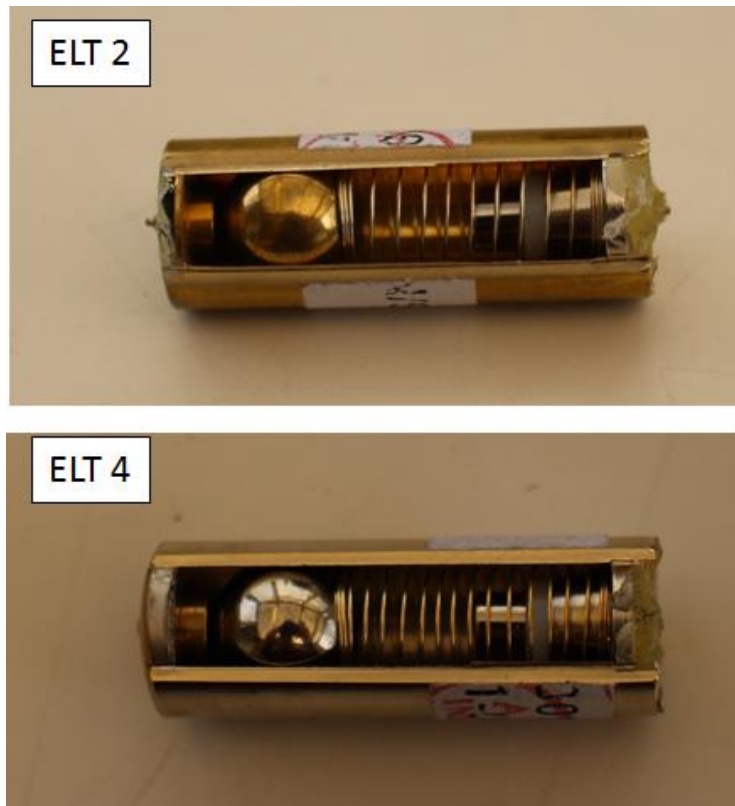
Figure 32 – G-switch assemblies for ELT beacons 2 and 4 on Test 3

ELT beacons 2 and 4 were disassembled for further investigation. The beacon case, batteries, circuit boards, switches and wiring all appeared to be undamaged. The g-switches were extracted and a portion of the cylinder was carefully cut away to expose the internal ball and spring mechanism, as shown in Figure 32. The ELTs were identical models, acquired in a single procurement from a commercial vendor, mounted in a symmetric configuration in the forward tail, with sufficient measured acceleration and delta-v to initiate ELT activation.

First examination of the g-switch assemblies showed different materials used for the ball, spring and casing. The ball color varied between ELT beacons 2 and 4 and the spring contained a different number of wrapped coils. The physical weights of the units were within 0.2 gram of each other. The g-switches were then measured under a 1-g static load by placing them upright and examining the ball position and spring compression under gravity load only, as shown in Figure 33.

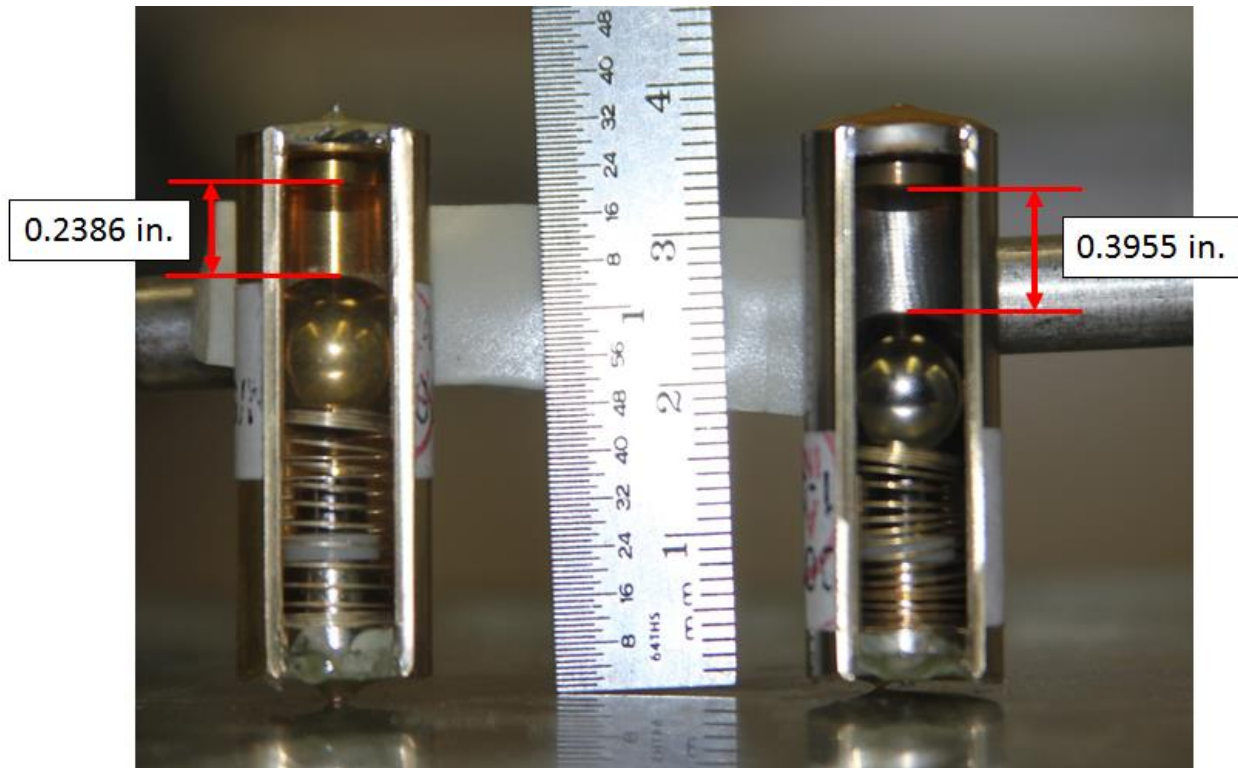
Figure 33 - G-switch assemblies for ELT beacons 2 and 4 on Test 3 under 1-g loading

It is clear from examining the ball position in Figure 33 that there are differences in the g-switch response under 1-g loading. The spring from ELT beacon 2 compressed 0.2386 in. while the spring from ELT beacon 4 compressed 0.3955 in. The spring on ELT beacon 4 compressed enough to allow the ball to make contact with the post in the middle. It is unknown whether the ELT 4 g-switch had arrived at LaRC in this condition or whether the crash caused the spring stiffness to change. The spring stiffness was unknown prior to g-switch disassembly. However, as with all units, once the ELTs had arrived at LaRC, they were put through functional checks to ensure proper operation. All ELTs, including Test 3 ELT 4, passed functional checkouts before being used in testing, and ELT 4 performed normally and activated upon sensing the impact from Test 3.
