# Combining Passive Thermography and Acoustic Emission for Large Area Fatigue Damage Growth Assessment of a Composite Structure

Joseph N. Zalameda\*<sup>a</sup>, Michael R. Horne<sup>b</sup>, Eric I. Madaras<sup>a</sup>, and Eric R. Burke<sup>a</sup>,

<sup>a</sup>NASA Langley Research Center Hampton, VA 23681-2199;

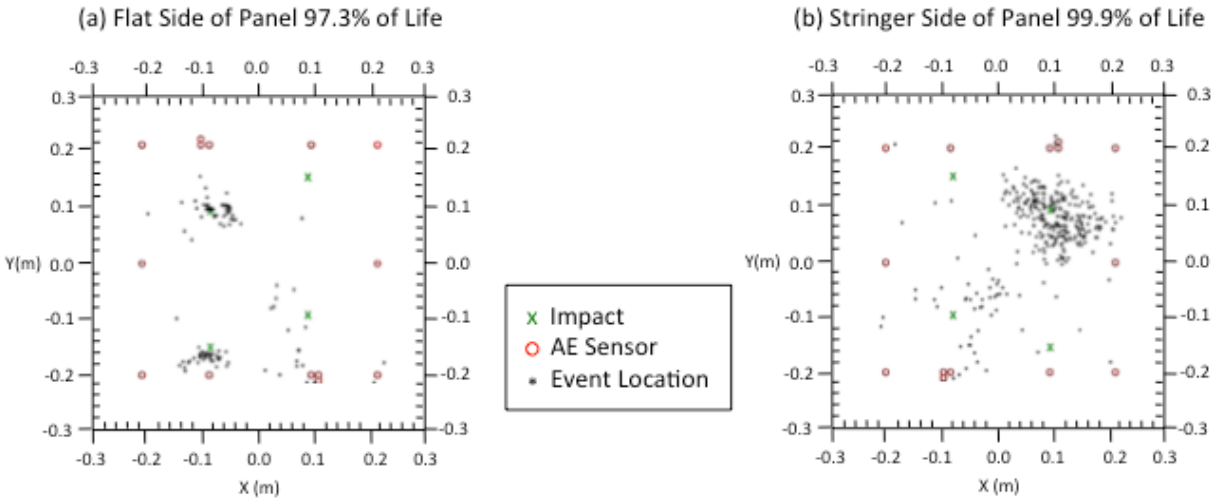
where  $V_i$  is the signal voltage,  $i$  is the time reference point,  $n$  is the number of time points in the signal,  $\Delta t$  is the sampling time per point. Trends of the energy over time, or load, are used to identify and track damage development. Signals from the distributed array of sensors are acquired simultaneously when any one sensor threshold triggers. This allows calculating the source or event location [10,11]. This is shown in Figures 3a and 3b where the acoustic emission events are shown for different fatigue tests. The accumulated acoustic events for Fig. 3a were for approximately 50 seconds and for Figure 3b was for 16.5 seconds. As the structure nears failure the accumulated acoustic events increases as a function of time as shown in Figure 3b.

Figure 3. Three-stringer panel acoustic emission event locations.

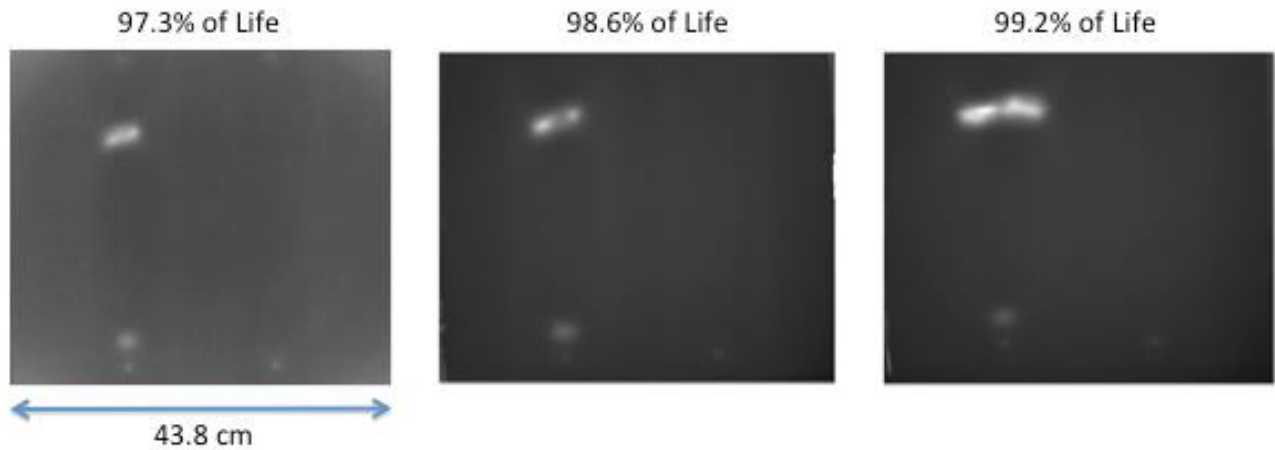
micrometer IR band and an image data acquisition computer. The IR cameras were both configured with 25 mm germanium optics. The focal plane array sizes for the cameras were from 640x512 to 1024x1204. The passive inspection captured the thermal variations during the fatigue loading. The setup required a Plexiglas® shield to contain fragments if ultimate failure occurred. The IR cameras were located behind the shield with the lens positioned in front of a viewing hole. The added benefit of the shield is it filters out spurious IR background sources. The cameras were synchronized using the load signal from the test machine. The sinusoidal load signal was offset corrected and the zero crossover points were used to produce a TTL trigger signal. The trigger signal was converted to a series of pulses using a signal generator. The IR cameras were operated at a frequency range of 16 to 90 Hz depending on acquisition time duration. Higher frequencies were used to capture the damage progression as the panel approached ultimate failure. Example unprocessed thermal images of the flat side are shown in Figure 5. The bright areas indicate the heated damaged sites.

Figure 5. Unprocessed thermography images (flat side) of damage growth as a function of remaining fatigue life.

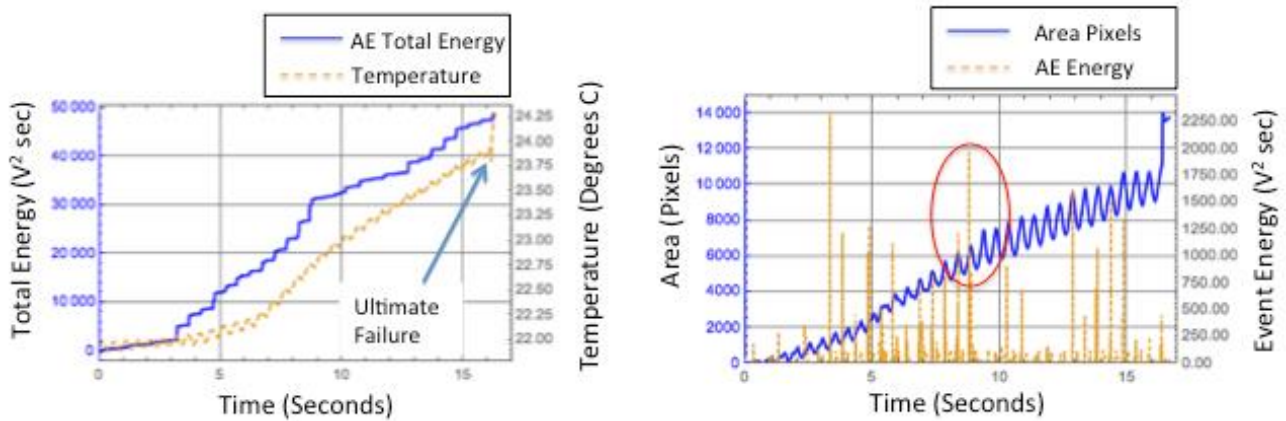
The total event energy is determined by summing the *SE* values for all the acoustic emission sensors over time. This is shown in left plot of Figure 7. The total event energy is compared to the averaged temperature over delaminated area I1 which is the area where ultimate failure occurred. Shown in the right plot of Figure 7 is the area pixels (estimated damage growth cyclically changing with periodic load) around delaminated area I1 versus the event energy over time. The estimated damage growth is determined by counting the number of “hot” pixels between 22.5 – 30.0 degrees C.

Sudden changes in damage growth related to a previously measured significant acoustic emission event (energy over a 1,000) might provide a capability to determine damage depth. The acoustic emission event can provide a time difference between the start of the event to when the thermal energy conducts to the surface and is visible. This time difference can potentially determine defect depth. An example is the circled area in the right plot of Figure 7, where a significant acoustic emission event precedes a jump in the damage size. Further testing of additional composite structures is required to study the feasibility of damage depth detection. Both plots of Figure 7, however, show trends of the acoustic energy over time and released thermal energy can be used to identify and track damage development and identify the area of failure within the composite.

Figure 7. Comparison of total acoustic emission energy to temperature and damage growth to event energy.

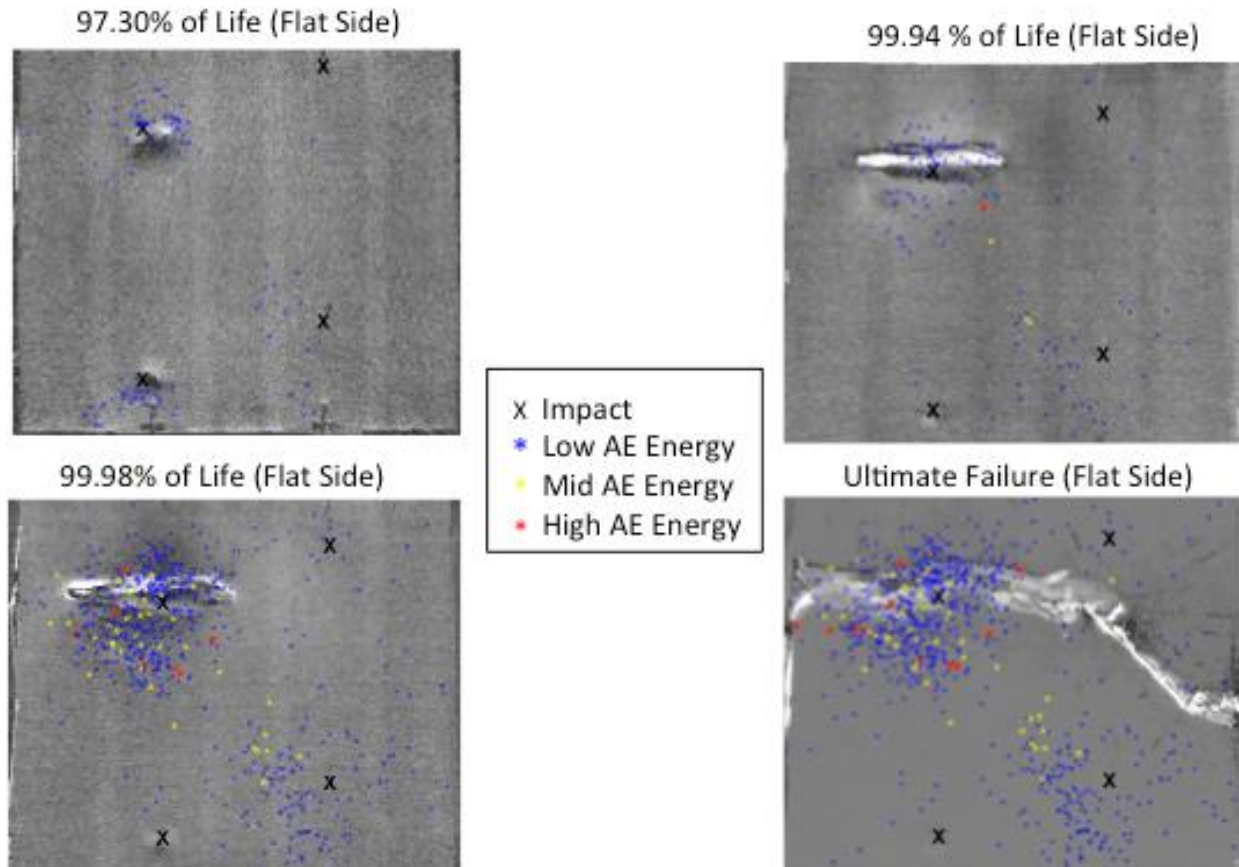
where the event indicator values of less than 13 were given a low energy color of blue (opacity of 0.5), indicator values between 13 and 15 were designated as a mid energy event color yellow (opacity of 0.7), and greater than 15 was a high energy event with color red (opacity of 1.0). As the structure nears failure, the accumulated acoustic events and indicator values increases as shown in Figure 9. Ultimate failure occurred at the location where the red high energy indicators and mostly yellow indicators clustered. It is important to note the location of the acoustic emission events are prone to errors due to the progression of damage (fiber breaks, delaminations, matrix cracking) as the structure nears failure. These defects can affect the propagation of the acoustic emission signal in terms velocity and waveform mode conversions resulting in processing errors, however, overall on average the clustered location is comparable to the thermal indications of the growing damage areas. In particular for the left image in Figure 10, some of the clustered

Figure 9. Mapped acoustic emission events onto the process thermal images (flat side).

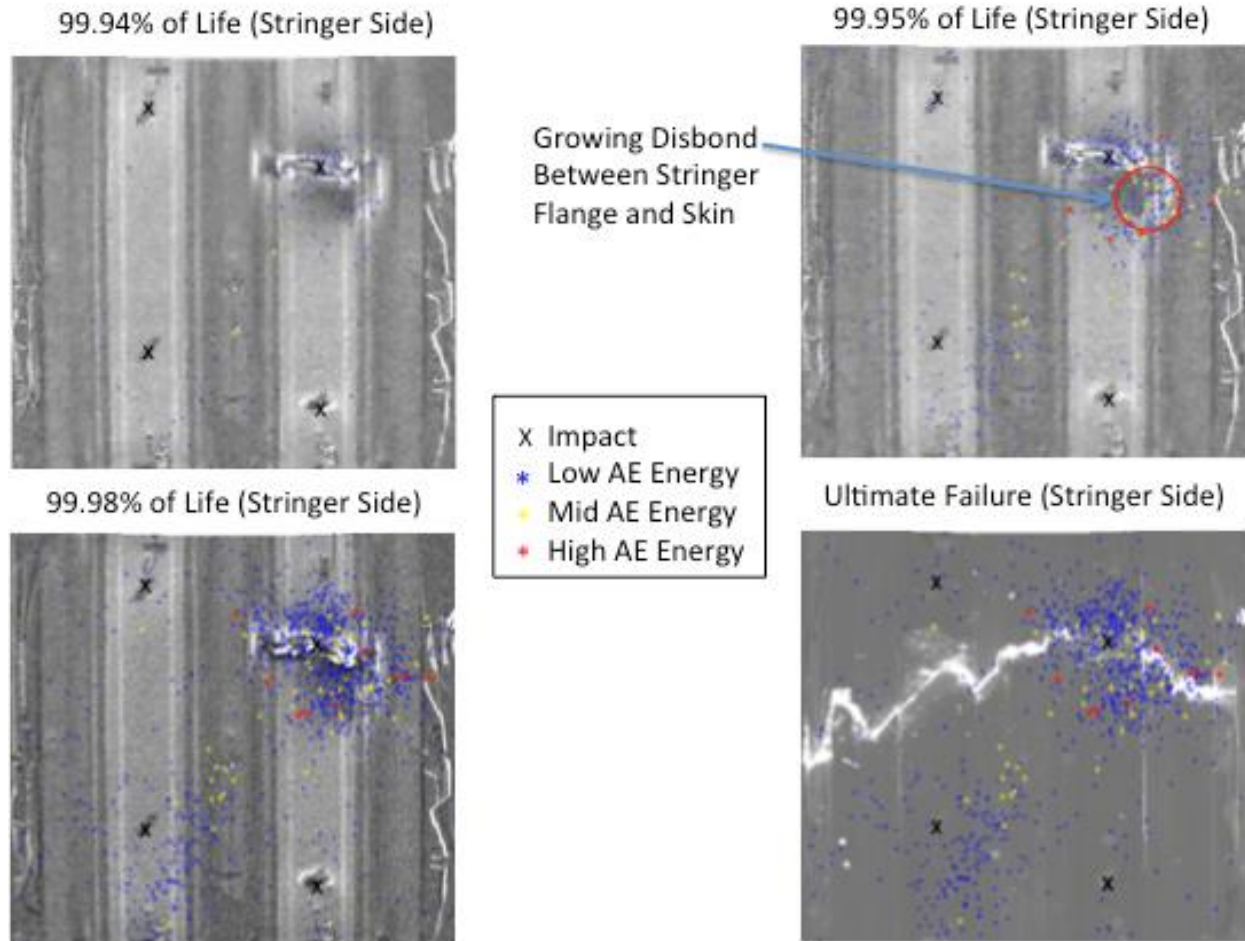
points tends to accumulate below the delamination on the right side. This is due to a growing disbond between the stringer flange and the skin below the delamination.

Figure 10. Mapped acoustic emission events onto the process thermal images (stringer side).
