## Evidence of Processing Non-Idealities in 4H-SiC Integrated Circuits Fabricated With Two Levels of Metal Interconnect

**Abstract.** The fabrication and prolonged 500 °C electrical testing of 4H-SiC junction field effect transistor (JFET) integrated circuits (ICs) with two levels of metal interconnect is reported in another submission to this conference proceedings. While some circuits functioned more than 1000 hours at 500 °C, the majority of packaged ICs from this wafer electrically failed after less than 200 hours of operation in the same test conditions. This work examines the root physical degradation and failure mechanisms believed responsible for observed large discrepancies in 500 °C operating time. Evidence is presented for four distinct issues that significantly impacted 500 °C IC operational yield and lifetime for this wafer.

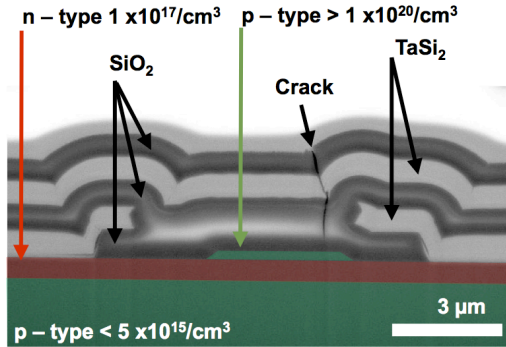
**Crack Formation Induced Fail-Open of Top Metal Interconnect.** The focused ion beam (FIB) cross-section shown in Fig.1, illustrates an example of dielectric and metal cracks that caused topmost metal conductive interconnect traces to electrically fail open. It is important to note that the crack forms only on the right side of Fig. 1 where the patterned edge of a lower TaSi<sub>2</sub> metal trace slightly overlaps (distorting upward) the edge of a SiC mesa feature due to slight misalignment of these two mask features. Devices close to the wafer center (roughly < 1 cm) did not exhibit this problem as the misalignment in this region was insufficient to result in such overlap/distortion. Misalignment and cracking grew more severe with increasing radial distance from the wafer center, consistent with rotational misalignment of the bottom metal mask pattern to the substrate n-mesa pattern during fabrication. Such cracks are not observed on other kinds of topology, such as where the lower TaSi<sub>2</sub> trace edge ends over the flat SiC region on the left side of Fig. 1. Cracking has neither been observed on the large bond pad edge cross-section shown in Fig. 2. If there had been

Fig. 1. Cracking sometimes occurs Where metal 1 and metal 2 overlaps the gate.

cracking at the edge of the bond pad (Fig. 2), previous experiments have shown that the underlying TaSi<sub>2</sub> metal laterally oxidizes causing electrical failure of the bond pad in less than a few hours at 500 °C. The measured resistance vs. time between adjacent connected bond pads plotted in Fig. 2 demonstrates desired minimal change in conduction properties (in part due to absence of crack features) over 4800 hours of 500 °C electrical testing time. Since it is related to misalignment, this cracking problem should be solvable by improved alignment and/or design rules with larger misalignment tolerances so as to prevent overlapping of lower metal edges with mesa features. The SiO<sub>2</sub> where the cracks originated was possibly weakened by water vapor absorption. To inhibit this possible contributing mechanism to the observed cracking, a protective stoichiometric Si<sub>3</sub>N<sub>4</sub> cap is planned for the next wafer run.

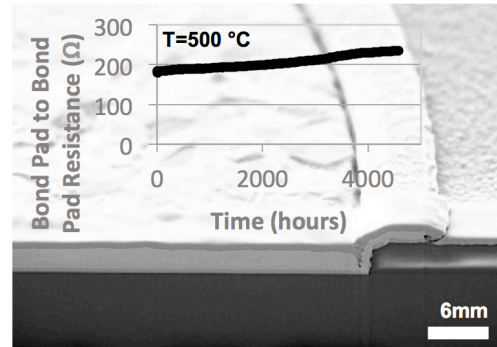
Fig. 2. By design, cracking did not occur around the oxide on bond pads. There was 32% increase in pad to pad resistance over 4800 hours.

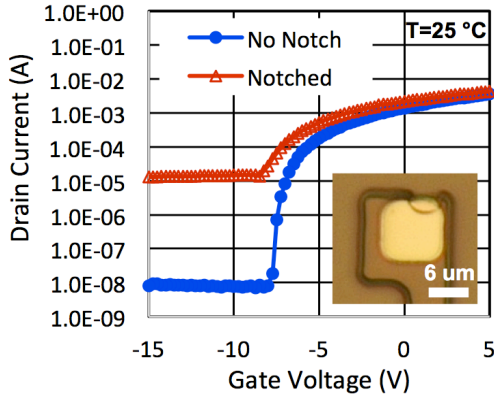
**Gate-to-Channel Leakage/Short From Notching of Gate Etch Mask Metal.** As described in [2], the JFET fabrication process starts by patterning a gate etch mask and dry etching ~2000 Å into the SiC to define the p<sup>+</sup> gate. The gate etch mask remains in place for a subsequent self-aligned implant step followed by liftoff patterning of a second metal etch mask that laterally defines the JFET n-channels when an additional ~5000 Å of SiC is dry etched. While the gate etch mask is supposed to prevent removal of any SiC from p<sup>+</sup> gate regions during the second (n-channel) dry etch, this particular JFET IC wafer displayed random notches in the gate mesa pattern. These notches arose from non-uniform oxidation/peeling along the edges of the gate etch mask during a prolonged unplanned storage of the sample in room air. When the second dry (n-mesa) etch was conducted, the notched regions did not sufficiently protect the p<sup>+</sup> SiC from removal, which then exposed underlying n-mesa regions in areas where contacts to p<sup>+</sup> gates were subsequently deposited. Fig. 3 inset shows where a p<sup>+</sup> gate contact overlaps such a notch. This allows the deposited metal p<sup>+</sup> gate contact to also form a parasitic electrical contact to the underlying exposed n-channel epilayer, including along the vertical etched sidewall of the n-epilayer. While both Fig. 3 JFETs demonstrate sufficient turn-off for successful circuit operation at 25 °C, turn-off characteristics of “notched” JFETs are undesirably orders of magnitude larger than notch-free devices. While not directly measured at high T, the leakage mechanisms of metal-semiconductor contacts/diodes are known to increase with anneal time and exponentially with T [3]. Therefore, this parasitic leakage is surmised to contribute to rapid failure of circuits at 500 °C. The degree of notching (and thus the degree of leakage) varied across the wafer. Very few devices with more than 10 gate fingers were free of notches. Notches have not been observed in any process runs before and after this wafer whose processing time between the gate and mesa etches have been a week or less, and were shipped to vendors in vacuum boxes.

Fig. 3. JFET turn off leakage with and Without a notch in the p-gate mesa.

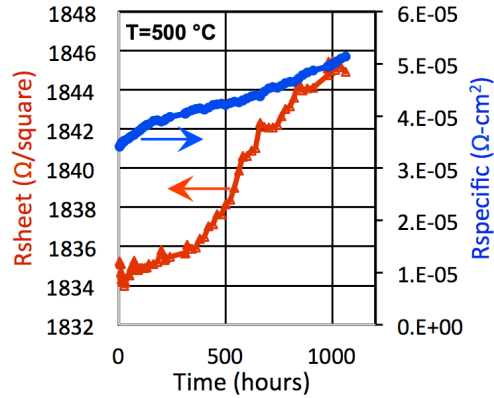
**Device Resistance Degradation.** Fig. 4 plots sheet resistance ( $R_{\text{Sheet}}$ ) and specific contact resistance ( $R_{\text{Specific}}$ ) extracted from prolonged measurement of a packaged 500 °C transmission line method (TLM) test device of the source/drain implant for over 1000 hours.  $R_{\text{Sheet}}$  changed less than 1% while  $R_{\text{Specific}}$  changed 50%. This suggests a degradation in the contact area or metal while the

Fig. 4. < 1% variation in  $R_{sheet}$ , but 50% increase in  $R_{specific}$ .

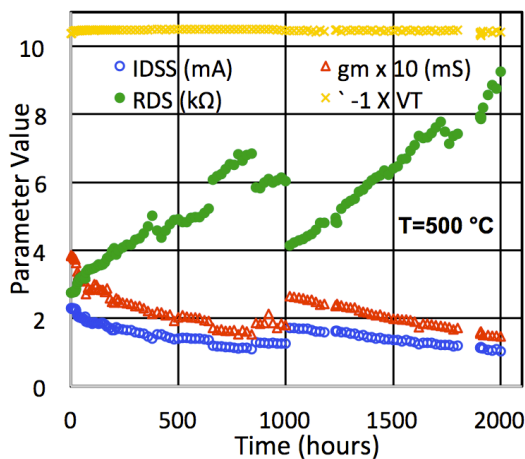
high-dose SiC implanted sheet resistance is stable. The 500 °C testing time evolution of transistor parameters for a JFET in a NOT circuit are shown in Fig. 5. The threshold voltage ( $V_T$ ) changes less than 2% over 2000 hours. Transconductance ( $g_m$ ) and the on-state current ( $I_{DSS}$ ) decrease with time at temperature while on-state resistance  $R_{DS}$  increases, which is qualitatively consistent with the Fig. 4 trend. Data discontinuity shown in Fig. 5 at 1000 hours corresponds to a brief temperature cycle to 25 °C and back. Most of the drift in  $R_{DS}$  recovered during this cycle. It is important to note that the recovery of  $R_{DS}$  seems inconsistent with contact oxidation or metal trace failure mechanisms that would be irrecoverable. Delamination of the contact area has not been seen in focused ion beam (FIB) cut cross-section images of similar devices on the wafer. Therefore, the root physical cause (or causes) of this degradation remains under investigation at this time.

Fig. 5. < 2% variation in  $V_T$ . Note changes from thermal cycle to RT at 1000 hours.

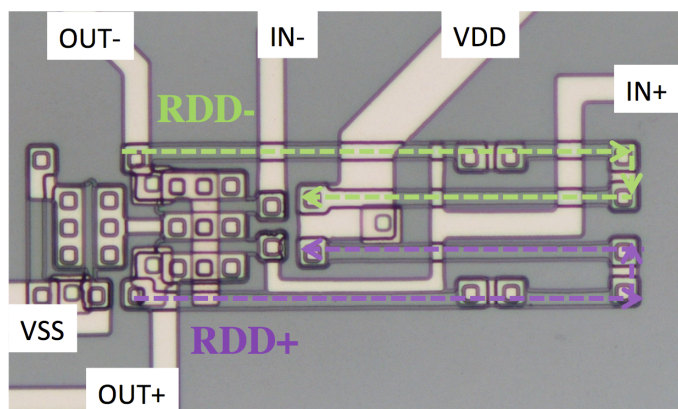
**Parasitic Circuit Imbalance Induced by Mobile Ion Contamination.** Differential amplifier circuits rely on well-balanced circuit legs (i.e., transistors and/or resistors) to operate. Resistive load differential amplifier ICs (including 2-stage op-amps which were also used as sense-amps for test memory ICs) were fabricated and electrically verified as operational at room temperature with expected gains. However, on all ICs custom-packaged for high temperature testing, these differential-based amplifiers all rapidly failed as they were heated past 200 °C. A packaged diff-amp (Fig. 6) underwent bias-temperature stress measurements while directly measuring “balanced” resistors RDD+ and RDD- (highlighted with colored dashed lines) IV characteristics. Fig. 7 shows an example of the resistor IV imbalance measured after +30V 200 °C positive bias stress of the VDD metal trace, while Fig. 8 shows that the imbalance is mostly eliminated following a subsequent -18V 300 °C stress applied to the VDD metal trace. This reversible bias-temperature-time stress behavior is consistent with reversible mobile ion contamination phenomenon well-

Fig. 6. Optical image of the differential amplifier shows the two balanced resistors with one having a VDD trace pass over top.

Subsequent surface analysis detected sodium (Na) on the surface of wafer samples. Some sources of sodium contamination in the NASA processing laboratory have been identified and eliminated. Additional processing steps that largely mimic sodium mitigation strategies of the silicon IC industry as well as layout design changes are being implemented for future processing runs [4,5]. However, the effectiveness of these lower-temperature IC strategies to withstand/enable prolonged 500 °C SiC IC circuit operation remains to be proven.

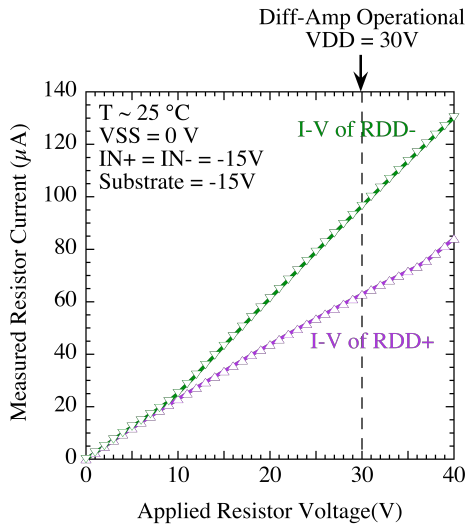
Fig. 7. Diff-amp resistor IV imbalance observed following biased heating (VDD=+30V) to 200 °C and cool down.

known to be detrimental to metal-oxide-semiconductor (MOS) devices [4]. In this particular case, positive ions in the oxide become mobile at elevated temperature and are repelled by positive VDD bias, piling up near the SiC-oxide interface beneath the VDD metal. The resulting positive ion charge buildup near the SiC-insulator interface produces a parasitic surface inversion channel of electrons (supplied by the n-mesa resistor), causing turn-on of a parasitic n-MOSFET under the VDD trace which substantially imbalances current flow of RDD- relative to RDD+. Application of negative VDD terminal bias at temperature drives positive ions back towards the gate, turning off the parasitic MOSFET, restoring post-cool down resistor balance (Fig. 8) and experimental room temperature operation of diff-amp and op-amps.

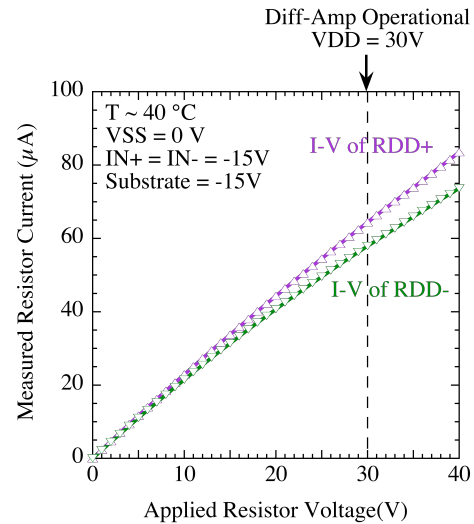
Fig. 8. Observed restoration of diff-amp resistor IV balance following 2 hour 300 °C VDD stress of -18V and cool down.
