NASA/TM-2015-218987

Crash Tests of Three Cessna 172 Aircraft at NASA Langley Research Center's Landing and Impact Research Facility

Justin D. Littell
Langley Research Center, Hampton, Virginia

November 2015

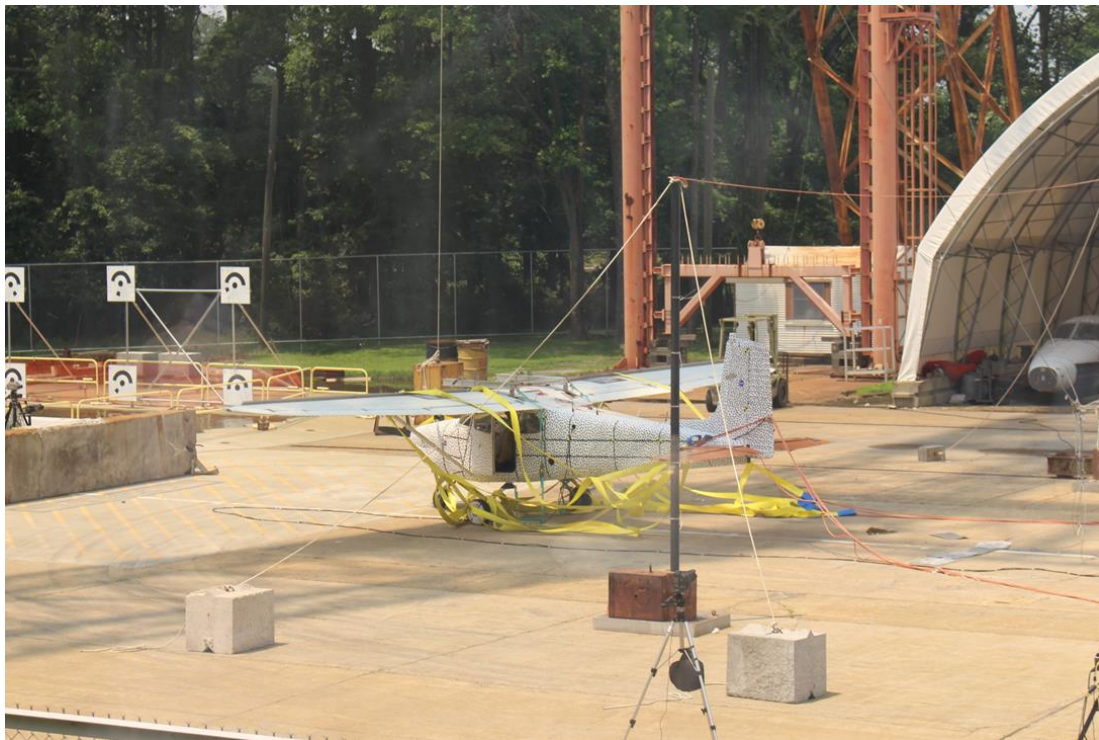
Figure 12 - Airplane configuration post-test

The airplane, stopped by the catch net, came to rest approximately 50 feet away from the initial impact location. The net was wrapped around the nose and wings of the airplane, stopping it within 20 feet of first contact. A photograph showing the post-test airplane and net is shown in Figure 12.

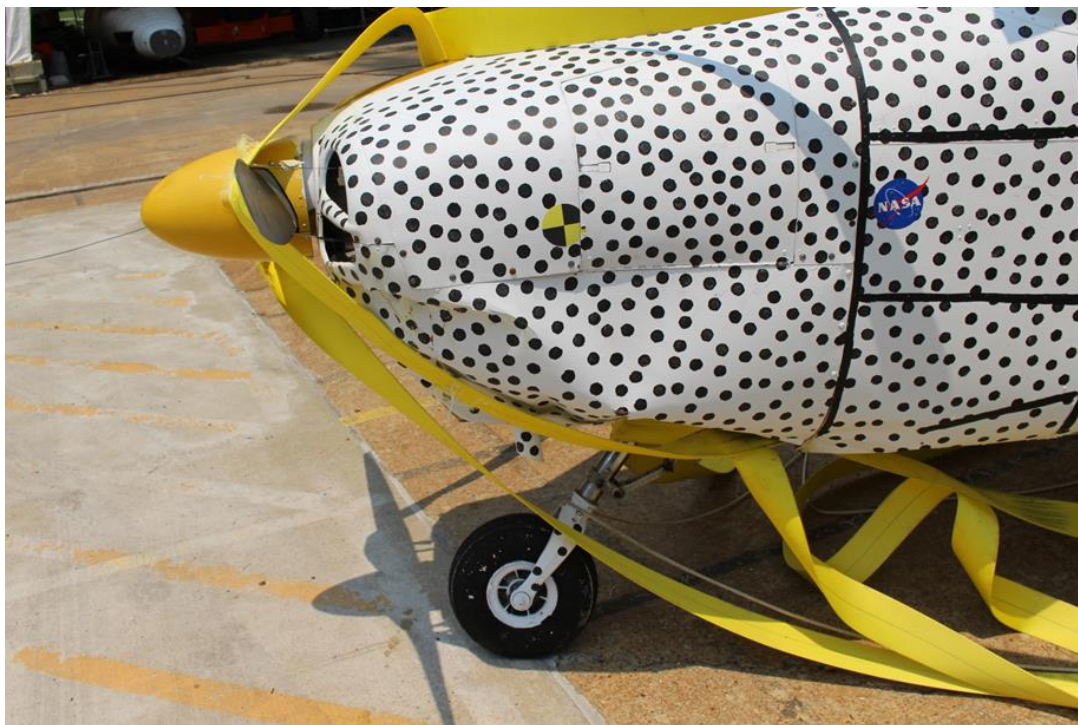
Figure 13 - Test 1 – Post-test nose buckling and landing gear orientation

One of the first things that was noticed during post-test inspection was the unusual orientation of the nose gear. The gear, while still intact, exhibited an unusual forward lean angle, pointing much further forward than before the test. Inspection of the high speed videos suggests that the firewall attachment location of the gear buckled under the loads seen from the initial ground contact and the compression of the nose gear

during the time in which the main gear was deforming. This finding was confirmed when conducting post-test inspections of the firewall with the nose cover skin removed. The buckling of the firewall also caused dents to appear in the nose cover skin, as seen in Figure 13.

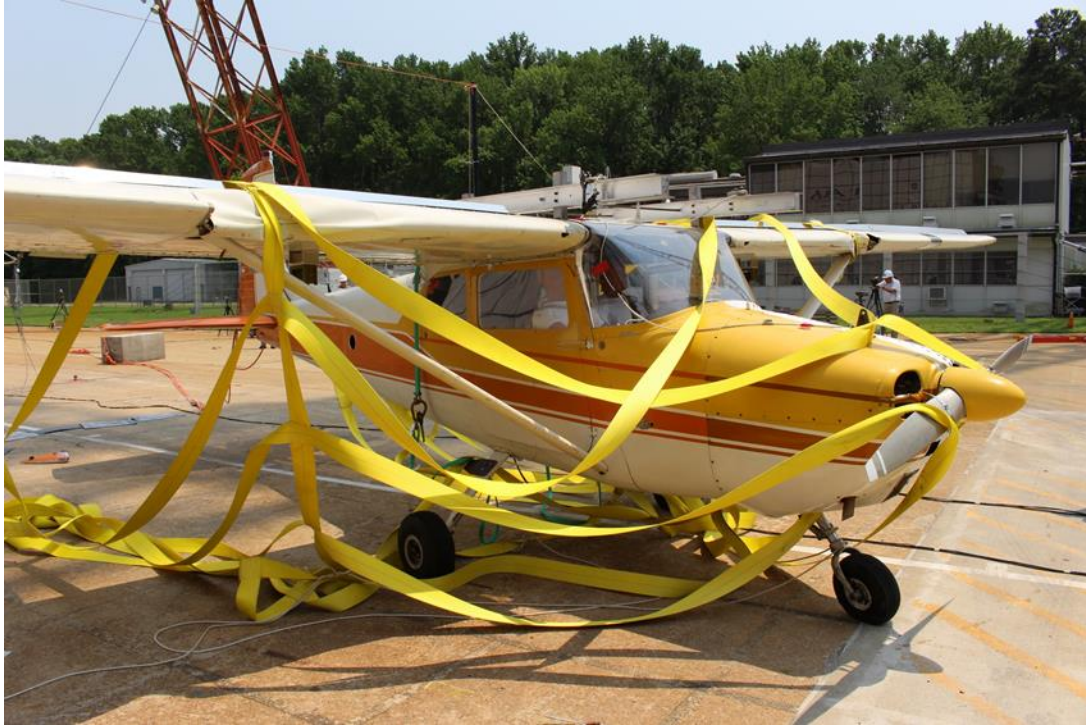
Figure 14 - Test 1 – Post-test wing damage

Damage also occurred on the wings near the wing strut attachment locations. It was also at this approximate location where a vertical strap from the catch net was located. The tension in the net occurring from the forward airplane velocity caused the net to start to compress the wing leading edge at the vertical strap location.

It should also be noted that the main landing gear and wheel is visible in Figure 14. All post-test inspections of the main landing gear springs showed no signs of damage, even after the landing gear exhibited large amounts of deformation during the initial ground contact. One major finding was the deformation from the ground contact did not plastically deform the gear. The wheels themselves still held air post-test, and the airplane was able to be rolled away back into the preparation hangar from the impact location for tear down.

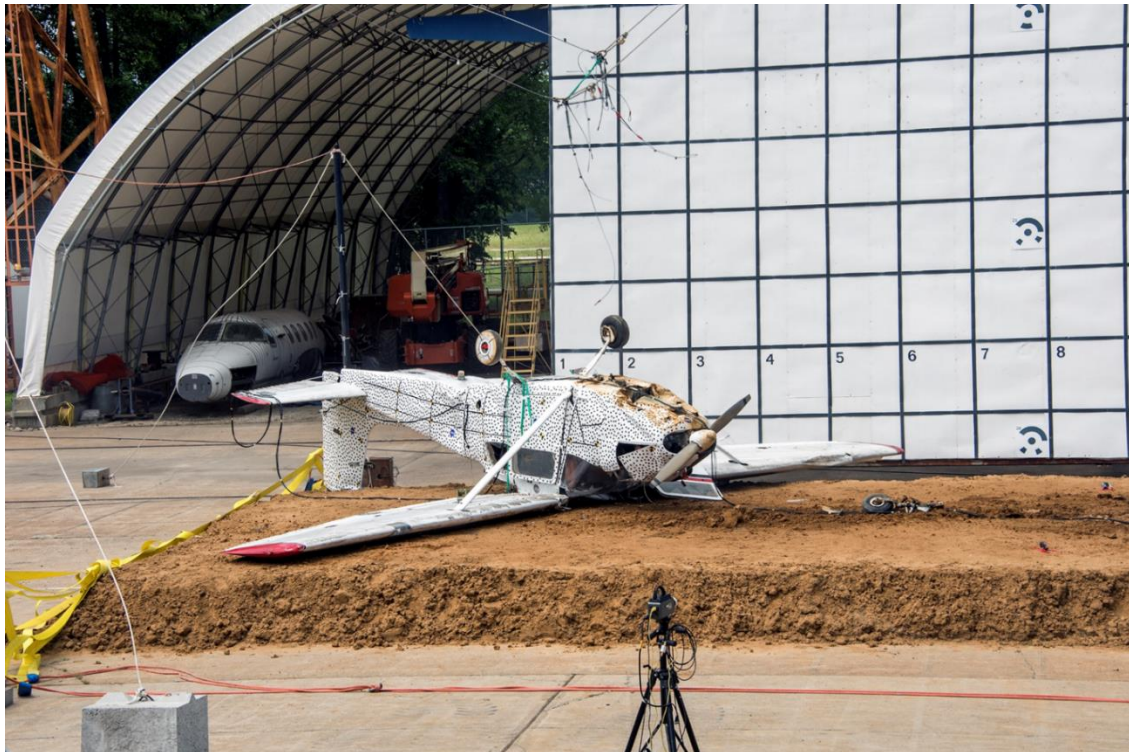
Figure 21 - Airplane configuration post-test

The airplane came to rest on the soil surface approximately 20 feet away from the impact point, upside-down and skewed toward the co-pilot's direction. The short slide-out distance is due to the flipping of the airplane at impact. The aircraft and separated nose gear can be seen in Figure 21.

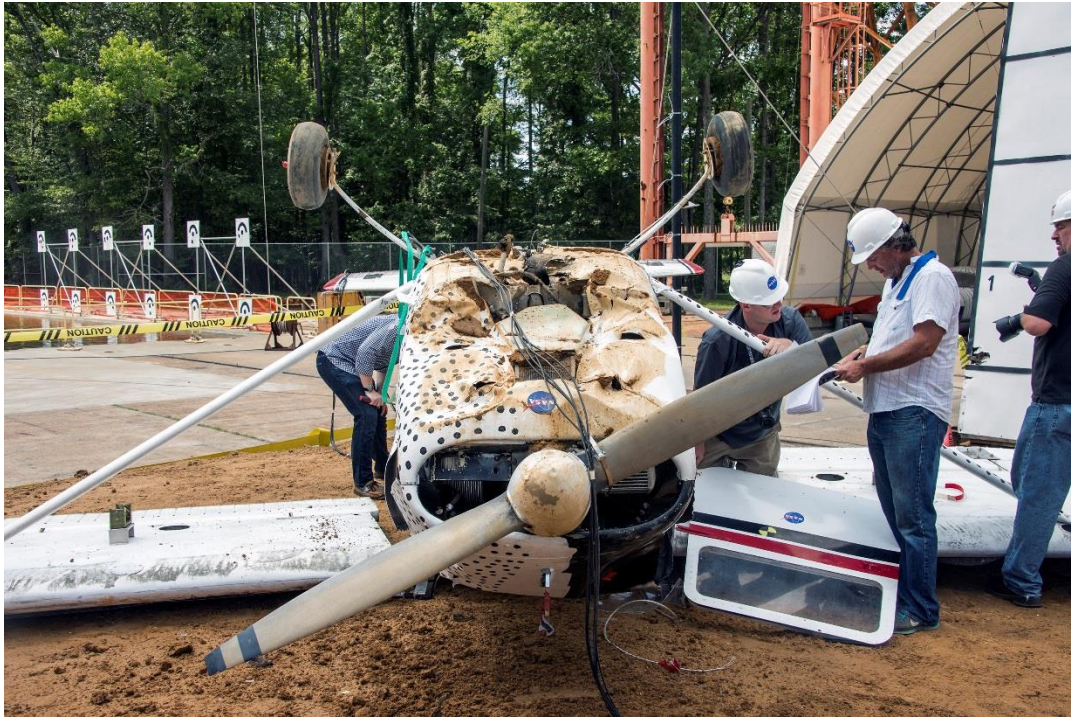
Figure 22 – Test 2 – Post-test nose damage

Major nose damage was caused by the nose gear protruding into the dirt, causing a large bending moment about the firewall. The firewall buckling caused skin damage seen in the nose of the airplane. The nose gear also broke free from the firewall and ended up in the soil, approximately 10 feet away from the airplane. The damage in the underside of the nose is shown in Figure 22. Some of this damage was caused by the firewall buckling and landing gear breaking away, while some was caused by the underside of the nose penetrating into the dirt, shearing portions of the skin near already failed regions near the firewall. The propeller, however, appeared to be intact, with only a small amount of denting on the spinner.

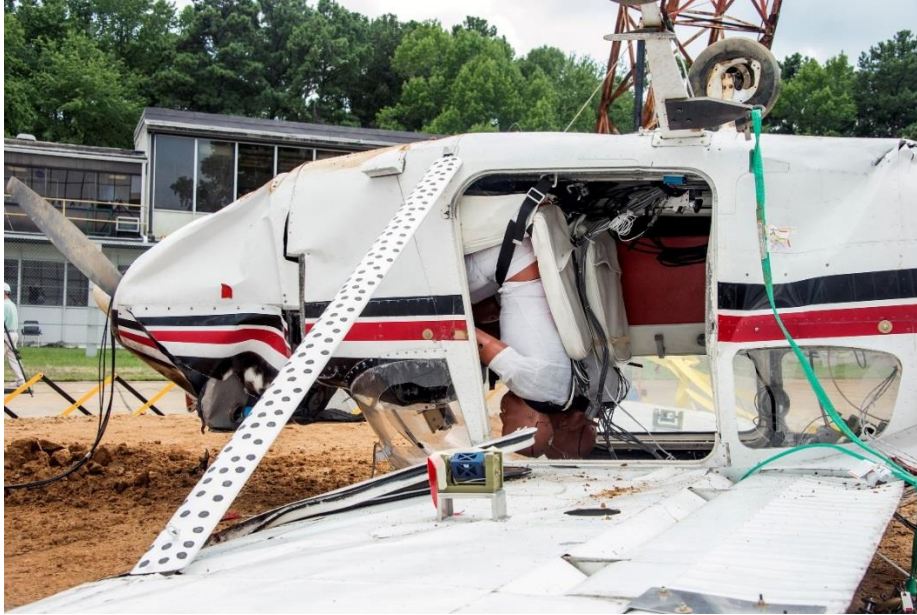
Figure 23 – Test 2 – Post-test airframe damage - Nose and co-pilot side cabin

Figure 23 shows the extent of the damage on the co-pilot side of the airframe. A large gap, along with a large amount of skin buckling can be seen at the firewall location by the nose, and along the lower portion of the nose, near where the nose gear would normally be. Cabin damage is most noticeable by noting the co-pilot door has broken free from the rest of the airframe. The removed door, along with the creases in the skin behind the door, indicate large amounts of bending in the cabin area of the fuselage also.

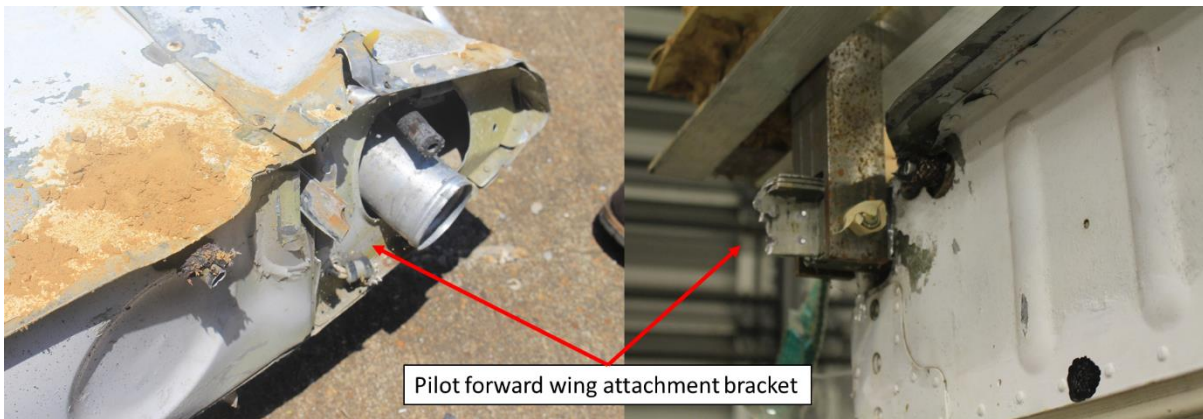
Figure 24 – Airframe damage - Pilot's wing. At impact location (top) and further inspections in the hangar (bottom)

Damage on the pilot side of the airframe is most notable by examining the wing attachment locations, as shown in Figure 24. The attachment brackets on the wing connections fractured, causing the wing to come completely dislodged at the wing attachment locations on the fuselage and come to rest next to the body of the airplane. Further inspections of the wing attachment locations post-test suggest that age and wear on the wing attachment brackets caused this failure.

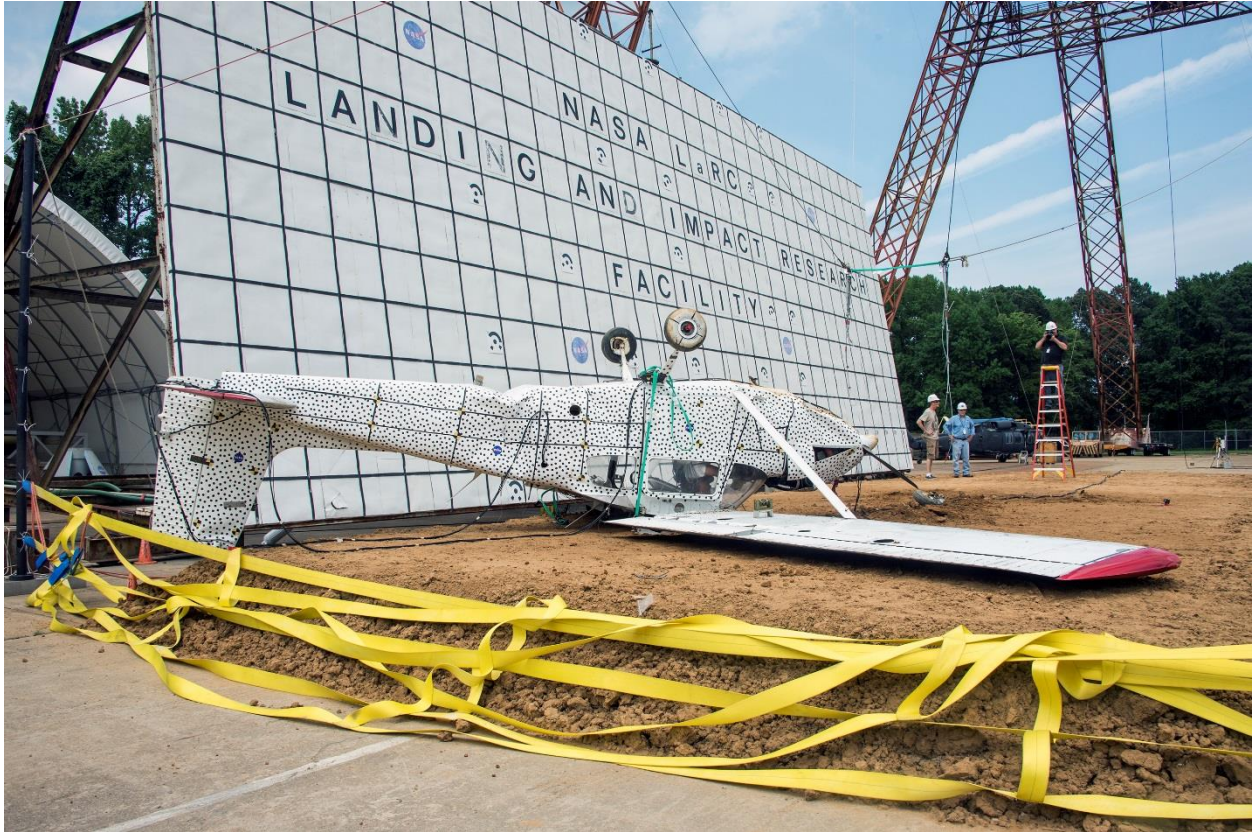
Figure 25 – Test 2 – Post-test pilot side tail damage

The tail also saw a large amount of deformation during the test, however it did not break free of the cabin. Instead, large amounts of buckling were examined in the area slightly aft of station 108, as shown in Figure 25. It is at this location where the floor of the cabin ends, and thus presents an area of differing overall airframe stiffness. It is likely because of the difference in stiffness that the buckling occurred in this region.

In both of the tests conducted onto soil, the tail buckled just aft of the cabin-tail junction. Even with the differences in tail design (straight tail for Test 2 and swept tail for Test 3), the difference in global stiffness between the cabin and tail resulted in an ideal spot for the initiation and propagation of buckling. The difference, however is the straight tail only showed signs of major buckling whereas the swept tail did exhibit fracture. The addition of the rear window in the swept tail design likely weakened the tail structure enough to cause the fracture, along with the differences in impact conditions, made for a larger vertical acceleration in the tail for Test 3.

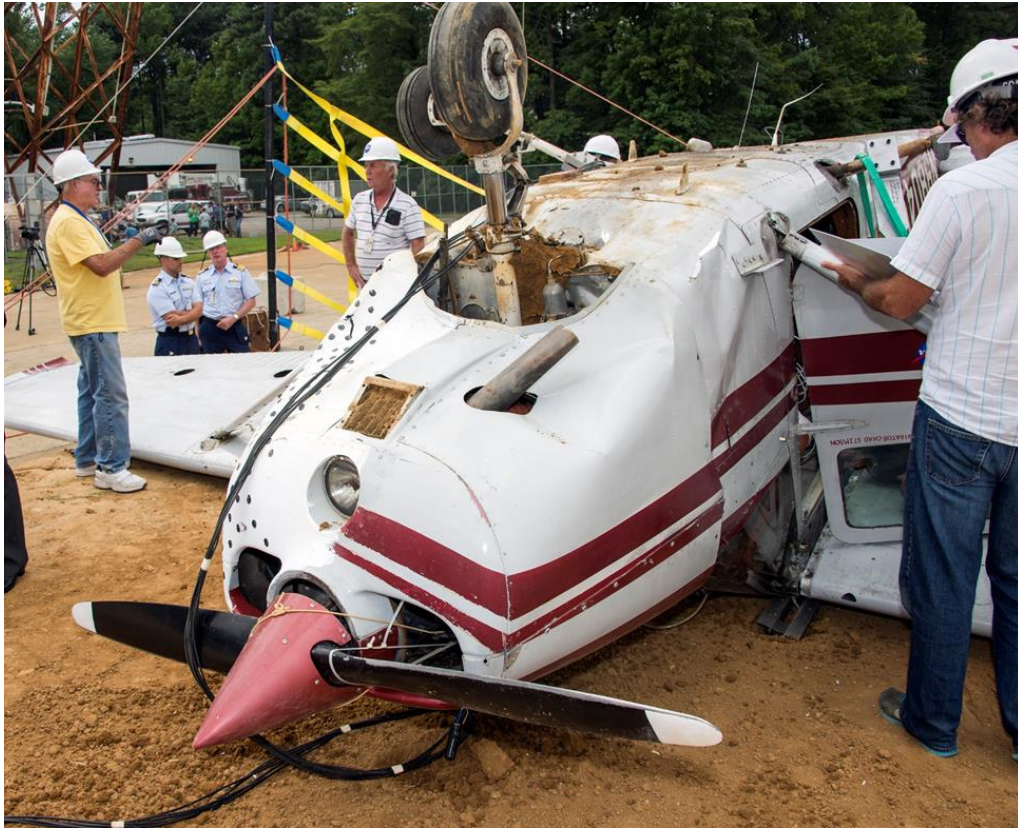
Figure 33 – Test 3 – Post-test nose damage

The nose of the airplane was much more intact than on the Test 2 airplane. Due to the slap down effect, the tail strike caused the airplane to lose much of its initial horizontal velocity, such that when the nose impacted, there was less of a shearing effect and more vertical crushing. The nose gear remained attached to the firewall, however there was still firewall damage, causing nose skin wrinkling and buckling, as depicted in Figure 33.

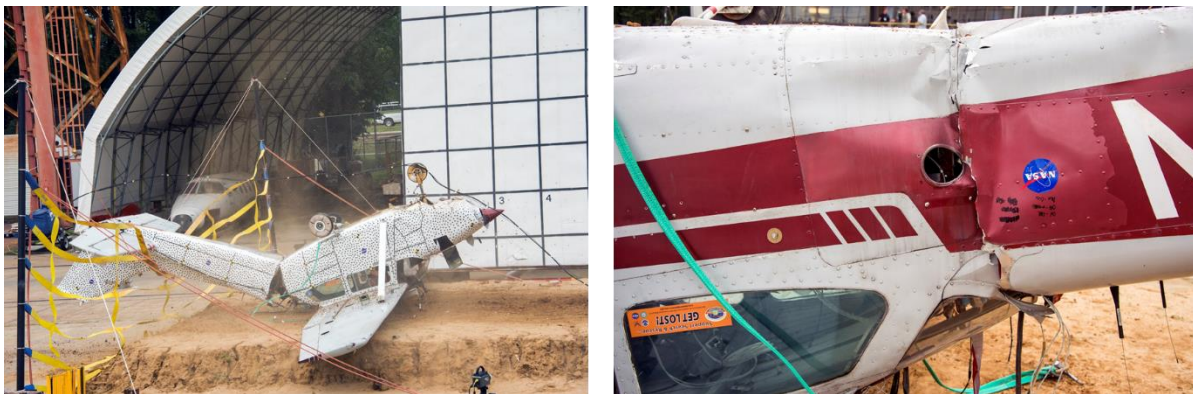
Figure 35 – Test 3 – Post-test tail failure

The tail fracture occurred just aft of the 108 station in the airplane, where the cabin transitioned into the tail. This transition area offered an ideal place for failure due to the differences in stiffness. A still image is captured during the test in Figure 35, left, showing the opening caused by the fracture in the tail during the test. Figure 35, right, shows a close up of the fracture, which is located just aft of the rear window, at station 108.
