The Evolution of Failure Analysis at NASA's Kennedy Space Center and the Lessons Learned

Failure in LEO: the Solar Alpha Rotary Joint (SARJ):

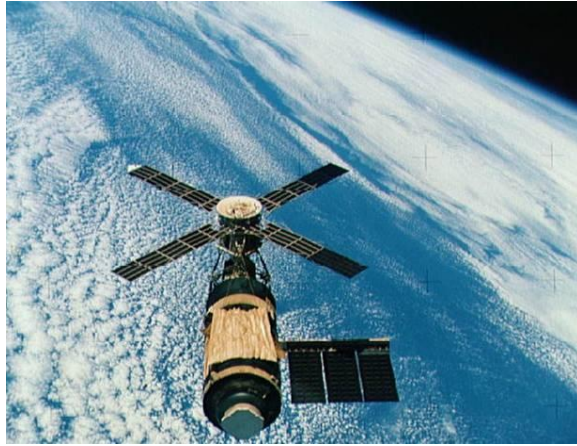
Successes from the Skylab program could have been overshadowed by accidental early deployment of a meteor shield during launch which was then torn off by atmospheric drag, causing problems maintaining a constant internal module temperature. A parasol-like shield was designed, then launched and deployed by the first Skylab crew thus fixing the problem (Figure 1). Skylab maintained its near-circular orbit at an altitude of 435 km (270 miles) throughout the life of the program, and remained on orbit for another 5 and ½ years until it re-entered Earth's atmosphere and disintegrated over the Indian Ocean and Western Australia in 1979.

Figure 1. Skylab orbiting the Earth, as seen by a departing crew capsule after one of the long-duration missions. The parasol-like repair shield is seen at the bottom of the image, a fix that enabled mission and program success.

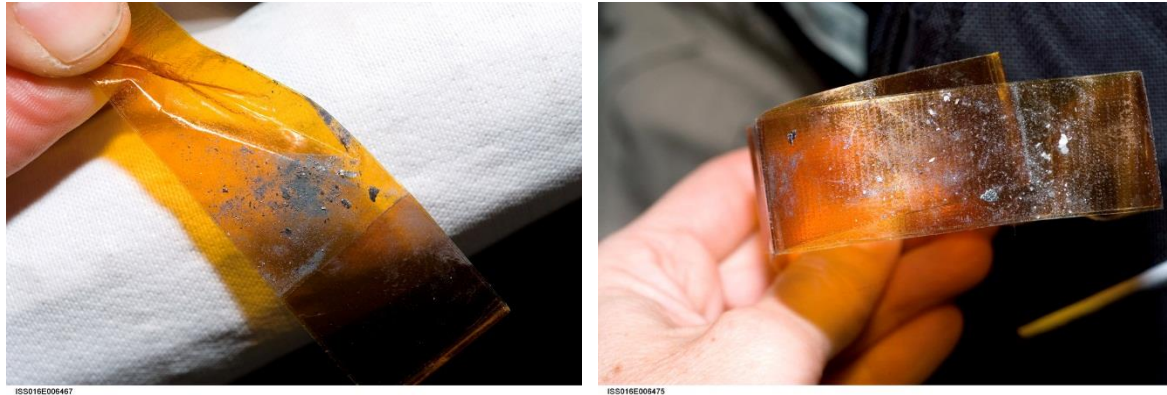
During the second EVA, a task was added to the planned activities for astronaut Dan Tani: to inspect the Multi-Layer Insulation covers on the starboard SARJ for evidence of the cause of the anomalous data, such as a micrometeoroid impact or an interference problem. Upon finding no external cause of the problem, Tani removed the insulation cover and observed apparent metallic debris gathered on the magnetic Trundle Bearing Assembly and a mottled appearance of the race ring surface. Tani gathered fragments using polyimide tape so that the pieces could be returned for analysis by engineers on the ground [10].

Figure 4. On-orbit images of debris samples on polyimide tape that needed to be returned to Earth for failure analysis. Credit: NASA

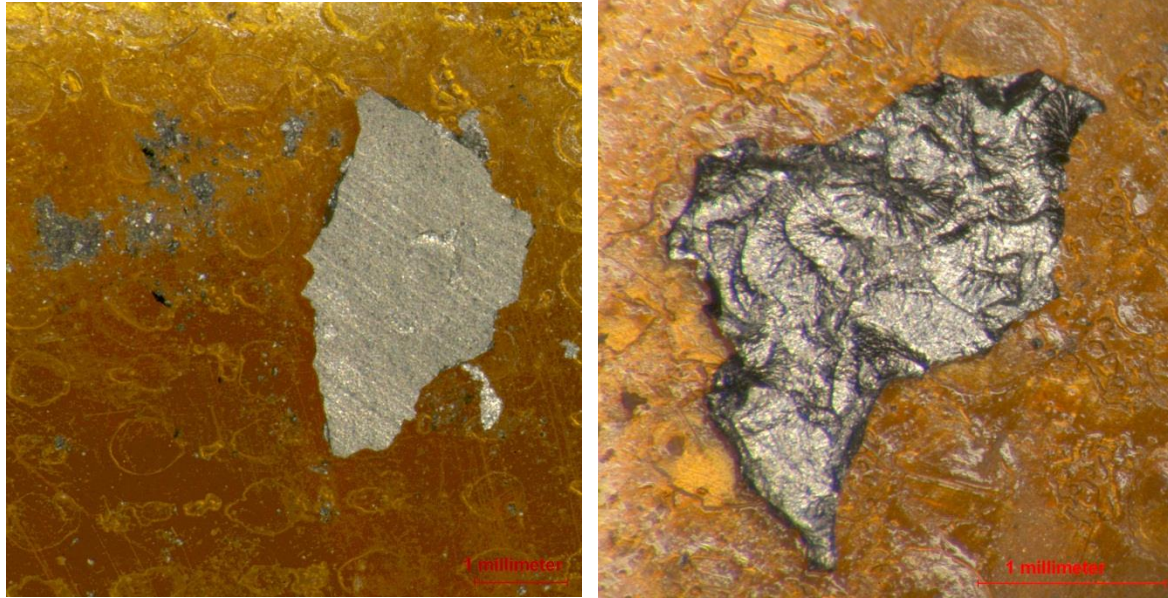
The three pieces of polyimide tape collected by astronaut Tani and returned to Earth were photodocumented and initially observed in a stereomicroscope. The particles sizes for the debris ranged from very fine particulate less than 100 μm up to approximately 1 mm. The first significant observation was apparent machine markings still present on the surface of some of the larger fragments and fracture features visible on other fragments (Figure 6). Additionally, the debris was classified as fine particulates, flattened agglomerations, and large chips. The debris had a slight magnetic response [13].

Figure 6. Stereomicroscopic inspection revealed that the shards included both original surface finish (left) and fracture features (right). Credit: T. Long & C. Wright/NASA KSC

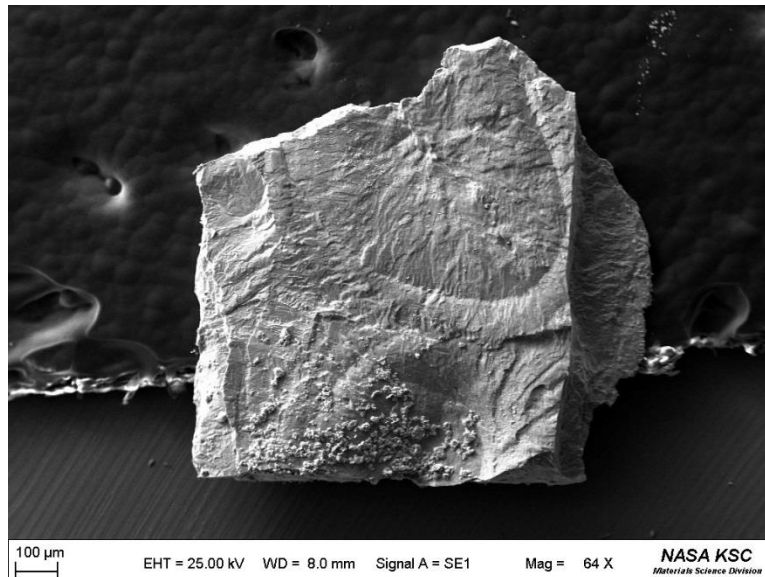
SEM observation of the debris revealed the clues that started to tell the story about what had happened to the SARJ race ring. The machine markings on some of the larger fragments were again confirmed via the SEM and when one of these fragments was flipped over, fracture features were revealed. The debris shards displayed classic evidence of Hertzian contact stress failure, with fracture paths parallel to the outer surface [14]. These fracture features were relatively brittle in nature, resembling a progressive failure with crack arrest marks clearly evident (Figure 7). Niobium-rich precipitates, verified via EDS and typical for this alloy, appeared at the subsurface initiation sites of the fractures.

Figure 7. SEM micrograph of a larger starboard SARJ chip showing subsurface crack initiation at Nb-rich precipitates and crack arrest marks. Credit: T. Long & C. Wright/NASA KSC

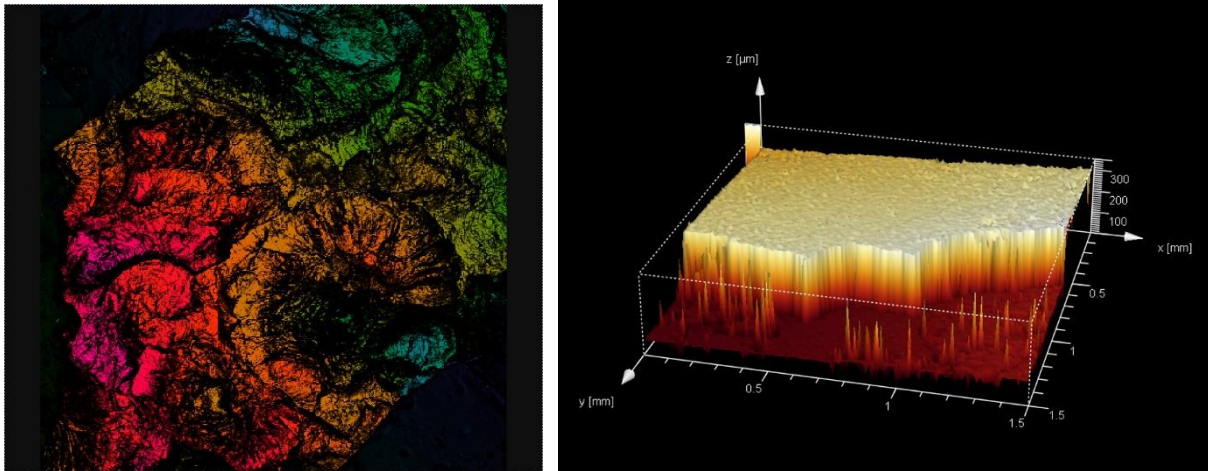
Laser confocal microscopy (Figure 8) and metallography were both used to characterize the thickness of the debris, which indicated that the debris generation was limited to the nitride case. However, M&P engineering was concerned by the observation of extrusion-like damage and

agglomerated fine particulate, which indicated that further damage was occurring and failure of the race ring could be exacerbated by the presence of this debris.

Figure 8. Laser confocal microscopy was utilized to non-destructively measure the thickness of the starboard SARJ debris. Credit: C. Wright/NASA KSC

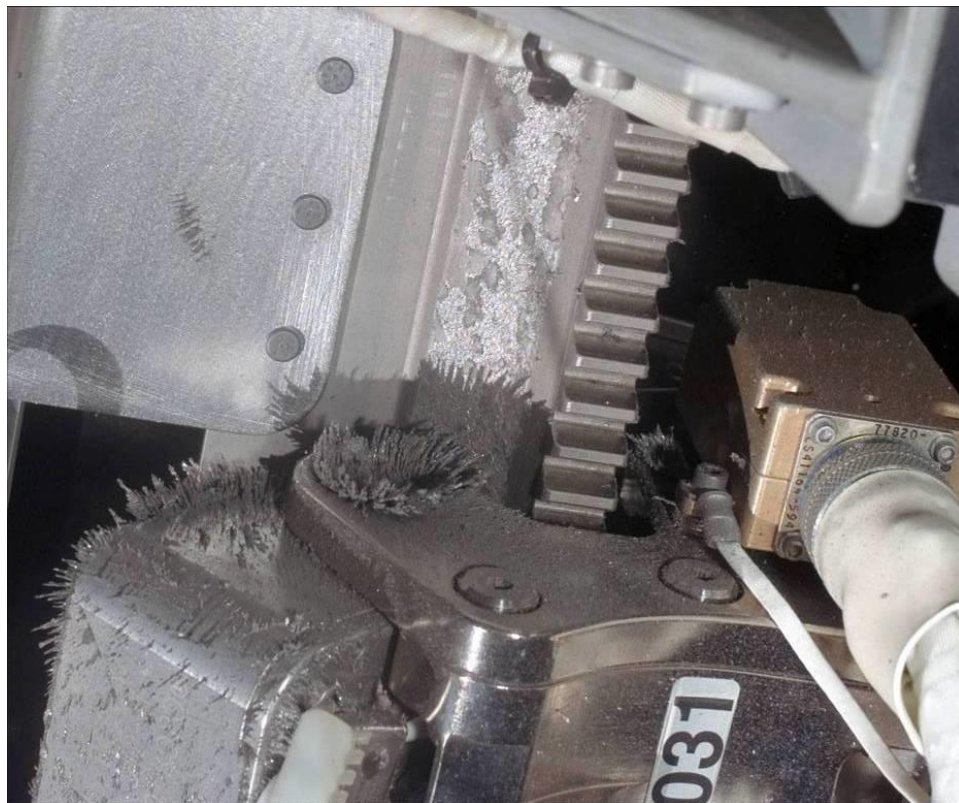
In December of 2007, approximately a month after the original failure analysis at the KSC laboratory, Expedition 16 astronauts Dan Tani and Peggy Whitson performed a nearly seven hour EVA which focused on inspecting the starboard SARJ race rings and bearings beneath 16 of the 22 drive lock assembly covers. Various amounts of the similar types of debris were observed, while one of TBAs was removed for evaluation back on Earth. During EVAs 13 and 14, 29 tape samples, containing hundreds of fragments of debris, were collected. High-resolution photographs of the raceway surfaces revealed surface degradation with debris adhering to the TBAs (Figure 9).

Figure 9. On-orbit photograph of one of three raceway surfaces of the starboard SARJ during Expedition 16 EVA showing damage to the race and magnetized debris on the TBA. Credit: NASA

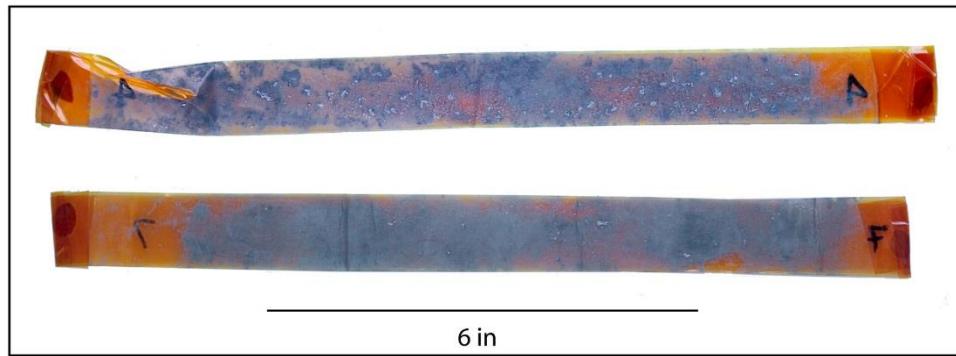
Figure 10. Photograph of two representative SARJ sample tapes from the Expedition 16 spacewalks showing a dust-like fine debris covering the majority of the adhesive tape surface as well as some larger fragments that were evident when visually inspected. Credit: P. Marciniak/NASA KSC

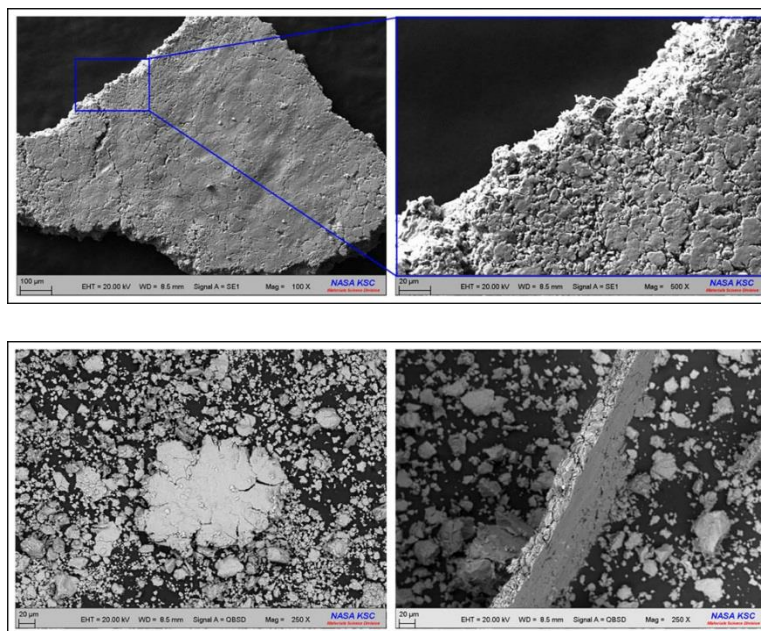
Figure 11. Representative SEM micrographs of agglomerated (top) and extruded (bottom) SARJ particles from Expedition 16 EVA. Credit: C. Wright/NASA KSC

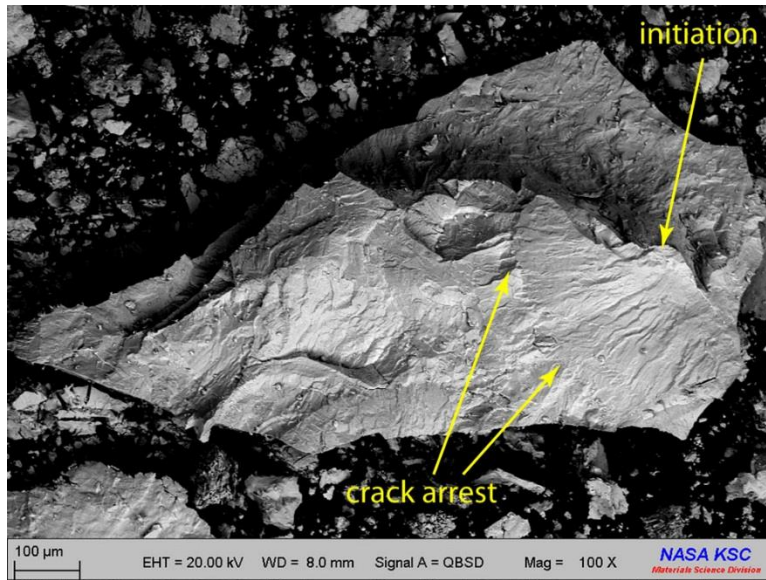
Figure 12. Fracture features of the Expedition 16 EVA samples were similar to those from the original STS 120 samples, with subsurface crack initiation and crack arrest marks. Credit: C.

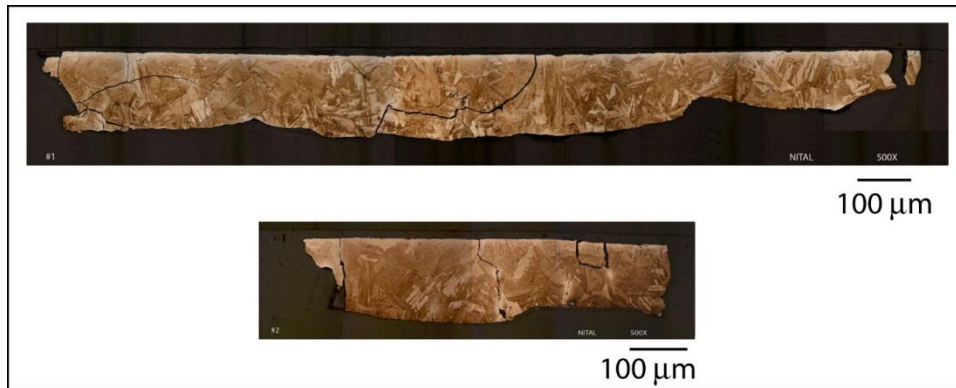
Figure 13. Etched starboard SARJ fragment showing transgranular crack propagation and fracture within the nitride case of the 15-5 PH race surface. Credit: P. Marciniak & B.

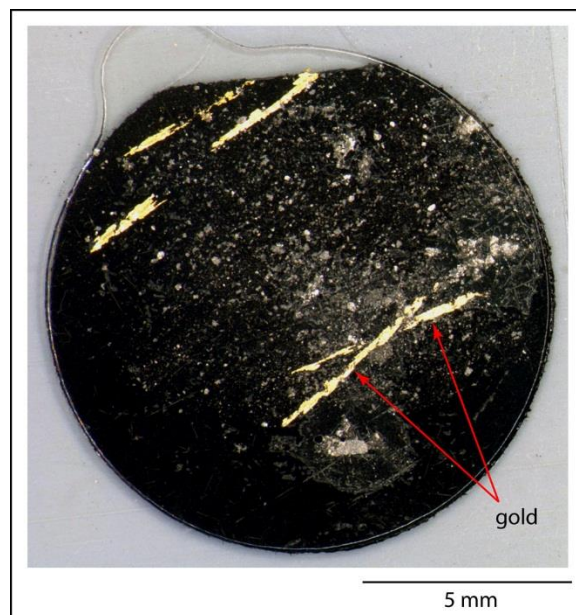
TBA rollers [19]. The gold plating should have been metallurgically bonded to the substrate, but Figure 14 shows that microscopy tape could easily detach the plating in ribbons. Additional investigation by the engineering team revealed that the loss of gold plating was occurring on flight spares, and that artificially-aged samples from new gold-plated rollers were experiencing a loss of adhesion due to corrosion at the interface between the plating and substrate. The resulting inadequate lubrication led to high levels of friction and roller contact conditions, which ultimately led to damage of the race ring's nitride surface as subsurface loads moved to the case/core interface, which caused spalling to initiate at sub-surface discontinuities, in this case niobium-rich precipitates, which acted as stress concentrators. It was theorized that weak magnetic forces in the microgravity environment caused the debris to stay within the SARJ, causing the larger chips to be pulverized and then agglomerate. An additional conclusion by the investigation team was that the SARJ design had a kinematic susceptibility to tip due to roller mistracking, which, combined with the high frictional forces, led to high roller-edge stresses and resulted in the 15-5PH race surface spalling at the nitride case [20].

Figure 14. Stereomicroscope image of TBA sample, taken from an inner 45 roller surface. Gold plating was observed flaking off of the roller sides as samples were prepared. Credit: C.
