# Dynamic Open-Rotor Composite Shield Impact Test Report

*Silvia Seng and Charles Frankenberger  
Naval Air Warfare Center Weapons Division, China Lake, California*

Use of advanced composites in fuselage structures may address airplane threats from uncontained blade failures. This report documents results of testing to validate the effectiveness of composite panels for shielding the fuselage from debris.

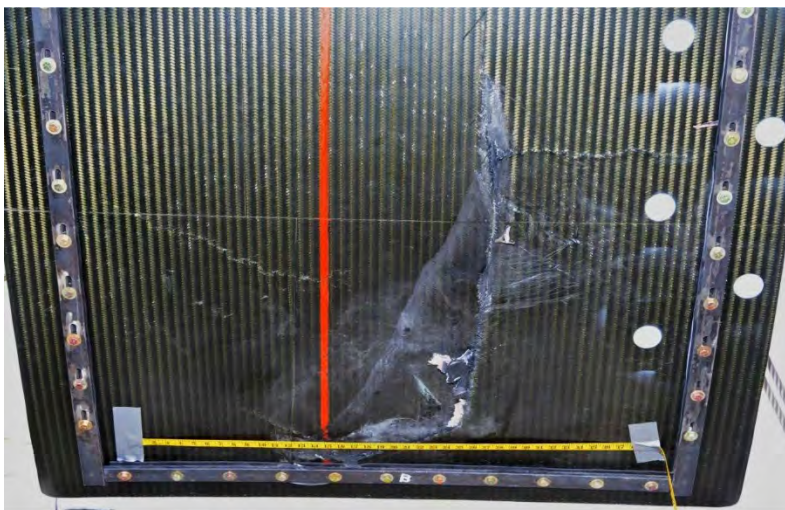
The release angle of the lower blade was 188°. The blade released cleanly from the hub and rotated about the CG of the released fragment. The trajectory of the blade was approximately 4° above horizontal. The blade impacted tip first, with the length of the blade along the velocity vector. The blade caused a large tear in the panel, approximately 45 in. vertically and 12 in. horizontally, and penetrated completely (Figs. 30 to 33). Two additional horizontal cracks, visible in Figure 30, caused delamination but did not penetrate the full thickness of the composite. After passing through the panel, the blade impacted the mount frame and deflected upwards from the test panel mounting fixture. Upon recovery of the blade on the test pad, the tip was missing and the residual length of the blade was only 36 in. (Fig. 34).

Figure 30.—20-ply composite panel postimpact damage, front side.

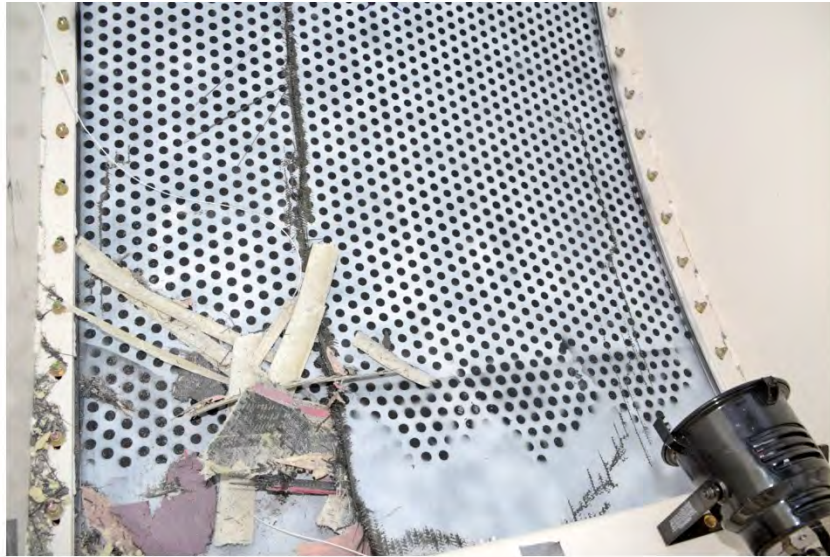
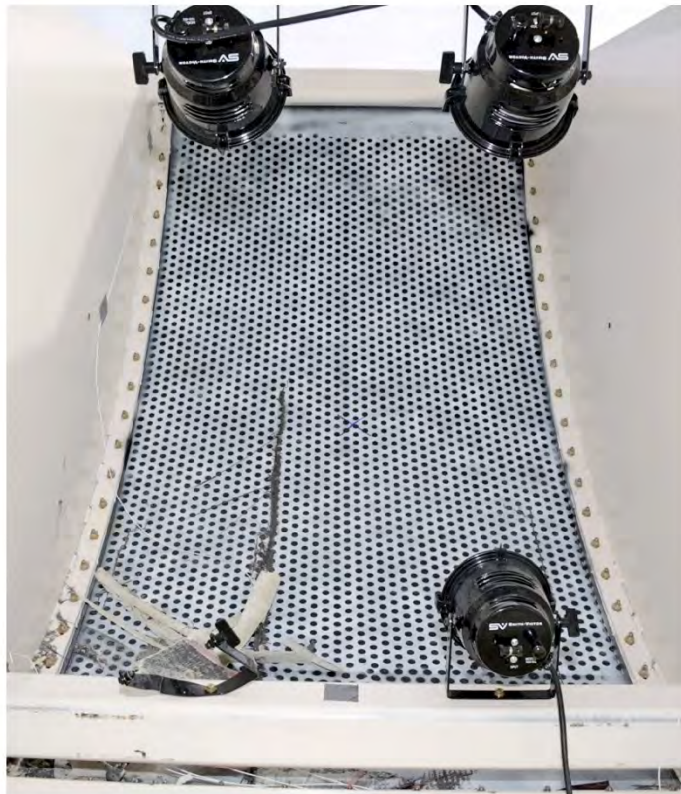
The back side of the panel had a matching crack vertically but had additional vertical and horizontal cracks along the bottom of the panel and up both sides of the panel that did not penetrate the full thickness of the panel (see Figs. 31 and 33).

Figure 31.—20-ply composite panel, back side. (a) Lower right corner. (b) Full panel.

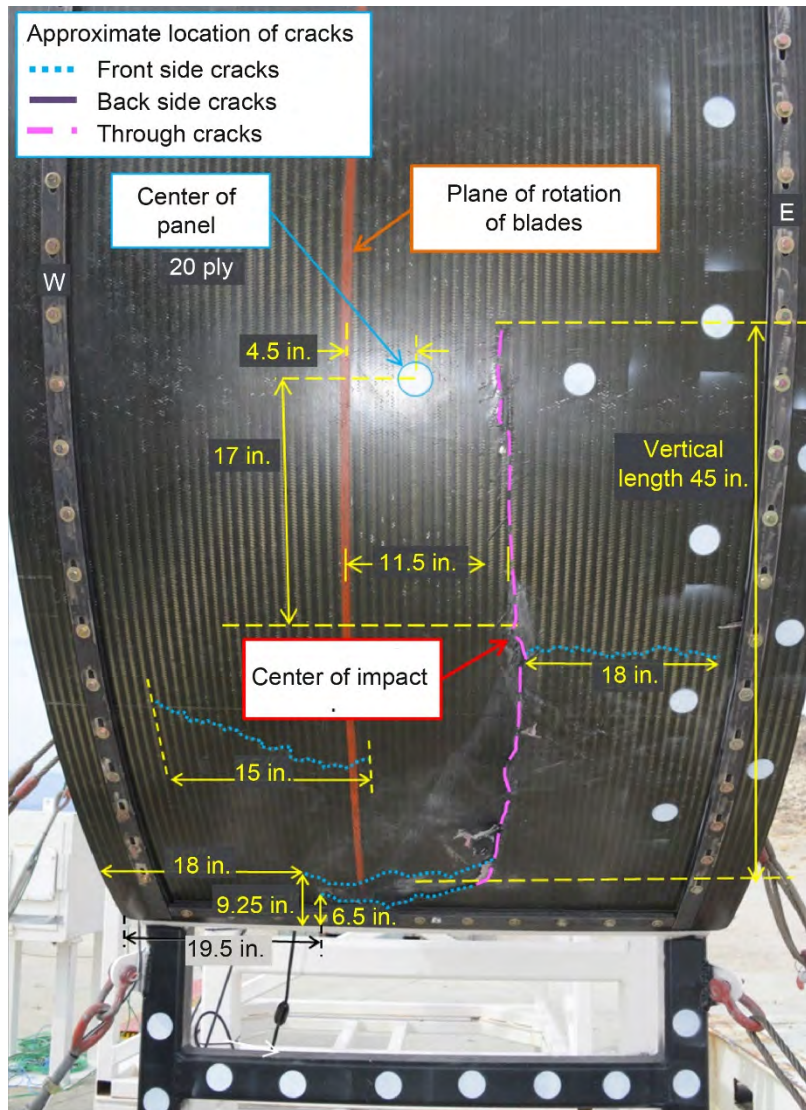
Figure 32.—20-ply composite panel postimpact damage, front side, with measurements.

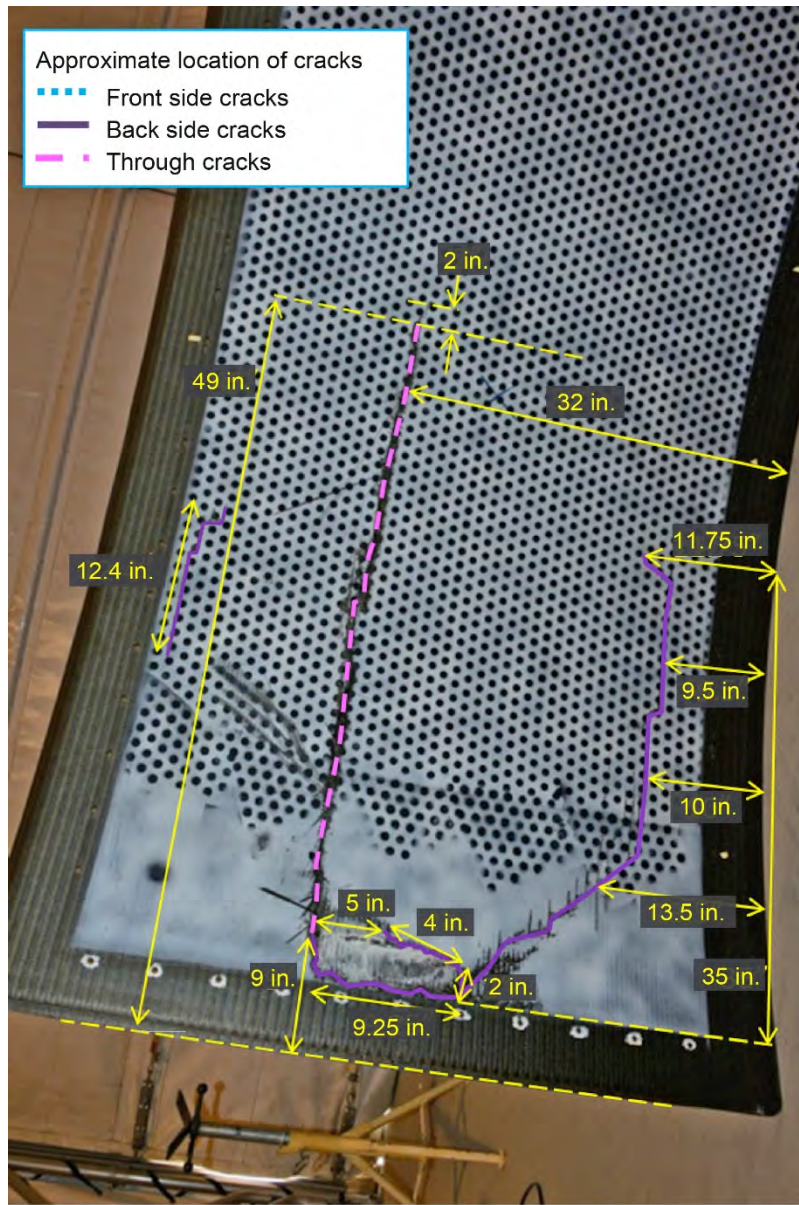
Figure 33.—20-ply composite panel postimpact damage, back side, with measurements.

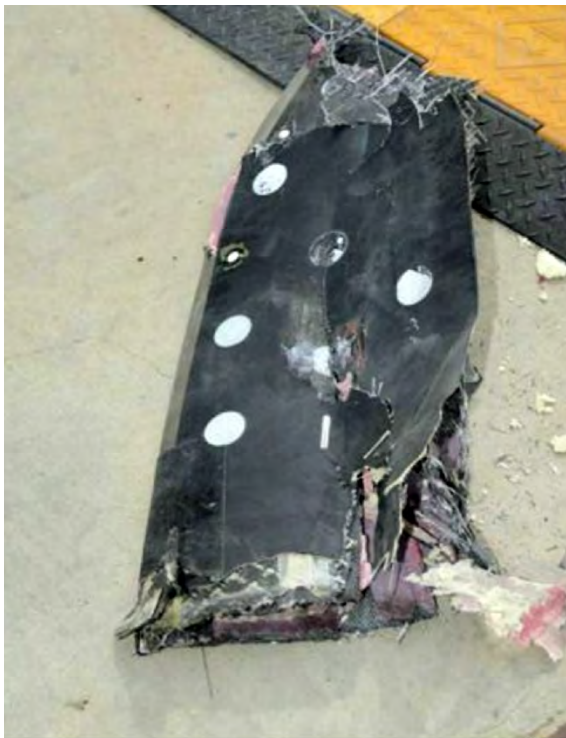
Figure 34.—Lower blade after penetration of 20-ply composite panel.

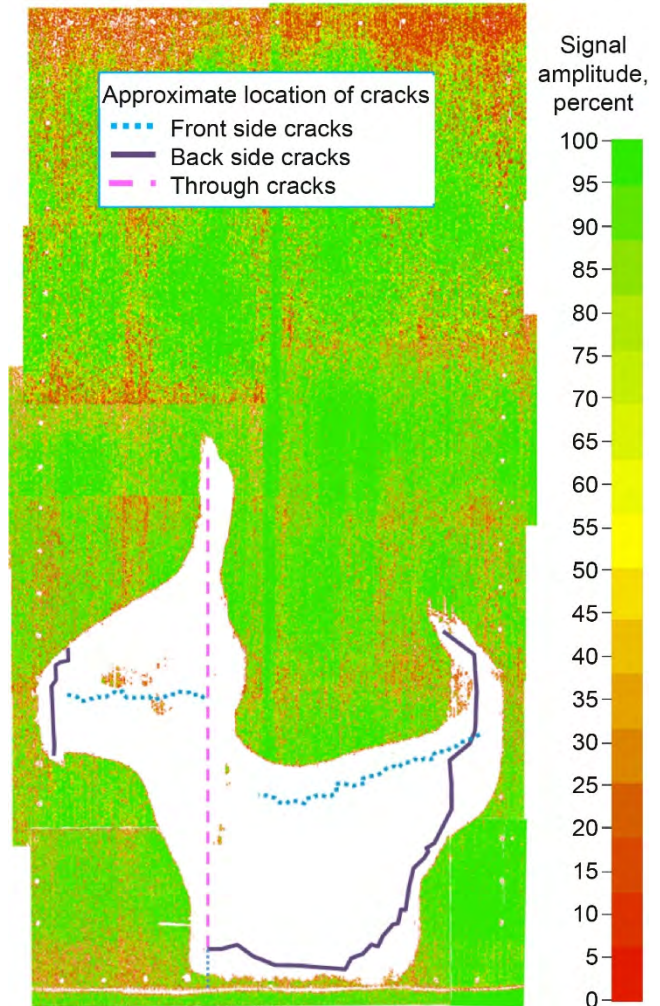
Ultrasound nondestructive inspection (NDI) of the 20-ply composite panel, shown in Figure 35, indicates a large area of delamination. The signal transmission scale is shown with the figure. No transmission at all (indicating delamination) is shown as white. The red dots throughout the green background are noise and are not indicative of damage. The small white holes along the border of the scan are the bolt holes for mounting the panel to the test fixture. The large white area on the scan indicates a large area of delamination, which corresponds to the visible cracks in the composite panel. The small patches of signal transmission within the large delaminated area may indicate partial damage or “kissing disbands”; however, this could not be determined from the ultrasound NDI. A thin line just below the bottom attachment of the panel to the fixture may indicate damage due to the mounting structure. A thin white line protruding from the lower left area of the delaminated area was caused by a thin piece of material protruding from the crack, which blocked transmission of the signal, not a delamination.

Figure 35.—Posttest ultrasonic nondestructive inspection of 20-ply composite panel, back side.

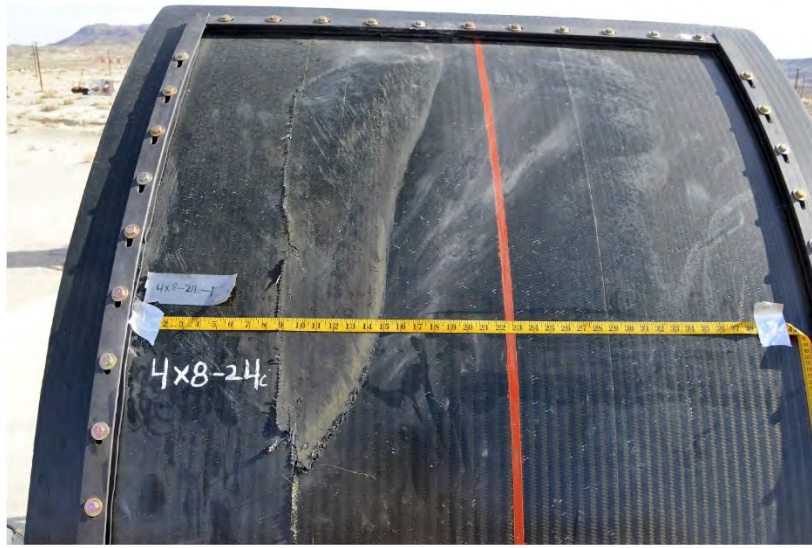
Figure 36.—24-ply composite panel postimpact damage, front side.

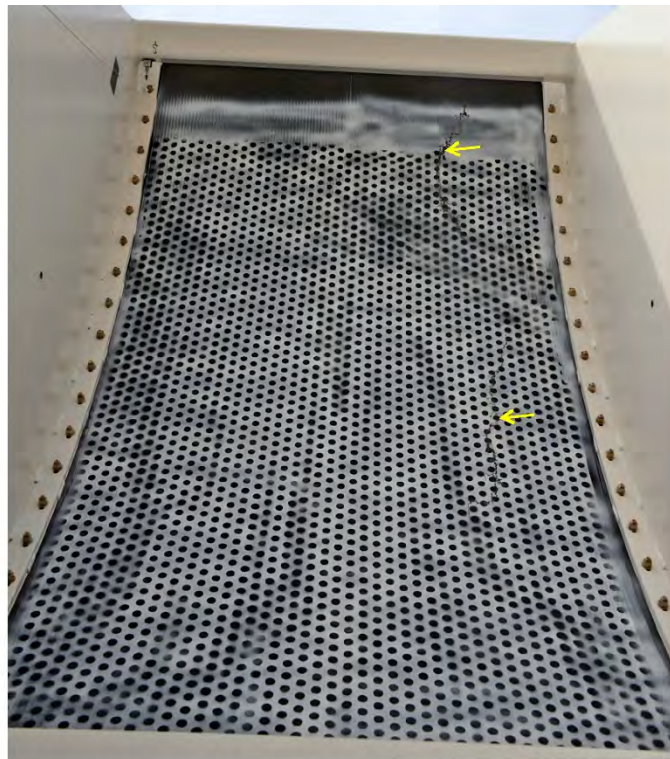
The release angle of the upper blade was  $8^\circ$ . The blade released cleanly from the hub and rotated about the CG of the released fragment. The trajectory of the blade was approximately  $4^\circ$  below horizontal. The blade impacted tip first, with the length of the blade aligned with the velocity vector. The blade caused tears on both the front and back of the panel, but the tears were not aligned with one another and did not penetrate the panel completely. The damage to the composite panel is shown in Figures 36 to 39. Tears on the front side are visible in Figure 36, and tears on the back side are indicated by the arrows in Figure 37.

Figure 37.—24-ply composite panel postimpact damage, back side.

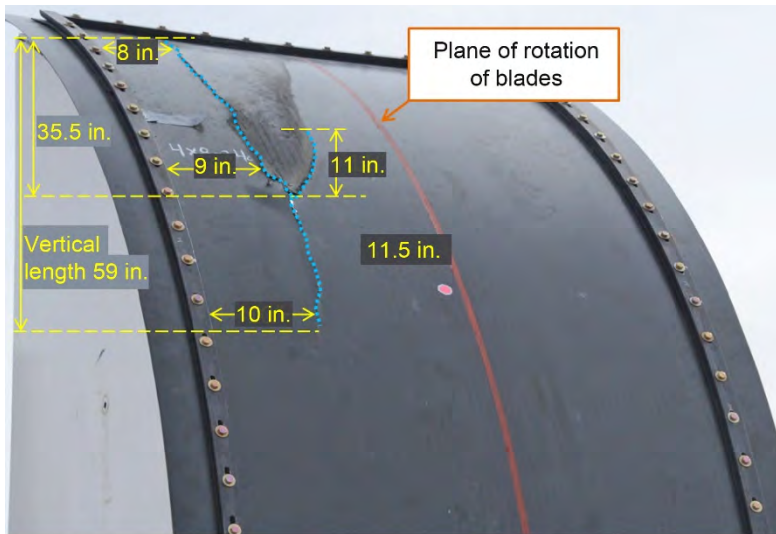
Figure 38.—24-ply composite panel, front side, with measurements.

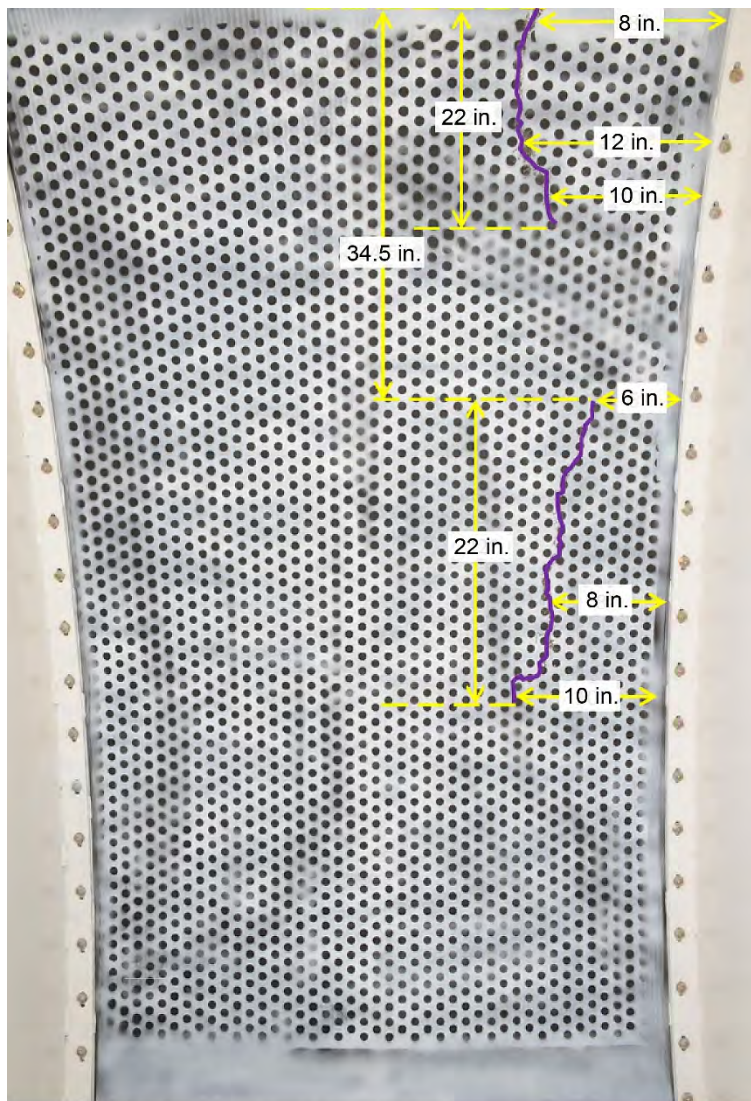
Figure 39.—24-ply composite panel, back side, with measurements.

The blade did not penetrate the 24-ply panel, but cracks were generated both on the front and back sides of the panel. Two main cracks were generated on the back side as shown in Figure 39. Radial displacements for the 24-ply panel are shown in Figures 45 and 46. Figure 45(a) shows a contour plot of the radial displacement at the time of maximum panel deflection. This is the total displacement, including any contribution from the motion of the test fixture. A number of points are indicated in the figure. The points labeled “0” and “1” span the first crack that formed on the back side of the panel shown in Figure 39 between 2 and 2.5 ms after impact. A time history of the radial displacement of three of the indicated points is shown in Figure 45(b). Note that during the time of impact the displacement at point 2 is radially inward as would be expected, but the displacements at points 0 and 1 are outward indicating a highly dynamic process. The dashed vertical line in Figure 45(b) indicates the time at which the crack that formed between points 0 and 1 occurred. Figure 45(c) shows the radial displacement along the line labeled “Section 1” shown in Figure 45(a) for a number of consecutive frames up to the point of maximum deflection. Note that there is significant radial displacement at both ends of the segment line, which are near the fixture frame. This indicates that there is some motion in the frame itself. Although the motion of the frame is likely not a rigid-body motion, an attempt to measure the displacement of the panel relative to the frame was made by averaging the displacement of four points located at the corners of the measurable area and subtracting that motion from the overall deflection (Fig. 46). This measure of displacement relative to the frame is shown in Figure 46(a). Relative to the average of the four points, the maximum radial displacement is just over 2.6 in. This relative measure of radial displacement is shown as a function of time in Figure 46(b) for the seven points shown in part (a). There is a significant difference in the relative displacement shown in Figure 46(b) compared with the total displacement of the points shown in Figure 45(b).

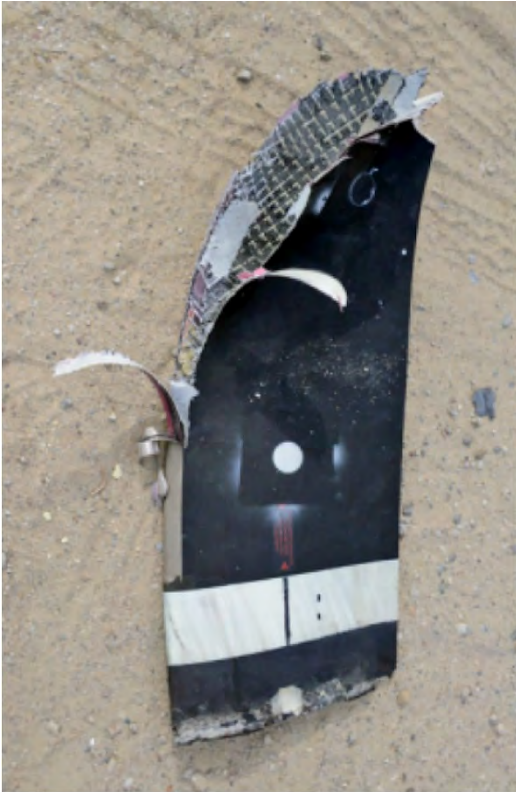
Figure 40.—Upper blade after impact on 24-ply composite panel.

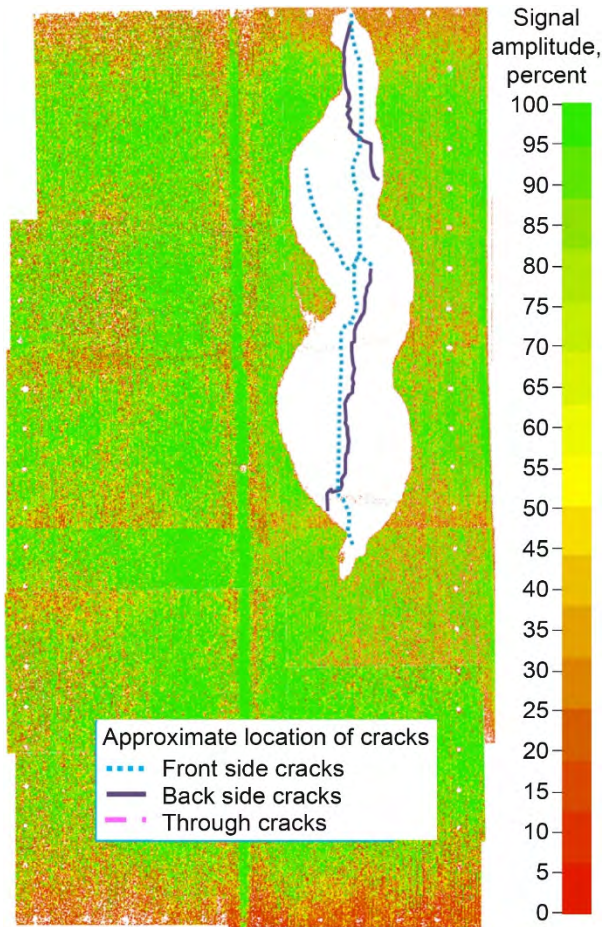
Figure 41 shows the results of the NDI scan of the 24-ply panel. No transmission at all (indicating delamination) is shown as white. The red dots throughout the green background are noise and are not indicative of damage. The small white holes along the border of the scan are the bolt holes for mounting the panel to the test fixture. The large white area on the scan indicates a large area of delamination, which corresponds to the visible cracks in the composite panel.

Figure 41.—Posttest ultrasonic nondestructive inspection of 24-ply composite panel, back side.

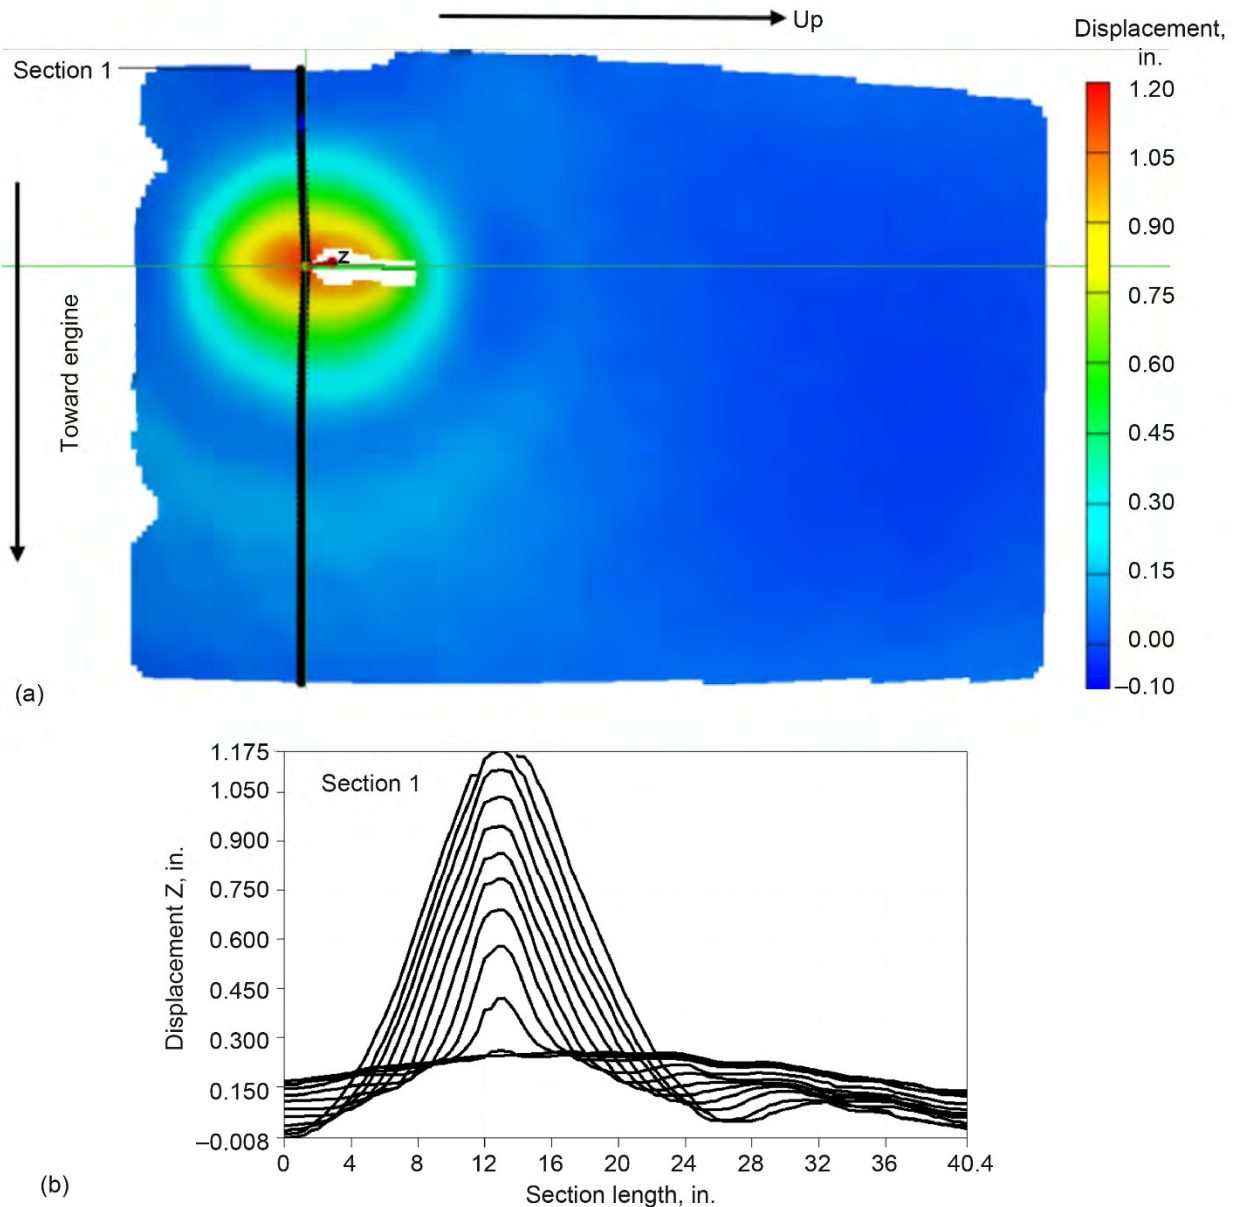
The 20-ply panel was penetrated by the blade. At the point of maximum deflection prior to failure the radial displacement at the point of impact was 1.175 in. The radial displacements for the 20-ply panel are shown in Figure 43. Figure 43(a) shows a contour plot of the radial displacement just prior to failure, with positive values being inward in the general direction of blade travel. Figure 43(b) shows the deflection along the segment line shown in part (a) for a number of consecutive frames up to the point of failure.

Figure 43.—Inward radial displacement of 20-ply panel after blade penetration. (a) Contour plot just prior to failure. (b) As function of length along segment line shown in part (a) for several frames up to time of maximum deflection; time between each line is 66.7 ms.

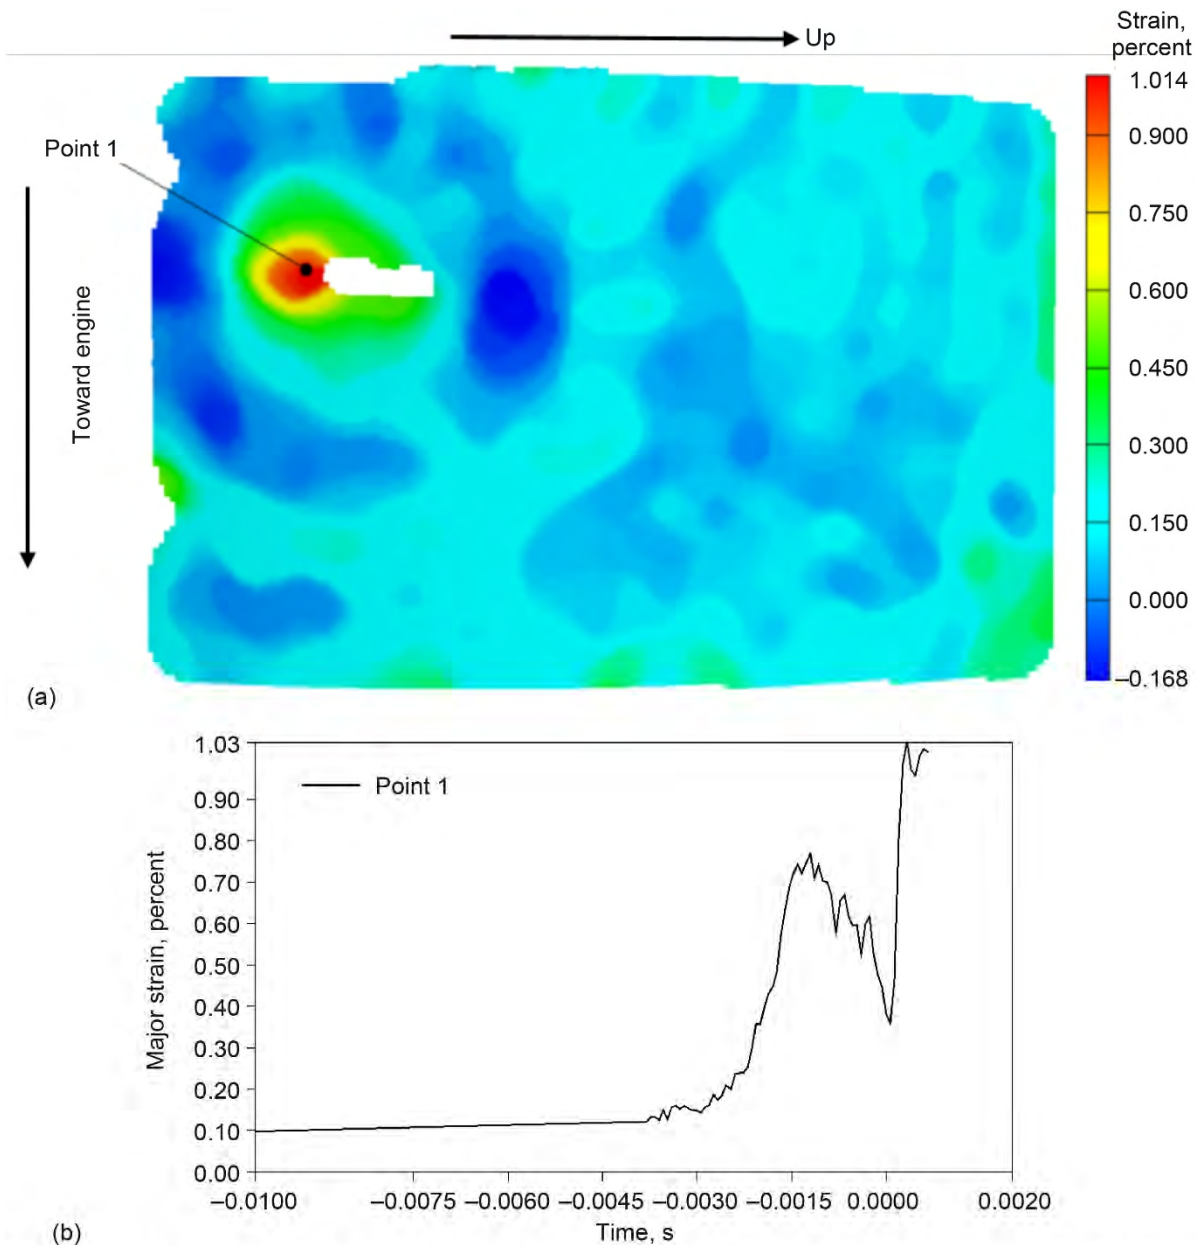
Maximum principal strains for the 20-ply panel are shown in Figure 44. Figure 44(a) shows the distribution of maximum principal strain in the panel just prior to failure. At the point shown in the figure, the value was just over 1 percent.

The time history of maximum principal strain of the point indicated in Figure 44(a) is shown as a function of time in part (b) up to the point of failure. In the figure, blade impact begins at 0.000 s. Prior to this time there is a strain response likely related to the blast generated from the shape charge, which travels faster than the blade. After penetration occurred, tracking the points was no longer possible.

Figure 44.—Maximum principal strain in 20-ply panel after blade penetration. (a) Contour plot just prior to failure. (b) As function of time at point shown in part (a).

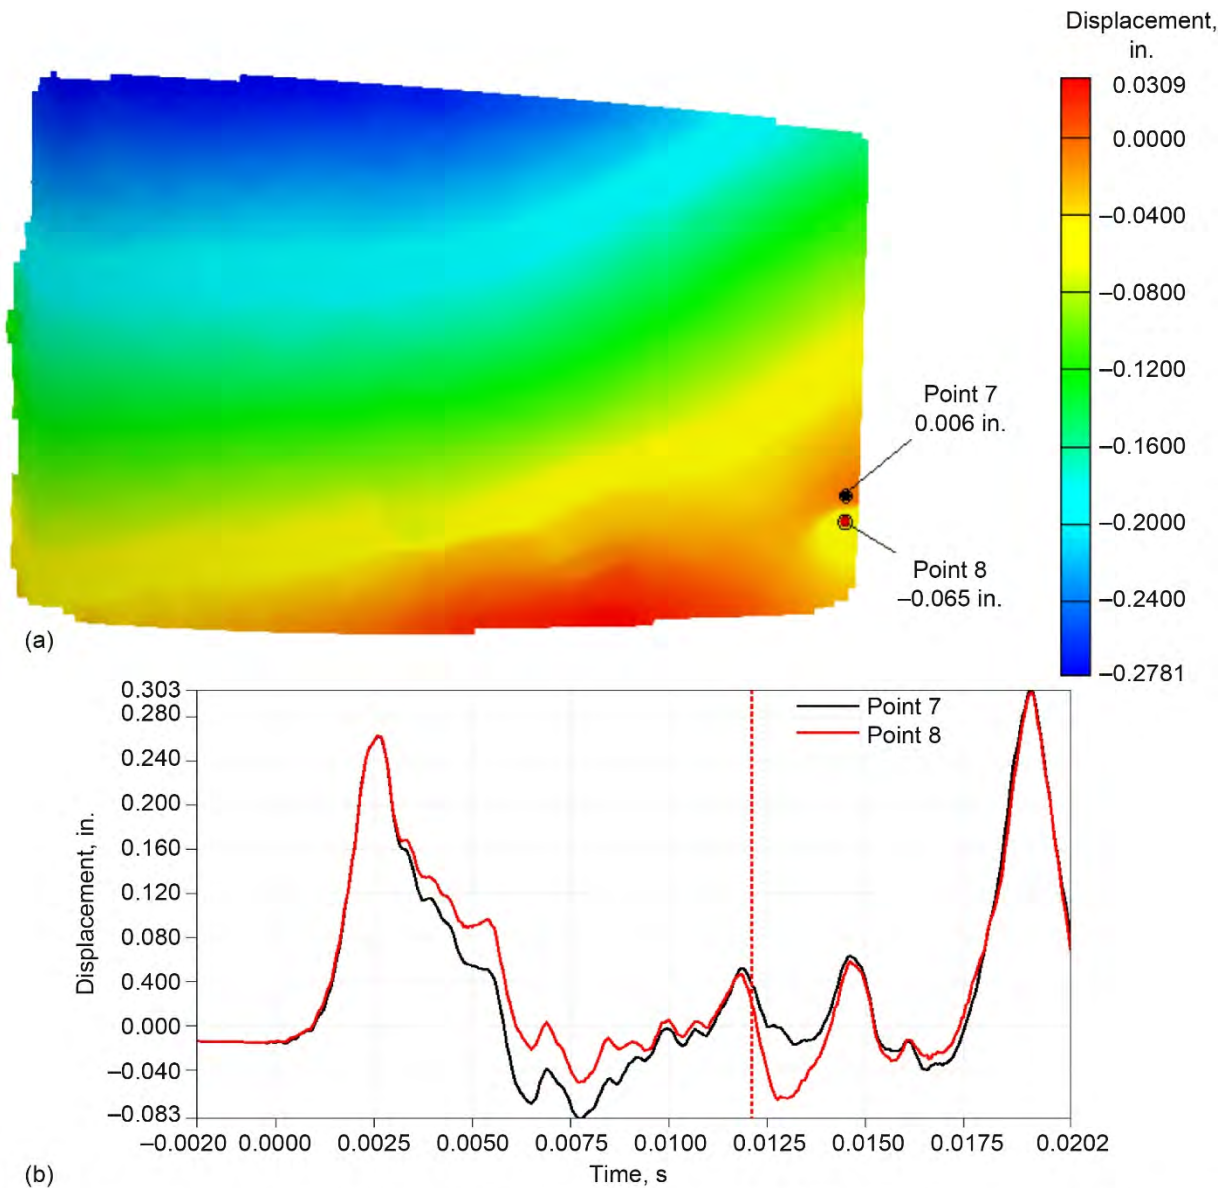
Figure 48(a) shows the y-displacement of the panel near the time at which the second crack initiated near the panel boundary. This crack formed between the points labeled “7” and “8.” The figure shows that at this time there is generally an inward displacement of the panel near the upper and lower edges of the figure, possibly due to deformation of the frame fixture. The y-displacement of these two points is shown in Figure 48(b) as a function of time. In the figure, first impact occurs at 0.0000 s. The dashed line in the figure indicates the time of the initiation of the crack at this location. The figure shows that up until approximately 3 ms after impact, the y-displacement of the two points was essentially the same. After this, the displacement of point 8 was greater than that of point 7, indicating that the distance between the two points decreased. Right before failure, the relative displacement of the two points changed, and the distance between the two points began to increase, indicating that a tensile strain transverse to the crack location existed at the time of failure.

Figure 48.—y-displacement in 24-ply panel during blade impact. (a) At 0.0129 s, just after second crack initiates. (b) Of points labeled in part (a) as function of time.

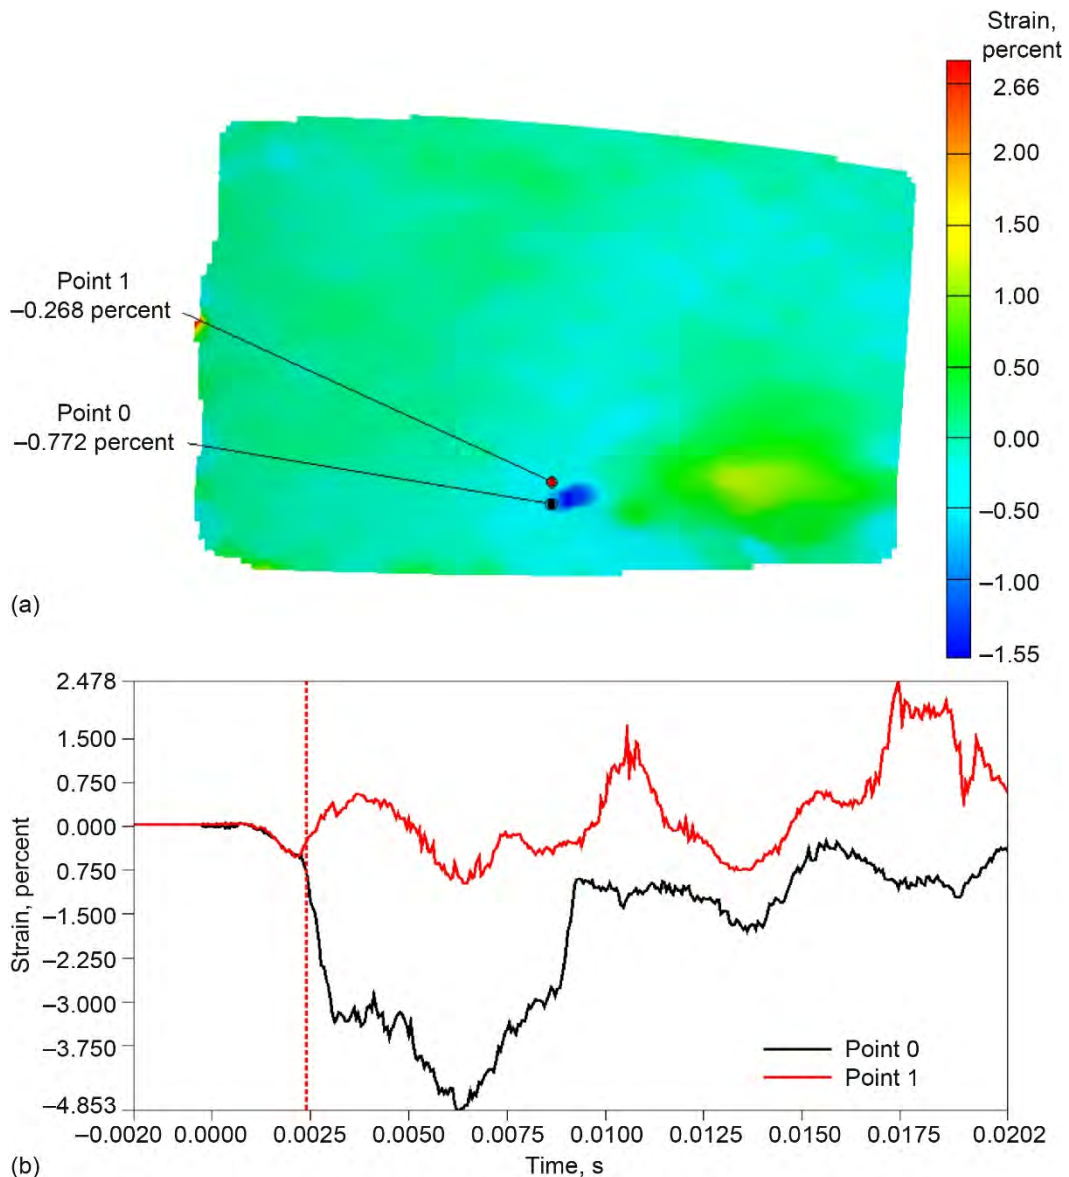
Strains in the 24-ply panel are shown in Figures 49 to 51. The strain in the y-direction (transverse to the cracks) at the time of the first crack initiation in the 24-ply panel is shown in Figure 49(a). In the region of the formation of the first crack, between the points labeled “0” and “1,” the strain in the y-direction is compressive. The y-direction strain at these points is plotted as a function of time in Figure 49(b). Because of the limited resolution of the cameras, it was not possible to measure the strain at the exact location of crack initiation.

Figures 49(a) and (b) show that at the time of the first crack initiation this region was in a compressive strain state.

Figure 49.—Strain in y-direction in 24-ply panel during blade impact. (a) At time first crack initiates. (b) At points labeled in part (a) as function of time.

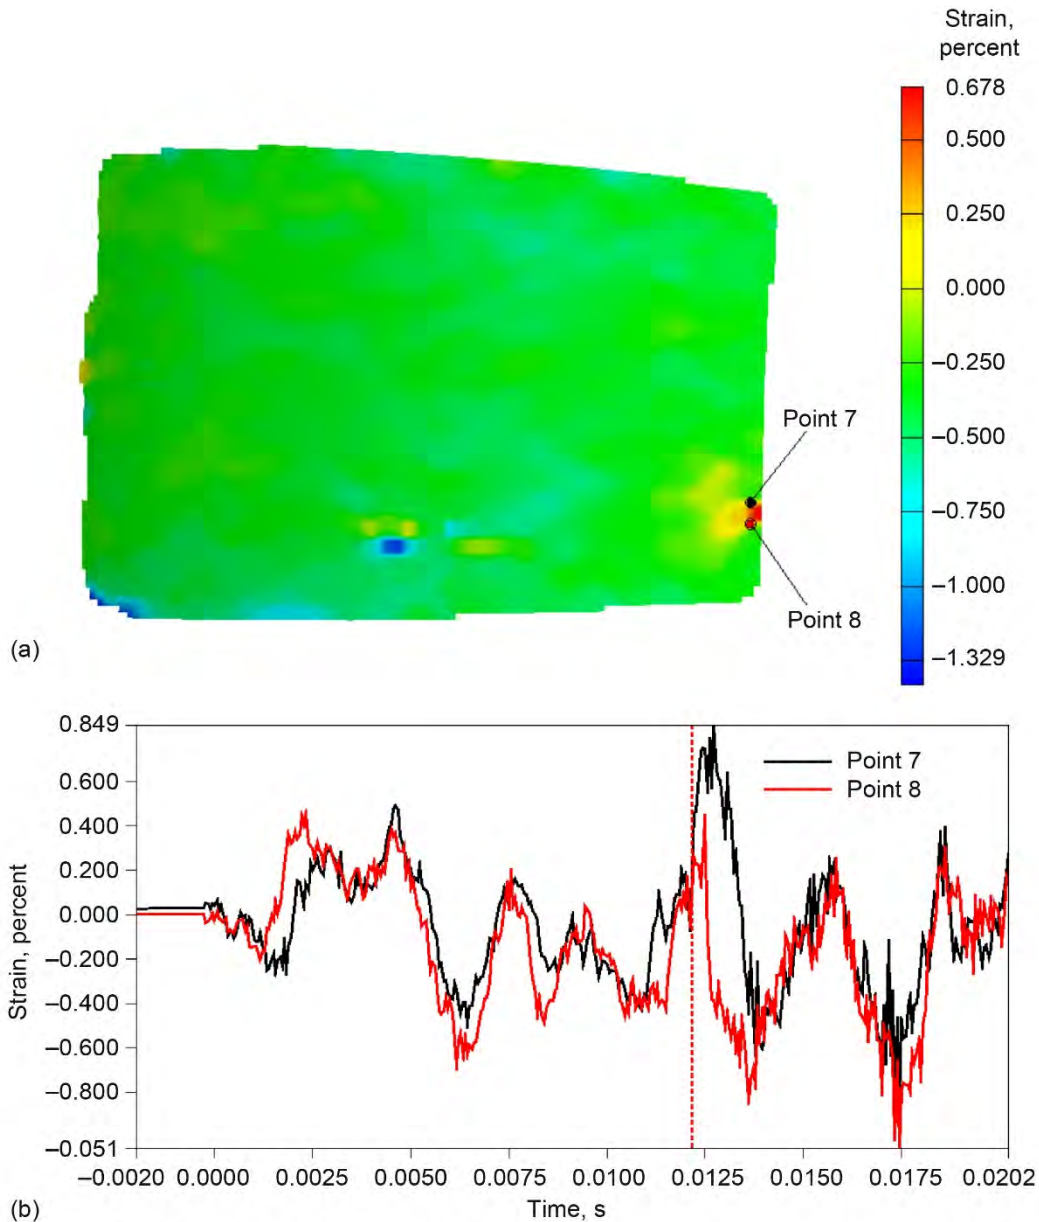
Figure 50(a) shows a contour plot of the strain in the y-direction (transverse to the panel cracks) at the time the second crack initiated. The second crack initiated at the panel boundary, which was outside of the computable area, so it was not possible to compute the strain at the initiation site. However, as seen in the figure, the transverse strain is generally positive in this region, indicating that the crack initiated as a result of tensile transverse strain. Figure 50(b) shows the strain in the y-direction for the two points indicated in part (a), as a function of time.

Figure 50.—Strain in y-direction in 24-ply panel during blade impact. (a) At time second crack initiates. (b) At points labeled in part (a) as function of time.
