# Evidence of Processing Non-Idealities in 4H-SiC Integrated Circuits Fabricated With Two Levels of Metal Interconnect

David J. Spry<sup>1</sup>, Philip G. Neudeck<sup>1</sup>, Liangyu Chen<sup>2</sup>, Laura J. Evans<sup>1</sup>, Dorothy Lukco<sup>3</sup>, Carl W. Chang<sup>3</sup>, Glenn M. Beheim<sup>1</sup>,

1) NASA Glenn Research Center, 21000 Brookpark Rd., Cleveland, OH 44135, USA

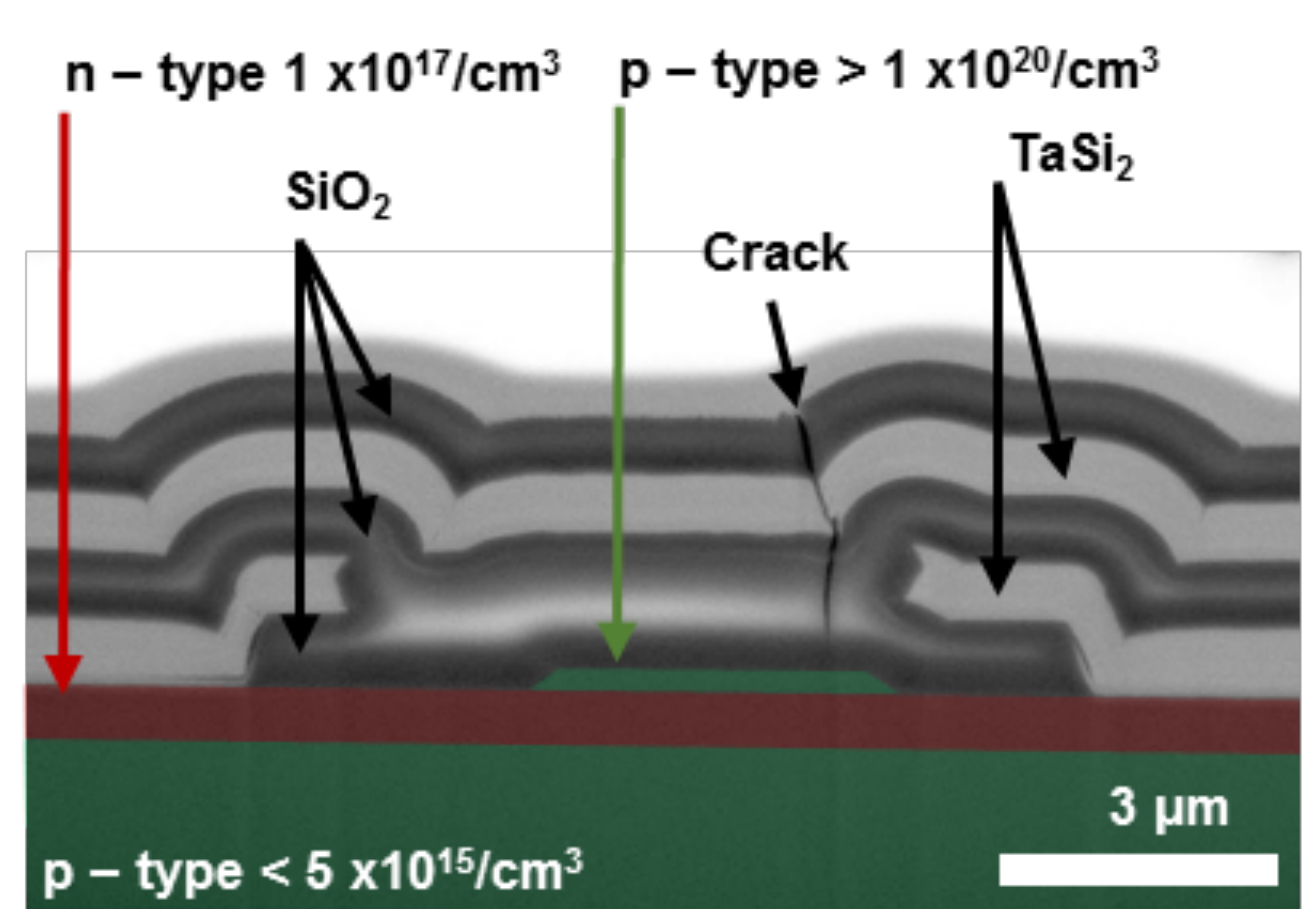
Fig. 1. Cracking sometimes occurs where metal 1 and metal 2 overlap the gate.

**Crack Formation Induced Fail-Open of Top Metal Interconnect.** The focused ion beam (FIB) cross-section shown in Fig.1, illustrates an example of dielectric and metal cracks that caused topmost metal conductive interconnect traces to electrically fail open. Devices close to the wafer center (roughly < 1 cm) did not exhibit this problem as the misalignment in this region was insufficient to result in such overlap/distortion. Misalignment and cracking grew more severe with increasing radial distance from the wafer center, consistent with rotational misalignment of the bottom metal mask pattern to the substrate n-mesa pattern during fabrication. Such cracks are not observed on other kinds of topology, such as where the lower TaSi<sub>2</sub> trace edge ends over the flat SiC region on the left side of Fig. 1. Cracking is also not observed on the large bond pad edge cross-section shown in Fig. 2. The measured resistance vs. time between adjacent connected bond pads plotted in Fig. 2 demonstrates desired minimal change in conduction properties (in part due to absence of crack features) over 4800 hours of 500 °C electrical testing time. Since it is related to misalignment, this cracking problem should be solvable by improved alignment and/or design rules with larger misalignment tolerances so as to prevent overlapping of lower metal edges with mesa features.

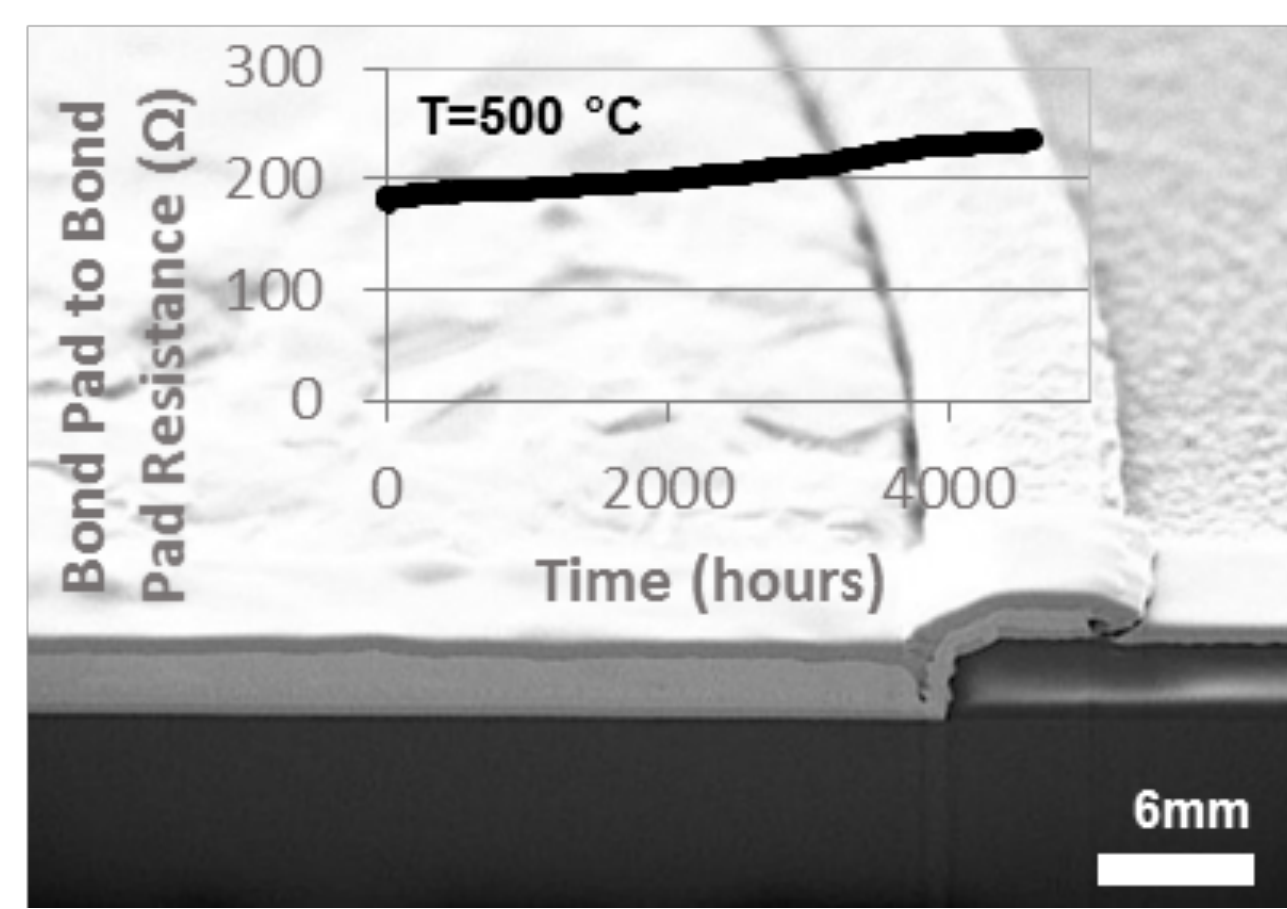
Fig. 2. By design, cracking did not occur around the oxide on bond pads. There was 32% increase in pad to pad resistance over 4800 hours.

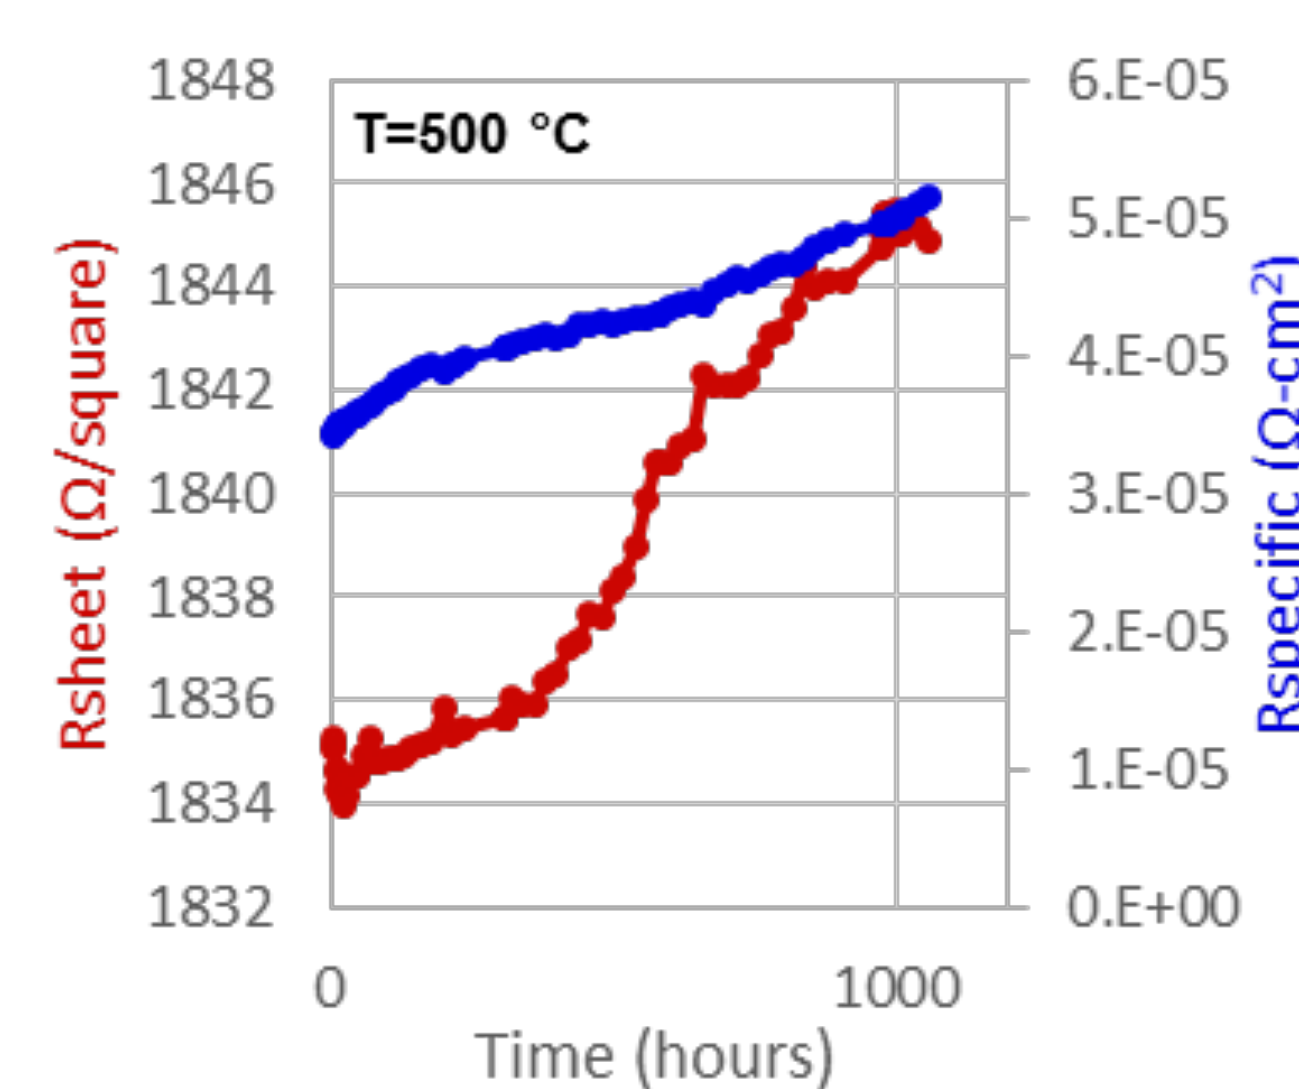
Fig. 4. < 1% variation in  $R_{sheet}$ , but 50% increase in  $R_{specific}$

**Device Resistance Degradation.** Fig. 4 plots sheet resistance ( $R_{sheet}$ ) and specific contact resistance ( $R_{specific}$ ) extracted from prolonged measurement of a packaged 500 °C transmission line method (TLM) test device of the source/drain implant for over 1000 hours.  $R_{sheet}$  changed less than 1% while  $R_{specific}$  changed 50%. This suggests a degradation in the contact area or metal while the high-dose SiC implanted sheet resistance is stable. The 500 °C testing time evolution of transistor parameters for a JFET in a NOT circuit are shown in Fig. 5. The threshold voltage ( $V_T$ ) changes less than 2% over 2000 hours. Transconductance ( $g_m$ ) and the on-state current ( $I_{DSS}$ ) decrease with time at temperature while on-state resistance  $R_{DS}$  increases, which is qualitatively consistent with the Fig. 4 trend. Data discontinuity shown in Fig. 5 at 1000 hours corresponds to a brief temperature cycle to 25 °C and back. Most of the drift in  $R_{DS}$  recovered during this cycle. It is important to note that the recovery of  $R_{DS}$  seems inconsistent with contact oxidation or metal trace failure mechanisms that would be irrecoverable. Delamination of the contact area has not been seen in focused ion beam (FIB) cut cross-section images of similar devices on the wafer. Therefore, the root physical cause (or causes) of this degradation remains under investigation at this time.

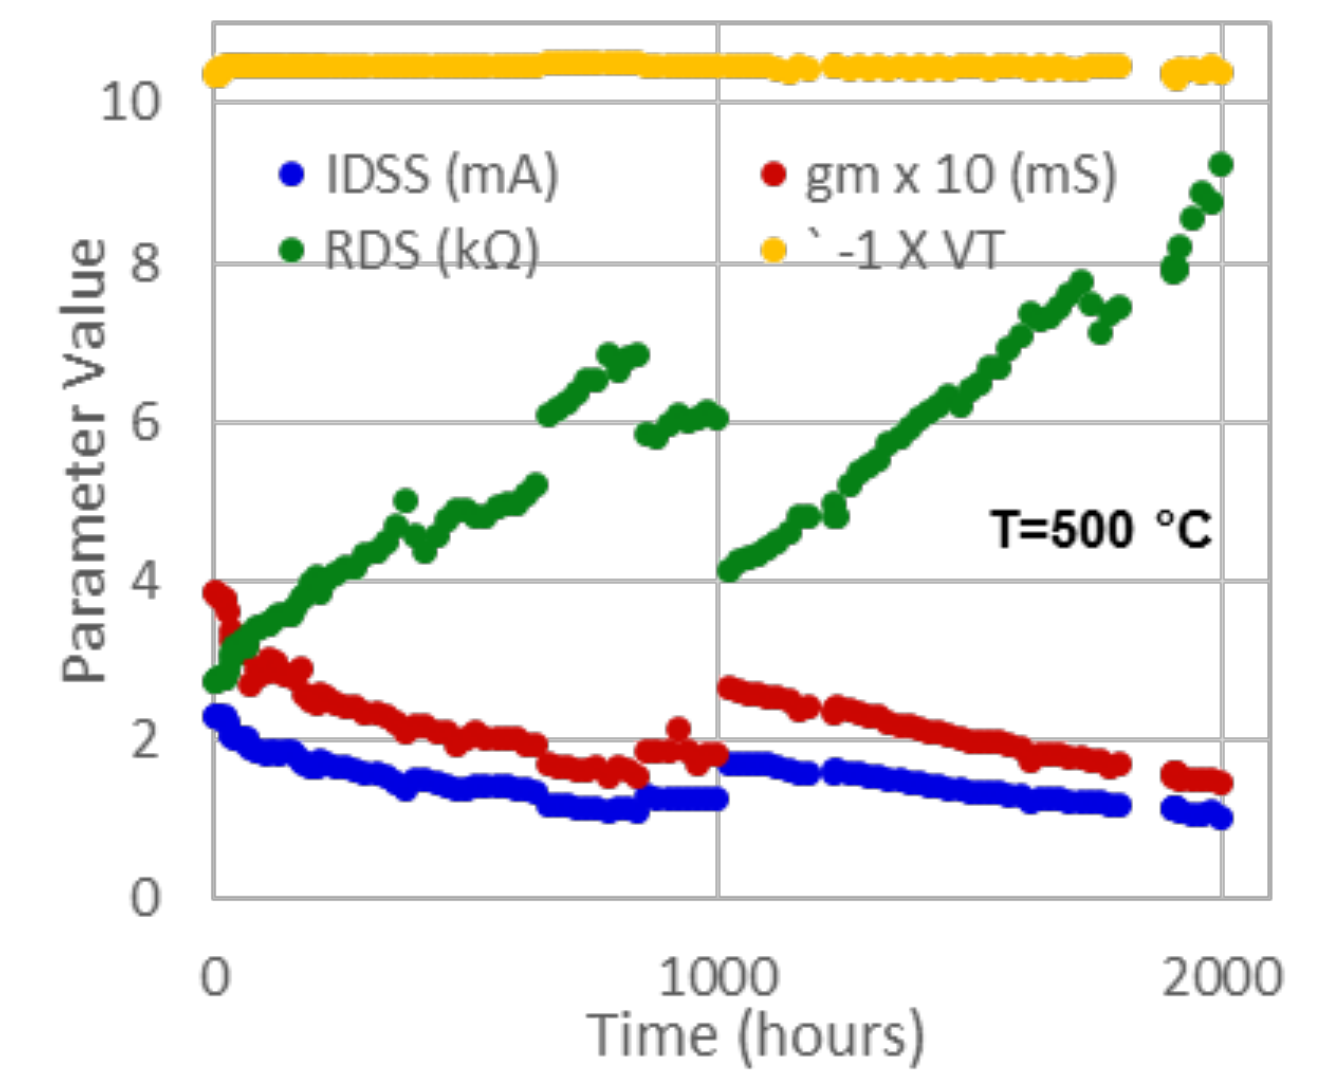
Fig. 5. < 2% variation in  $V_T$ . Note changes from thermal cycle to RT at 1000 hours.

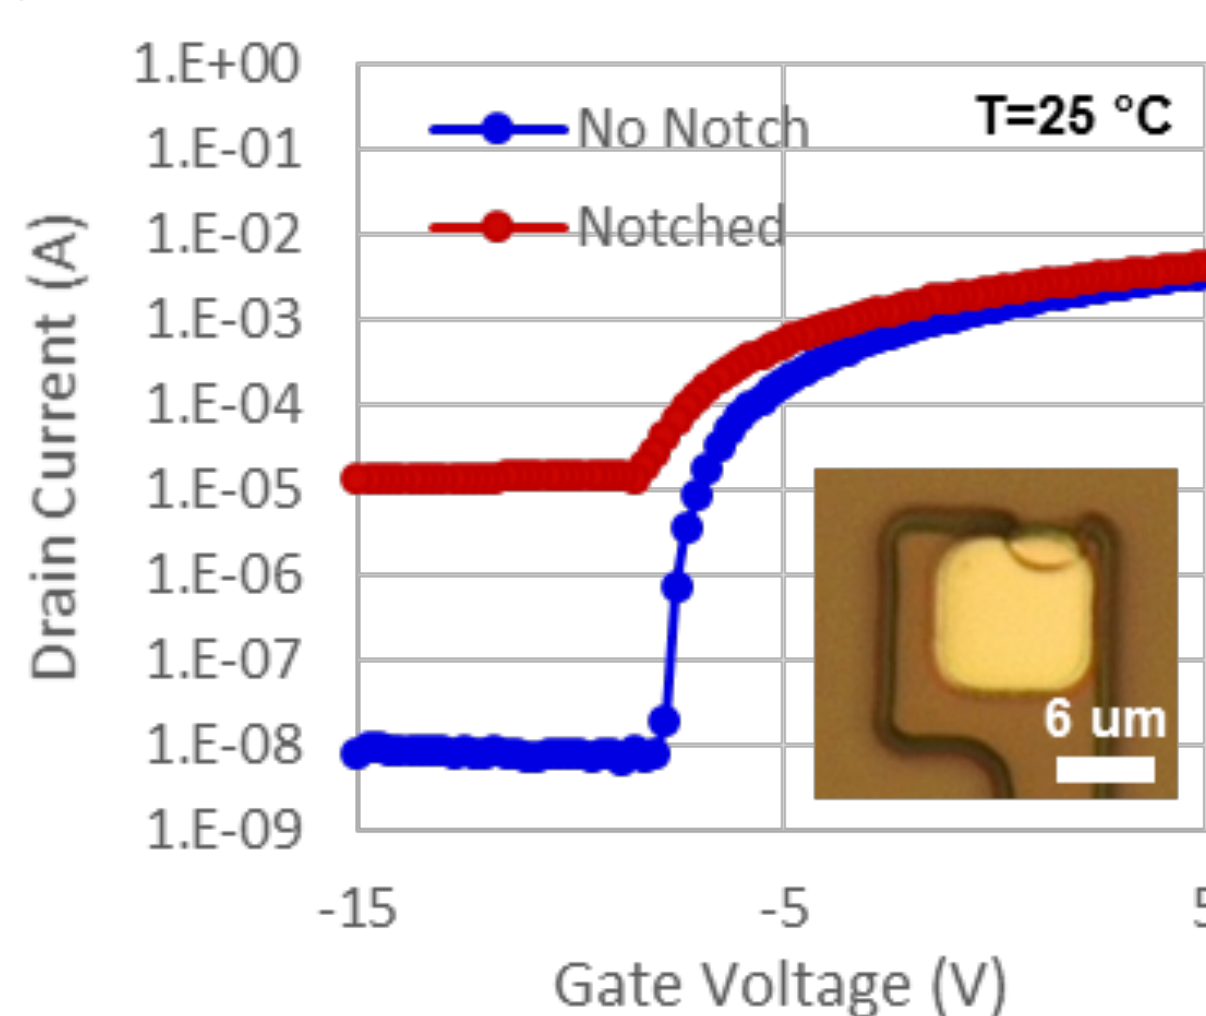
Fig. 3. JFET turn off leakage with and without a notch in the p-gate mesa.

**Gate-to-Channel Leakage/Short From Notching of Gate Etch Mask Metal.** These notches arose from non-uniform oxidation/peeling along the edges of the gate etch mask during a prolonged unplanned storage of the sample in room air. When the second dry (n-mesa) etch was conducted, the notched regions did not sufficiently protect the p<sup>+</sup> SiC from removal, which then exposed underlying n-mesa regions in areas where contacts to p<sup>+</sup> gates were subsequently deposited. Fig. 3 inset shows where a p<sup>+</sup> gate contact overlaps such a notch. This allows the deposited metal p<sup>+</sup> gate contact to also form a parasitic electrical contact to the underlying exposed n-channel epilayer, including along the vertical etched sidewall of the n-epilayer. While not a complete short circuit at T = 25 °C, turn-off characteristics of “notched” JFETs are undesirably orders of magnitude larger than notch-free devices (Fig. 3). While not directly measured at high T, the leakage mechanisms of metal-semiconductor contacts/diodes are known to increase with anneal time and exponentially with T [2]. Therefore, this parasitic leakage is surmised to contribute to rapid failure of circuits at 500 °C. The degree of notching (and thus the degree of leakage) varied across the wafer. Very few devices with more than 10 gate fingers were free of notches. Notches have not been observed in any process runs before and after this wafer whose processing time between the gate and mesa etches have been a week or less, and were shipped to vendors in vacuum boxes.

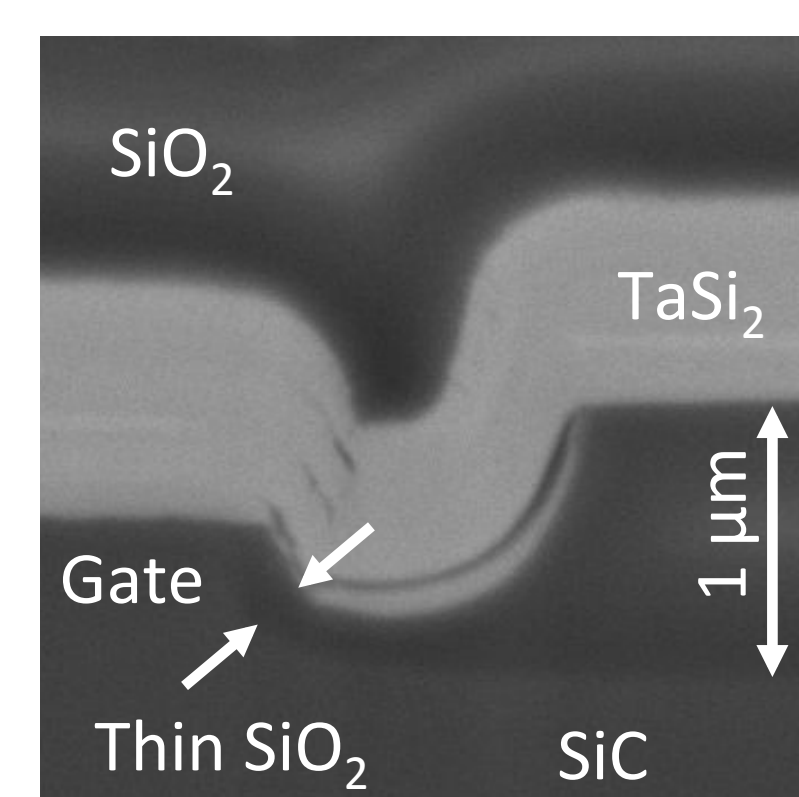
Gate mesa with a notch that is not fatal at room temperature but decrease it's 500 °C durability do to thin SiO<sub>2</sub>.

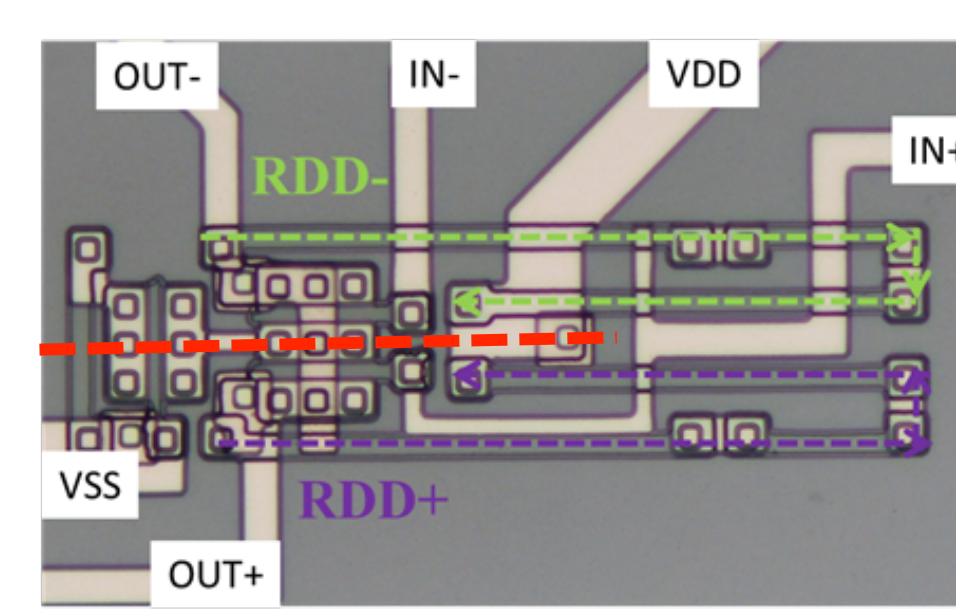
Fig. 6. Optical image of the differential amplifier shows the two balance resistors with one having a V<sub>DD</sub> trace pass over top. The red dashed line shows where the processing cross-section diagram in the background are referencing.

**Parasitic Circuit Imbalance Induced by Mobile Ion Contamination.** Differential amplifier circuits rely on well-balanced circuit legs (i.e., transistors and/or resistors) to operate. Resistive load differential amplifier ICs (including 2-stage op-amps which were also used as sense-amps for test memory ICs) were fabricated and electrically verified as operational at room temperature with expected gains. However, on all ICs custom-packaged for high temperature testing, these differential-based amplifiers all rapidly failed as they were heated past 200 °C. A packaged diff-amp (Fig. 6) underwent bias-temperature stress measurements while directly measuring “balanced” resistors RDD+ and RDD- (highlighted with colored dashed lines) IV characteristics. Fig. 7 shows an example of the resistor IV imbalance measured after +30V 200 °C positive bias stress of the V<sub>DD</sub> metal trace, while Fig. 8 shows that the imbalance is mostly eliminated following a subsequent -18V 300 °C stress applied to the V<sub>DD</sub> metal trace. This reversible bias-temperature-time stress behavior is consistent with reversible mobile ion contamination phenomenon well-known to be detrimental to metal-oxide-semiconductor (MOS) devices [3]. Subsequent surface analysis detected sodium (Na) on the surface of wafer samples.
