# Lessons Learned during the Refurbishment and Testing of an Observatory after Long- term Storage

John Hawk, Sharon Peabody, and  
Richard Stavely  
NASA Goddard Space Flight Center

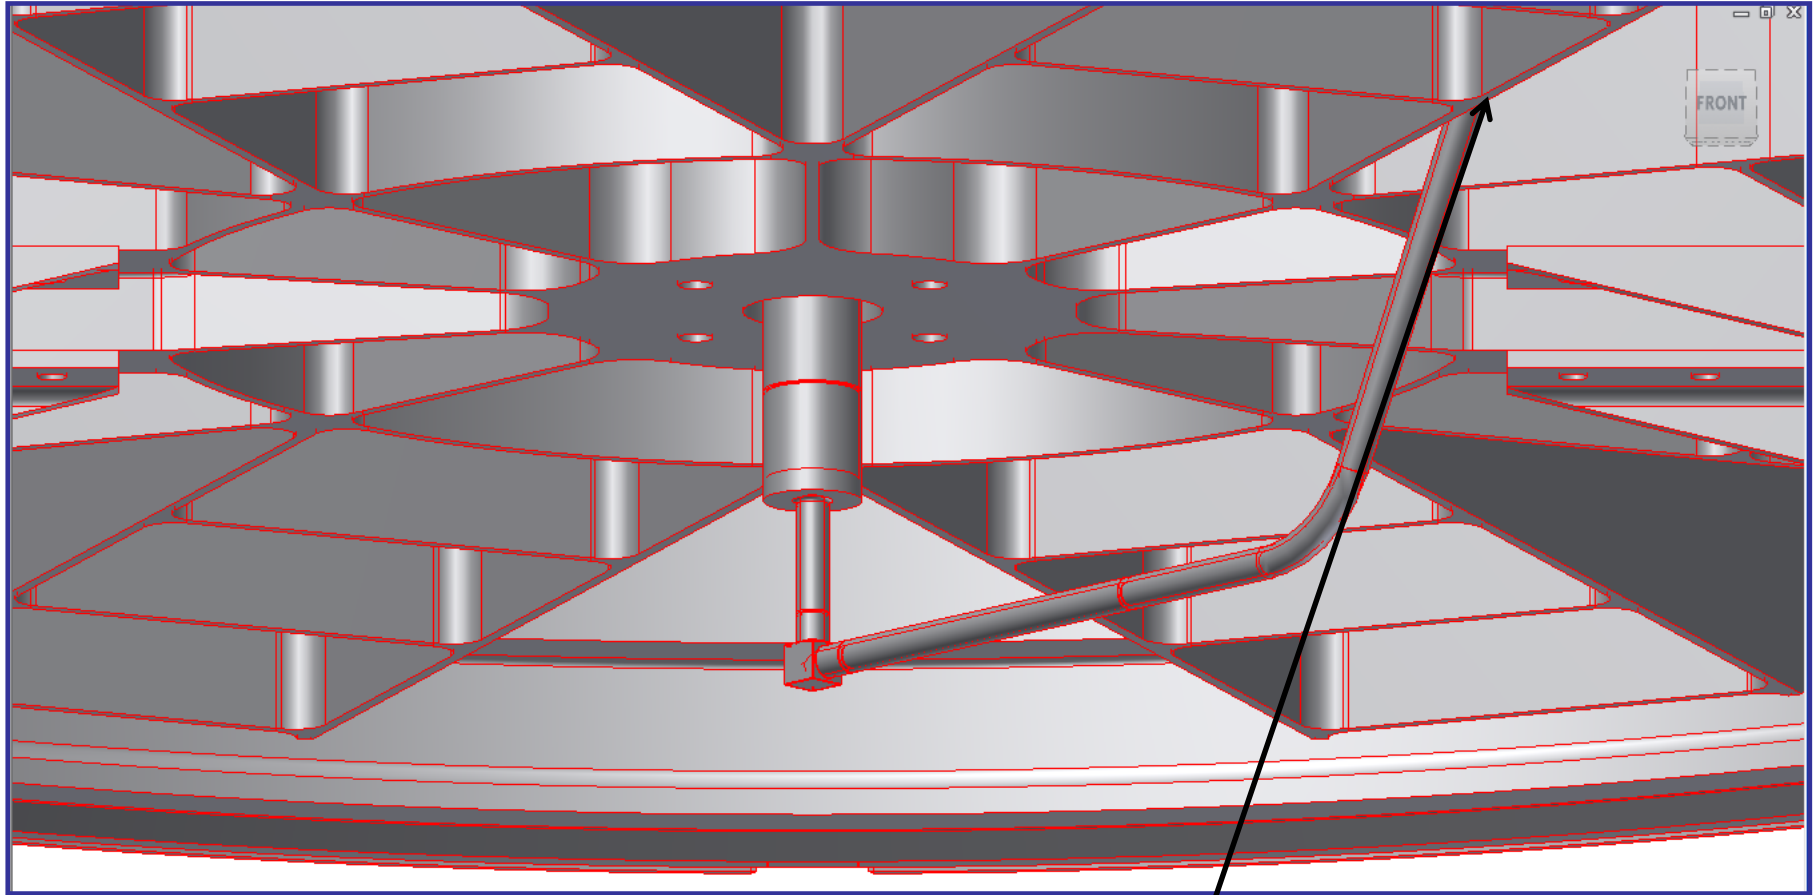
## External Run of Propulsion Line Zone 5

During the entirety of the thermal balance testing the external run of propulsion line zone 5 was running well below the minimum temperature requirement. During hot balance, this section of line reached a temperature of +2.3°C.

**Propulsion Line Heater Zone 5 Heater Control located inside the prop module**  
**Med Control Thermistor On @ 24°C Off @ 26°C**  
**Low Control Thermistor On @ 18°C Off @ 20°C**

- Further examination of the thermal balance test data from TRIANA testing revealed the same propulsion line 5 behavior.
- On the external run, an auxiliary dual element heater with a pair of series redundant thermostats had to be installed over the existing line 5 heater.
- The added thermostats were chosen with control points lower than the existing electronic controller set-points so that the auxiliary heater wouldn't impact the function of the existing heater.
- Structural analysis had to be performed to assure that there was no impact due to the added thermostat, heater, and aluminum tape masses.

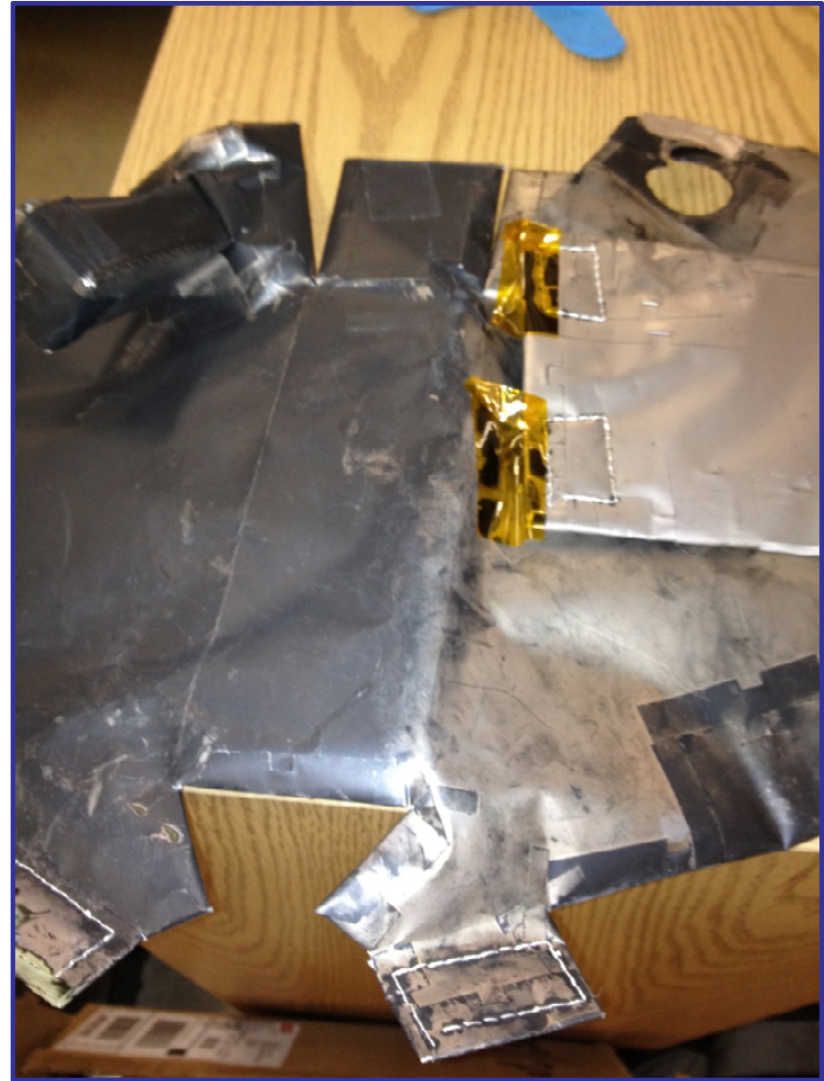
## Thermal Blankets

- Germanium missing from most areas of germanium black Kapton MLI; replaced outer layers.
- Several blankets totally missing.
- Had to figure out the original location of many others.

- *MLI in long term storage should be in a humidity controlled environment and handling minimized.*
- *Thermal Project Engineer should understand and inform Project Management regarding the scope and complexity of thermal blanket fabrication and installation.*
- *Individual blanket designs and fabrications should be identified with sufficient time allocated for these activities in the I&T schedule.*
- *Individual blanket installations should be identified in the I&T schedule as any other hardware installation task, rather than specifying a general time period for overall installations.*

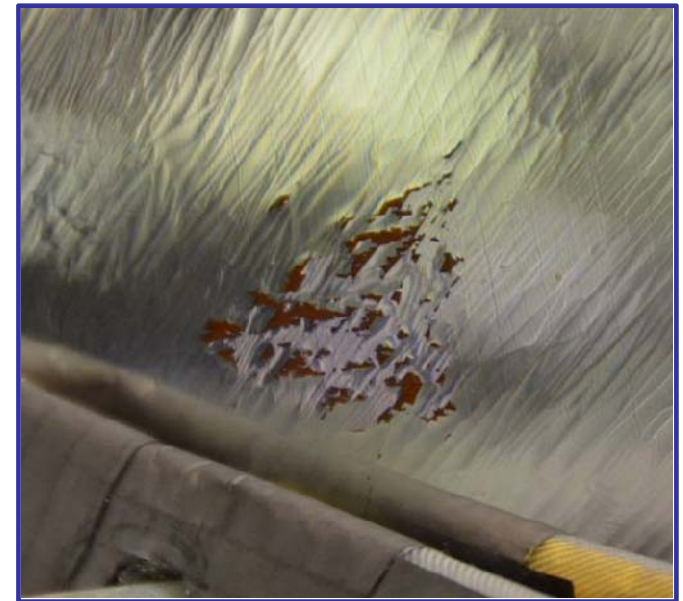
## Thermal Coatings

- Most thermal control surfaces showed damage due to mishandling, although the optical properties hadn't changed during storage.
  - NS43C white coatings touched up with Z93C55 white paint.
  - High temperature E-glass MLI near the thrusters were shedding particles; required stainless steel shells be installed to contain the particles.
  - Phosphoric-acid etched nickel inside the NISTAR baffles began flaking. Instrument was taken apart, surfaces stripped and recoated with Z306 black paint.
  - Root cause of shedding not clear.

- *Schedule and budget for increased cleanings and inspections of coatings throughout the I&T campaign.*
- *Early on in the refurbishment consider stripping and re-applying coatings to all shedding surfaces.*
