Solving Problems Caused by Small Micrometeoroid and Orbital Debris Impacts for Space-Walking Astronauts

E. L. Christiansen, D. M. Lear

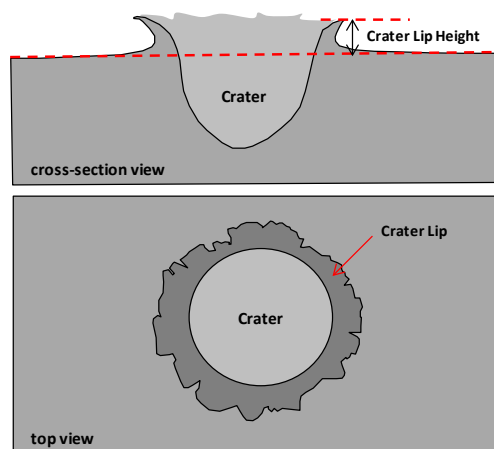
Figure 1.— MMOD impact craters into metals typically exhibit raised sharp-edged “crater lips.”

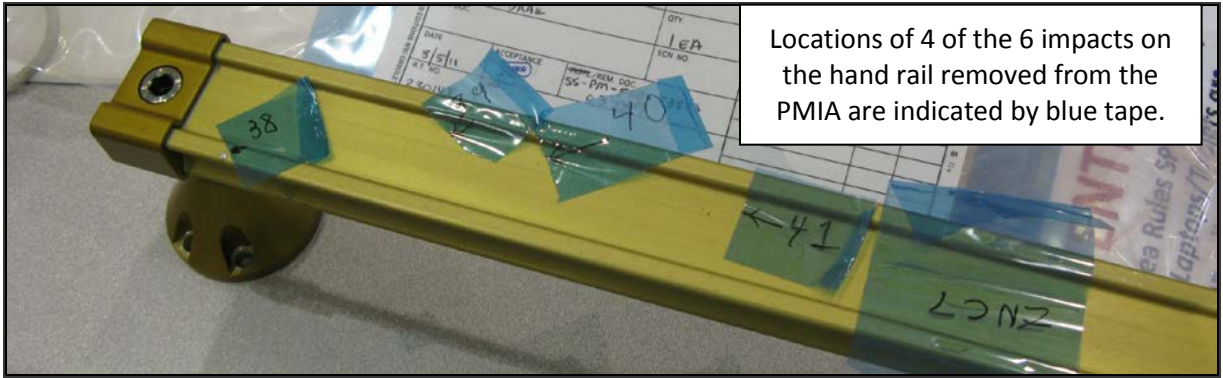
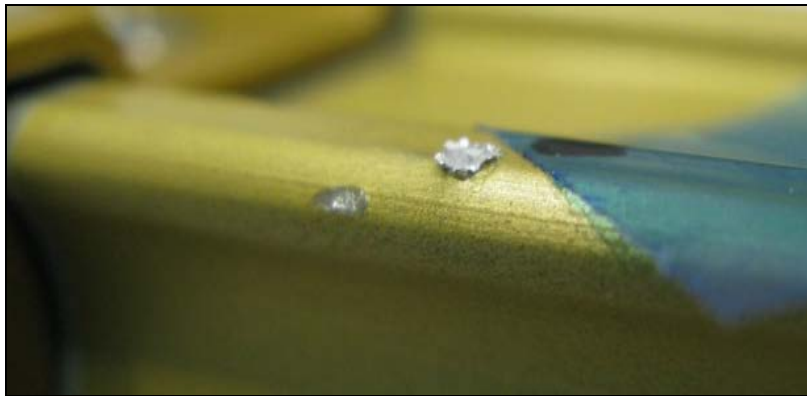
Figure 2.— The JSC HVIT group found six craters on one handrail removed from the ISS Pump Module Integrated Assembly (PMIA) and returned on STS-135. The largest crater found on the PMIA handrail (#38 in overview) was 1.85-mm in diameter with 0.33-mm-high crater lips.

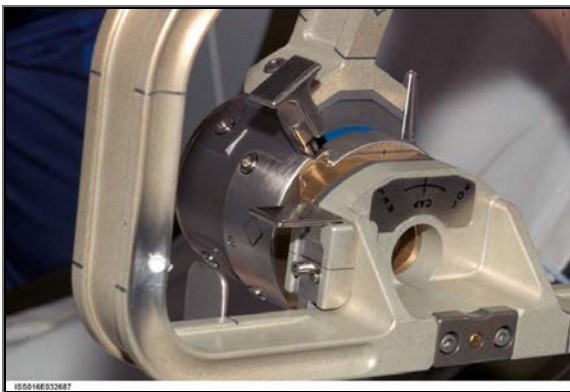
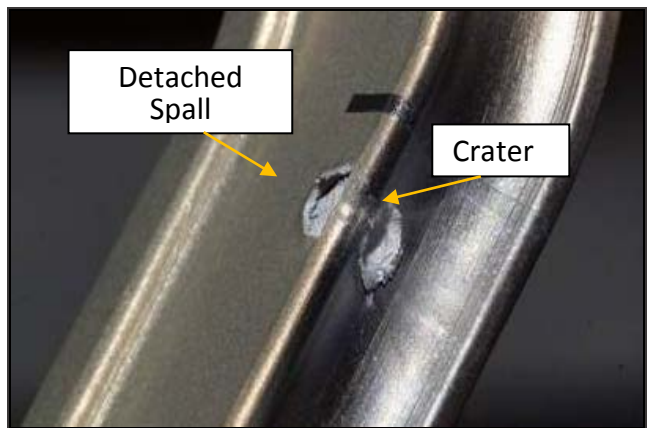
Figure 3.— Prior to STS-123 EVA, the ISS crew found a nearly 5-mm diameter crater on the EVA D-handle tool stored externally on ISS. Note that the detached spall from the side opposite the MMOD impact crater also has sharp edges. The D-handle is made of materials that are similar to those used in a typical ISS dog-bone handrail.

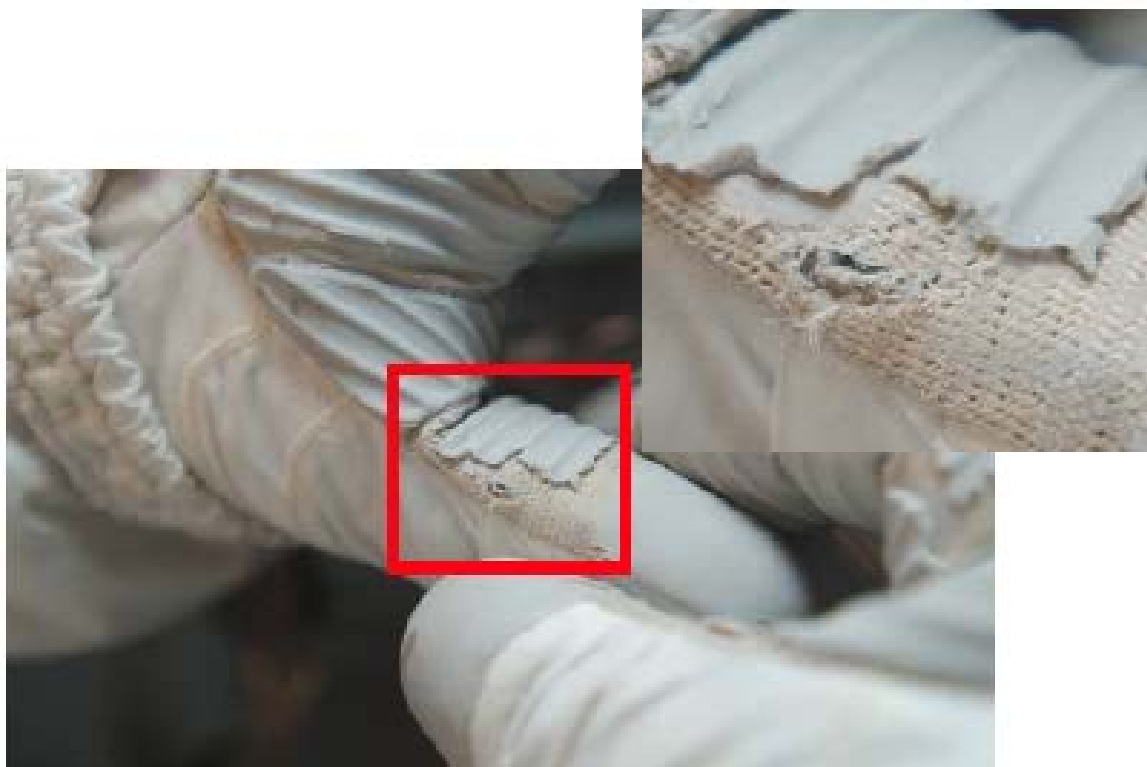
If the crater lips from hypervelocity impacts are large enough, they can tear or cut into the materials used in the EVA gloves. Crater lip heights of 0.01 in. (0.25 mm) were found to be sufficient to cut EVA glove materials in ground experiments coordinated by the NASA EVA engineering community. These experiments were performed after there were several incidents of cut gloves reported on EVAs during STS-109, STS-110, STS-116, STS-118, STS-120, STS-125, and other missions. Some of these glove cuts were large enough to result in early termination of the EVA. For instance, on STS-118, during a routine glove inspection, one of the EVA crew members noticed a possible tear on the thumb of his left glove. To be safe, EVA managers decided to end the spacewalk after about 5.5 hours, and examination and photography of the glove performed during suit removal revealed the extent of the glove tear (figure 4). A similar incident occurred during the third EVA of STS-120. MMOD craters are not the only possible cause of this glove damage, but are one of the leading possible causes.

Figure 4.– Damage to the left glove of one of the EVA crew after STS-118 EVA #3.

1. Toughening the gloves by adding additional materials to areas that are sensitive to cuts.
2. Monitoring the status of MMOD impacts on the handrails via photographs and maintaining a database of potential sharp edges on handrails, referred to as the ISS Imagery Inspection Management System (IIIMS), for EVA planning purposes. HVIT and Image Science and Analysis Laboratory personnel jointly review photographs of ISS handrails and other surfaces to identify MMOD damage that is documented in the IIIMS database and used to inform EVA crews of potential sharp edges during EVA planning. Currently, the IIIMS contains more than 200 records of MMOD impacts to handrails and other areas that could be contacted during EVA.

3. Developing EVA procedures and tools to detect and repair or cover sharp edges from MMOD impacts on handrails.
