Failure Analysis Results and Corrective Actions Implemented for the Extravehicular Mobility Unit 3011 Water in the Helmet Mishap

John Steele,¹ Carol Metselaar,² Barbara Peyton,³ Tony Rector,⁴ and Robert Rossato⁵
UTC Aerospace Systems, Windsor Locks, CT 06096-1010

Water entered the Extravehicular Mobility Unit (EMU) helmet during extravehicular activity (EVA) #23 aboard the International Space Station on July 16, 2013, resulting in the termination of the EVA approximately 1 hour after it began. It was estimated that 1.5 liters of water had migrated up the ventilation loop into the helmet, adversely impacting the astronaut's hearing, vision, and verbal communication. Subsequent on-board testing and ground-based test, tear-down, and evaluation of the affected EMU hardware components determined that the proximate cause of the mishap was blockage of all water separator drum holes with a mixture of silica and silicates. The blockages caused a failure of the water separator degassing function, which resulted in EMU cooling water spilling into the ventilation loop, migrating around the circulating fan, and ultimately pushing into the helmet. The root cause of the failure was determined t

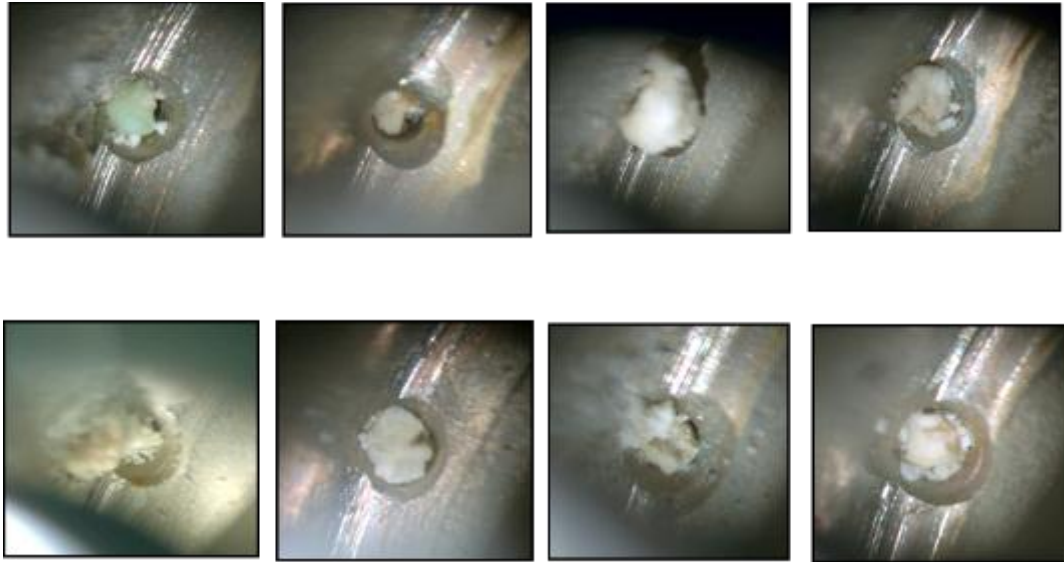
Upon return of the FPS, visual inspections identified contamination in all eight water separator drum inlet feed holes (Figure 3) and along the walls leading to the feed holes. Analysis showed the material to be primarily loosely bound silica, with zinc acetate, aluminum silicate, and aluminum oxide present as well. These constituents are all native to the EMU/Airlock system, but the quantity and location were out of family. The majority of the material was silica based.³

In operation of the EMU Transport Water Loop, small particles are filtered with a 20 micrometer filter prior to entering the water separator, which indicates the contaminant material either entered as very small particles that agglomerated in the separator or entered in solution followed by localized precipitation. Testing of EMU 3011's returned FPS (S/N 006) both with and without the drum-hole contamination confirmed that the blocked drum holes were the cause of the water in the helmet mishap.

Figure 3. Blocked water separator drum holes.

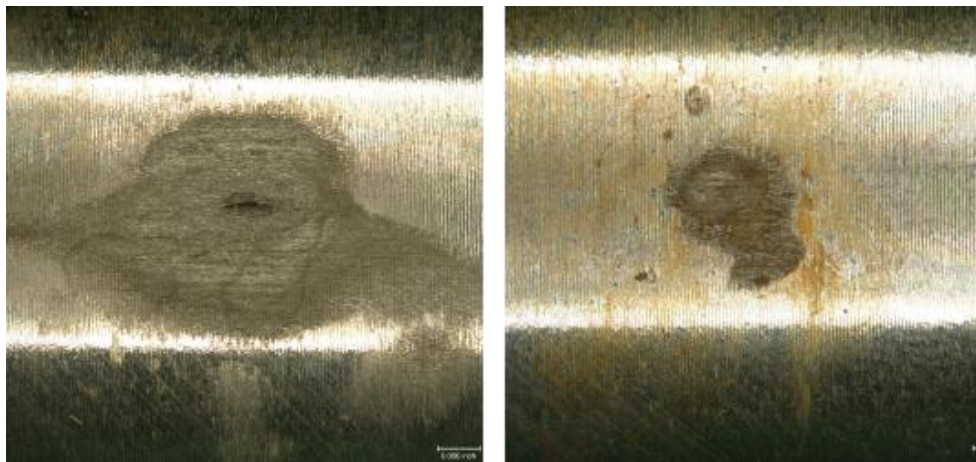
On December 26, 2013, “smudges and scratches” were noted on the exterior of the housings of the recently processed ALCLR filters, prompting an inspection. Further analysis of the hardware revealed that the housings were pitting and corroding, in some cases all the way through the housings (Figure 7).⁸

Figure 7. Pitting and corrosion on the external surfaces of the ALCLR housings.
