NASA/TM-2014-218538 (Corrected Copy)
NESC-RP-14-00957

A Comprehensive Analysis of the X-15 Flight 3-65 Accident

October 2014

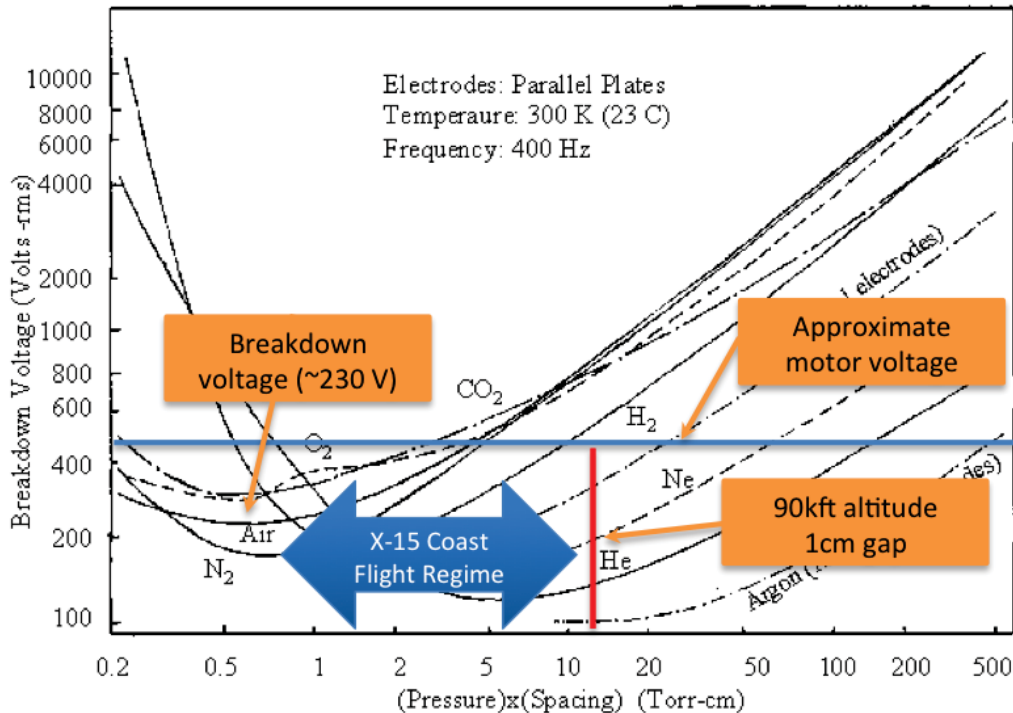
Figure 8.1-1. Paschen Curve for 400 Hz Potential at 300 degrees Kelvin [ref. 32]

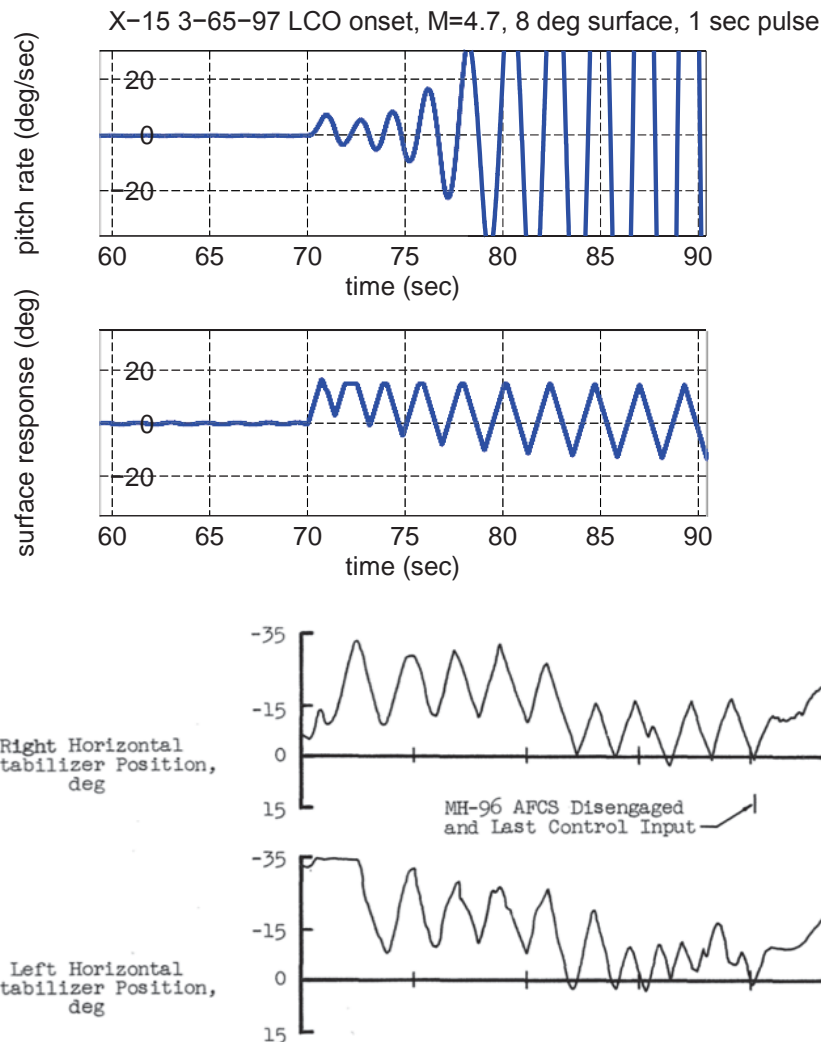
Figure 8.5-3. X-15 3-65 MH-96 Servo Actuator LCO (simulated) versus Flight Data

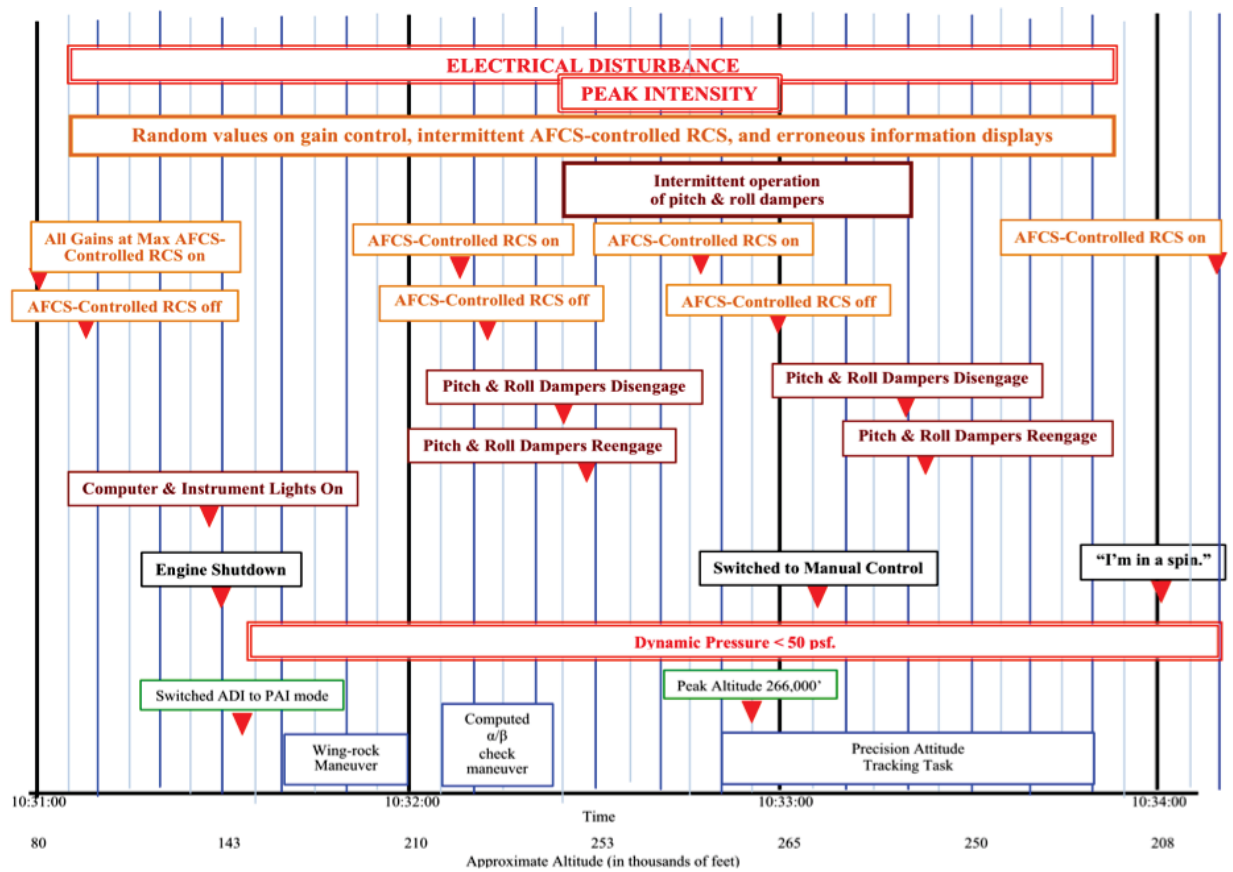
Figure 9.1-1. 3-65 Event Timeline

At 10:32:27 PST (MET + 138 seconds), the pilot reported that the pitch and roll dampers had tripped out.

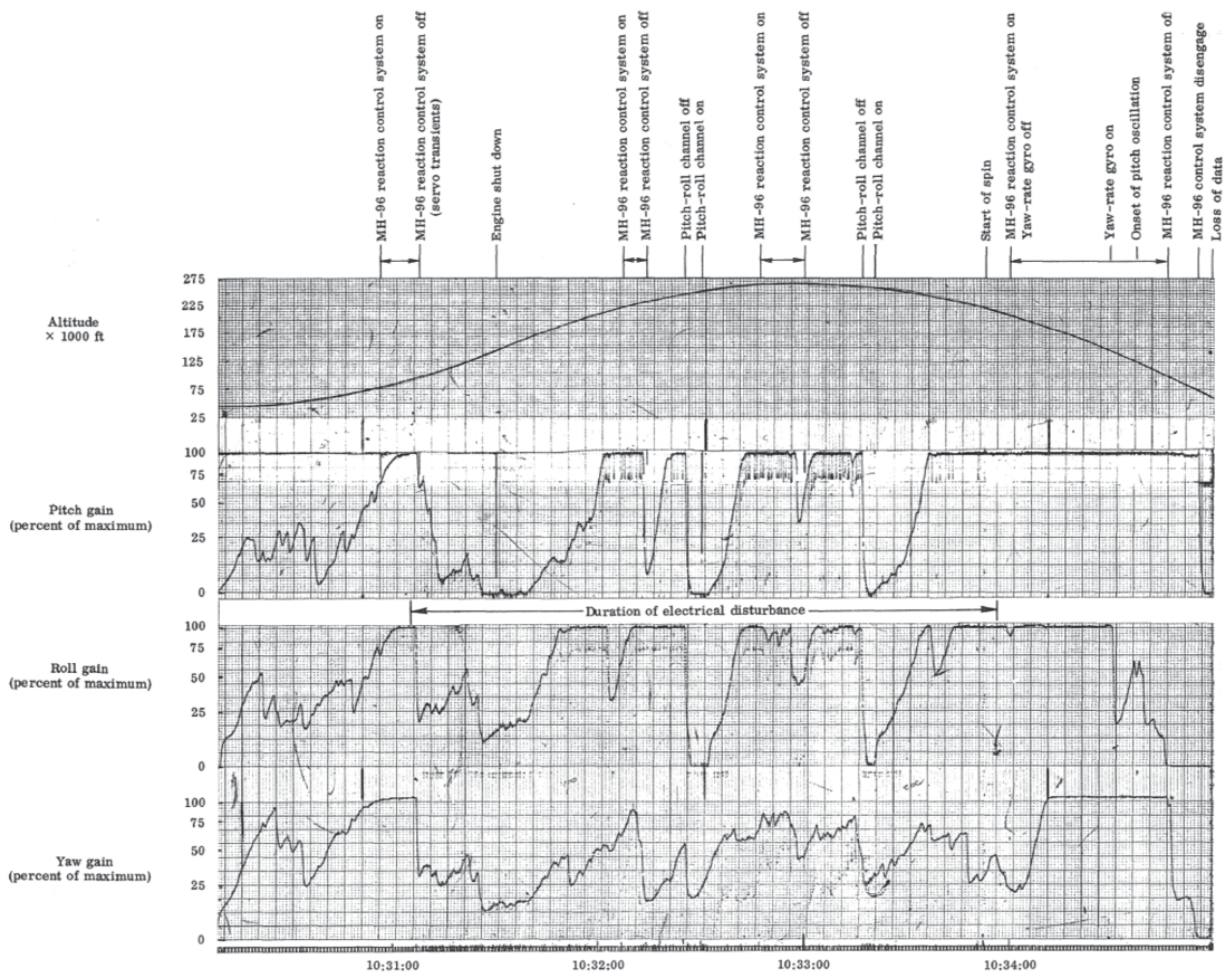
However, 14 seconds later, at 10:33:39 PST (MET + 211 seconds) and about 240,000 feet, the pilot reported that the aircraft control seemed “squirrely.” Twenty-two seconds later at 10:34:01 PST (MET + 233 seconds), the pilot said, “I’m in a spin.” Ground control did not acknowledge either of these transmissions. The pilot repeated, “I’m in a spin,” at 10:34:16 PST (MET + 248 seconds). At 10:34:17 PST (MET + 249 seconds), the flight controller said, “Say again.” At 10:34:17 PST (MET + 249 seconds), the aircraft was in descent at 184,000 feet with a velocity of 5,100 fps. The aircraft would begin to break apart 37 seconds later.

Figure 9.1-2. AFCS Gain Variation during Flight 3-65

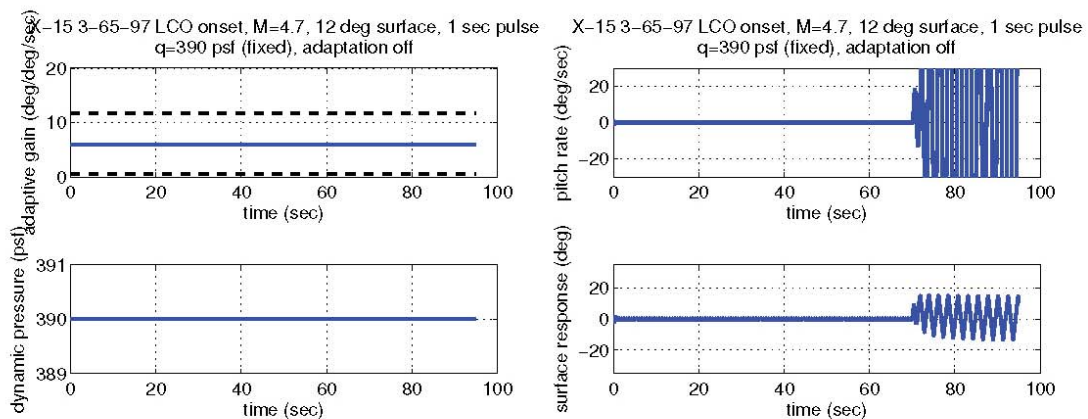
The same divergent LCO can be induced in the system even in a fixed gain condition with fixed dynamic pressure, if the pilot input magnitude is large enough to induce rate limiting in the actuator (Figure A.16). This occurs with moderate gain levels exceeding those of the fixed-gain SAS but much below the MH-96 maximum gain. This implies that a more serious mechanism involving the fundamental stability of the SAS inner loop is responsible for the limit cycle behavior, since in the fixed-gain case the behavior persists.

Figure A.16: Fixed dynamic pressure, large pilot input, fixed gain

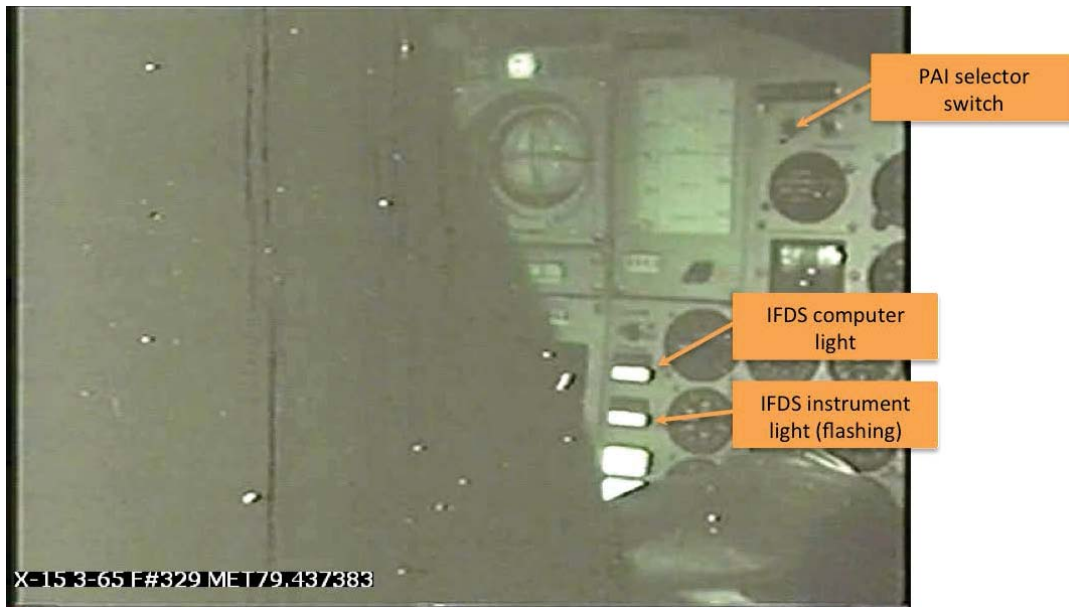
Figure B-10. Cockpit Film – Begin IFDS Malfunction (MET = 79 seconds, 10:31:27 PST)

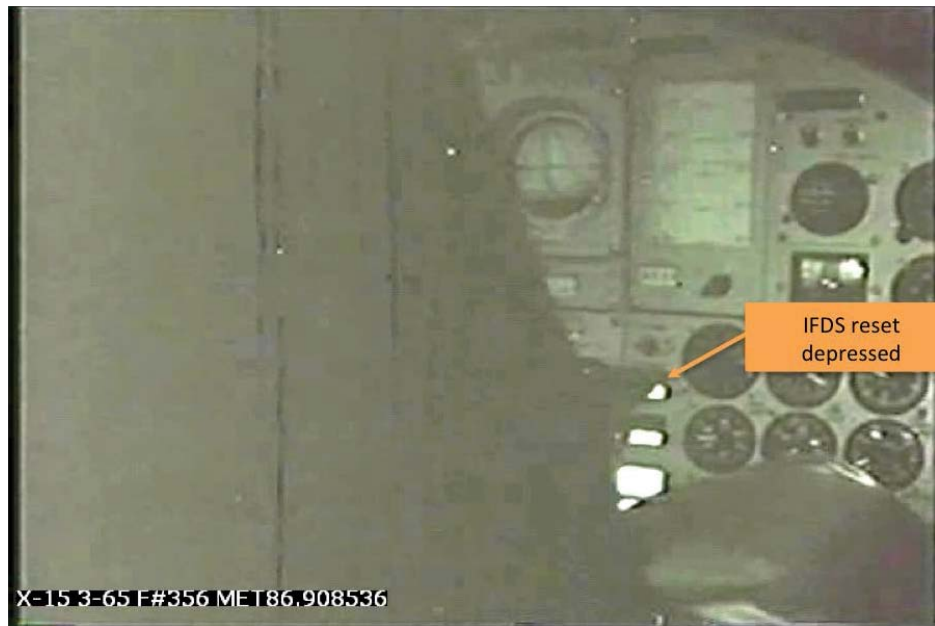
Figure B-12. Cockpit Film – Pilot Attempts IFDS Reset (MET = 87 seconds, 10:31:35 PST)

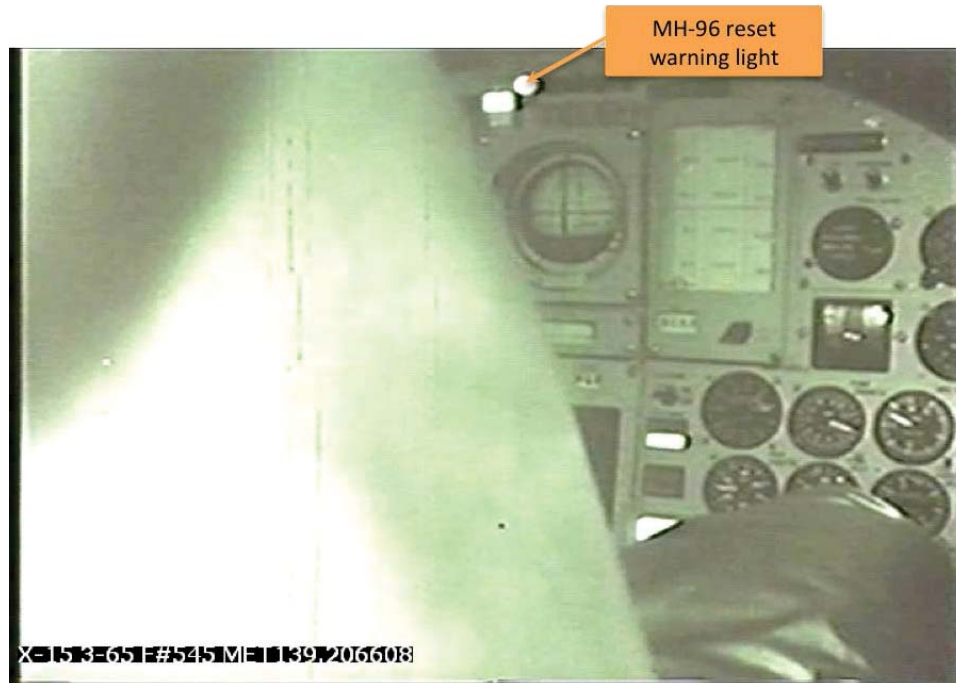
Figure B-14. Cockpit Film – One of At Least Two MH-96 Disengages (MET = 139 seconds, 10:32:27 PST)

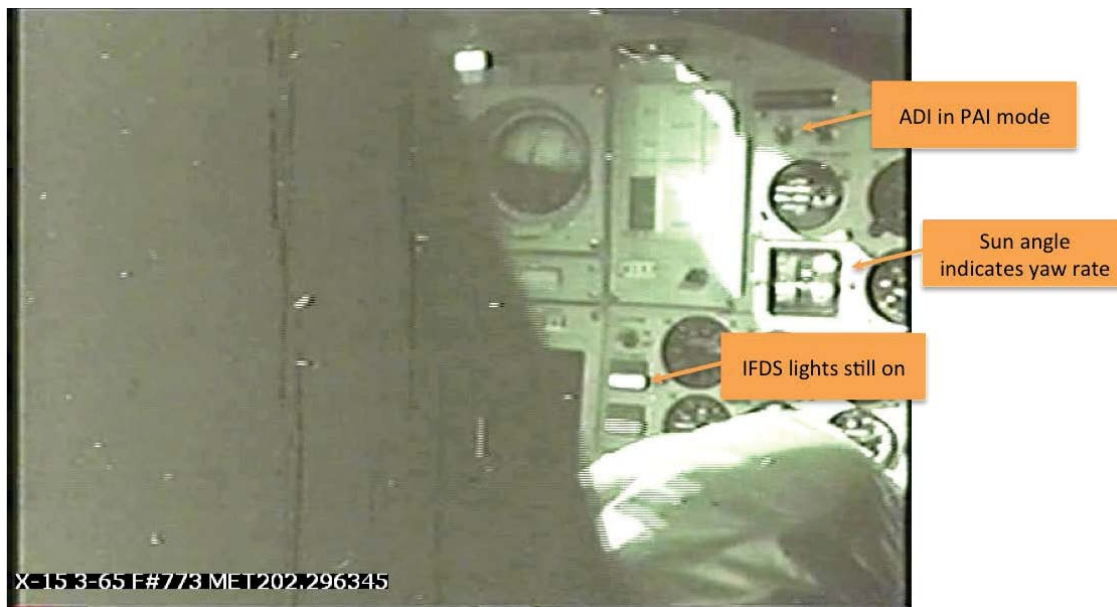
Figure B-16. Cockpit Film – Spin Entry (MET = 202 seconds, 10:33:30 PST)

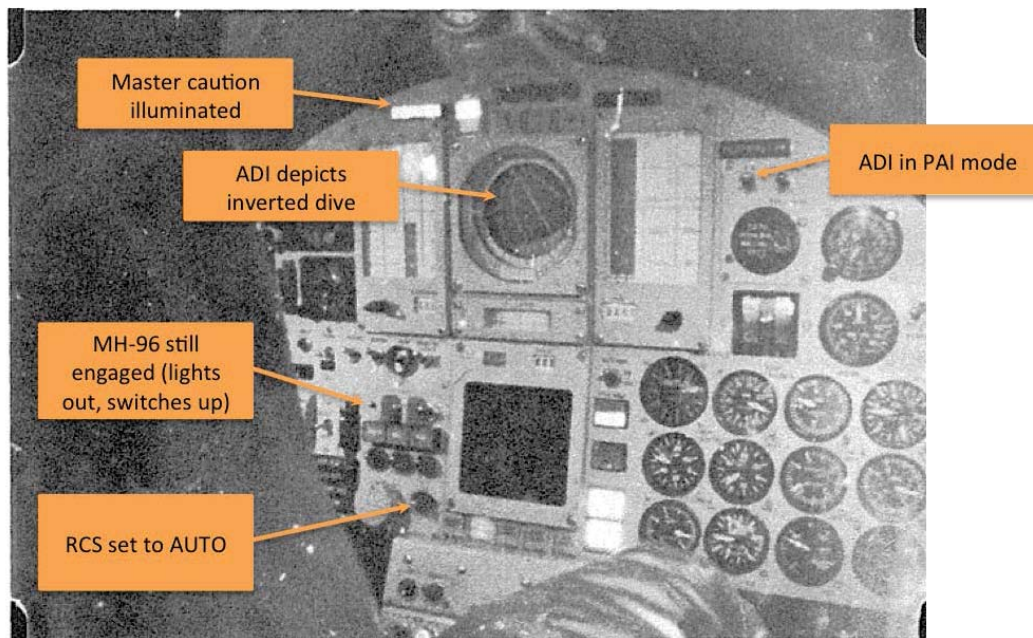
Figure B-17. Cockpit Film – Last Camera Frame (MET = 286 seconds, 10:34:54 PST)
