GENESIS SOLAR WIND COLLECTOR CLEANING ASSESSMENT: 60366 SAMPLE CASE STUDY.

Y.S. Goreva¹, C.P. Gonzalez², K.R. Kuhlman³, D.S. Burnett⁴, D. Woolum⁵, A.J. Jurewicz⁶, J.H. Allton⁷, M.C. Rodriguez⁸, and P.J. Burkett². ¹Smithsonian Institution, Washington, DC; gorevay@si.edu, ²Jacobs-JETS at NASA/J, Houston, TX, ³Planetary Science Institute, Tucson, AZ, ⁴California Institute of Technology, Pasadena, CA, ⁵California State University, Fullerton, CA, ⁶Arizona State University, Tempe, AZ, ⁷NASA/JSC, Houston, TX, ⁸Geocontrol Systems-JETS at NASA/Johnson Space Center, Houston, TX.

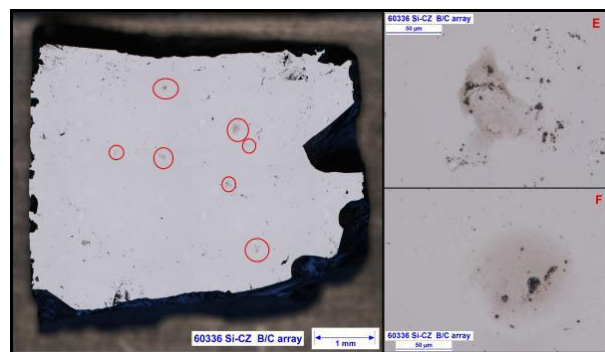
Results: Contamination appeared on the surface of 60336 after the initial 2007 UPW cleaning, presumably produced by reaction of a crash-derived contaminant with water. Figure 1 shows the sample after aqua regia and xylene treatment which did little to remove contaminants revealed by the PSI SEM examination (7/31/13). The sample was UPW cleaned for the third time and imaged (9/16/13; Fig. 2). The UPW removed the dark stains that were visible on the sample. However, some features, like “the Flounder” (a large, 100 micron feature in Fig. 3) appeared largely intact, resisting all cleaning efforts.

Fig. 1: Sample 60336 after aqua regia and hot xylene treatment (cf., 9/12/2013). The red circles indicate contamination added after the 8/6/13 imaging. Images on the right (E and F) show contamination at two different positions.

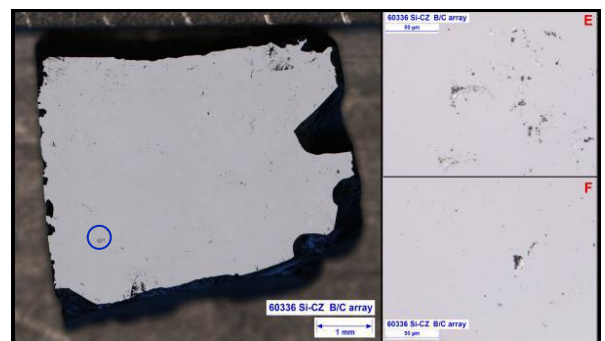
Fig. 2: Sample 60336 after UPW cleaning (9/16/13). Right: images showing the dark stains (Fig.1) are no longer visible.

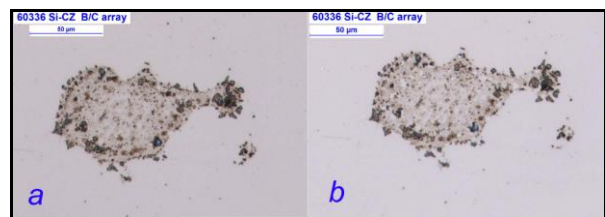
Fig. 3: Images of “the Flounder” contamination possibly added during initial UPW cleaning (Fig. 2 blue circle). (a) after SEM analysis and UPW cleaning; b) after aqua regia + hot xylene treatment, followed by UPW cleaning.

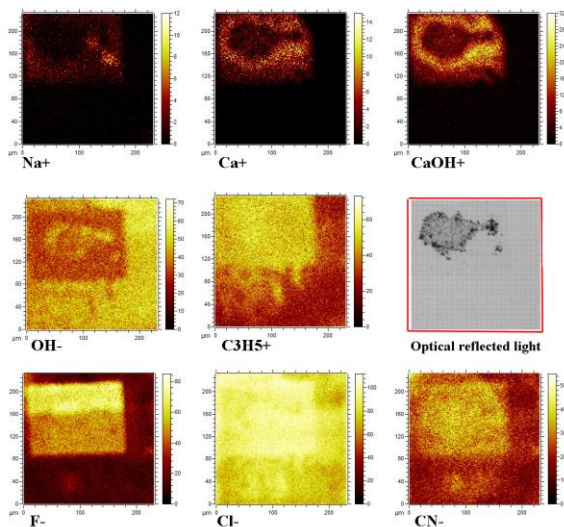
ToF-SIMS imaging has been useful of this technique for the characterization of contamination on Genesis samples [1]. Figures 4 and 5 are ToF-SIMS ion images (positive and negative) of the Flounder. The prominent square around the feature is an outline of the area scanned with high-vacuum SEM. From ToF-SIMS analysis it is clear that the SEM deposited various hydrocarbons in the scanned area. There is

also an apparent enrichment in F and Cl in the feature, as well as enrichment in Ca around it. Hydrocarbons obscured the speciation of the Ca compound; however, correlation of Ca⁺ and CaOH⁺ localizations suggest Ca oxide and/or hydroxide.

Fig. 4 ToF-SIMS images of “Flounder” before Ar sputtering.

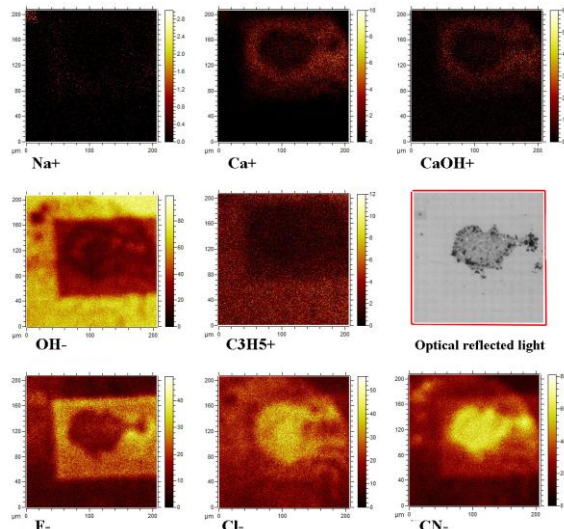
Ar sputtering (Fig. 5) removed most hydrocarbons, Na, as well as much of the Ca – suggesting that these

were likely present as a very thin surficial film.

Cl may be a compositional part of this contamination as ion images show mobilization of Cl in the areas of high-resolution SEM x-ray mapping (tail of the Flounder). Signal from CN⁻ is likely an artifact, but indicates the area of overall C-enrichment. No Ca or CaOH was detected outside of the Flounder.

Fig. 5: ToF-SIMS images of “Flounder” after Ar sputtering.

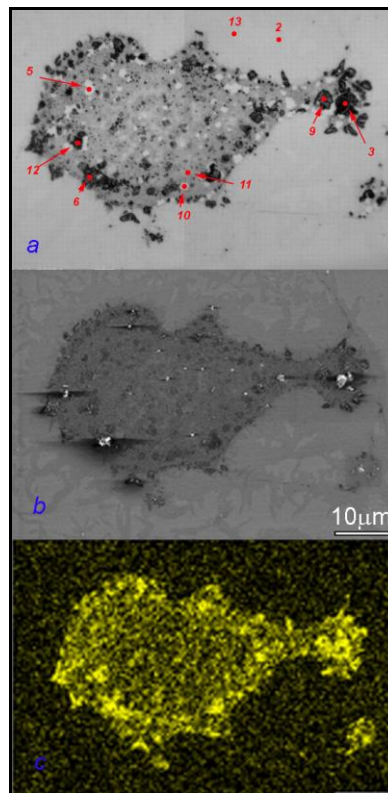
High-vacuum SEM imaging showed that there are numerous feature in the Flounder, including: (1) particles (possibly, non-conductive - charging in Fig. 6b), (2) thin films, and (3) an enrichment in C (Fig. 6c).

Low-vacuum SEM analyses of individual features within Flounder are presented in Table 1. Si values are high because the EDS excitation volume (3kV beam) is significantly larger than thickness of the contamination. Some compositional correlations with surface features can be observed: Points 2, 13 lay outside of Flounder; “white” specs (points 5, 10) have low C/O ratio, possibly Ca oxide or hydroxide; “black” specs (points 3, 9, 6, 12) have high C/O ratio, possibly Ca carbonate.

Fig. 6: a) Optical image of Flounder. b) SEM BSE (High vacuum) image. c) High-vacuum EDX X-ray map of Carbon.
