# DETERMINE ISS SOYUZ ORBITAL MODULE BALLISTIC LIMITS FOR STEEL PROJECTILES HYPERVELOCITY IMPACT TESTING

Hypervelocity Impact Technology Group (HVIT)  
Astromaterials Research and Exploration Science (ARES) Directorate  
Human Exploration Science Office, KX

July 2013

Prepared for the  
**ISS Systems Engineering and Integration Office**

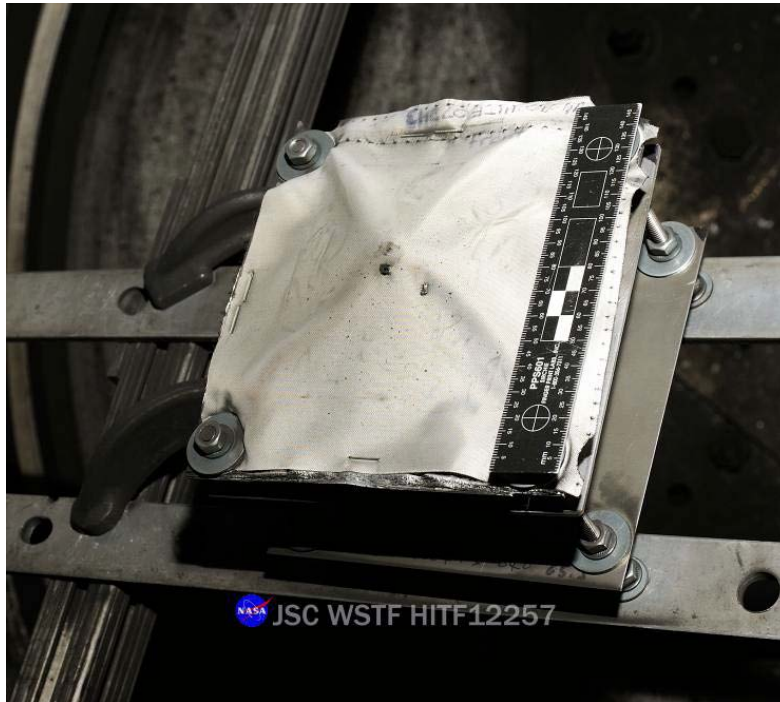
Test #1, HITF12257

Test No.	Actual Projectile Diameter (mm)	Actual Projectile Mass (g)	Actual Impact Velocity (km/s)	Impact Angle (deg)	Results
1 <a href="#">HITF12257</a>	1.79	0.02310	7.18	30	<p><b>Fail</b></p> <p>Beta cloth entry damage = 1.77mm x 1.96mm hole  Mylar Film damage = 45.97mm x 33.08mm hole  Fiberglass entry damage = 10.81mm x 13.44mm hole  Al 6061 Foil damage = 8.64mm x 8.26mm hole  Fiberglass exit damage = 12.89mm x 15.04mm hole  MLI exit damage = 7.71mm x 9.88mm hole  Al 6061-T6 plate damage = 8.14mm x 10.21mm hole  Al 5456-0 RW damage = 3 holes largest is 2.45 x 3.09mm  Al 2024-T3 WP damage = 0.198mm x 0.218mm x 0.051mm  deep crater &amp; many smaller</p>
2 <a href="#">HITF12258</a>	1.59	0.01610	4.99	30	<p><b>Fail</b></p> <p>Beta cloth entry damage = 1.54mm x 1.95mm hole  Mylar Film damage = 13.43mm x 9.34mm hole  Fiberglass damage = 2.87mm x 3.87mm hole  Al 6061 Foil damage = 6.04mm x 5.06mm hole  Fiberglass damage = 8.47mm x 12.48mm hole  MLI exit damage = 7.01mm x 7.80mm hole  Al 6061-T6 plate damage = 4.42mm x 6.33mm hole  Al 5456-0 RW damage = 2 holes largest is 6.57mm x 8.95mm  Al 2024-T3 WP damage = 0.58mm x 0.97mm x 0.275mm  deep crater &amp; many smaller</p>

Figure 16: Post-test of ISS Soyuz Orbital Module Test #1 (HITF12257) article mounted in 0.50-caliber target tank.

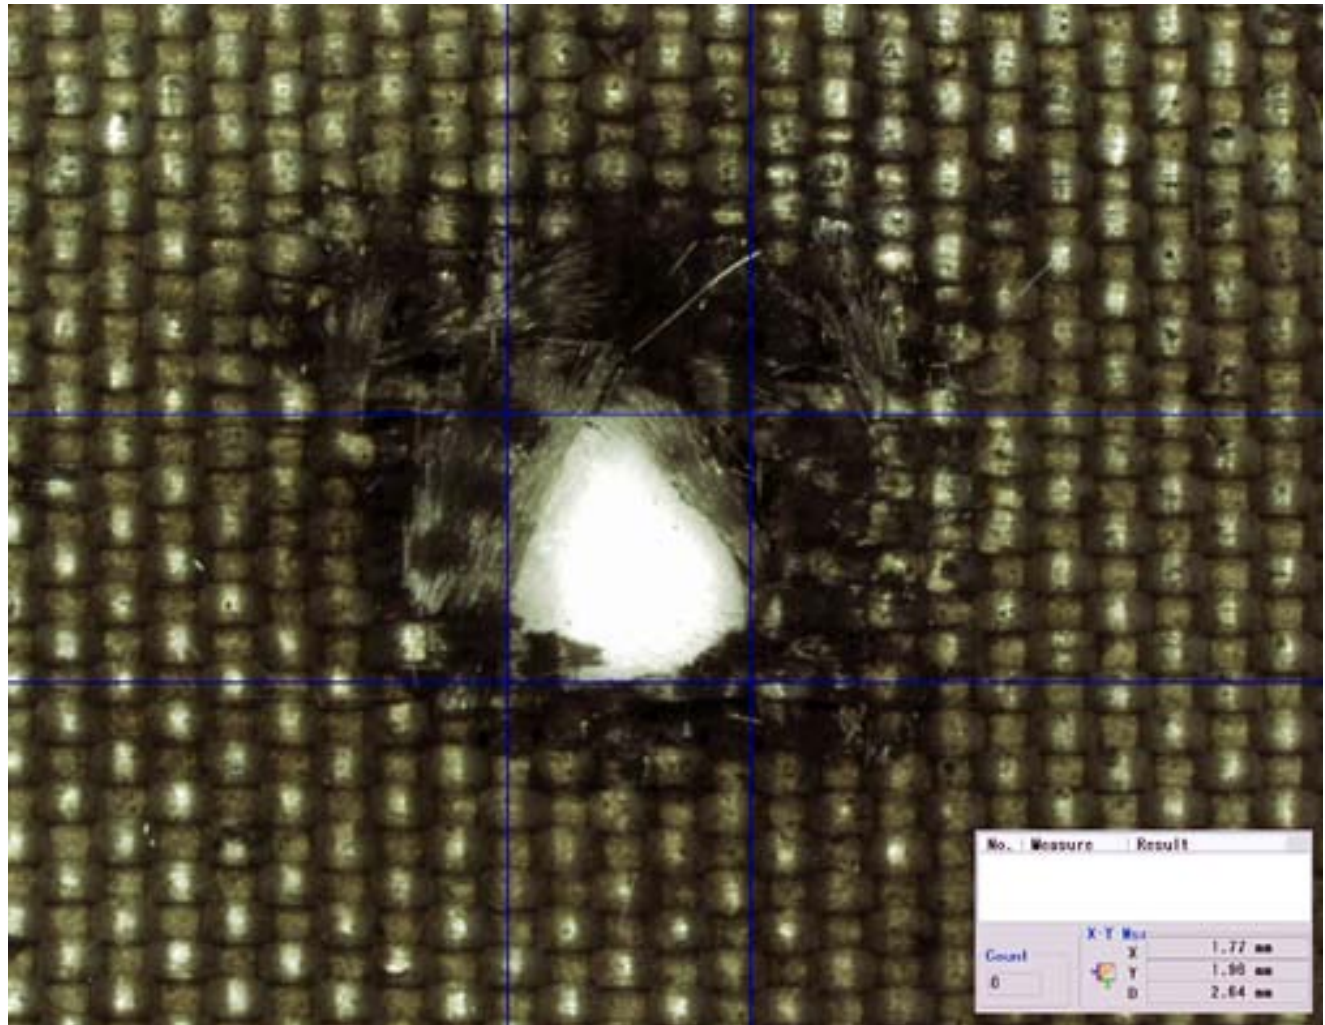
Test #1, HITF12257

Figure 18: Beta Cloth Bumper Layer 1 of ISS Soyuz OM Test #1 (Keyence 3D Microscope Image)

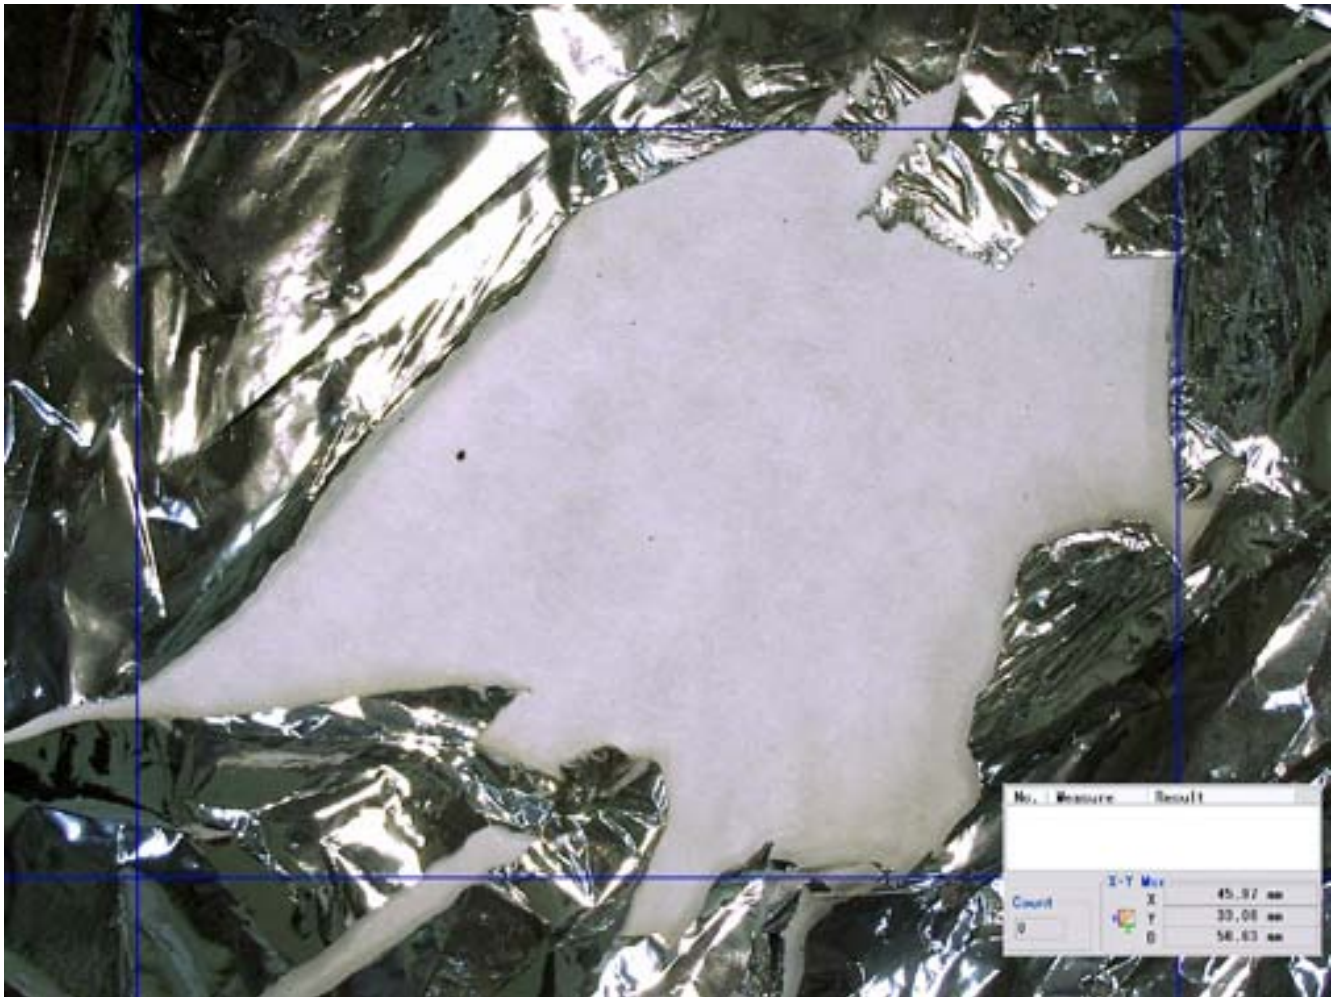
## Test #1, HITF12257

Figure 20: Mylar Film Layer 2 of ISS Soyuz OM Test #1  
(Keyence 3D Microscope Image)

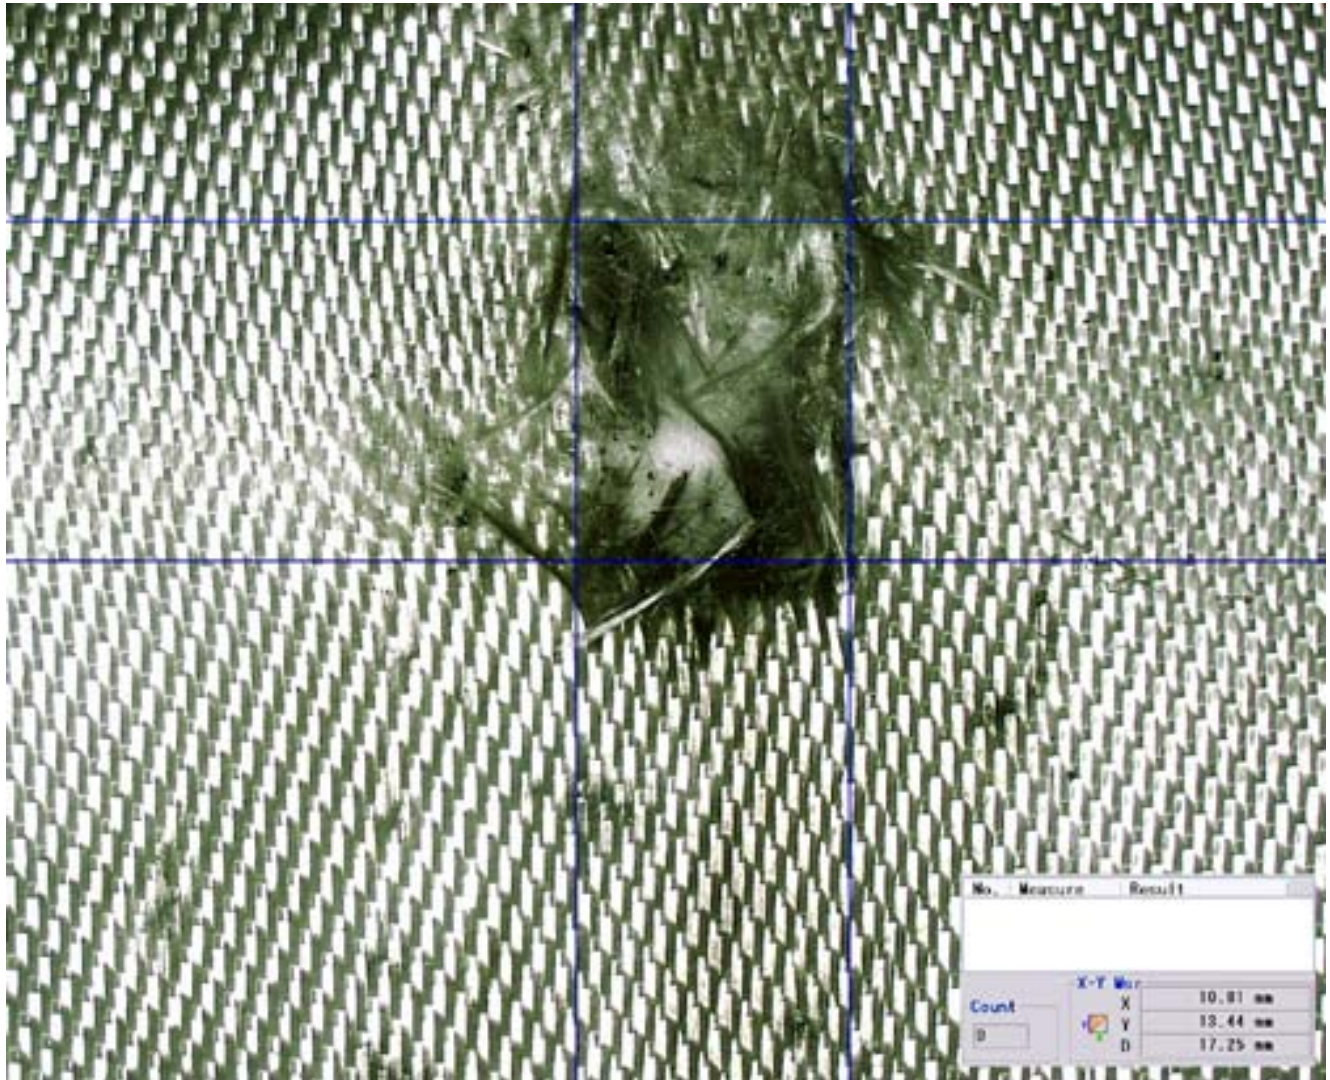
## Test #1, HITF12257

Figure 21: Fiberglass-7781 Layer 3 of ISS Soyuz OM Test #1  
(Keyence 3D Microscope Image)

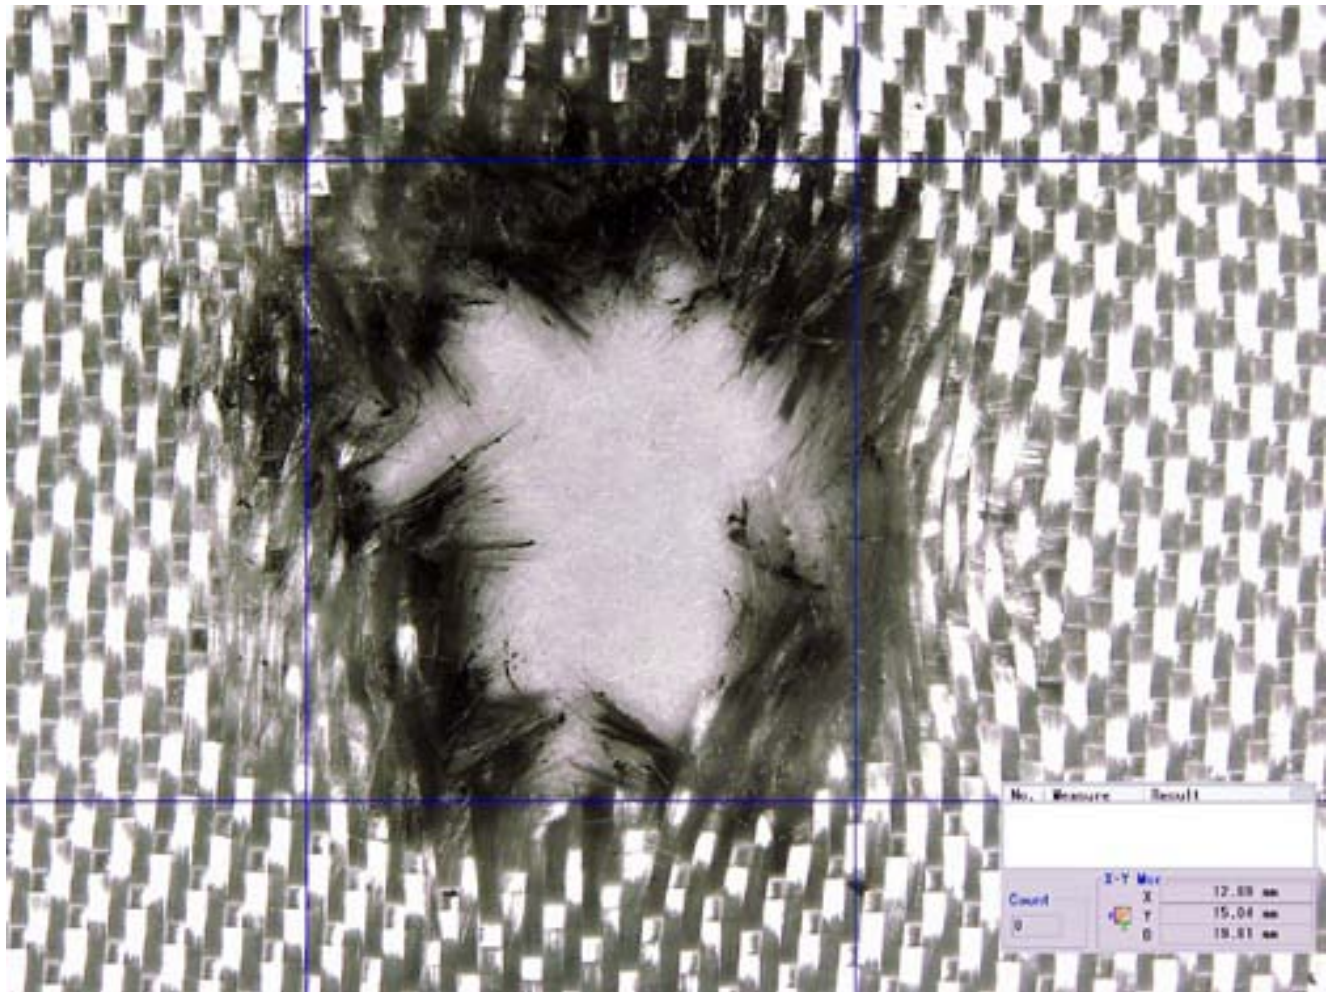
## Test #1, HITF12257

Figure 23: Fiberglass-7781 Layer 5 of ISS Soyuz OM Test #1  
(Keyence 3D Microscope Image)

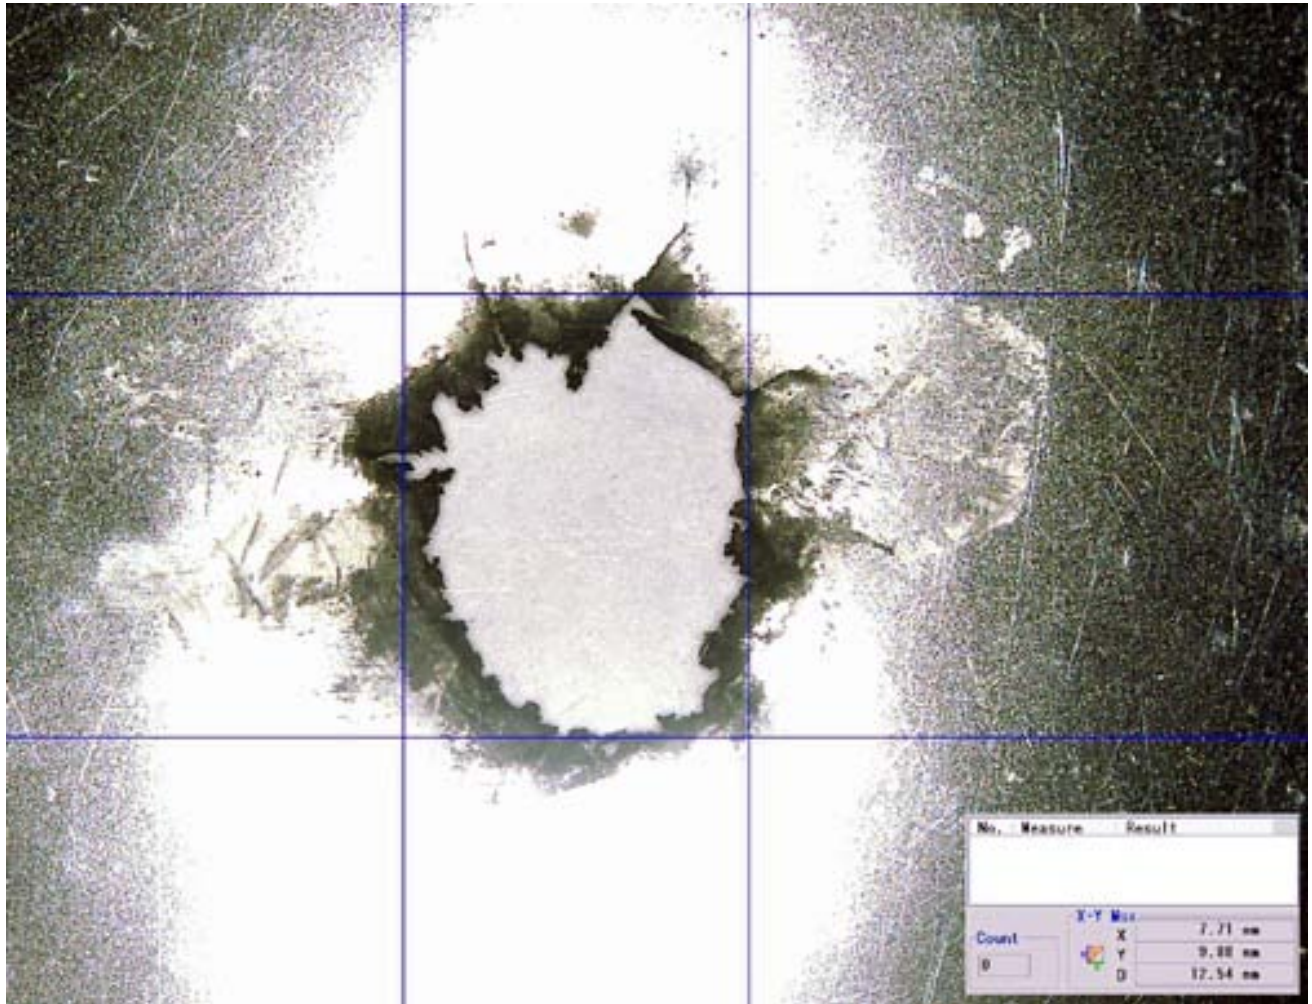
**Test #1, HITF12257**

**Figure 24: Multi-layer Insulation Aluminized Mylar Layer 6 Back of  
ISS Soyuz OM Test #1  
(Keyence 3D Microscope Image)**

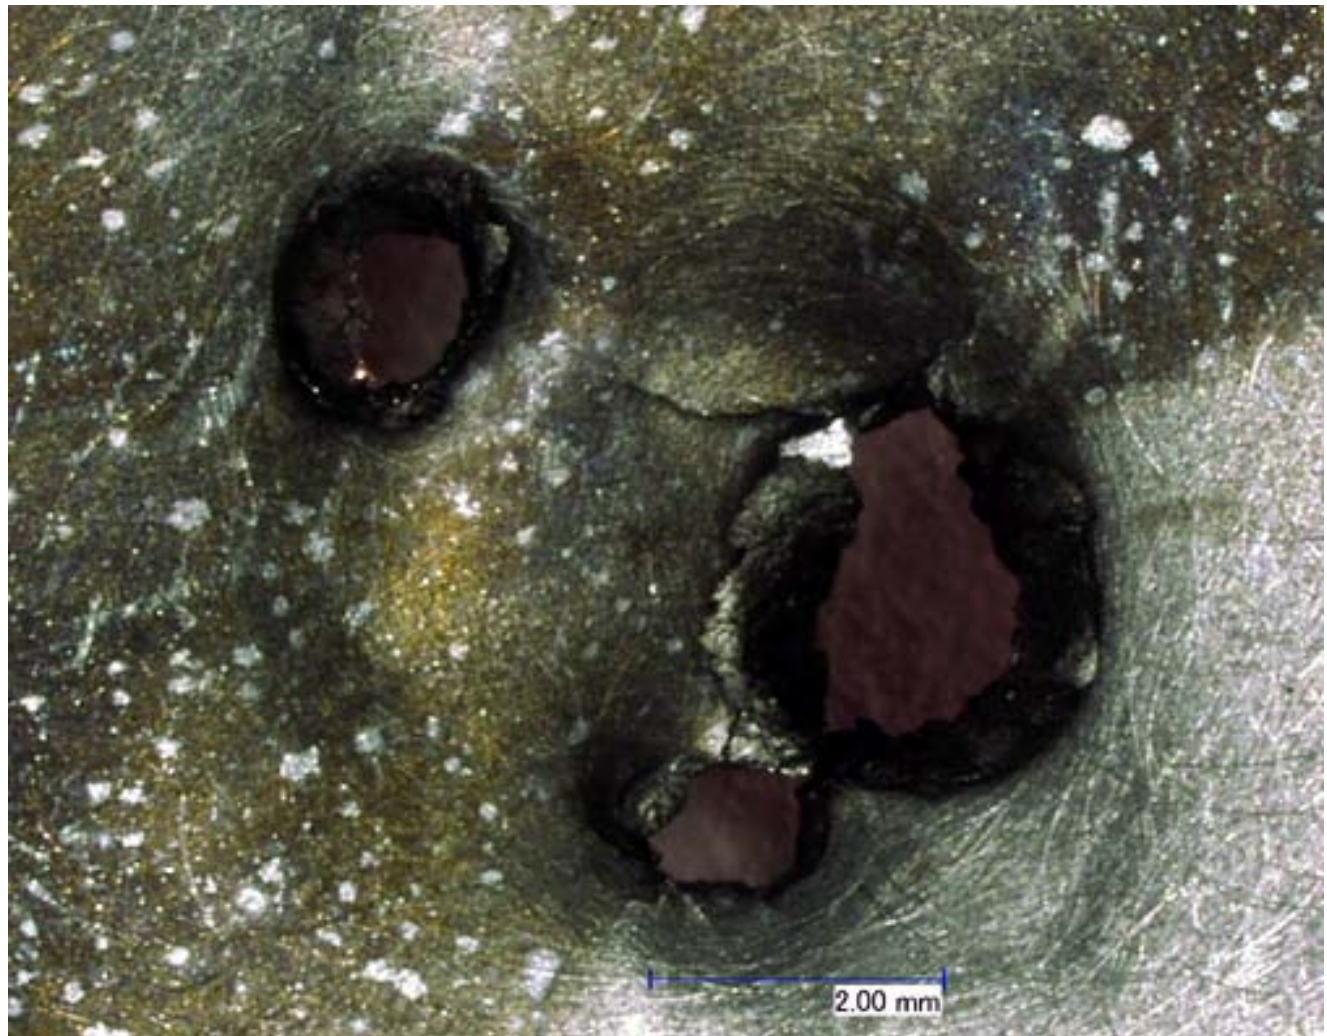
Test #1, HITF12257

Figure 28: Al 5456-0 Rear Wall Layer 8 Back of ISS Soyuz OM Test #1  
(Keyence 3D Microscope Image)

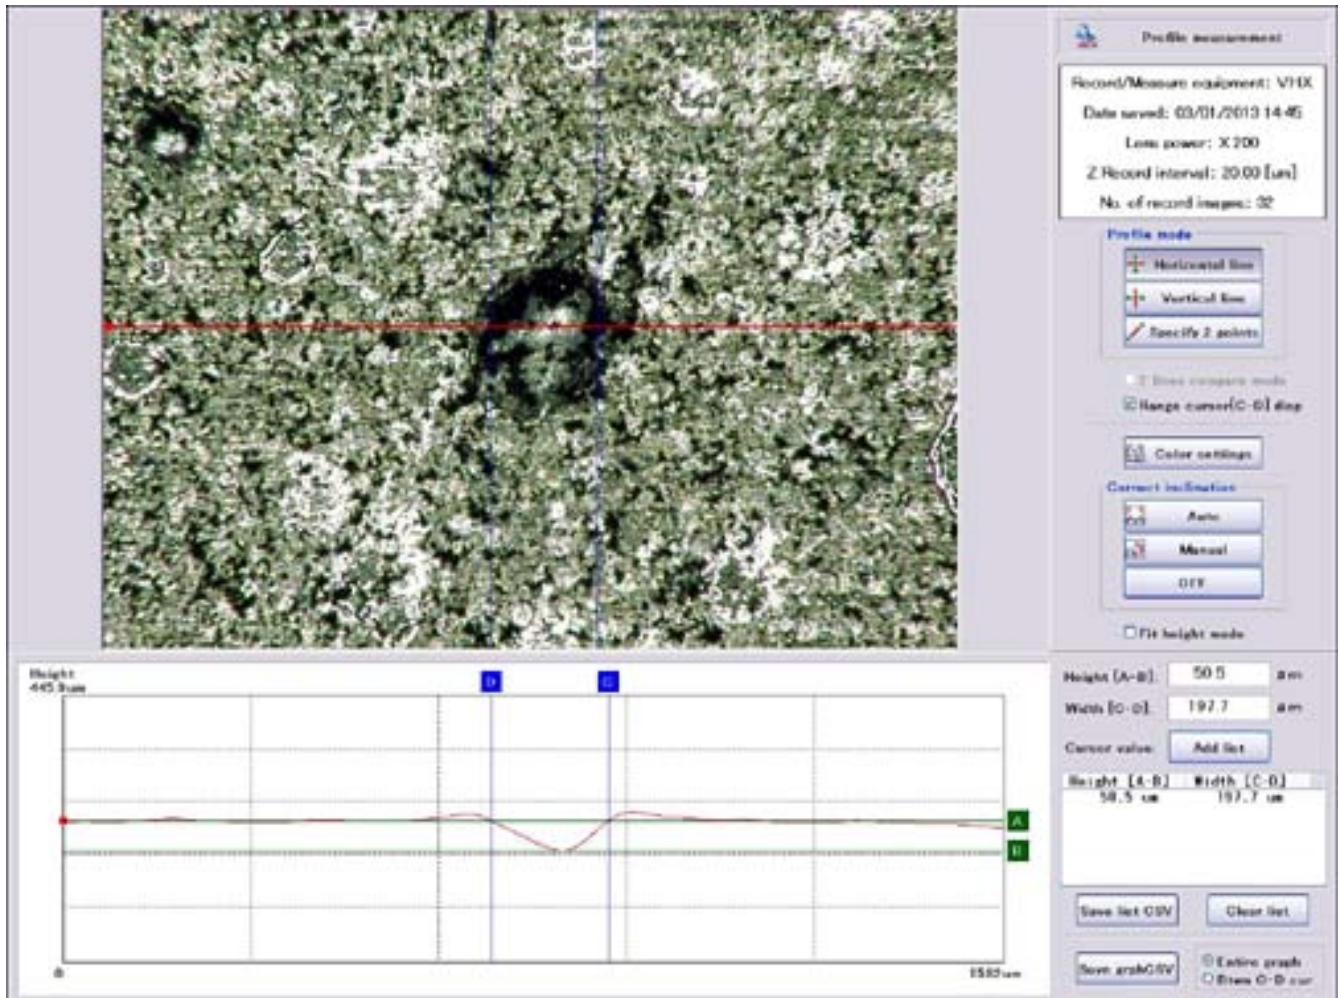
Test #1, HITF12257

Figure 30: Witness Plate of ISS Soyuz OM Test #1  
 (Keyence 3D Microscope Image)

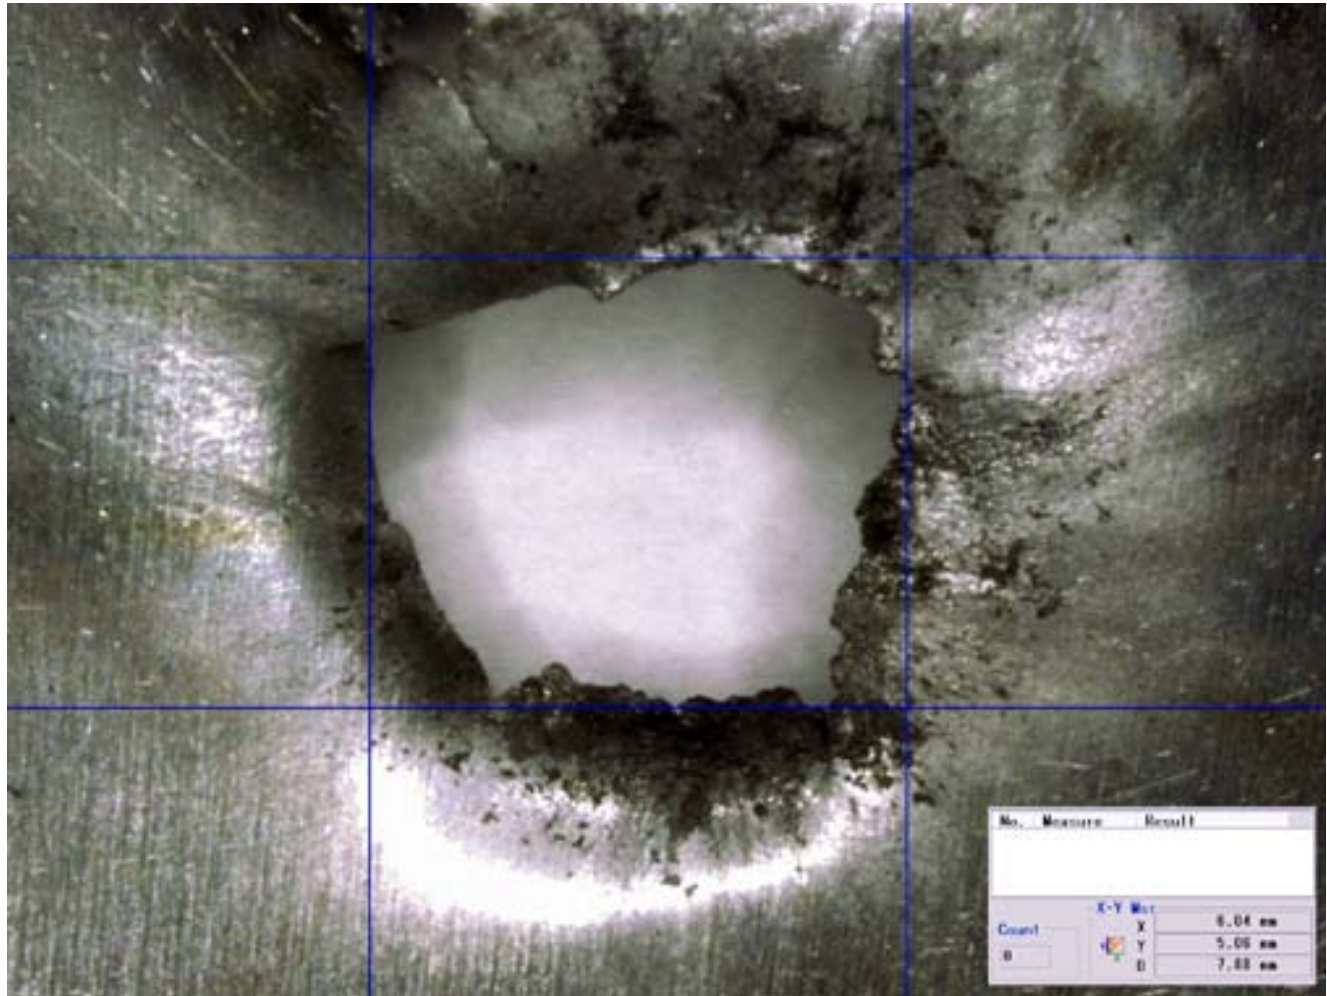
Test #2, HITF12258

Figure 39: Al 6061 Foil Layer 4 of ISS Soyuz OM Test #2  
(Keyence 3D Microscope Image)

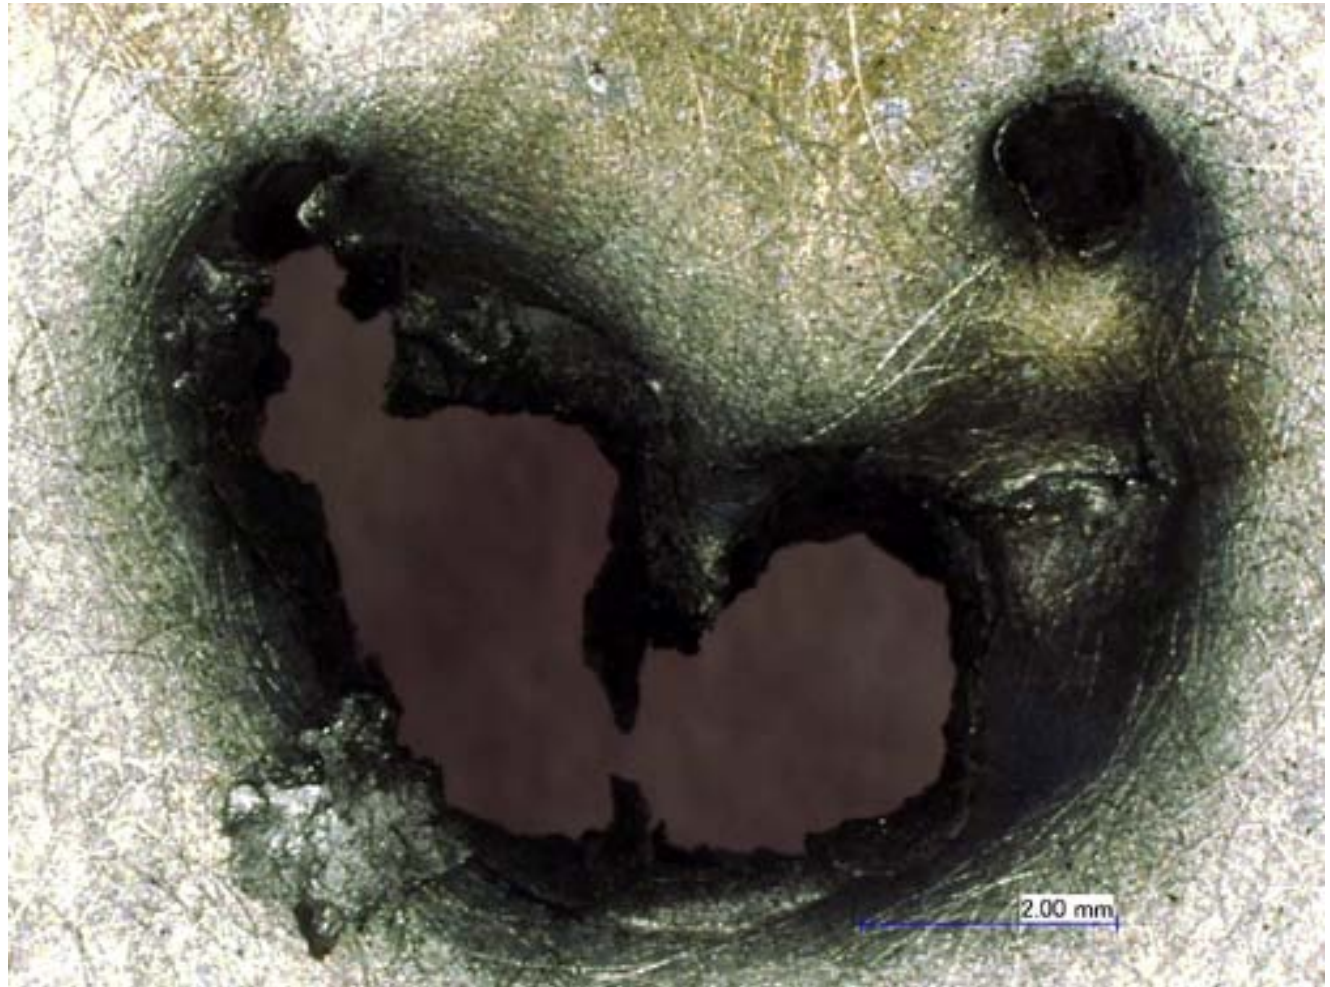
**Test #2, HITF12258**

**Figure 45: Al 5456-0 Rear Wall Layer 8 Back of ISS Soyuz OM Test #2  
(Keyence 3D Microscope Image)**

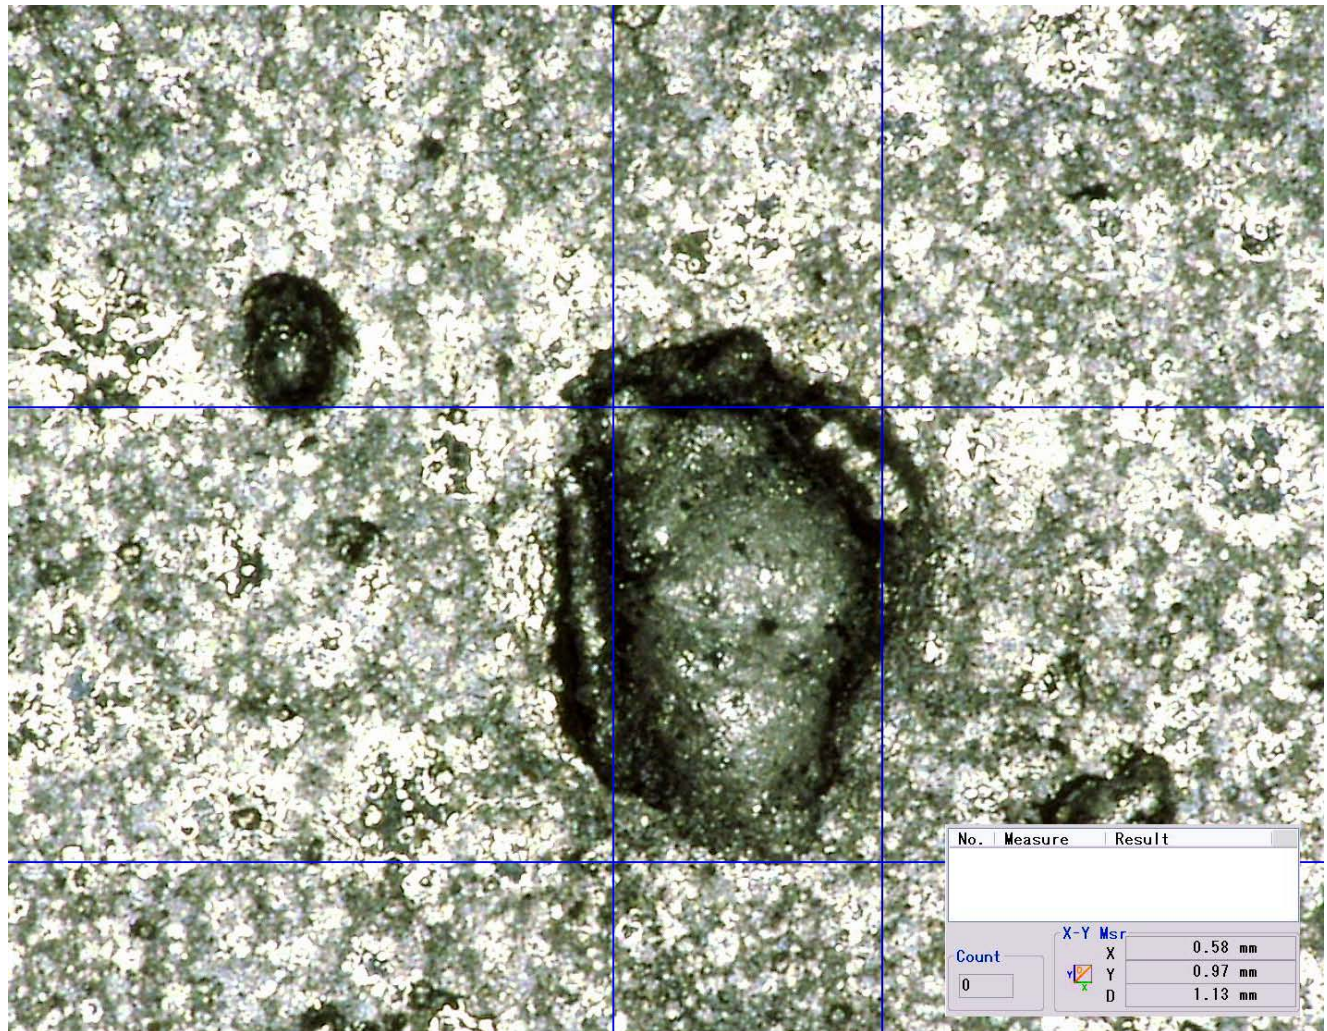
Test #2, HITF12258

Figure 46: Witness Plate of ISS Soyuz OM Test #2  
(Keyence 3D Microscope Image)

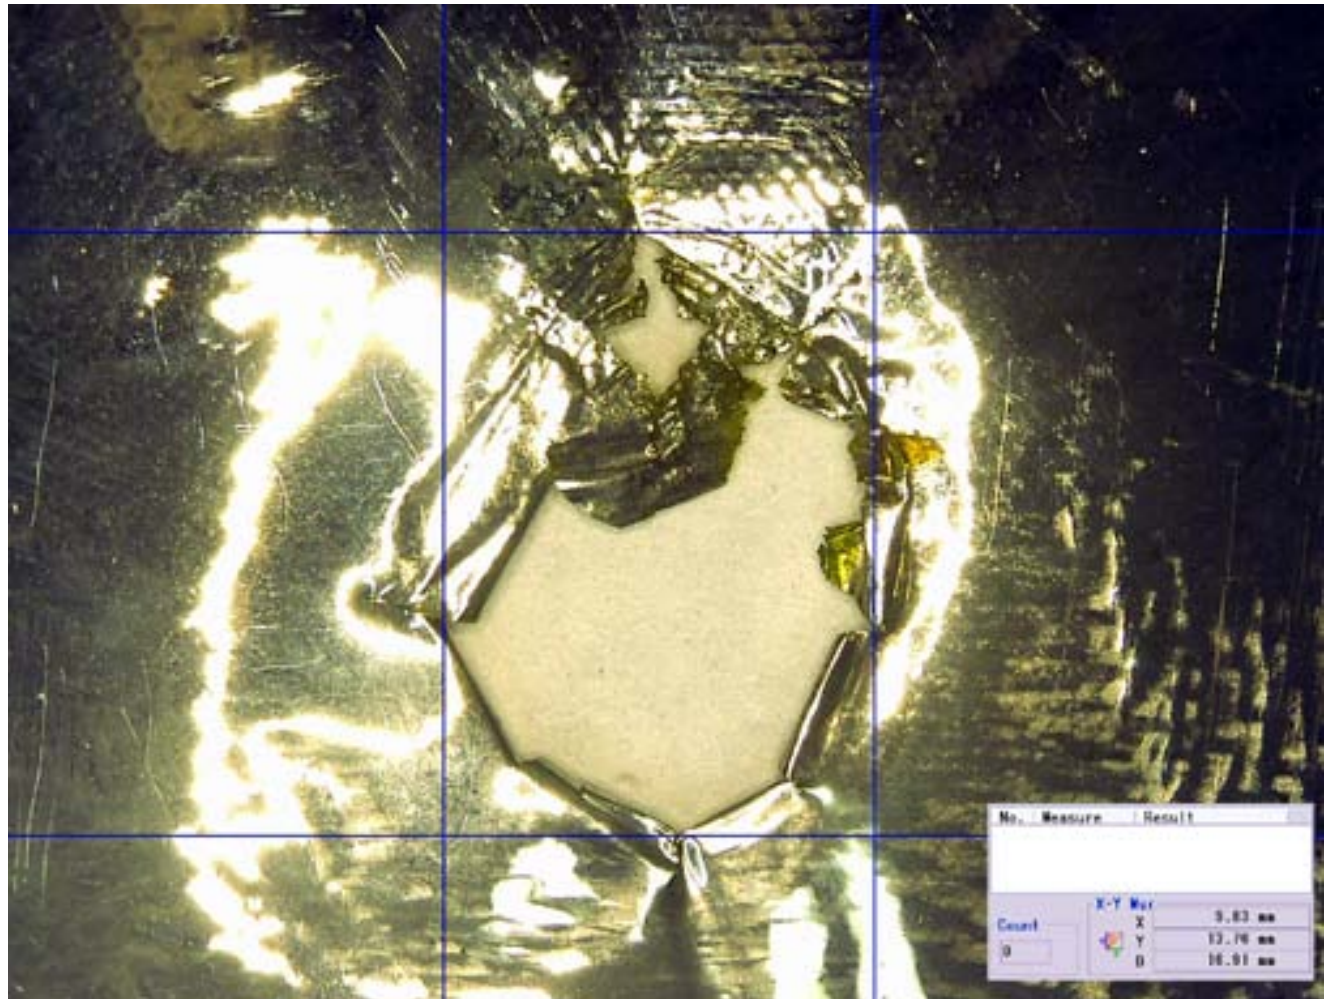
## Test #3, HITF12259

3 <a href="#">HITF12259</a>	1.72	0.02046	5.78	30	<p><b>Fail</b></p> <p>Beta cloth entry damage = 1.61mm x 2.11mm hole  Mylar Film damage = 9.83mm x 13.76mm hole  Fiberglass damage = 5.69mm x 7.78mm hole  Al 6061 Foil damage = 6.09mm x 5.58mm hole  Fiberglass damage = 8.24mm x 14.03mm hole  MLI exit damage = 6.38mm x 10.22mm hole  Al 6061-T6 plate damage = 7.38mm x 9.42mm hole  Al 5456-0 RW damage = 4.97 x 4.53mm hole  Al 2024-T3 WP damage = 0.140mm x 0.187mm x 0.034mm  deep crater &amp; several smaller</p>

Figure 54: Mylar Film Layer 2 of ISS Soyuz OM Test #3  
(Keyence 3D Microscope Image)

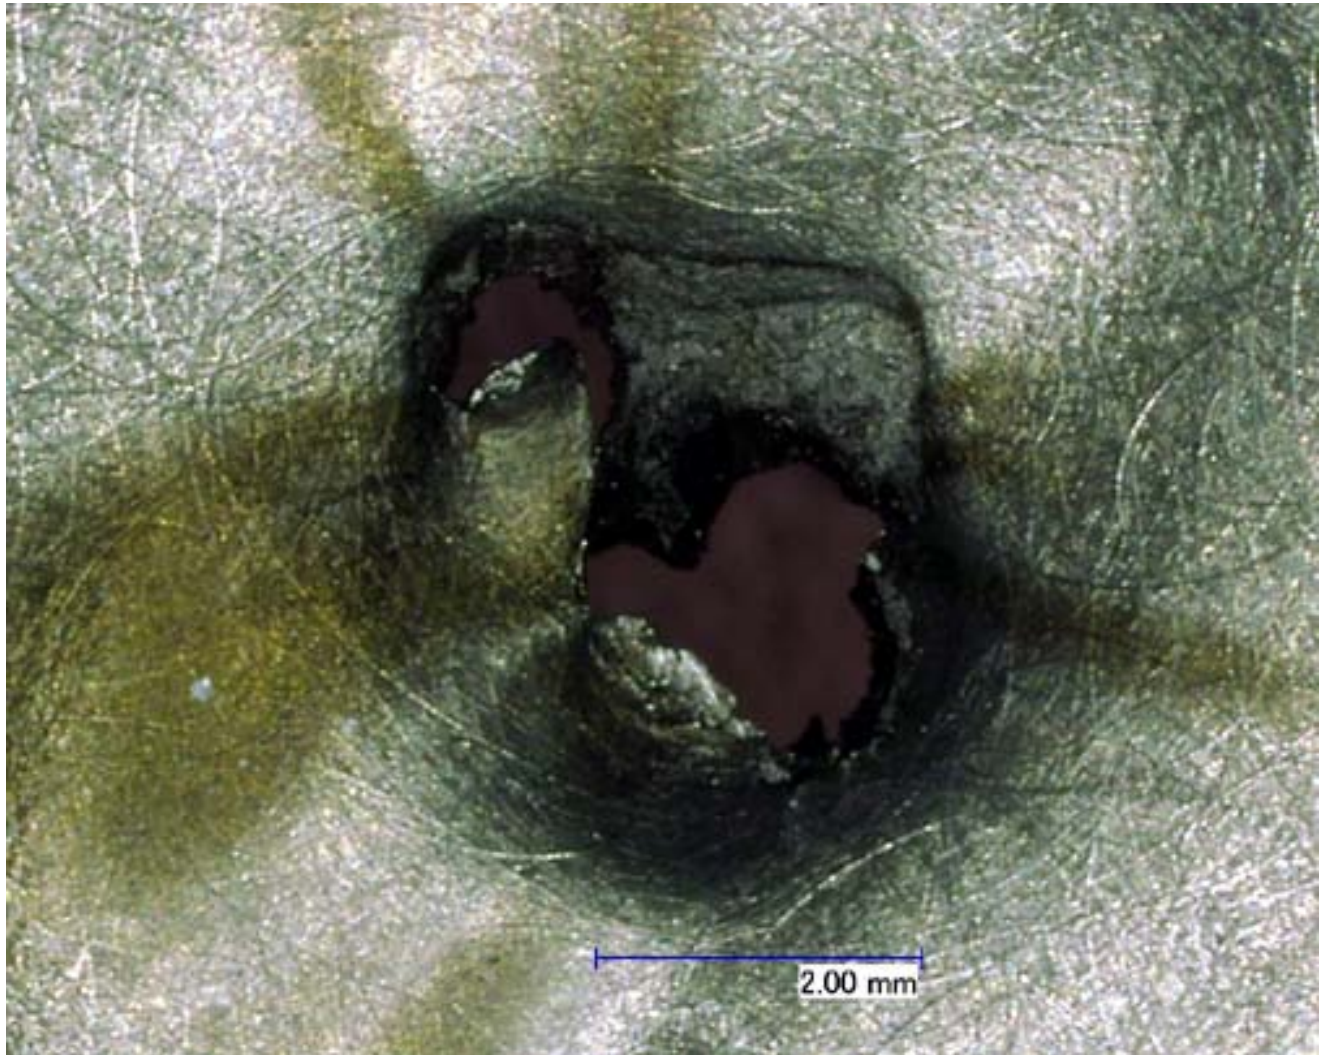
**Test #3, HITF12259**

**Figure 62: Al 5456-0 Rear Wall Layer 8 Back of ISS Soyuz OM Test #3  
(Keyence 3D Microscope Image)**

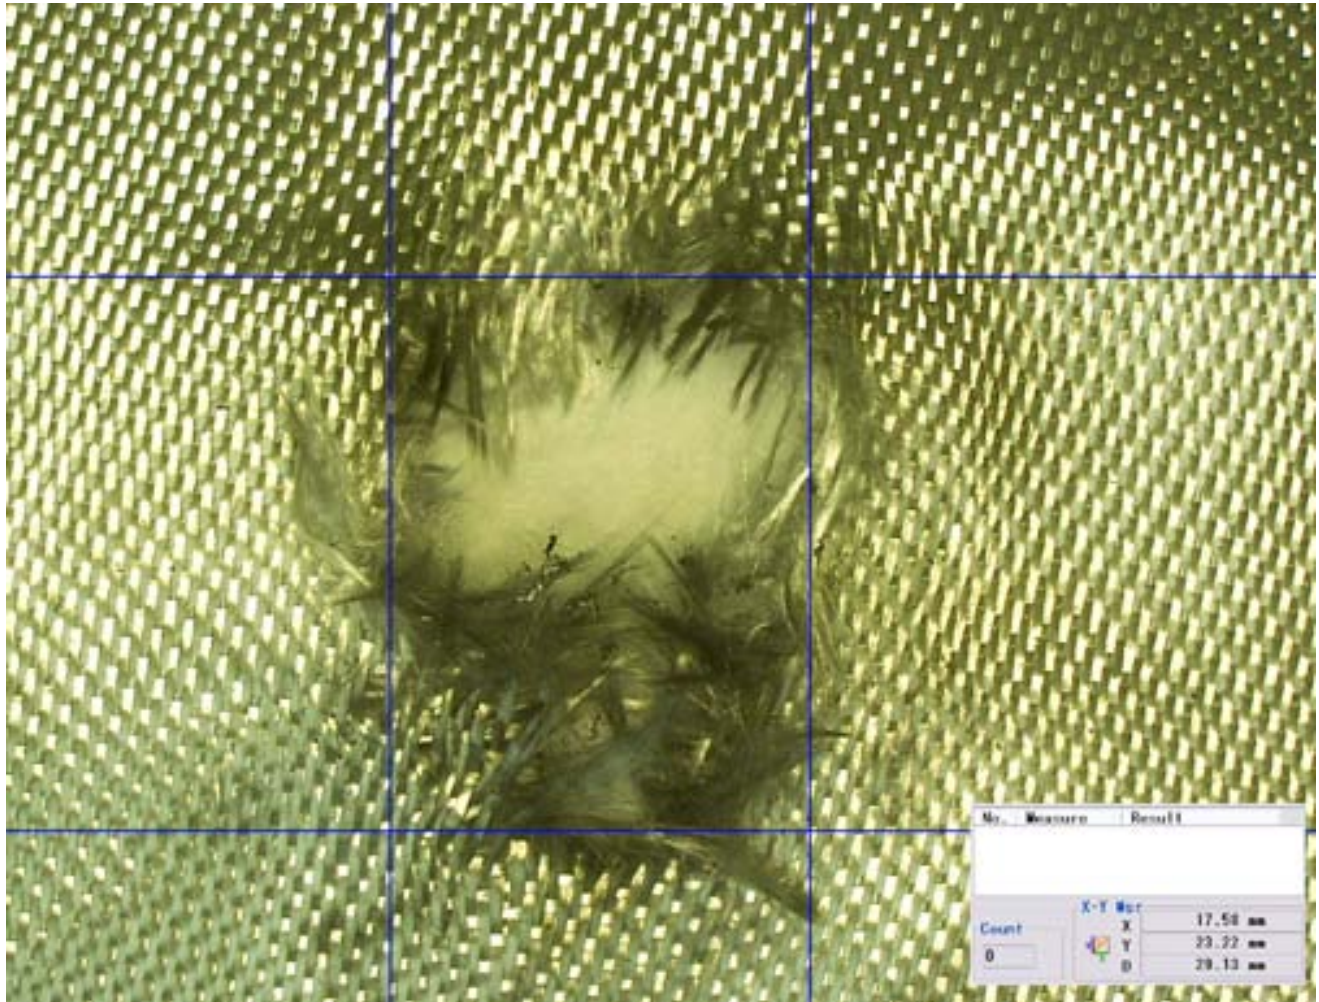
## Test #4, HITF12260

Test No.	Actual Projectile Diameter (mm)	Actual Projectile Mass (g)	Actual Impact Velocity (km/s)	Impact Angle (deg)	Results
4 <a href="#">HITF12260</a>	1.99	0.03157	7.06	45	<p><b>Fail</b></p> <p>Beta cloth entry damage = 1.98mm x 2.71mm hole  Mylar Film damage = 42mm x 41mm hole  Fiberglass damage = 17.58mm x 23.22mm hole  Al 6061 Foil damage = 14.40mm x 15.82mm hole  Fiberglass damage = 15.57mm x 20.44mm hole  MLI exit damage = 9.36mm x 12.81mm hole  Al 6061-T6 plate damage = 11.65mm x 15.93mm hole  Al 5456-0 <a href="#">RW damage</a> = 3.91 x 3.53mm hole  Al 2024-T3 WP damage = 0.645mm x 0.763mm x 0.667mm deep crater &amp; many smaller</p>
5 <a href="#">HITF12261</a>	1.29	0.00860	no data	30	<p><b>Pass</b></p> <p>Beta cloth entry damage = 5.39mm x 6.09mm hole  Mylar Film damage = 10.17mm x 10.04mm hole  Fiberglass damage = 6.82mm x 7.61mm hole  Al 6061 Foil damage = 9.22mm x 10.83mm hole  Fiberglass damage = 6.61mm x 7.62mm hole  MLI exit damage = 7.37mm x 9.95mm hole  Al 6061-T6 plate damage = 13.31mm x 14.77mm hole  Al 5456-0 <a href="#">RW damage</a> = 1.31 x 1.66 x 0.61mm deep crater on front  0.22mm high bump on back  Al 2024-T3 WP damage = no damage</p>

Figure 71: Fiberglass-7781 Layer 3 of ISS Soyuz OM Test #4  
(Keyence 3D Microscope Image)

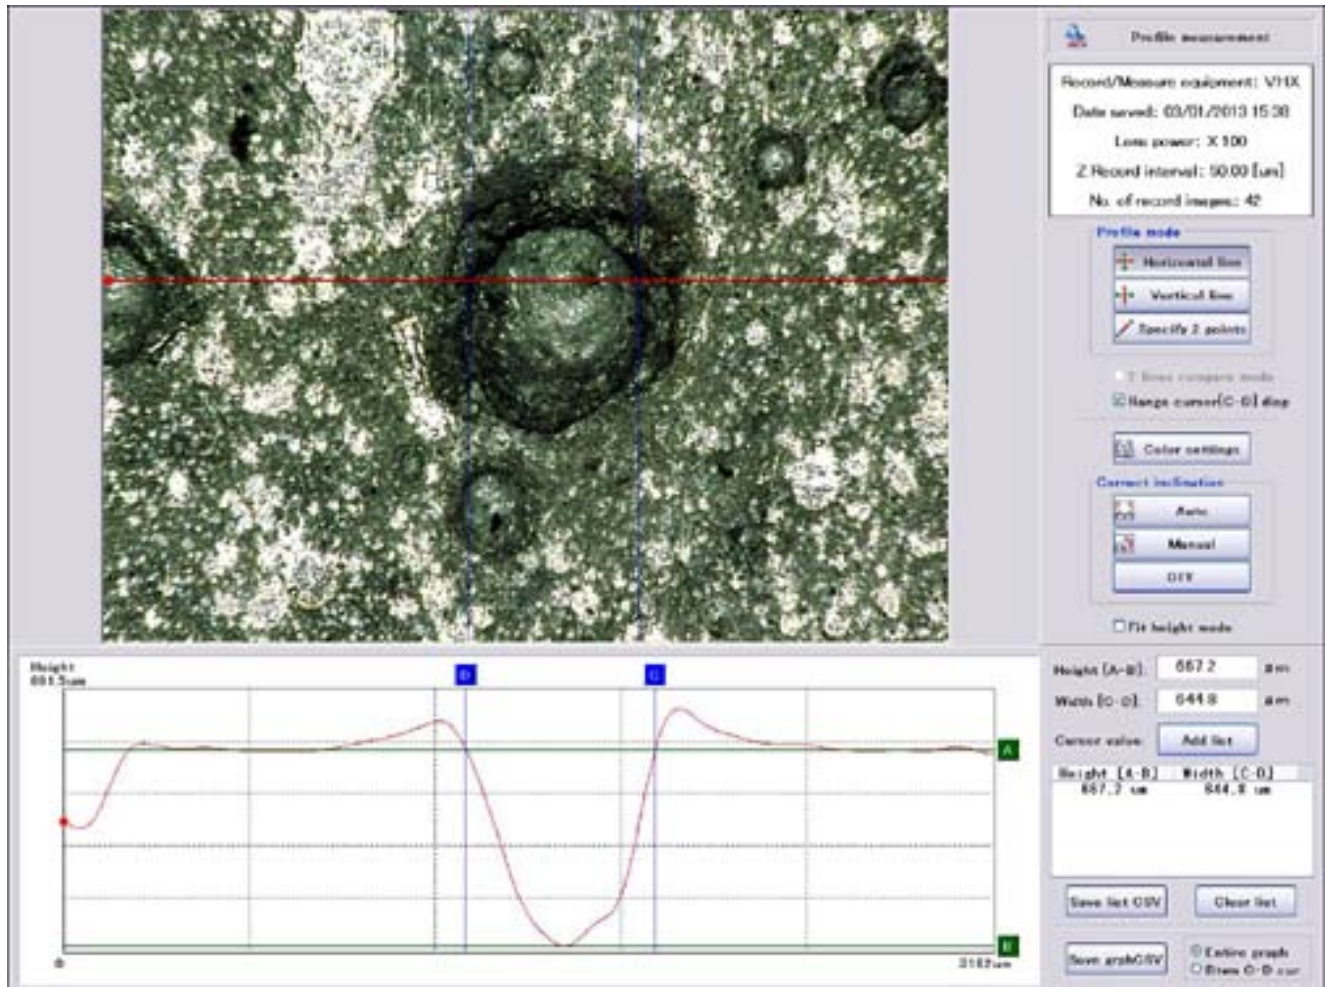
Test #4, HITF12260

Figure 80: Witness Plate of ISS Soyuz OM Test #4  
 (Keyence 3D Microscope Image)

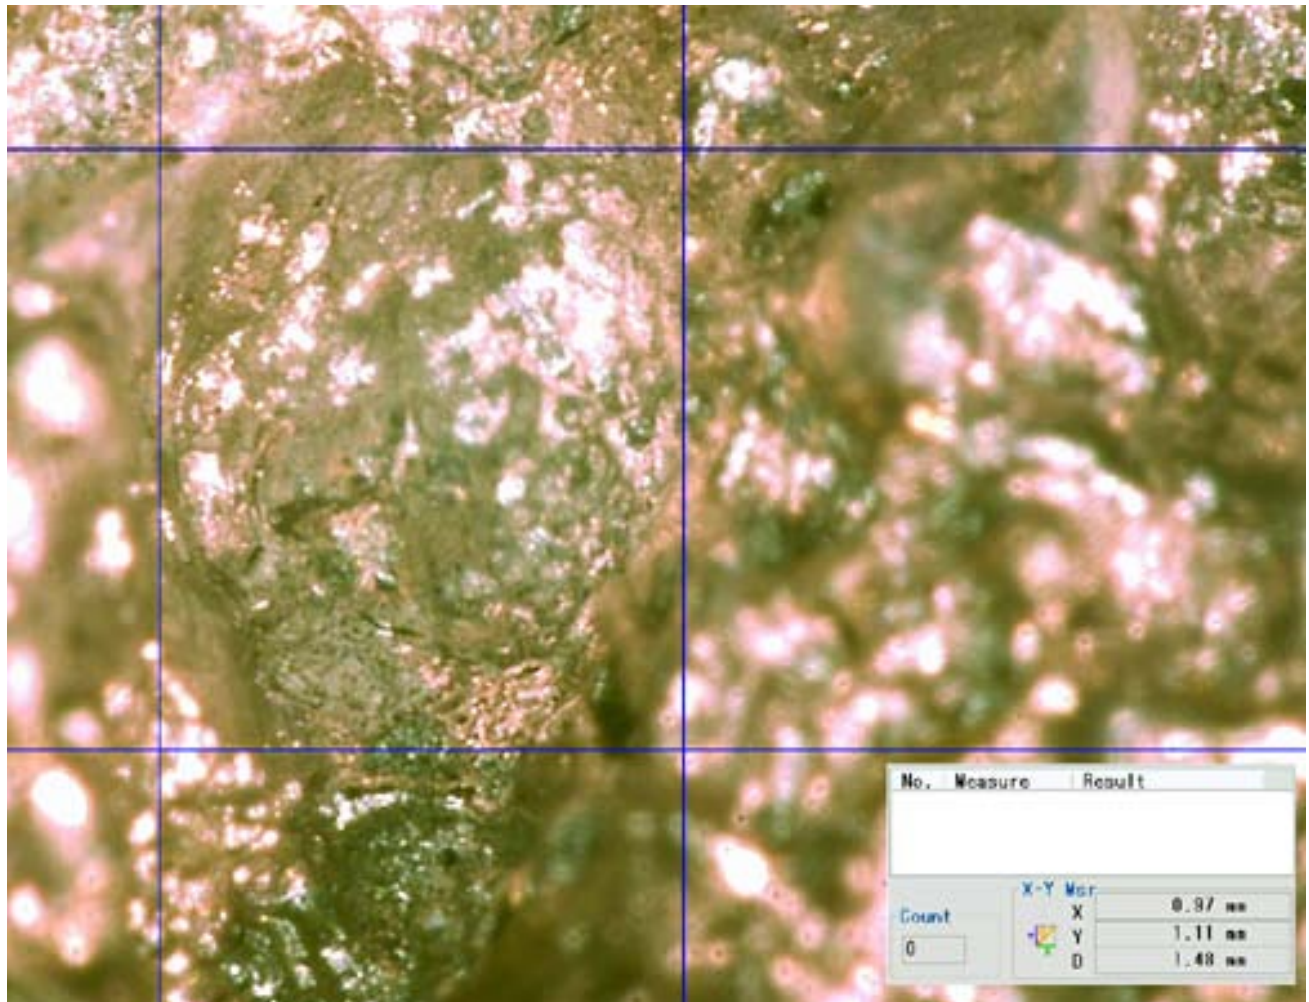
**Test #6B, [HITF12262 Rear Wall](#)**

**Figure 109: AI 5456-0 Rear Wall Layer 8 Front of ISS Soyuz OM Test #6B  
(Keyence 3D Microscope Image)**
